# National Property Inspections

John Q. Client, 123 Sample Avenue, Some City, NY, 10000

Tuesday, August 3, 2021

Inspection Date:  
08/03/2021

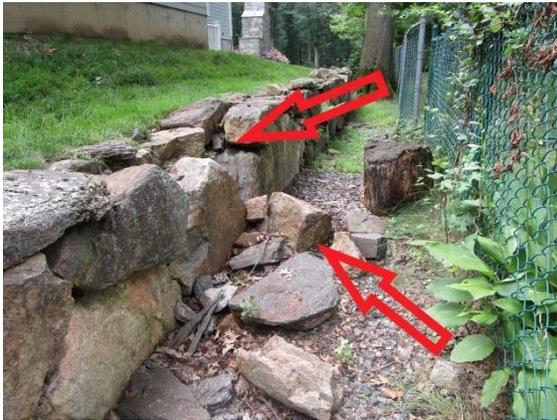
A collapse of a small section of the natural stone retaining wall adjacent to the driveway and right side of the home was observed. The earth behind the collapsed area has not moved. However, it is recommended that this condition be repaired to avoid erosion and further deterioration of the wall.

Retaining Walls: Retaining wall collapse

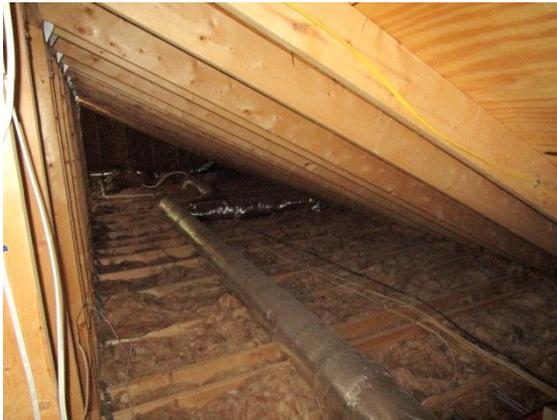
Attic Framing/Sheathing:

Roof rafters were 2 inch x 10 inch wood, 16 inches on center with plywood sheathing. There were no signs of cracked roof rafters or signs of water penetration. The attic framing and sheathing was in acceptable condition.

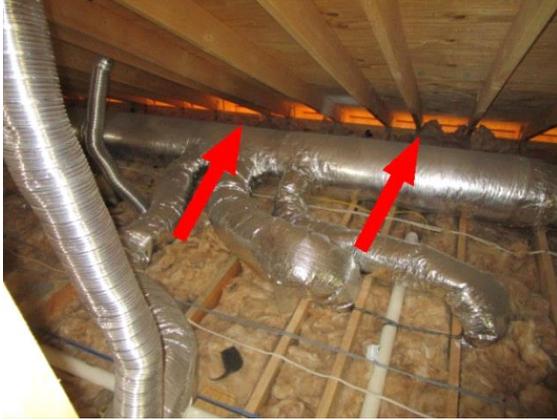
The attic was ventilated properly. No deficiencies were observed at time of inspection.

Attic Ventilation: Venting at eaves

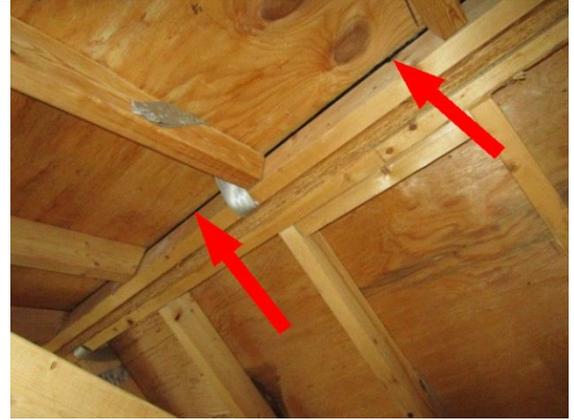
Attic Ventilation: Venting at roof ridge

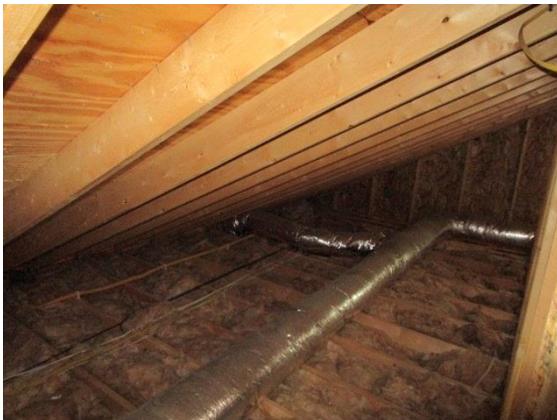
Fiberglass Batt insulation was in generally acceptable condition

Attic Insulation: Fiberglass batt insulation

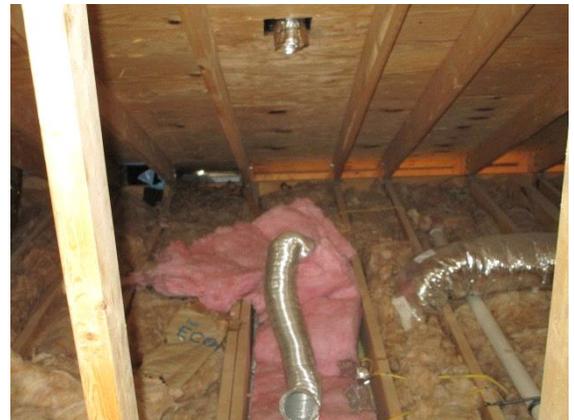
Attic Insulation: Disturbed insulation

Some areas of attic insulation were disturbed. Recommend the insulation be returned to its proper placement to insure maximum energy efficiency.

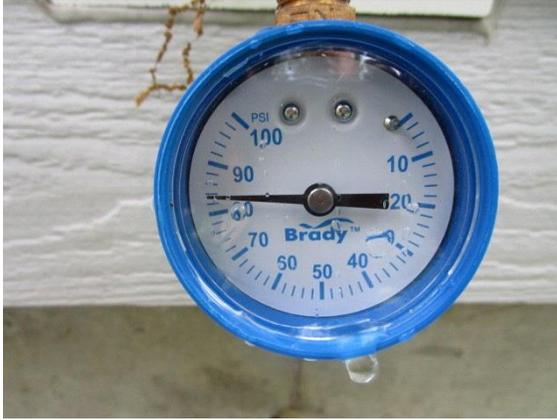
Plumbing: Water Pressure, 84 psi

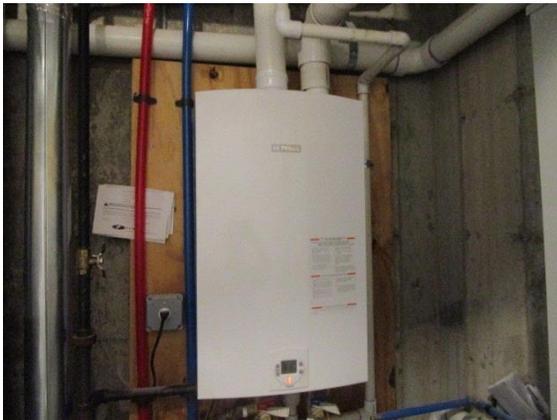
Tankless waster heater was in acceptable condition at the time of inspection.

Water Heater: Tankless water heater

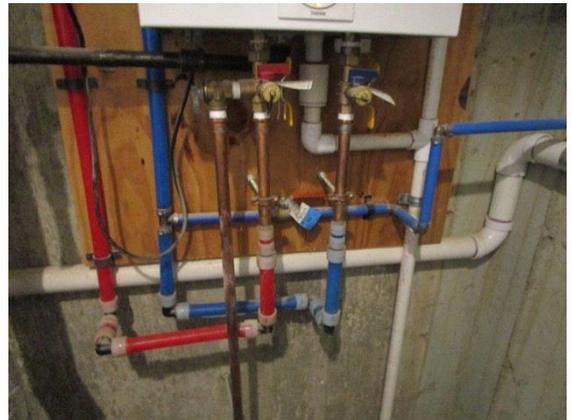
Water Heater: Water heater piping

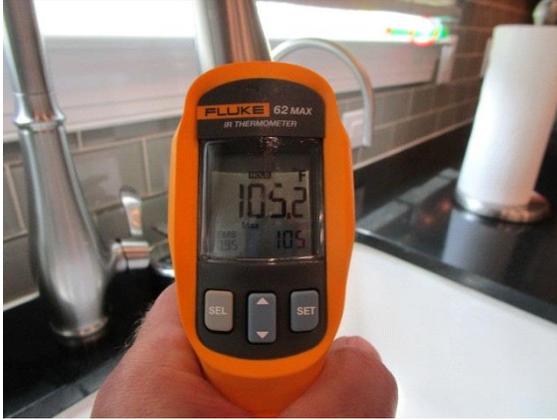
Water Heater: Hot water - 105.2 degrees F

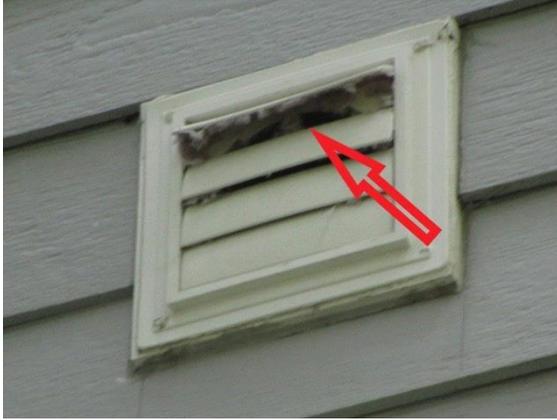
The dryer vent, which terminates on the right exterior wall of the home, appeared to have a significant build up of lint. We recommend this condition be corrected. Regular cleaning of the dryer venting system is necessary to reduce the risk of fire.

Laundry Facilities: Dryer vent - clogged with lint

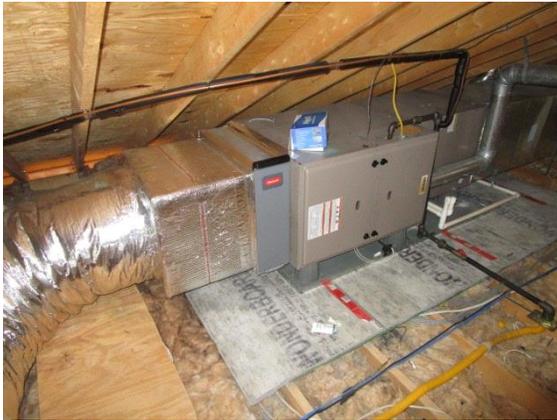
From a visual only inspection, the main house furnace was clean and appeared acceptable at time of inspection. The system was not operated because it was set for summer air conditioning operation and the temperature was above 65 degrees farenhiet.

Heating - Main: Main house furnace located in attic

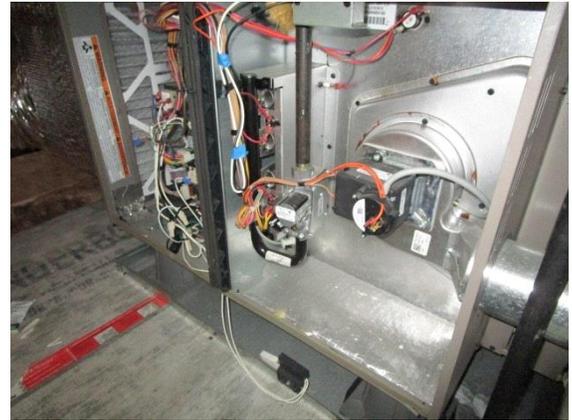
Heat Exchanger - Unable to detect cracks/holes without dismantling unit.

Heating - Main: Main house furnace interior

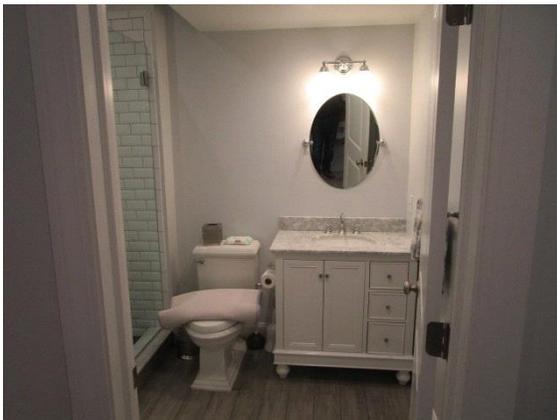
Basement Bathroom:

All components in the basement bathroom were acceptable at time of inspection.

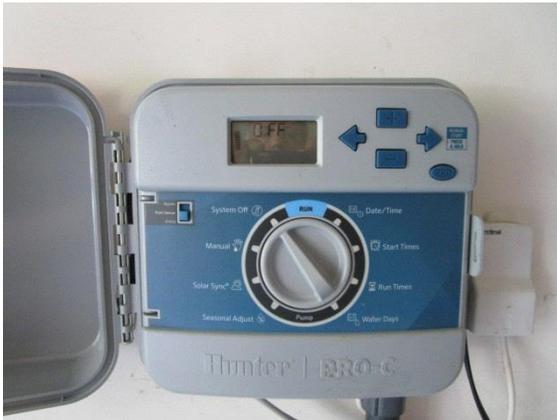
The sprinkler system was tested for basic operation of all zones. Confirming the operation or location of every sprinkler head, determining underground plumbing leaks and testing of automated control systems is beyond the scope of this inspection. You may wish to have an irrigation specialist further evaluate the sprinkler system.

Lawn Sprinkler: Sprinkler System - Timer/Controller  
Located in Garage

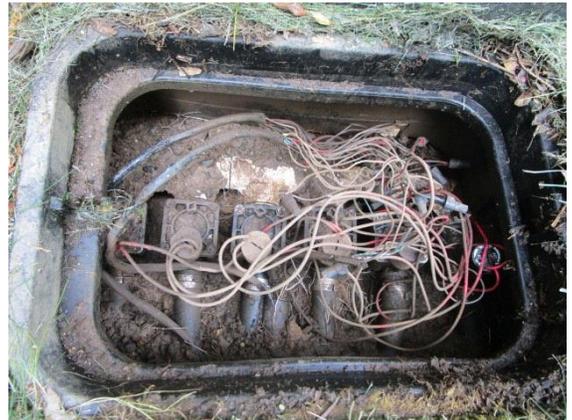
Lawn Sprinkler: Sprinkler System - Zone valves -  
Located on left side of home.
