National Property Inspections

Sample , 1000 Sample Ave, Sample, CA, 00000

Monday, September 7, 2020

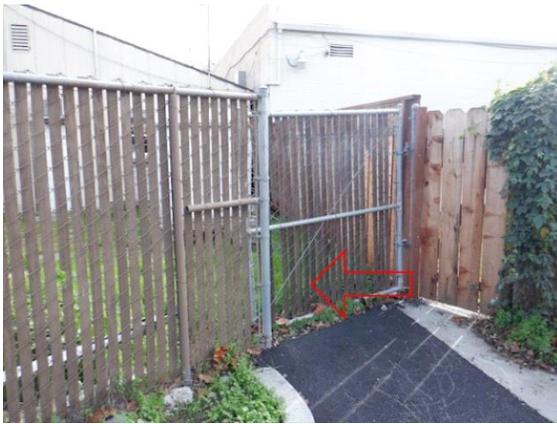
Fence gate was dragging the ground located at the back of the building.

Fences / Enclosures: Fence gate was dragging the ground

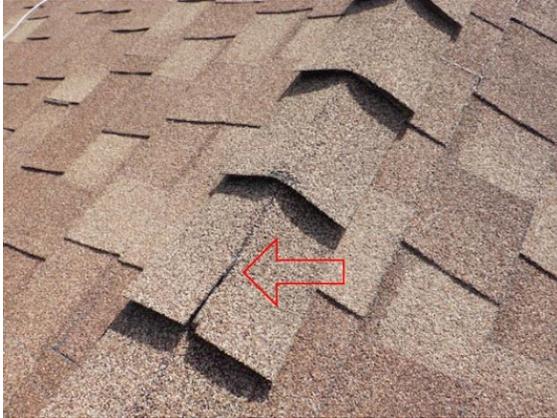
The asphalt shingles on the roof appear to be suffering from excessive granular loss. Cracked shingles were observed at the time of inspection.

Roofing: Cracked shingles were observed at the time of inspection.
The asphalt shingles on the roof appear to be suffering from excessive granular loss.

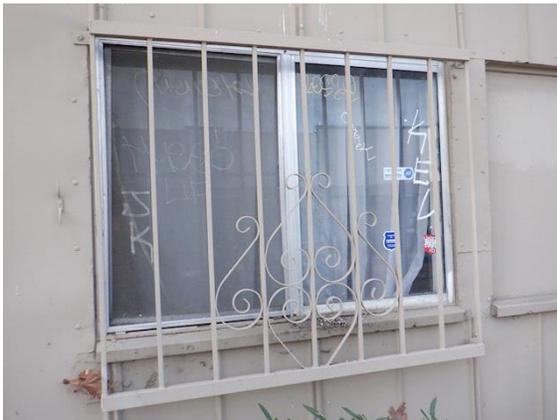
Observed security bars on the window.

Fenestration Systems: Observed security bars on the window.

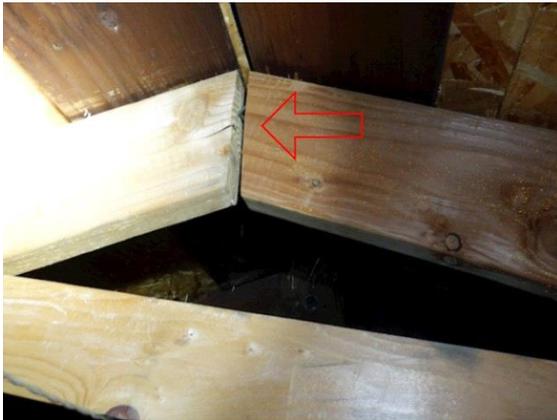
Gap was noticed on multiple rafters and between rafter and board sheathing from the original build. Observed previous moisture stain on the board sheathing. Recommend further evaluation by qualified contractor(s).

Attic / Roof Framing and Sheathing: Gap was noticed on the multiple rafter.

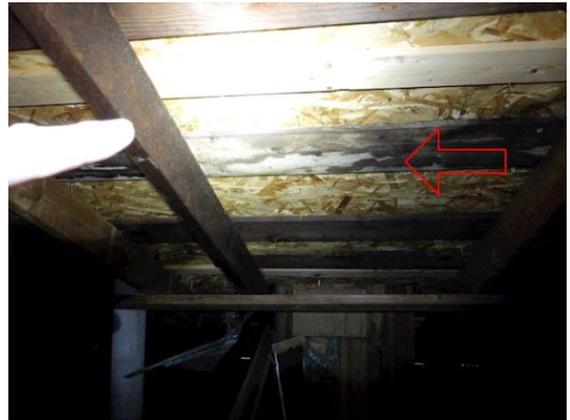
Attic / Roof Framing and Sheathing: Observed previous moisture stain on the board sheathing.

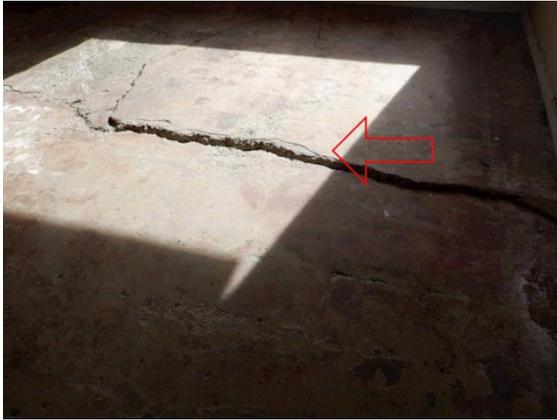
Settlement type cracks observed on the slab . Monitor regularly and evaluate/repair as required.

Interior Foundation unit 3121: Settlement type cracks observed on the slab

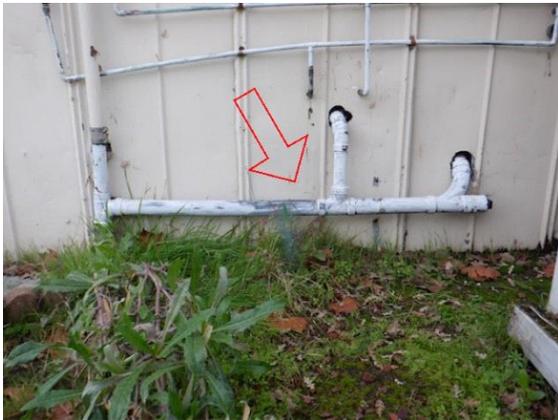
Plumbing: Observed sections of the drain pipe on the back exterior of unit #3121 slope upward

Observed sections of the drain pipe on the back exterior of unit # 2 slope upward. This could cause the drain to clog and not drain properly and should be corrected.

Recommend further evaluation/repair by qualified contractor(s).

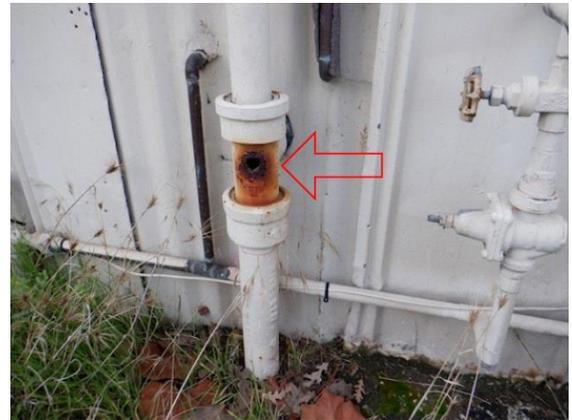
Plumbing: Some sections of the plumbing have signs of rust and holes

Some sections of the plumbing have signs of rust and holes which can become a possible leakage problem.

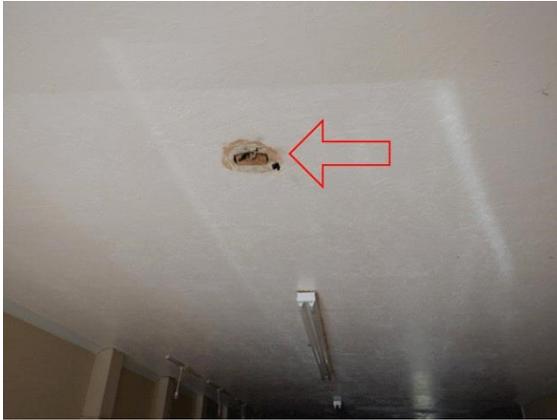
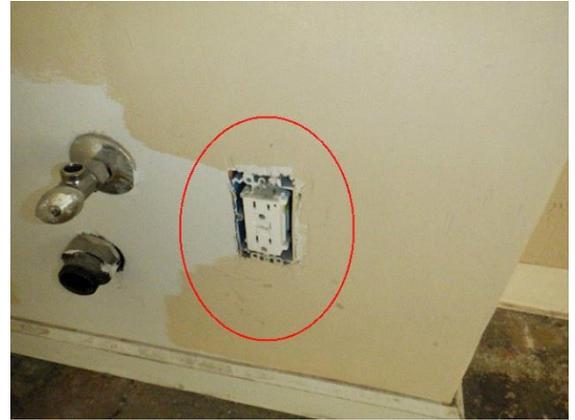
Approximately 90 % electrical outlets had no power at the time of inspection
Missing multiple electrical cover plates.

Office # 1: Missing multiple electrical cover plates.
