National Property Inspections

Sample , 000 Sample Ct, Sample, SM, 00000

Monday, September 7, 2020

Inspection Date:
09/07/2020

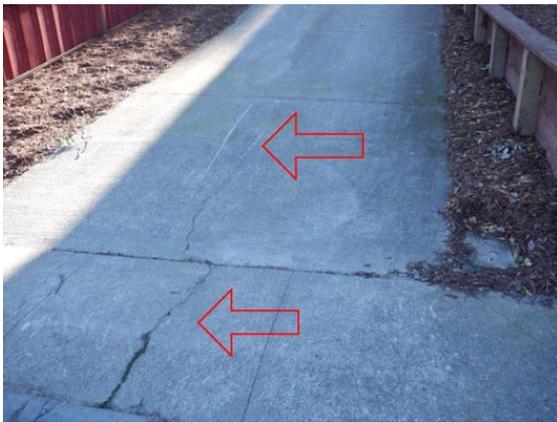
Driveway:

General deterioration, cracking. Driveway was functional at time of inspection.

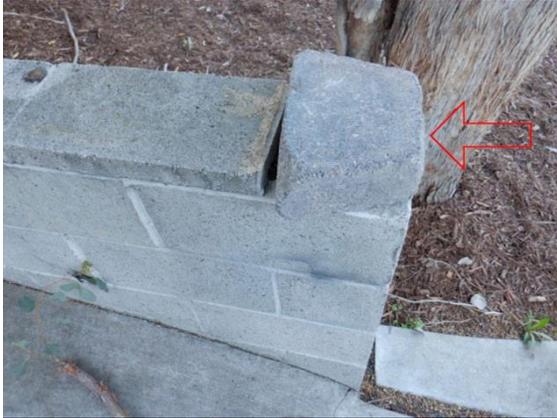
Noticed loose brick on the top of the retaining wall in front of the house.

Retaining Walls: Noticed loose brick on the top of the retaining wall

Recommend further evaluation/repair by qualified contractor(s).

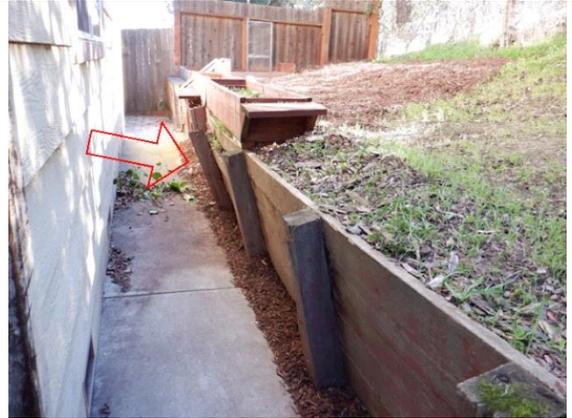
The retaining wall was showing signs of bowing/leaning. This retaining wall was holding up a significant static load (i.e. lateral pressure of the soil). If this wall has not been properly designed, the earth pressures will continue to push the wall forward or overturn it.

Retaining Walls: The retaining wall was showing signs of bowing/leaning

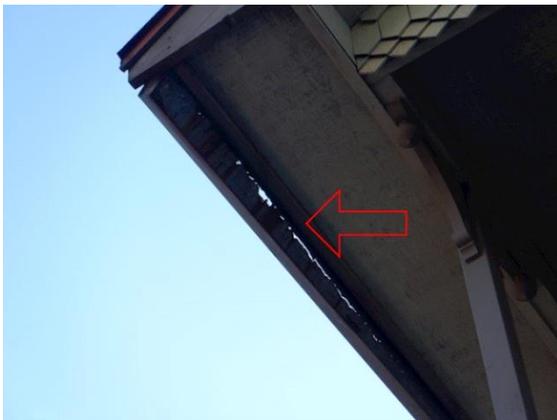
The gutters were filled with debris which was inhibiting water to drain off the roof and flow through the gutters and downspouts properly.

Observed damaged/rustet gutters in multiple location of the house.
Recommend further evaluation/repair by qualified contractor(s).

Gutters/Down Spouts: Observed damaged/rustet gutters

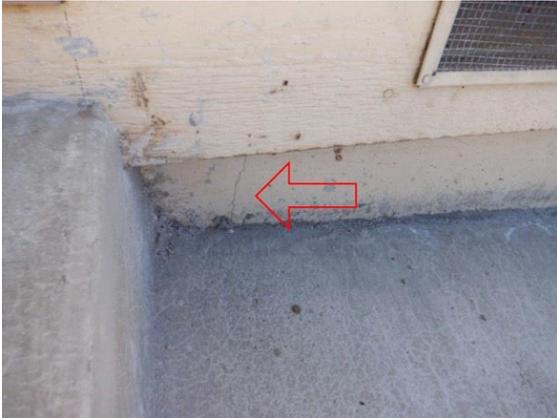
Foundation:

Foundation walls were found to have minimal cracking.

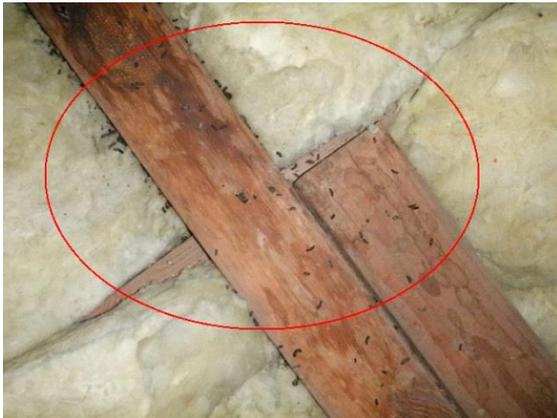
Water staining on roof sheathing, mainly around vent penetration. Dry at time of inspection. Noticed possibly sign of rodent activity in the attic.

Attic Framing/Sheathing: Noticed possible sign of rodent activity in the attic.

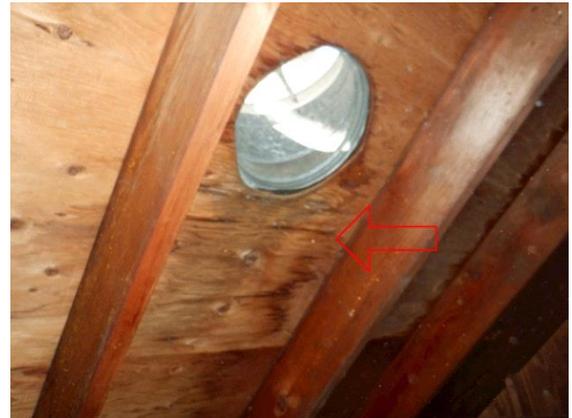
Leaks not always detectable.

Attic Framing/Sheathing: Water staining on roof sheathing, mainly around vent penetration

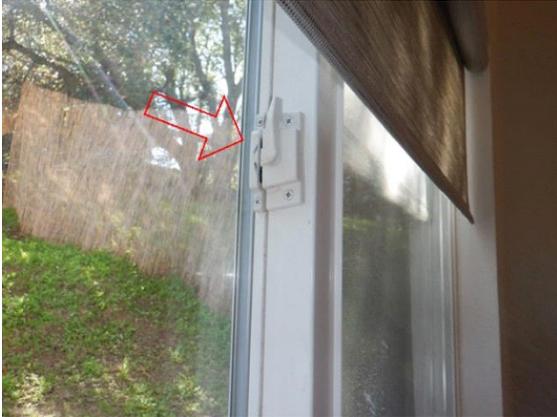
The window lock was broken or inoperable. This should be replaced for safety reasons.
Minor crack was noticed on the ceiling.

Living Room/Dining Room: The window lock was broken or inoperable.

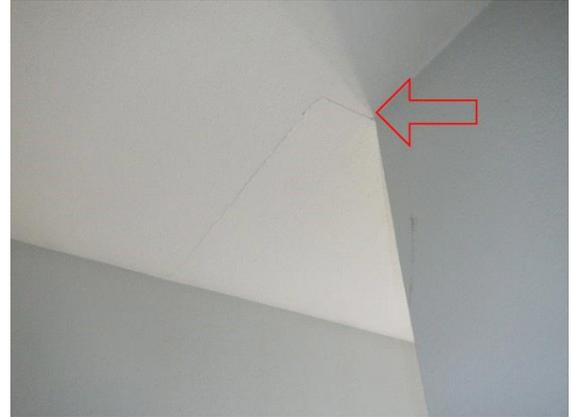
Living Room/Dining Room: Minor crack was noticed on the ceiling.
