Report V1.0

# Engineer's Foundation Evaluation

123 Main St, Your City, SC, 12345

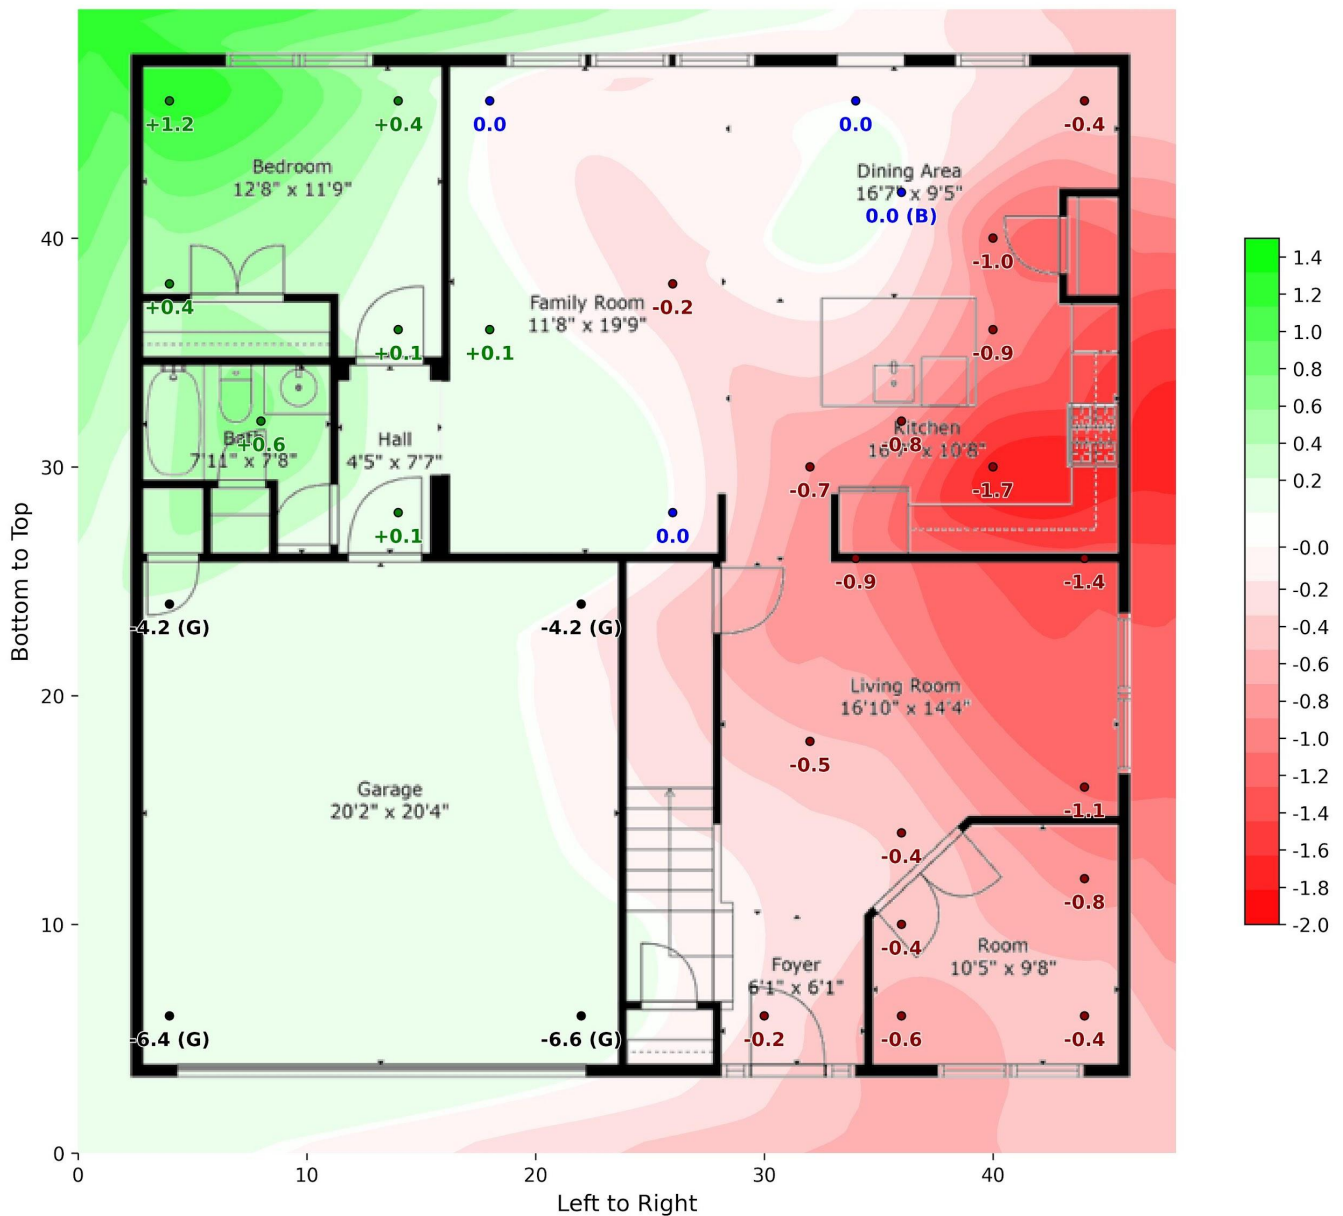
**Elevation Plot Graphic (Figure A)**

The elevation plot resulted in the graphic as depicted above in Figure A. The red-points and areas are elevation measurements that were lower than the base station elevation (0.0). The green-points and areas are elevation measurements that were higher than the base station elevation (0.0). The blue-points (and white areas) are equal to the base station elevation (0.0). The base station is depicted with a (B) symbol. The elevation plot takes into account differences in flooring thicknesses. The maximum elevation point was determined to be 1.2 inches and the minimum was -1.7 inches, resulting in an elevation difference of 2.9 inches of difference across the structure.

The elevation plot graphic above will show points labeled with a (G) symbol representing Garage. These elevation points were measured and plotted so they can be compared year-to-year, however, they are excluded from the foundation analysis. This is because garages can be non-monolithic and/or they are poured to purposefully slope toward the exterior garage door making any conclusions derived difficult to interpret.

Elevation differences across the structure are the first indicator that a foundation problem may or may-not exist. As documented above, the maximum elevation point of this structure was determined to be 1.2 inches and the minimum was -1.7 inches, resulting in an elevation difference of 2.9 inches of difference across the structure. The elevation plot takes into account differences in flooring thicknesses. The elevation deflection across an entire structure should, best-case-scenario, remain within 0.5 to 1-inch depending on the age of the structure. Measured differences approaching 2-inches are an initial sign of possible foundation fatigue. The maximum allowable elevation difference is subjective, depending on other factors such as the visual condition, size, and age of the structure (35 year(s) old) along with how the foundation performs when calculating deflection and tilt.

Based on observed elevations of the foundation from the elevation plot, the elevation differences do not fall within industry standards and tolerable limits. These findings indicate that the foundation does not have consistent and uniform elevation measurements. Note: elevation measurements alone is not the only indicator of foundation problems; see the deflection and tilt calculations (and the report's overall conclusion) for a complete understanding of foundation stabilization. If elevations fall outside of industry standard/tolerable limits, it is a first indicator that the foundation will fail in deflection and/or tilt.

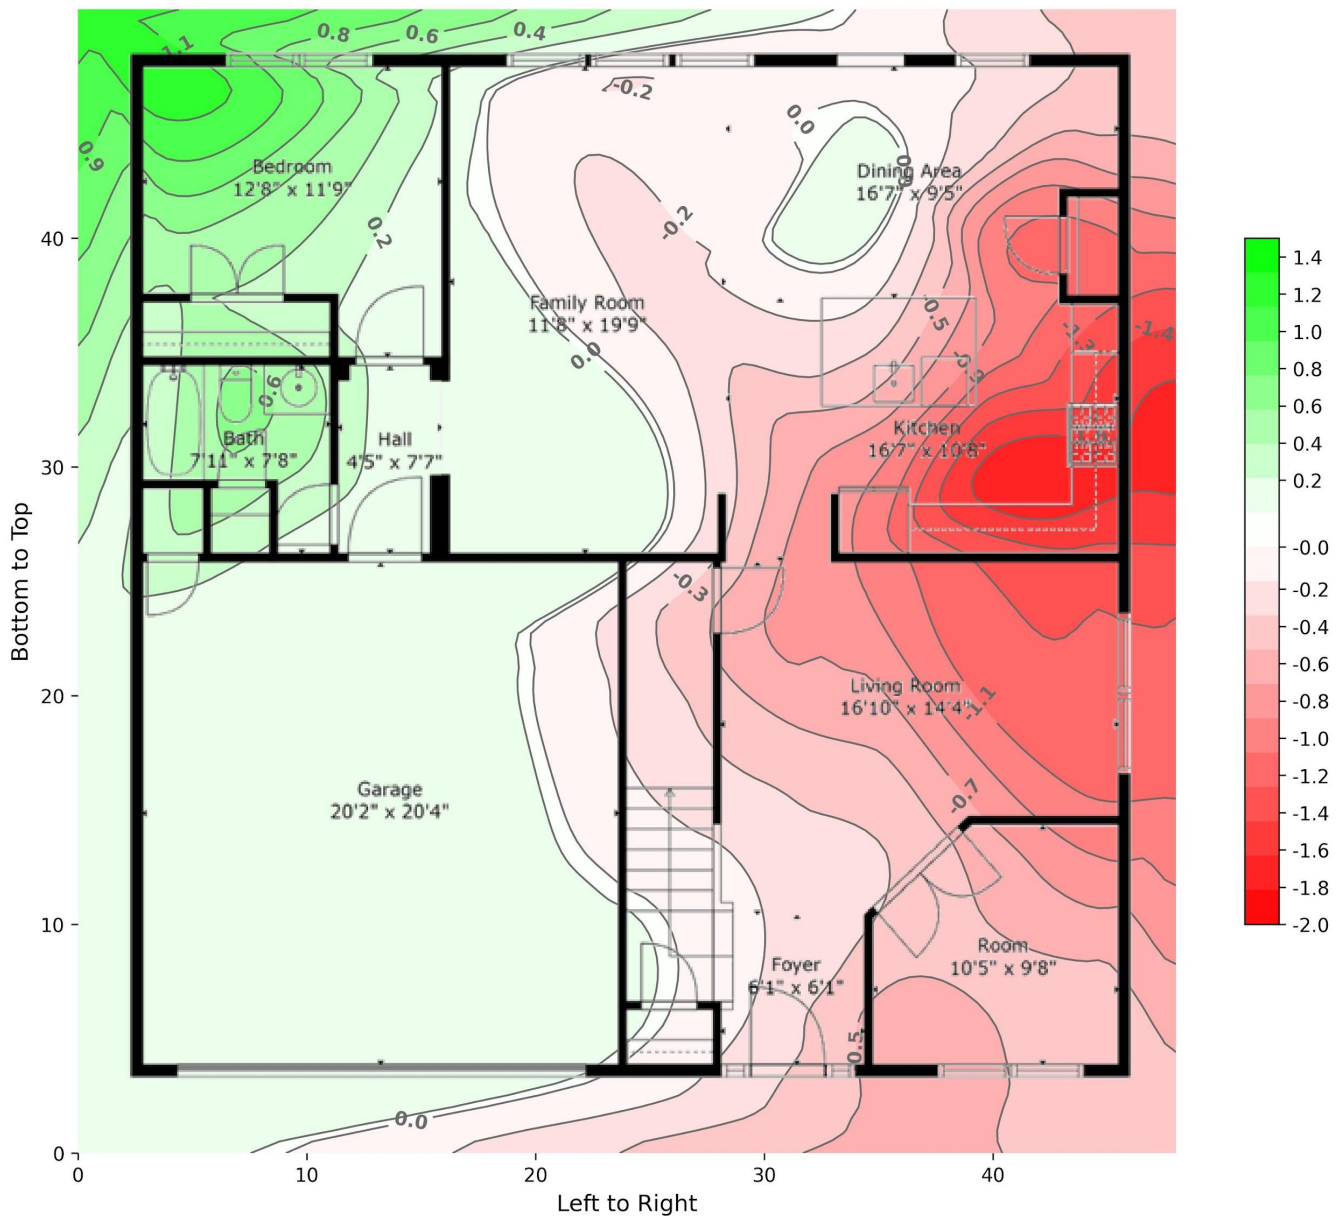
**Mesh Contour Graphic (Figure B)**

The mesh contours graphic depicted above in Figure B is similar to the elevation plot. The red, green, and white areas depict areas that are lower, higher, and equal to the base station elevation (0.0). The lines or contours (similar to map topography) are labeled at specific intervals.

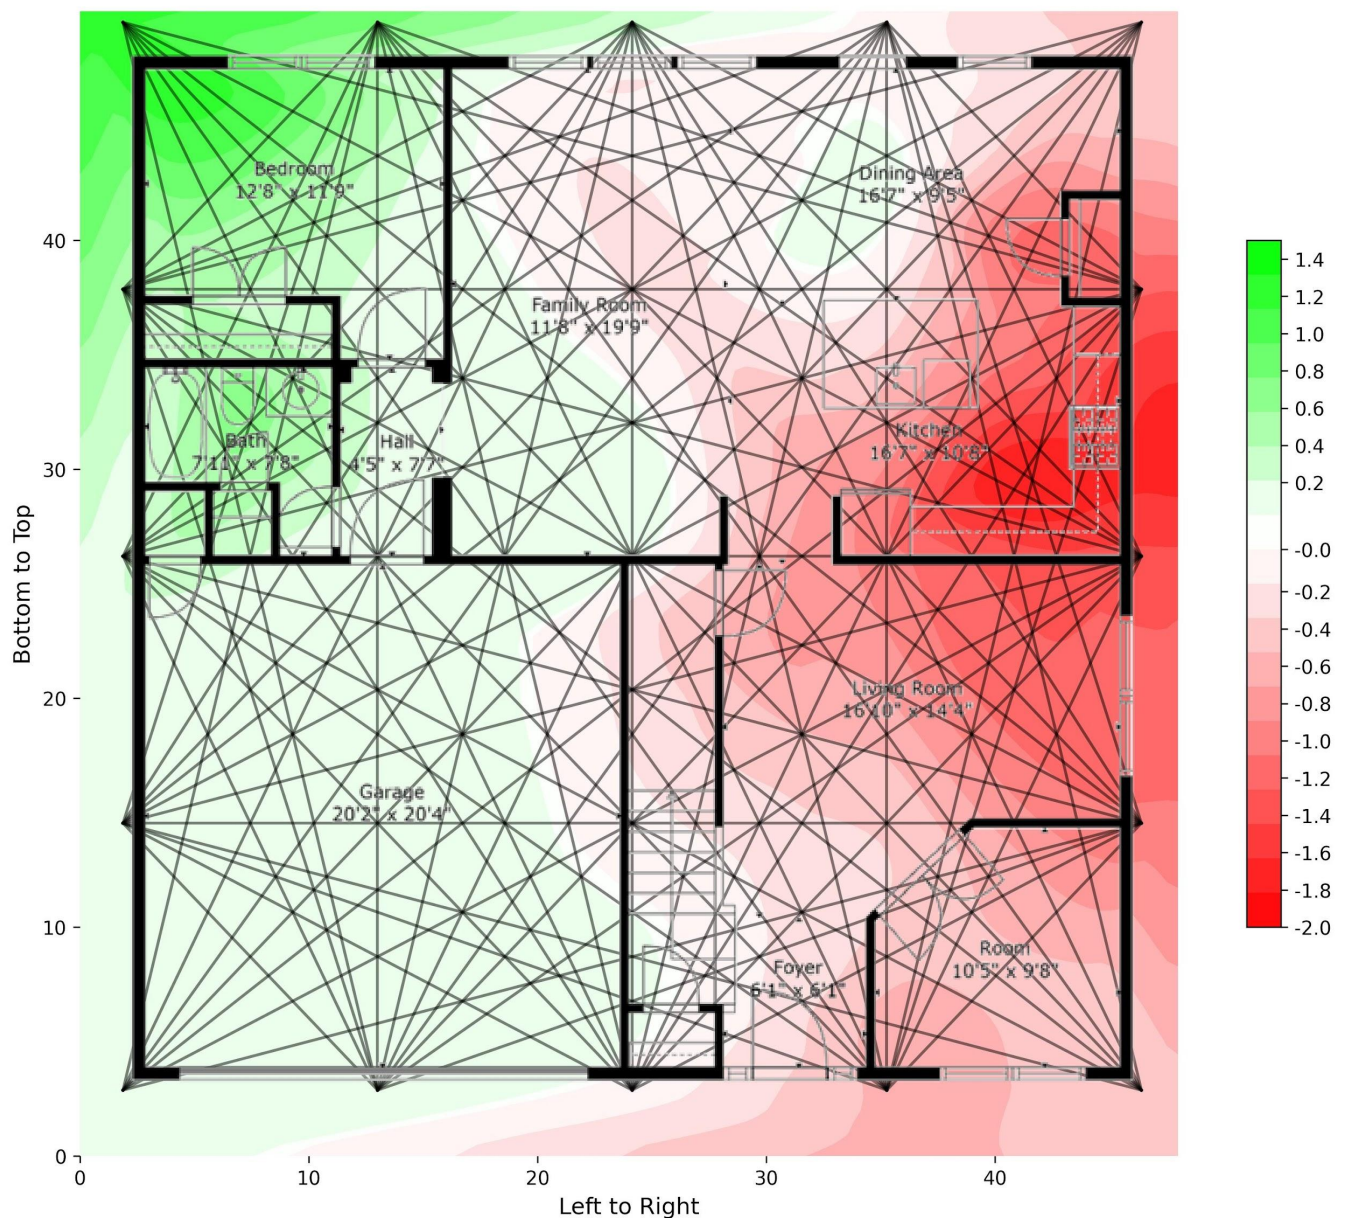
**All Profiles Graphic (Figure C)**

Below is a graphic that shows the locations of deflection and tilt profiles that were calculated. The total profiles calculated was 79 with a total usable profiles (above the effective length threshold) of 75.

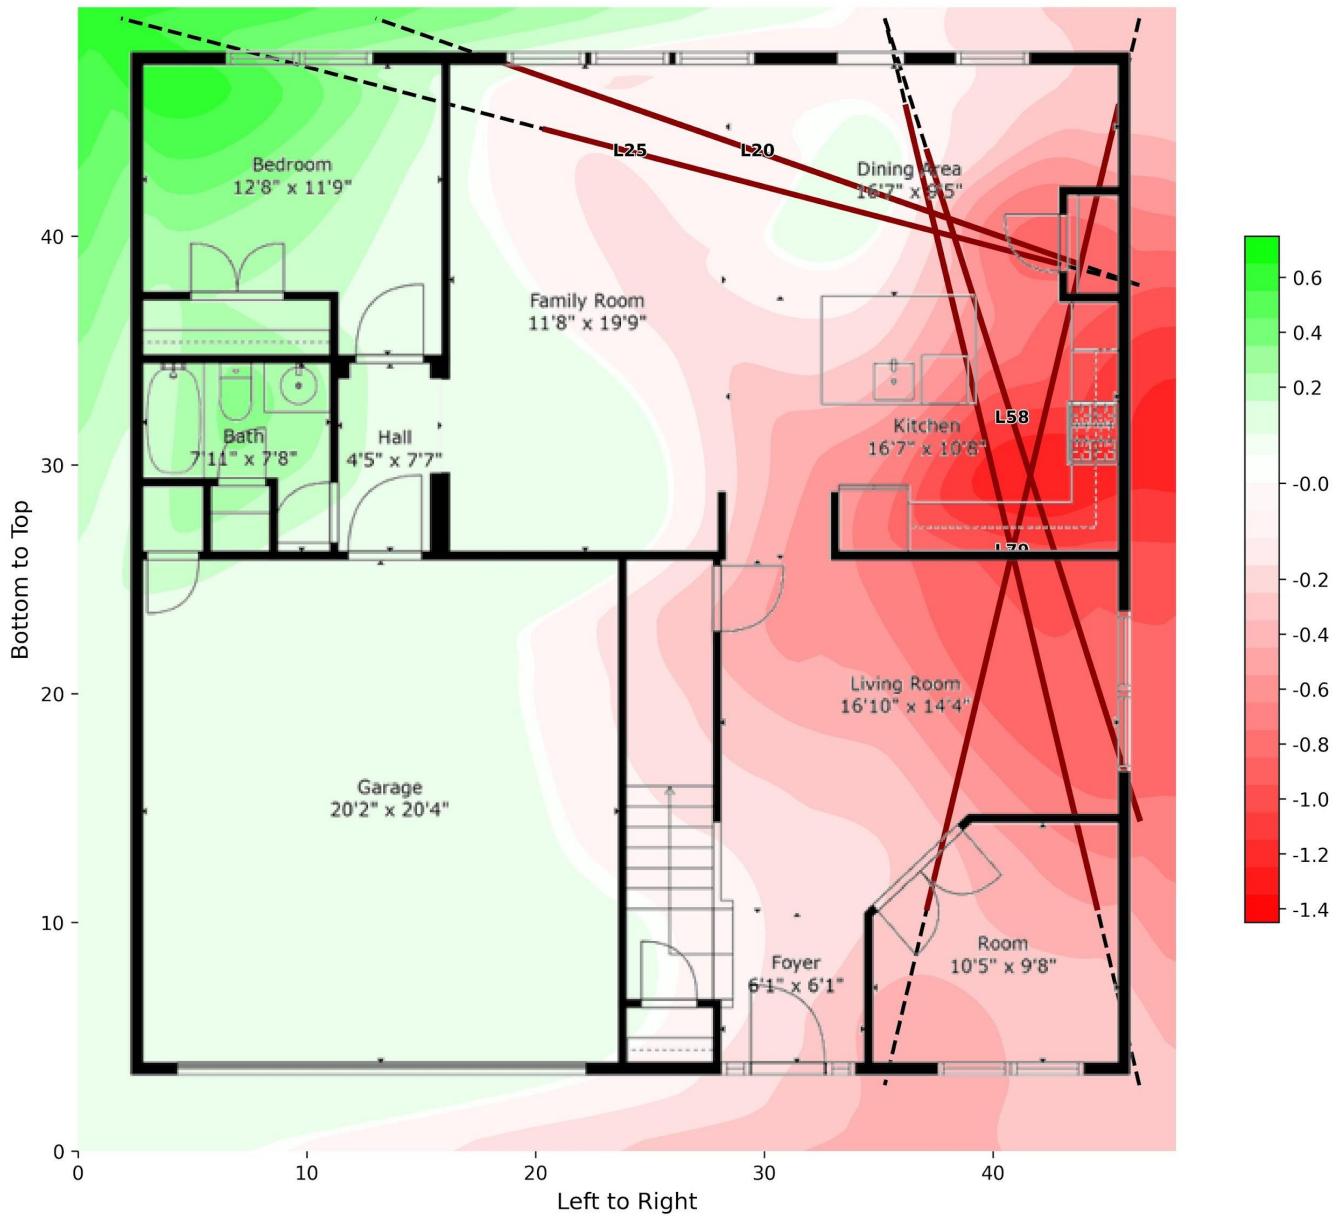
**Deflection Failures Graphic (Figure D)**

The above Figure D shows deflection failures along the foundation. Deflection failures can be considered localized failures in (sometimes) isolated portions of the foundation. The profile lines that were calculated are represented by a dashed black line and the areas that the deflection failures occur are represented by a dark red line segment. Of the 75 deflection profiles calculated, 5 profile failures were identified.

Deflection failures can be considered localized failures of the foundation in (sometimes) isolated portions of the foundation. Of the 75 deflection profiles calculated, 5 failures were identified.

Deflection failures are above standard acceptable limits; they exceed industry-standard thresholds and the structure should be considered actively moving/settling in areas where deflection failures are occurring. See the report's overall conclusion for a complete understanding of the overall foundation stabilization issue.

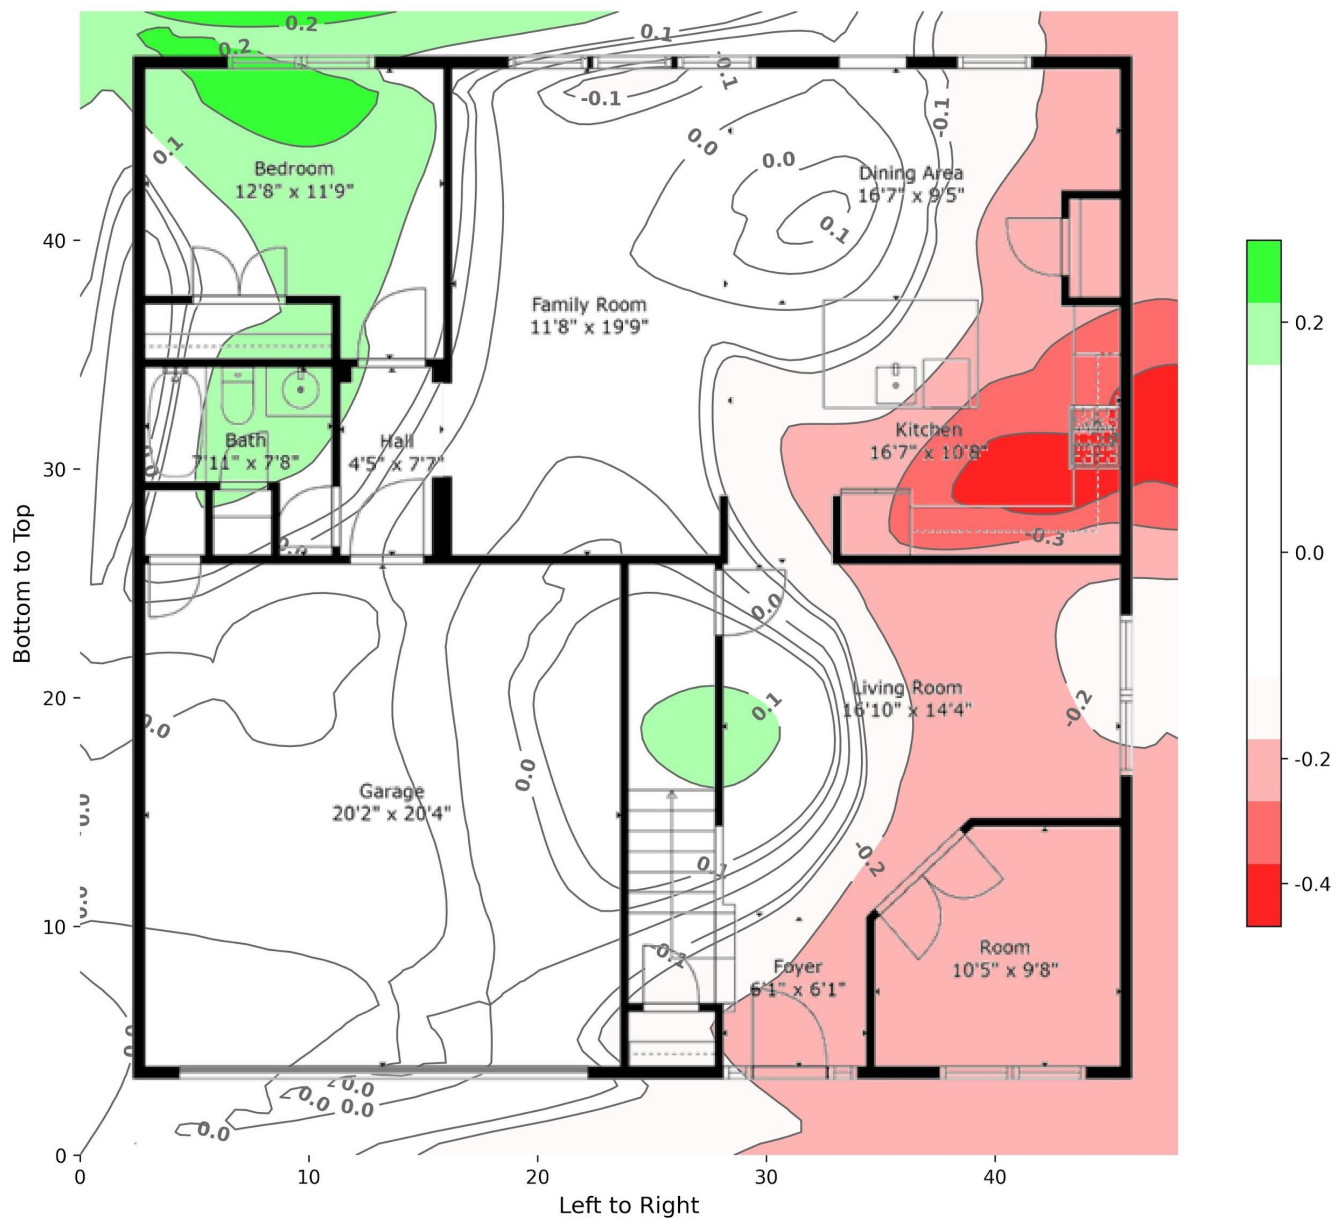
**Elevation Plot Difference Graphic (Figure F)**

A previous elevation plot completed in 2022 was available to use as a baseline of movement progression. Elevation differences are shown that show us the clear progression of movement from one date to another. As part of this evaluation, a contour mesh showing the elevation differences between the current contour mesh and the baseline was processed and is shown below.

The mesh contour graphic above in Figure F shows areas in red that are lower than the baseline elevation plot and areas of green that are higher than the baseline elevation plot (from the provided drawing completed in 2022). The darker the color (both red and green) the larger/smaller the elevation differences.

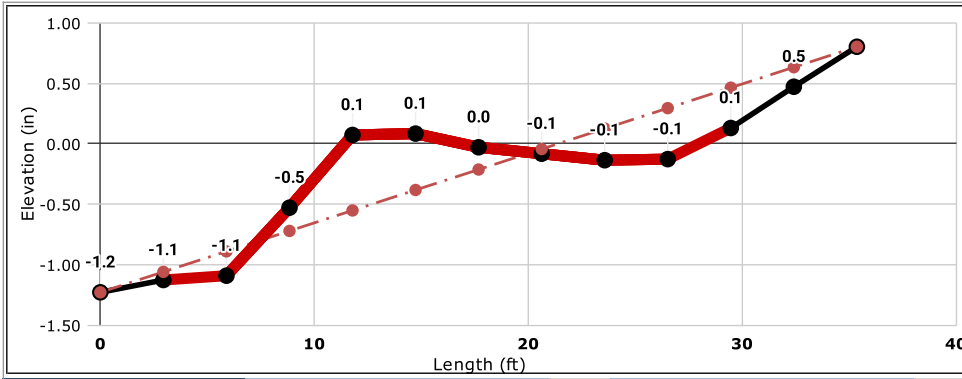
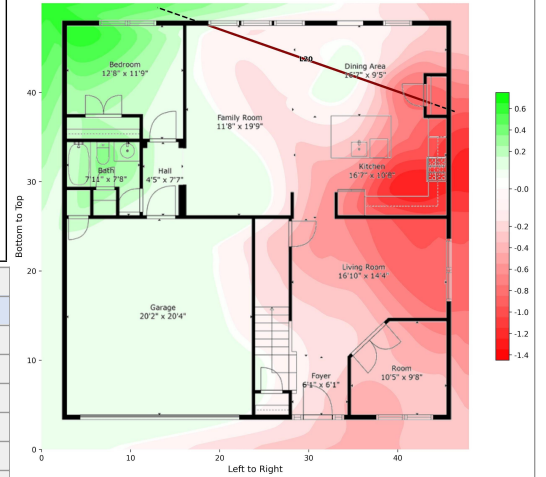
## Exhibit B: Identified Deflection/Tilt Failure (L20)

Performance Output						
Deflection & Tilt	Pass/Fail	Actual	Result Description			
Deflection 1 (using k)	FAIL	L /	279	EXCEEDS THE kL/360 (L/340) LIMIT BY 22%		
Deflection 2 (using k)	FAIL	L /	319	EXCEEDS THE kL/360 (L/340) LIMIT BY 6%		
Deflection 3 (using k)	FAIL	L /	325	EXCEEDS THE kL/360 (L/340) LIMIT BY 5%		
Deflection 4 (using k)	FAIL	L /	329	EXCEEDS THE kL/360 (L/340) LIMIT BY 3%		
Deflection 5 (using k)	PASS	L /	343	USING 99% OF THE ALLOWABLE kL/360 (L/340) LIMIT		
Tilt	PASS	0.48 %	USING 48% OF THE ALLOWABLE 1% LIMIT
