www.azinspector.com**PROPERTY CONDITION REPORT**

Client(s):	Client Name
Property Address:	12345 Address Dr Town, AZ 85379
Realtor:	Agent Name, Realty Office
Date:	05/11/2024
Inspector:	Steve Anderson
Report #:	S051103-24RT

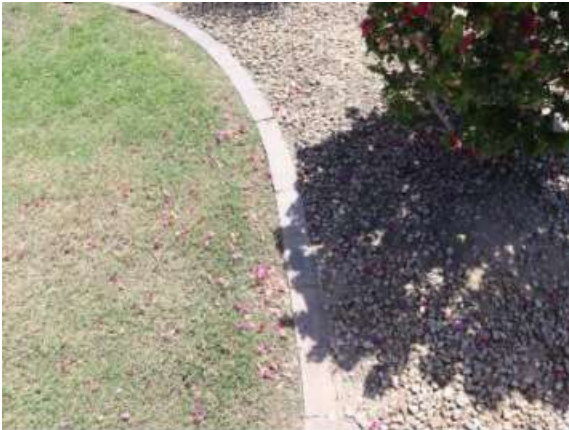
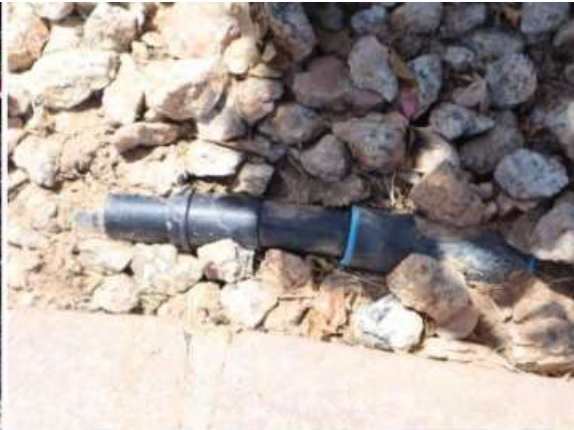
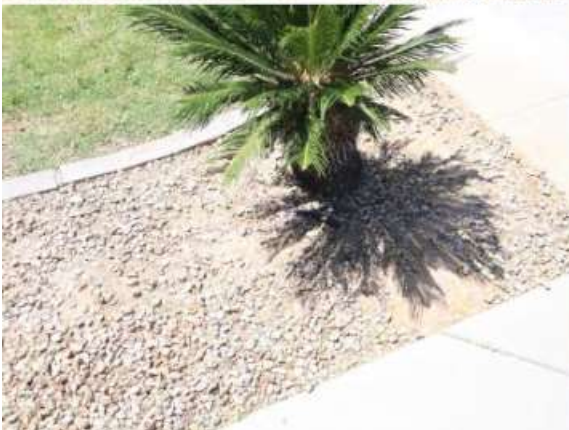
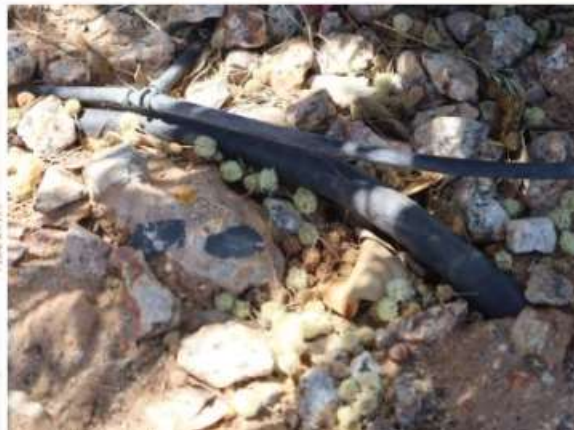
Repair: Some of the pipe for the irrigation system is exposed to the sunlight and will degrade from ultraviolet rays. All exposed pipe should be sheltered from the sun and needs repair by a qualified contractor.

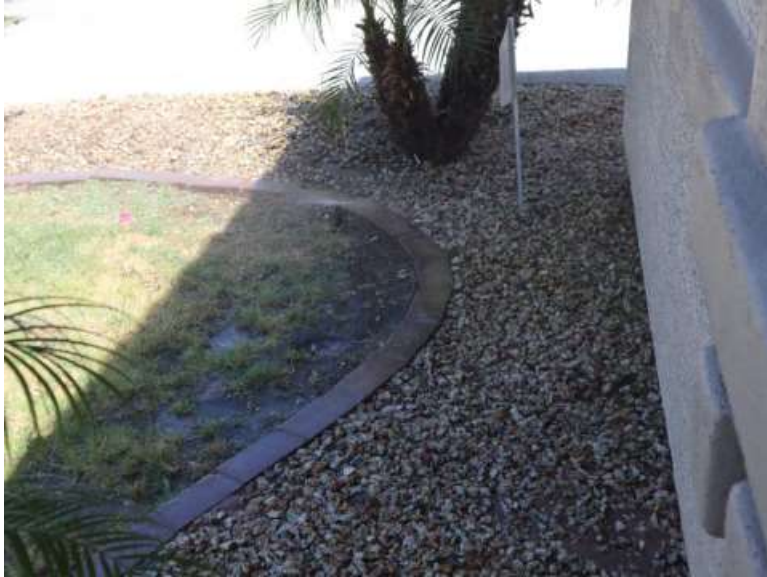
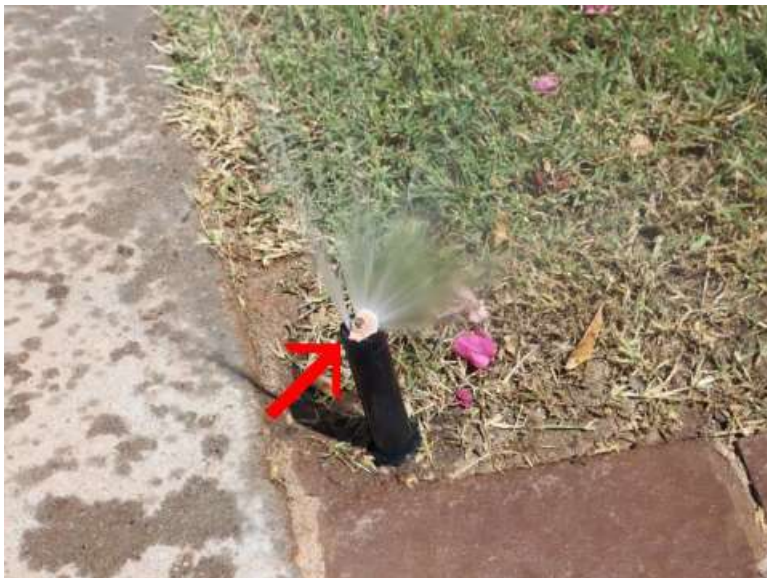
Repair: Although not every head or emitter was checked, it was observed that one or more of the emitters/heads were missing or broken and needs repair by a qualified contractor.

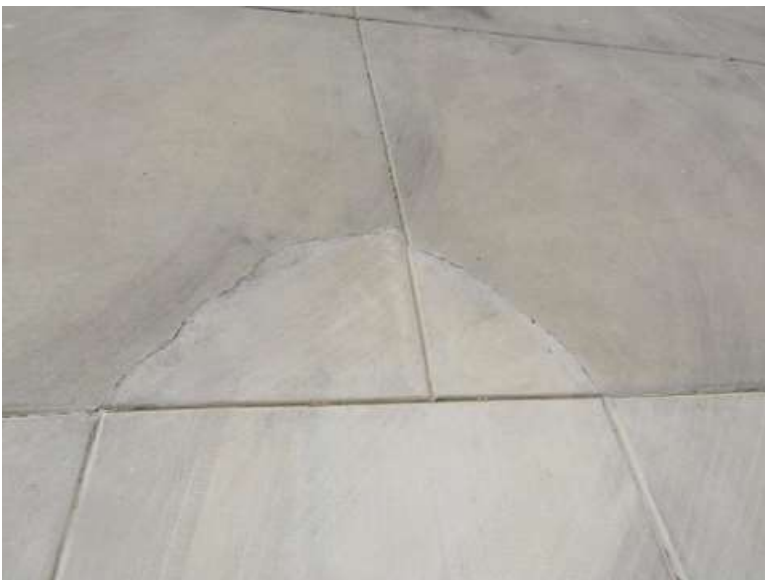
Some cracks are noted.

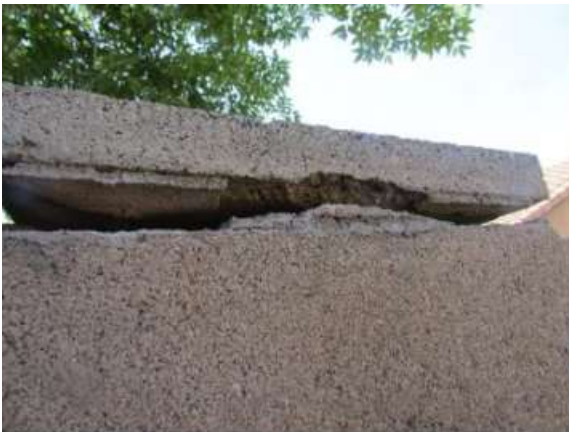
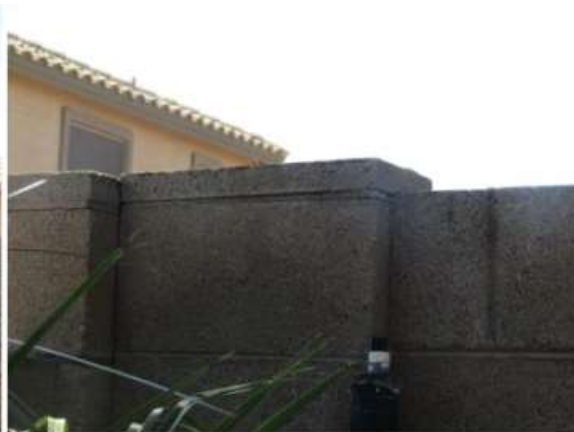
Repair: A couple of the column caps are loose on the fence around the yard. This should be corrected for the safety of anyone playing around the fence, especially children.

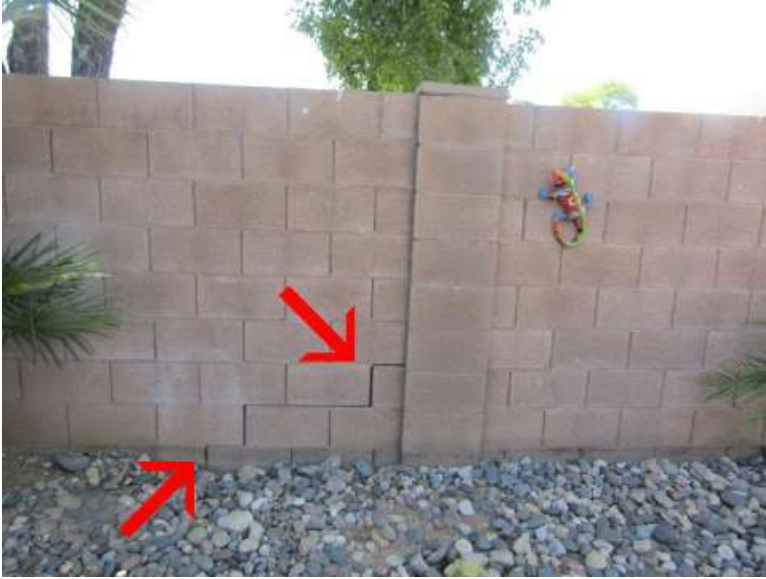
Monitor: The fence is cracking, most likely from tree roots. Although it is still sturdy, it should be monitored to ensure the safety of anyone playing around the fence, especially children.

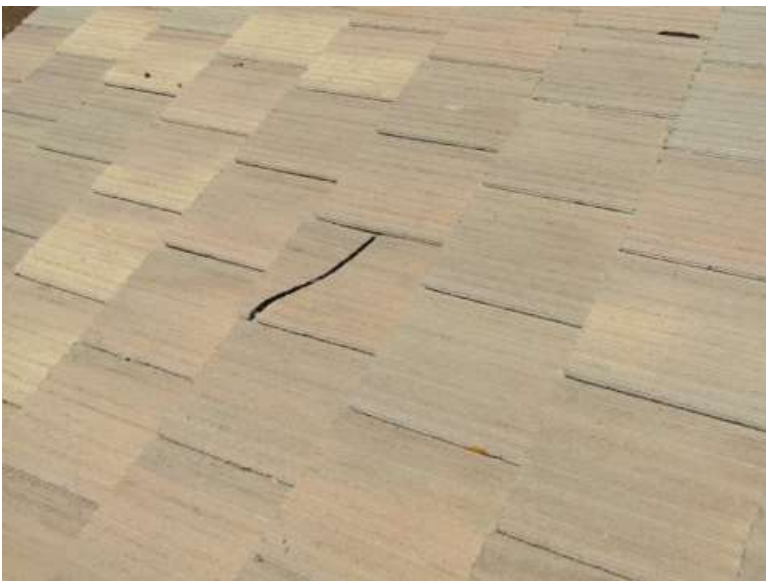
Repair: There is one cracked/broken field tile that should be replaced to prevent the possibility of water draining under the tiles and having access to the underlayment and needs to be repaired by a qualified contractor. The tile is on the east facing.

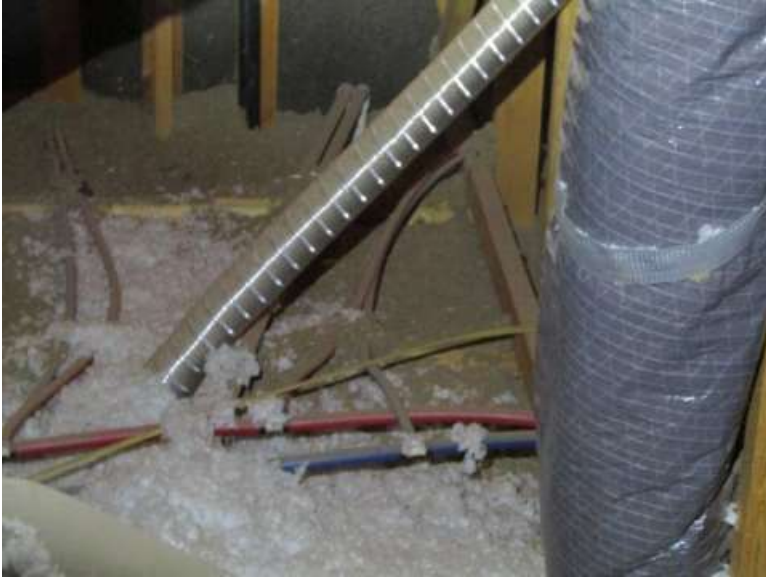
The visible water supply piping material on the interior of the building used to deliver water to the plumbing fixtures is a combination of flexible plastic (PEX) and copper. The visible and accessible distribution piping was generally in acceptable condition and was adequately supported with no signs of leakage or failure. Functional flow was tested by operating multiple faucets at the same time and judged to be satisfactory. Any exceptions are listed below. Most of the water supply lines are located in the attic area and insulation restricts viewing in most areas.

Recommend supply lines be insulated in the attic.

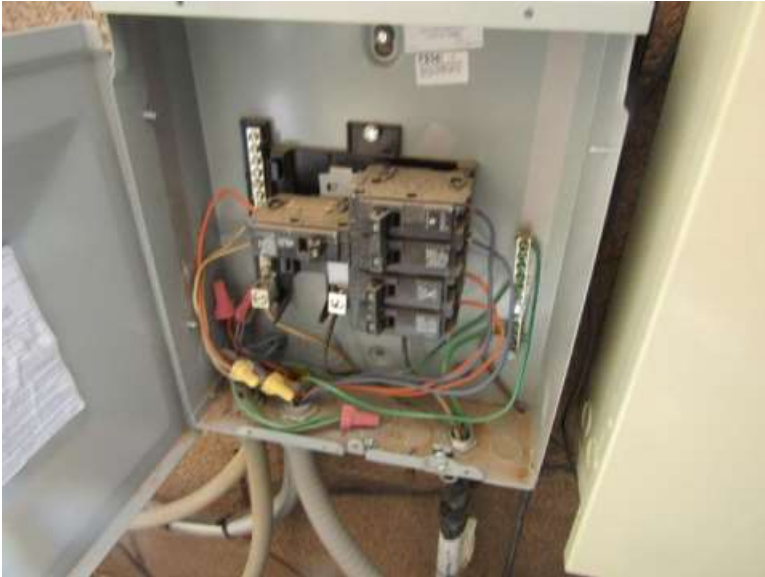
Repair: Several of the screws to secure the panel inner cover are missing.

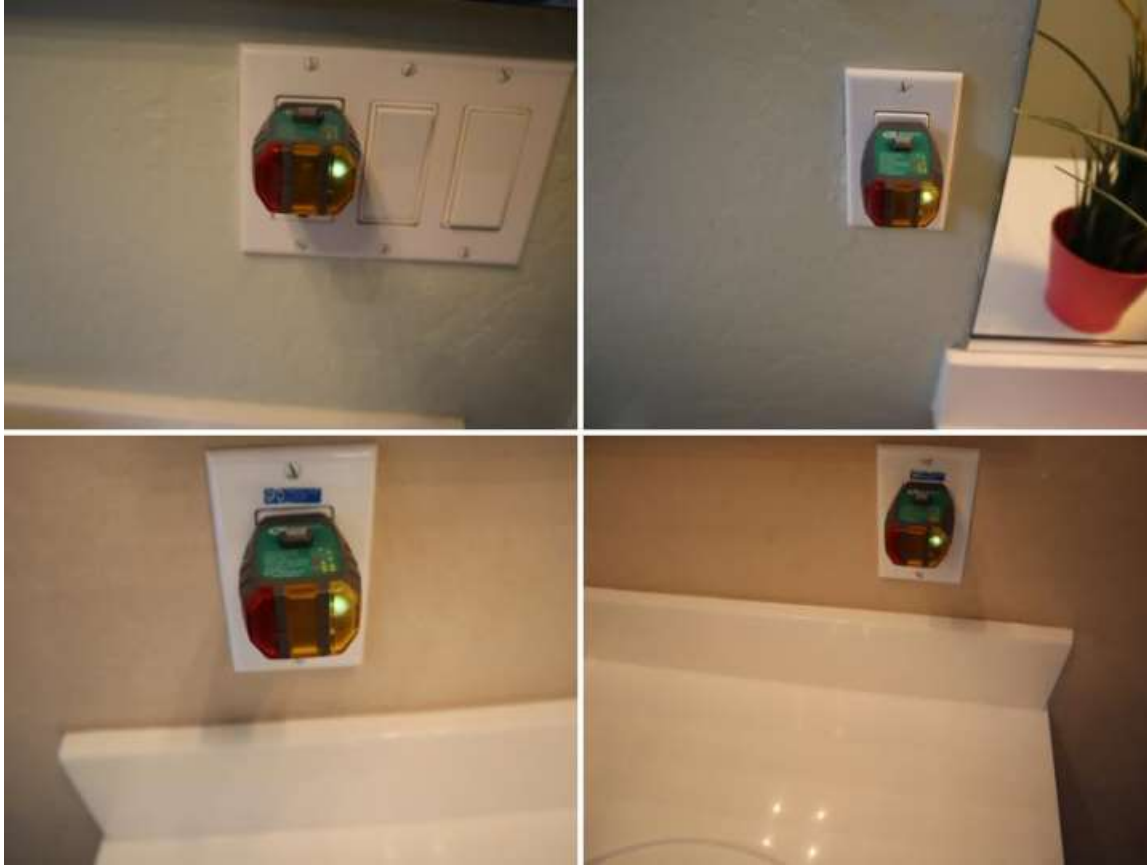
Safety Concern: One or more of the receptacles tested in the house has reverse polarity (wired incorrectly) and needs repair by a qualified contractor. Namely the bathrooms.

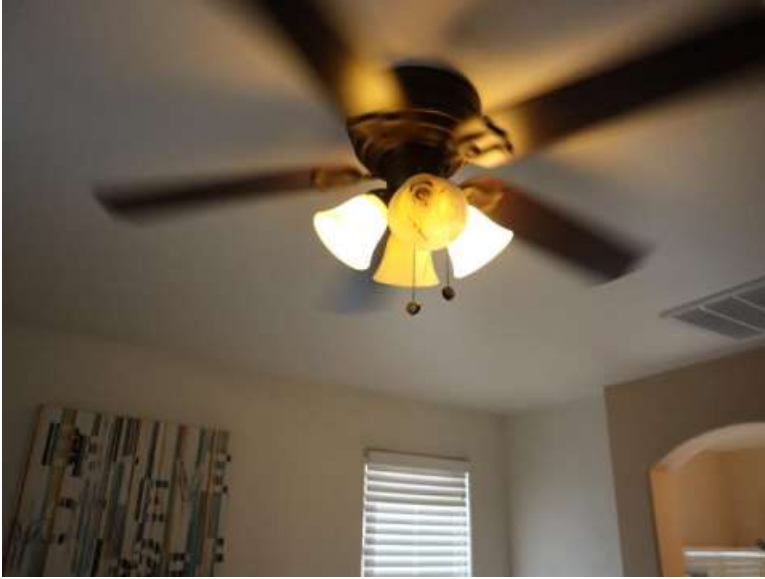
Repair: One or more of the interior light fixtures did not illuminate. Most likely, replacing the bulb will solve the problem.

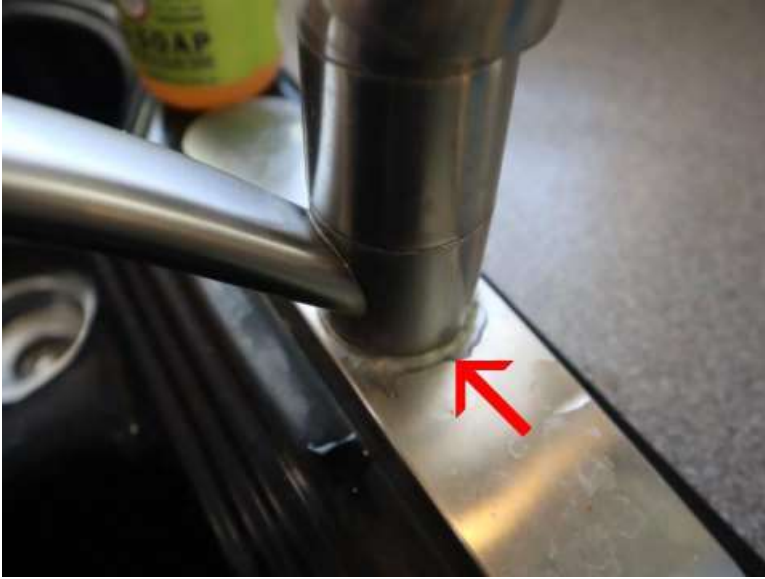
Repair: There is a leak from the base of the faucet when the water is on and needs repair by a qualified contractor.

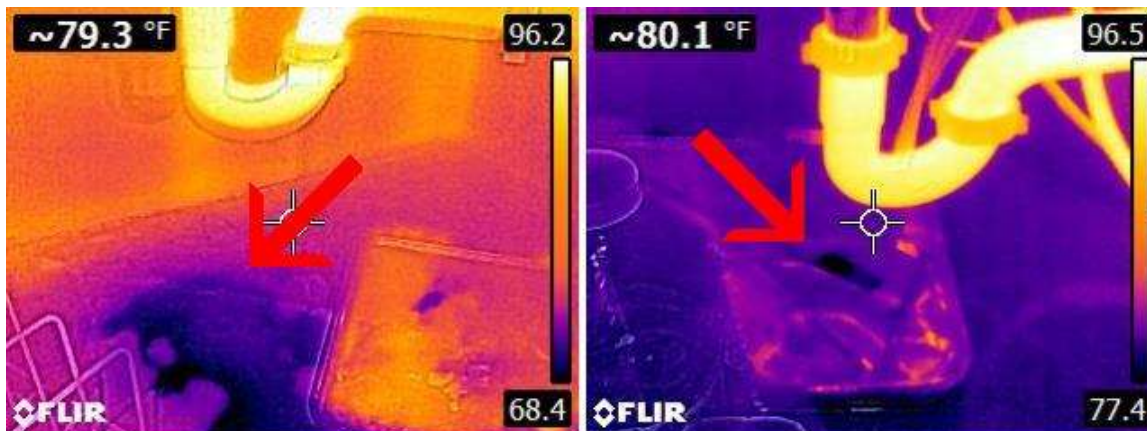
Repair: Water is leaking from under the sink at one or more of the drain connections and needs repair by a qualified contractor.

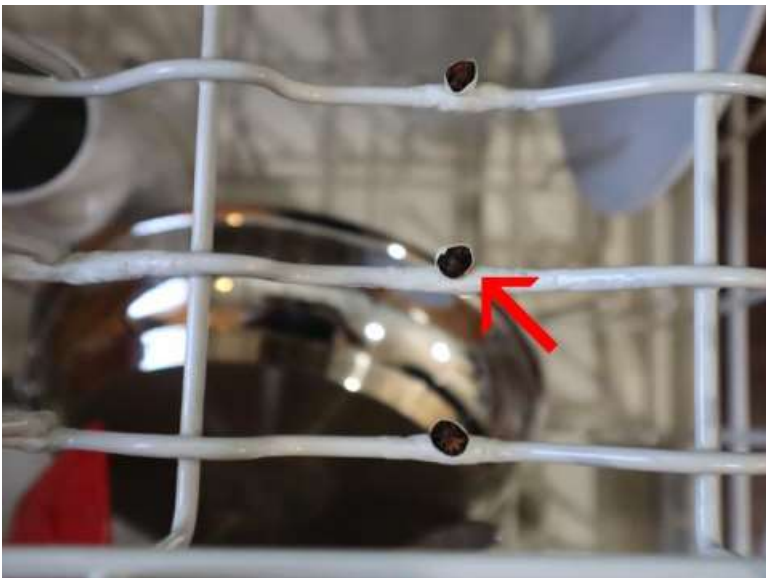
Monitor: Some rust has formed on the dishwasher racks. The cleaned dishes need to be monitored for any signs of rust deposits. If this is happening, then the racks will need to be replaced.

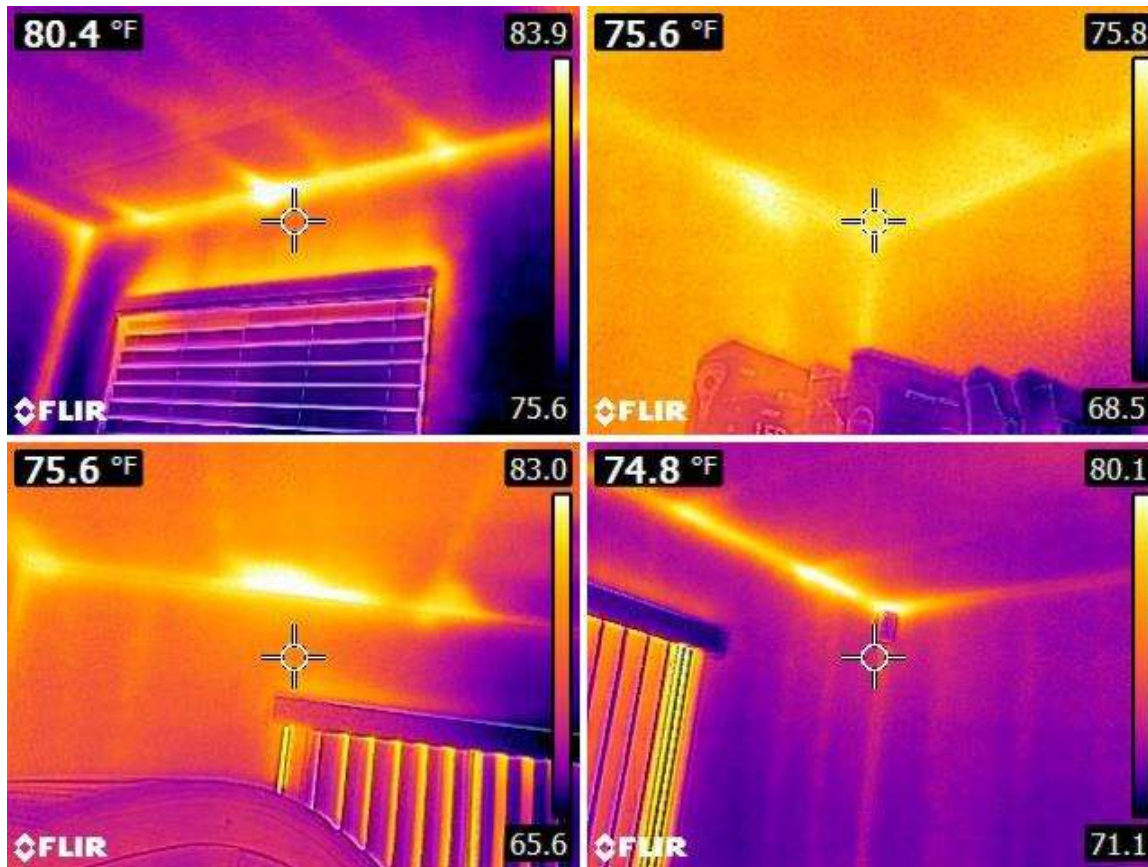
Note: There are areas with no insulation and/or very little insulation, especially at the eaves as seen from the IR camera (yellow areas, which are insulation voids where hot air is infiltrating the conditioned areas of the home). Any correction here will reduce thermal loss between the home and the attic.
