# NATIONAL PROPERTY INSPECTIONS

## COMMERCIAL MASTER TEMPLATE

Property Street Address  
City, TX Zip Code

Client Name  
JULY 27, 2022

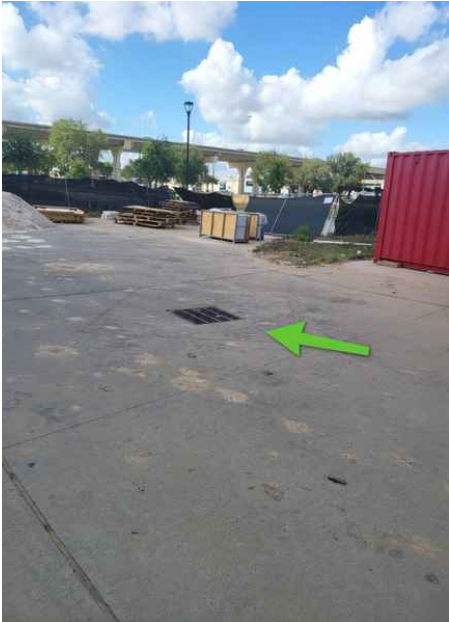
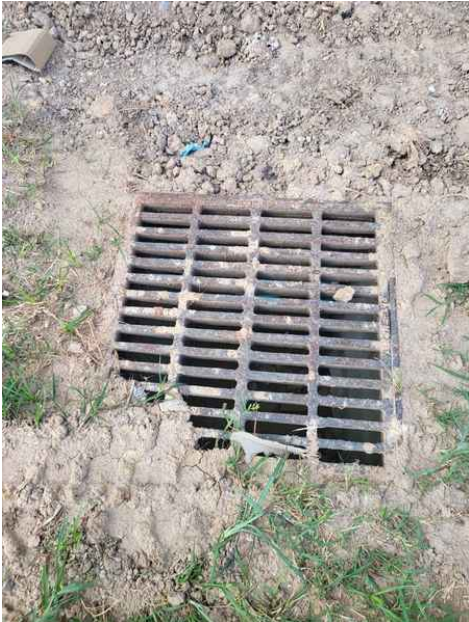
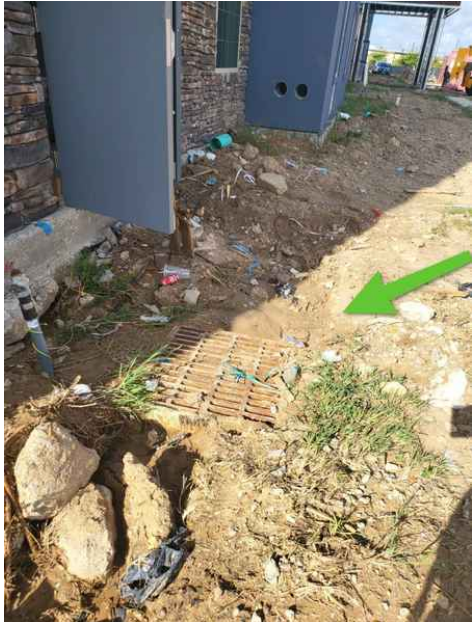
Strom drains - grate inlet

Rear drainage inlet grates were blocked by debris. Grates should be kept clear to avoid problems related to flooding. Construction of grates is still ongoing.

Recommendation  
Contact a qualified professional.

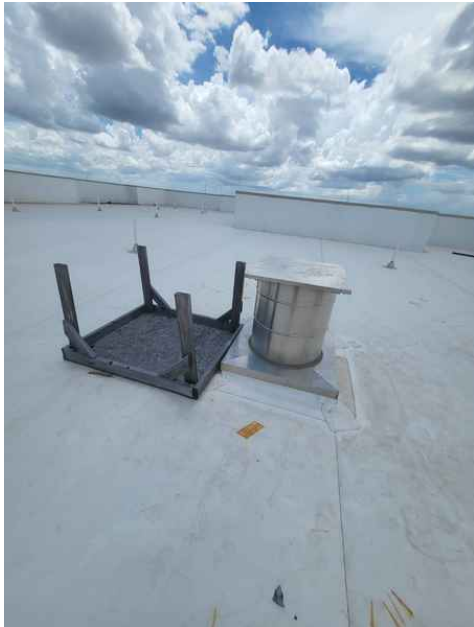
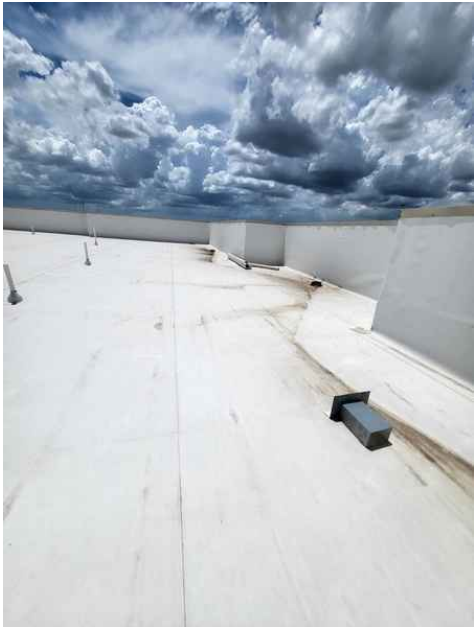
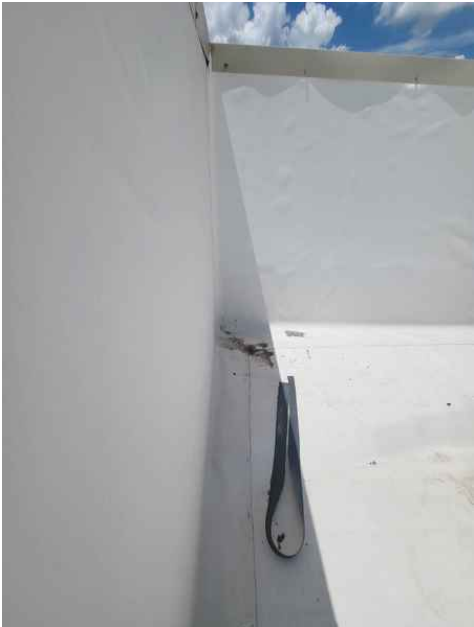
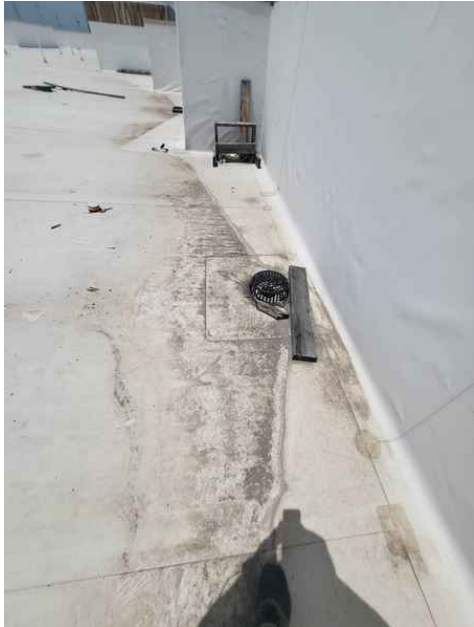
The Inspector observed materials or unnecessary equipment being stored on on the TPO roof membrane. This condition may result in roof damage, may impede roof drainage, and may void any warranty still in effect. All such materials or equipment should be removed and the roof maintained free of any such materials and equipment in the future.

Unnecessary materials on roof

Contact a qualified professional.

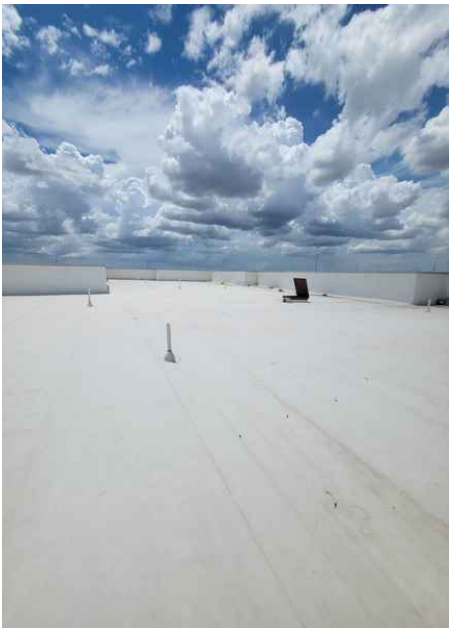
No significant deficiencies or anomalies observed at the time of inspection

Flashing

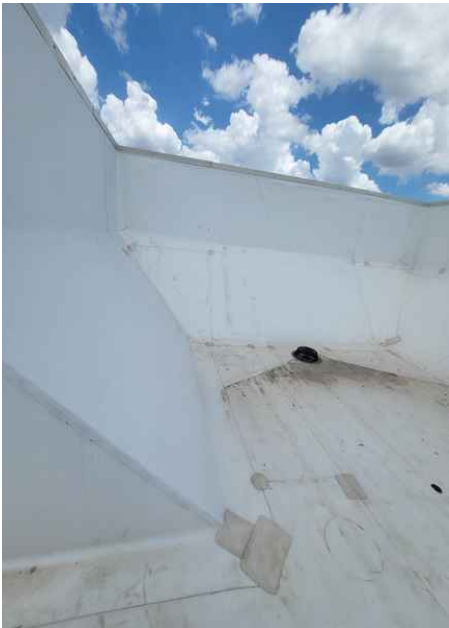
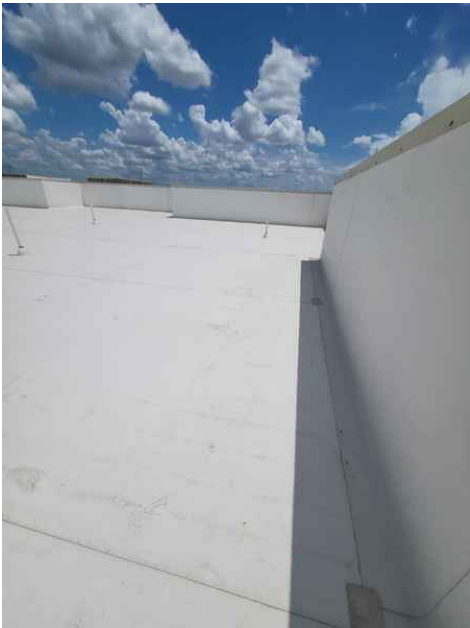
No significant deficiencies or anomalies observed at the time of inspection

Roof to wall flashing

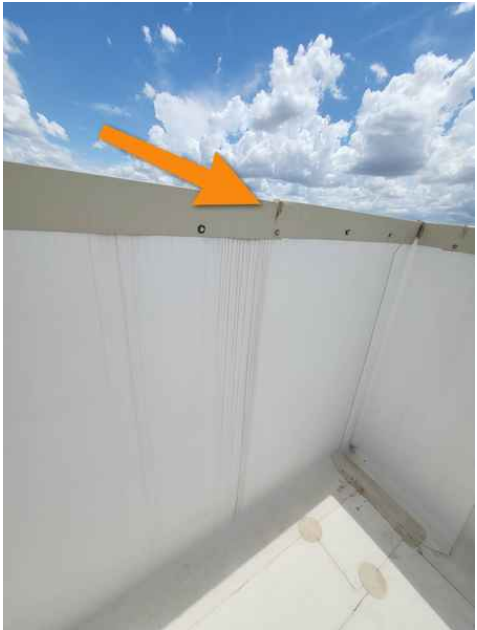
CAP FLASHING  
IMPROPERLY INSTALLED

Cap flashing protecting the parapet wall was improperly sealed and should be corrected. We recommend further evaluation by a roofing professional.

Poorly sealed allowing moisture intrusion

Contact a qualified roofing professional.

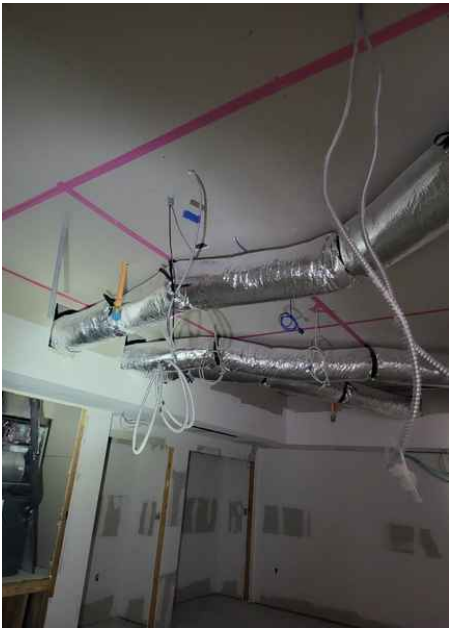
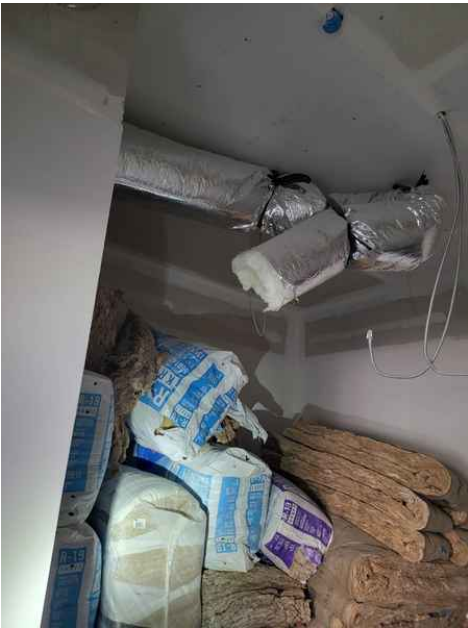
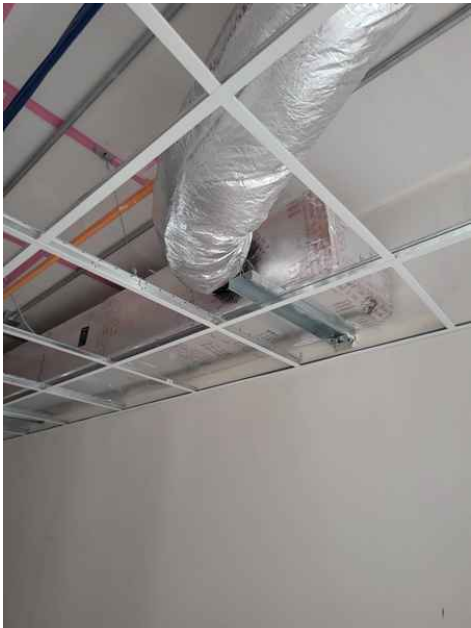
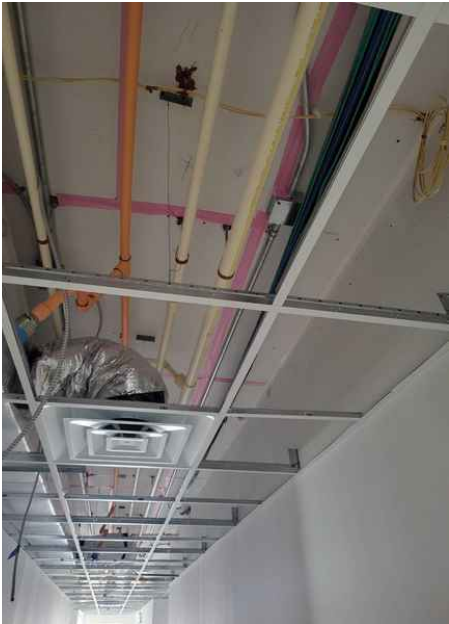
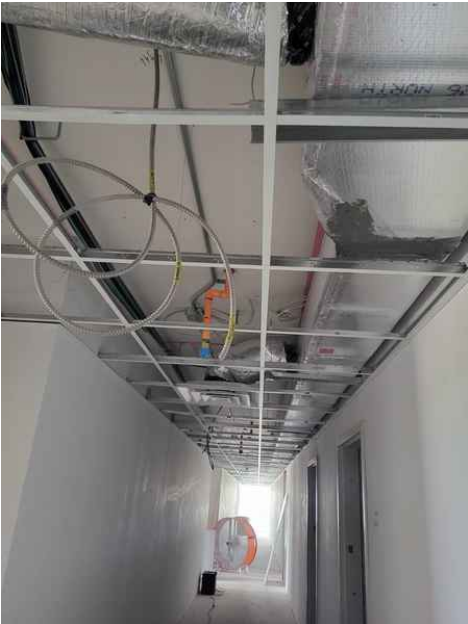
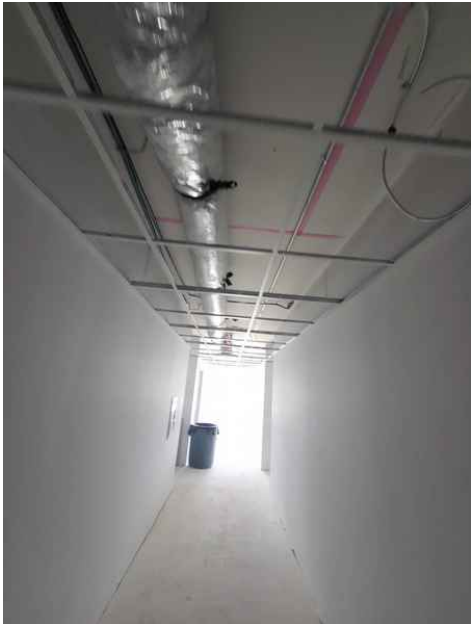
No significant deficiencies or anomalies observed at the time of inspection.

Visible ductwork
