# The Commercial Inspector

VOLUME 16 ISSUE 4

A Monthly Newsletter From National Property Inspections

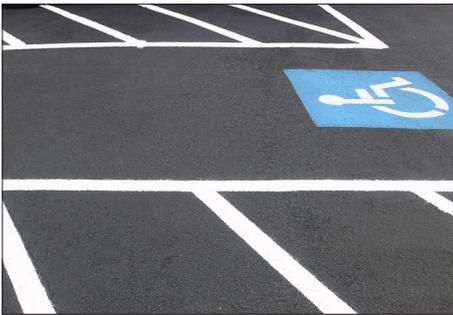
A. Your commercial property inspector typically will document the presence of handicap-accessible parking stalls, curb ramps, elevators, grab rails and restroom fixtures. Obvious obstructions also may be documented — for instance, stairs leading to a building without a ramp or a narrow entry door.

Your inspector most likely won't conduct a formal assessment for complete compliance with the Americans with Disability Act (ADA); however, he/she should complete a visual review of the property and assess the areas considered to be public accommodations based on the requirements of Title III of the ADA. Buildings constructed after Jan. 26, 1992, and considered to be places of public accommodations must remove architectural and communication barriers that are considered readily achievable in accordance with the resources available to building ownership. This is intended to provide disabled people with

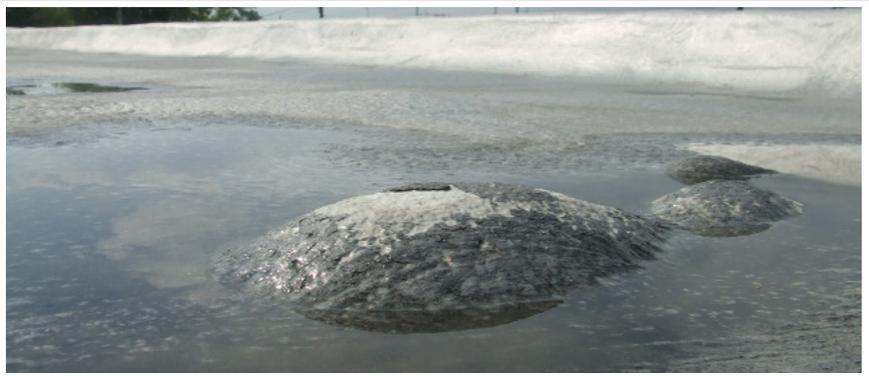
What Is This Picture?

- A ) An island surrounded by a lake
- B ) A water-covered road with a bump in the pavement
- C ) An exclusive aerial shot from the set of the next Star Wars movie
- D ) A blister on a roof of melting snow

*The correct answer is D. The photo shows snow melting around a blister that has formed on a roof. This could potentially cause a leak in the roof, leading to water damage.*

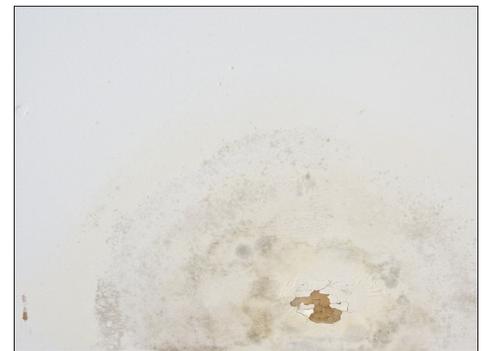
If you notice stains on the ceilings of your commercial building, they likely signal a leak, maybe from winter's snow melting or rain damage. There's no better time than now to fix the cause of these unsightly stains, and the repair will probably cost less than the damage that may ensue if the leak persists.

The first step is to find out what caused the stain — it was likely a leaky roof or pipe — and fix the problem. Otherwise, once you cover the ceiling stain, you'll just wind up with another one in its place. As soon as possible, call a certified roofing contractor or plumber to fix the problem. After the leak is fixed, the next step is to repair or replace the areas in the ceiling that were damaged.
