**Lewis Builders Inc.**  
**dba National Property Inspections**

**SAMPLE REPORT , 1234 Some Street , Anywhere , USA,**

Inspection Date :  
10/1/2009

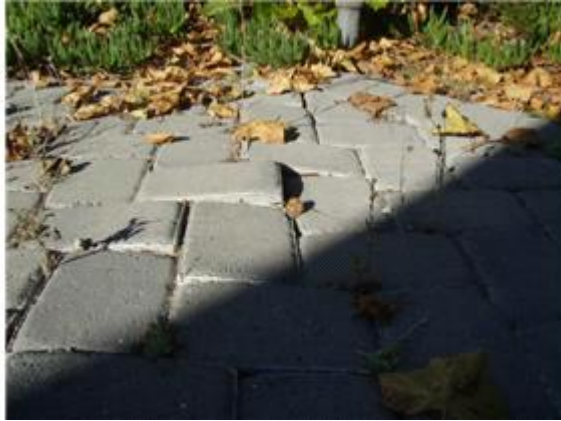
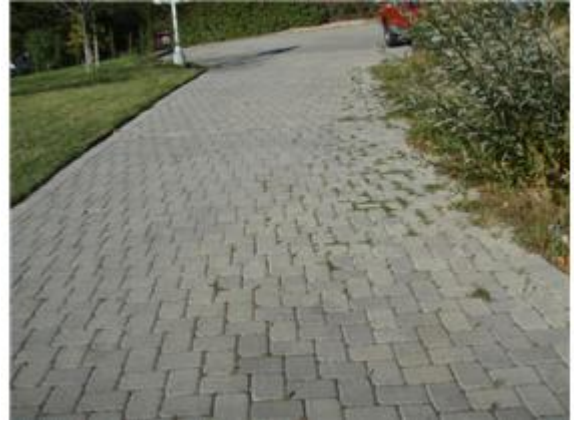
Comments : Pavers have settled and heaved in a few areas. Recommend further evaluation by a qualified masonry contractor.

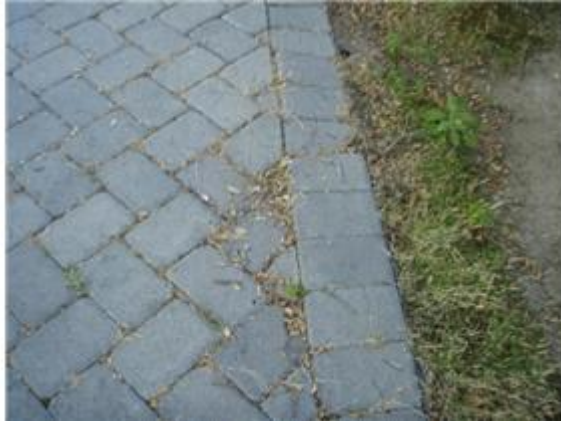
**PORCHES / STOOPS**

Comments : Pavers have settled and heaved in a few areas. Recommend further evaluation by a qualified masonry contractor.

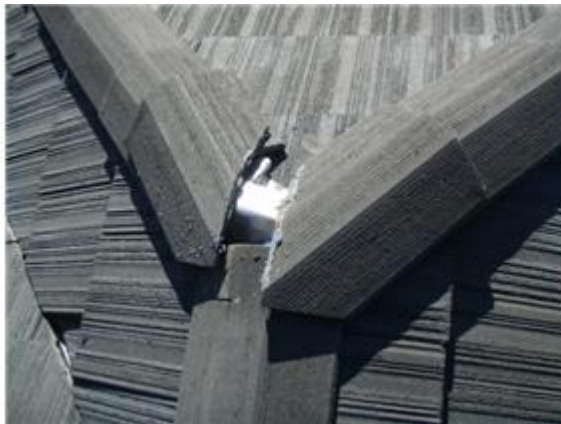
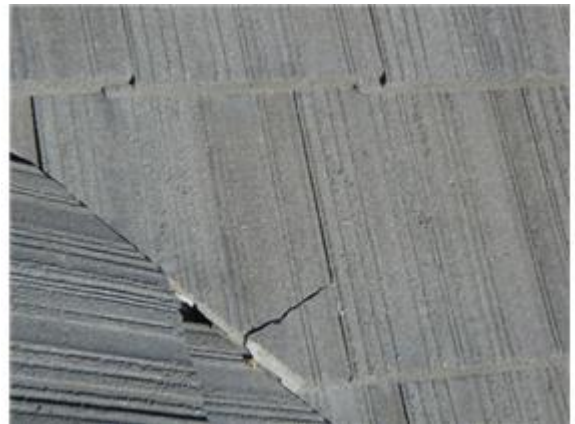
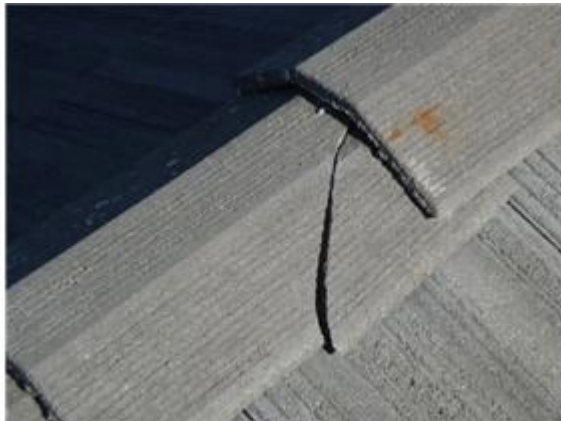
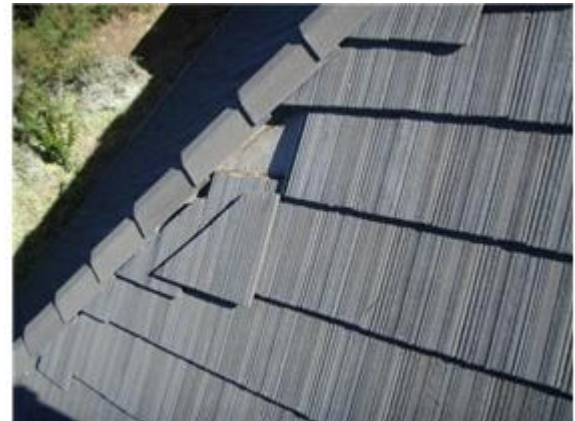
Tile roofing is generally in ok condition however there are a few tiles that have slipped out of position and a few tiles that have broken and need to be replaced. Recommend further evaluation and repairs by a qualified roofing contractor.

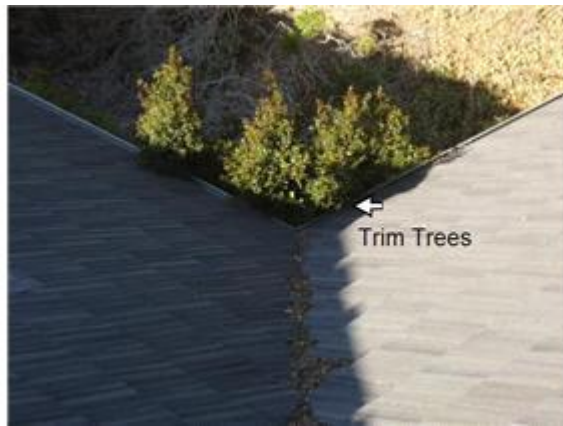
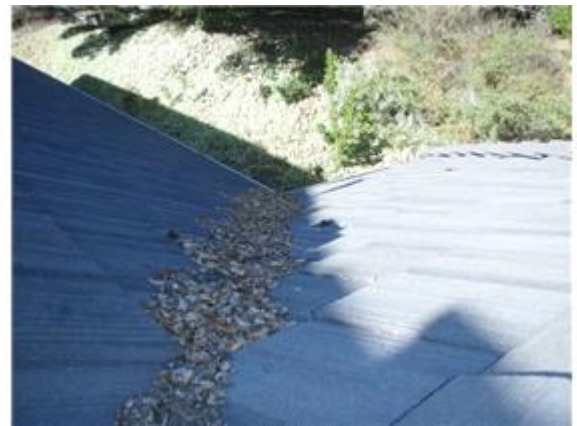
Comments : Debris noted in valley flashing. This can cause water drainage problems. Recommend keeping valley flashing free of debris including dead vegetation.

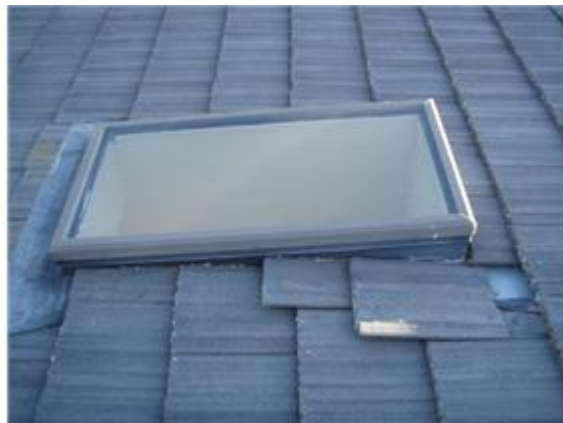
Comments : **Leaks not always detectable.**

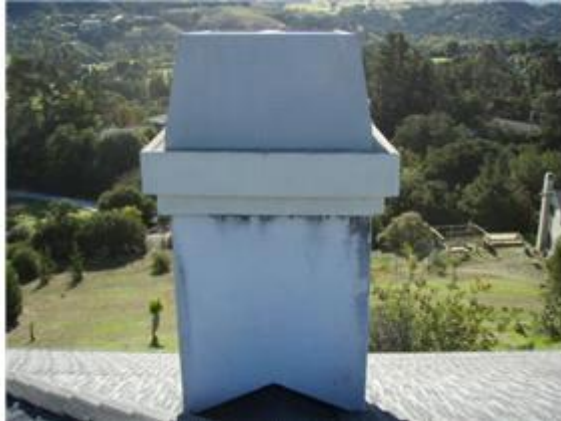
Comments : **Flue not inspected. Annual cleaning is recommended.**

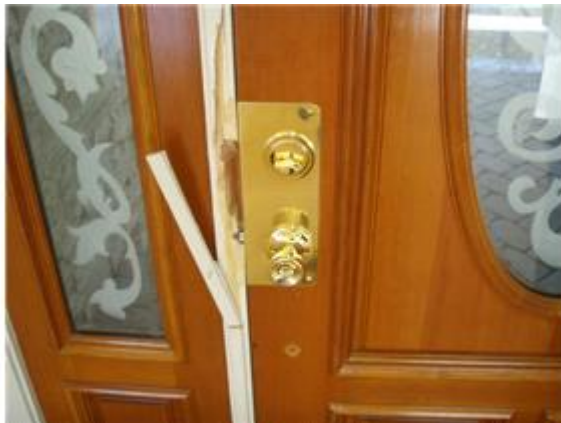
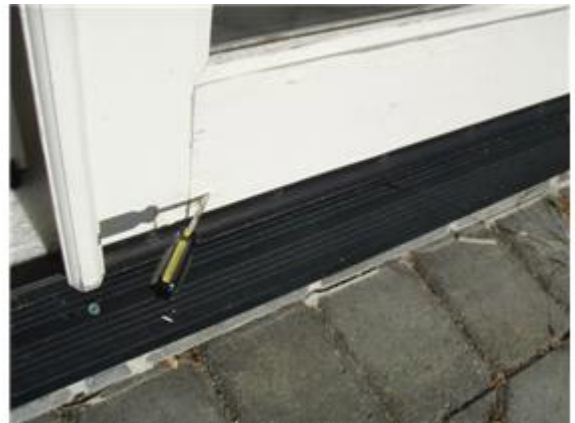
Comments : Front door has been damaged and is fastened shut. Recommend further evaluation and repairs by a qualified contractor.  
 Patio doors to the living room have dry rot and there is evidence of moisture intrusion. Recommend repairing or replacing doors.

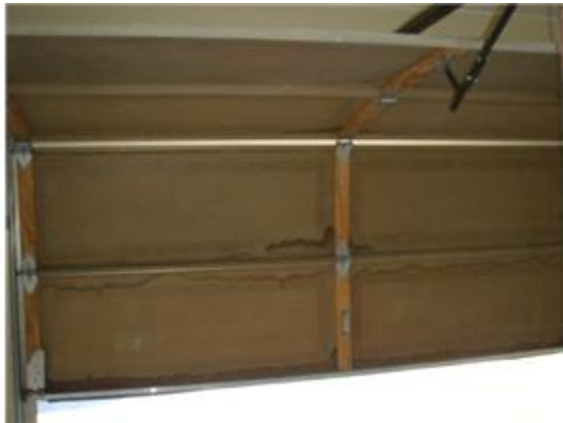
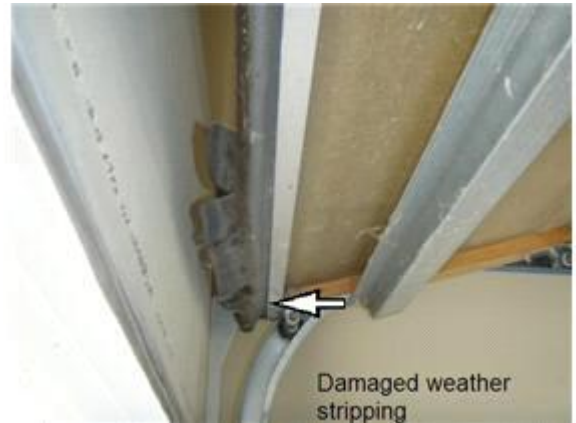
Comments : Water stains noted on wood panels and weather stripping for the bottom of the large door is damaged. Recommend further evaluation by qualified overhead door contractor.

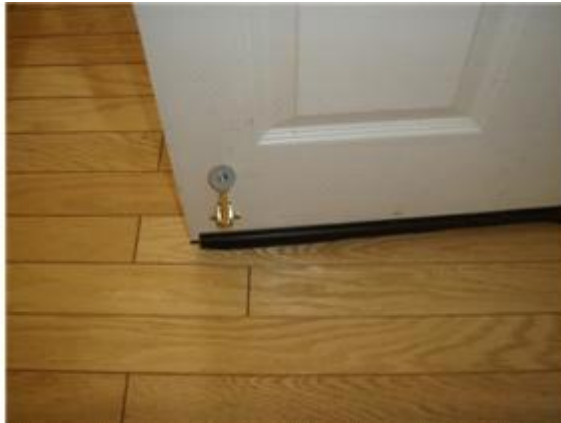
Comments : Pedestrian door in the garage should be a fire rated door assembly including self closing hinges. Door has self closing hinges but also has a door stop that allows the door to stay open. Recommend removing door stop to comply with fire safety requirements.

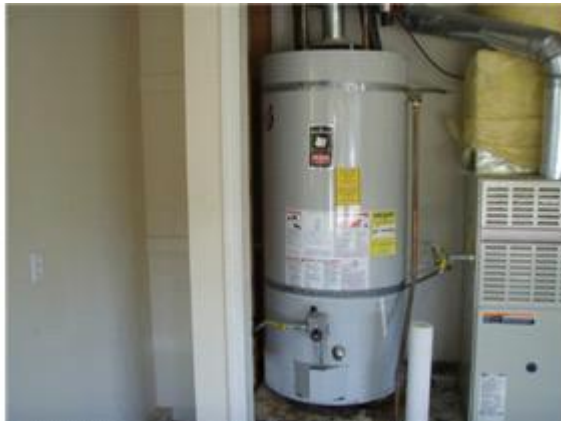
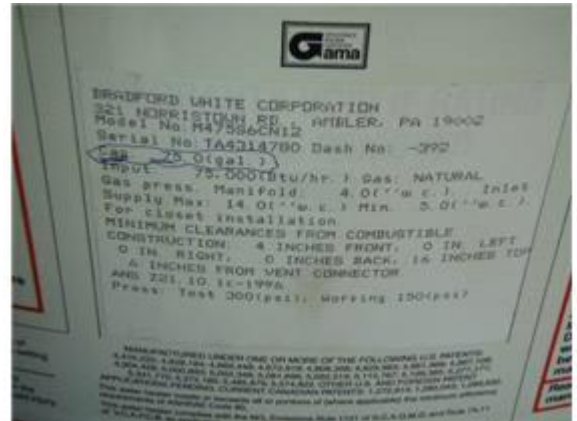
Comments : Recommend to install seismic straps per Manufactures recommendation.  
 T/P relief valve tube must exit within 6" of floor in plain view not obstructed by a wall. Recommend further evaluation by a plumbing contractor.

Evidence of a failed T/P relief valve and a leaking tank that has caused microbial growth in the surrounding area. Recommend further evaluation by a qualified environmental inspector/consultant.

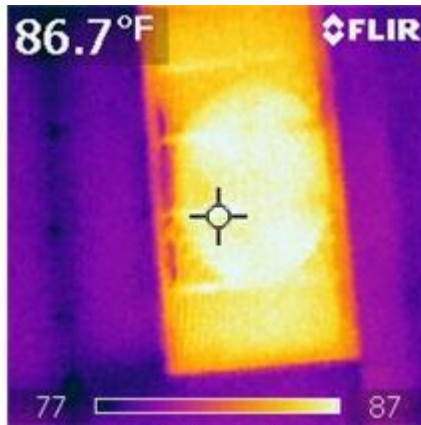
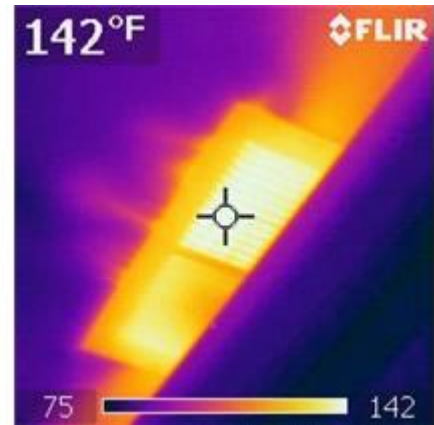
Comments : Infrared camera was used to sample the air temperature entering the forced air furnace and at each register. This test was conducted to find temperature differences that might indicate problems with the distribution system. Temperature differences at registers (room vents) were found within normal standards.

Filter is dirty. Recommend cleaning or replacing filter regularly as part of routine maintenance.
