Inspection Report

Sample Report

Property Address:
some where
Pembroke Pines FI 33029

Date: 8/9/2011	Time: 11:00 AM	Report ID:
Property: some where Pembroke Pines Fl 33029	Customer: Sample Report	Real Estate Professional: Jose Gouvea SSI Realty

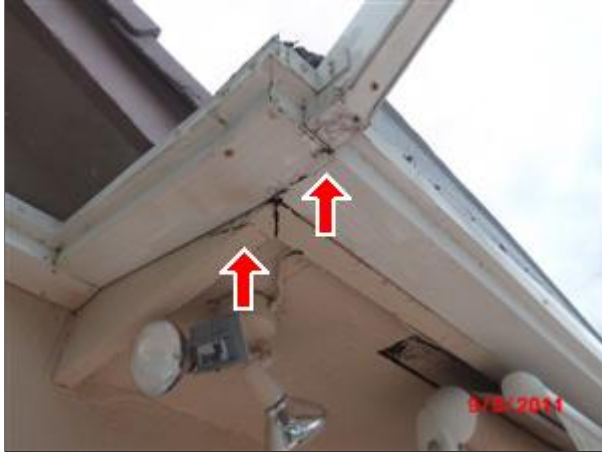
1.3 The both corners of the rear porch where the gutter and screen is attached to is rotted out from leaking gutters recommend repairs.

1.3 Picture 1 wood rot leaking gutter

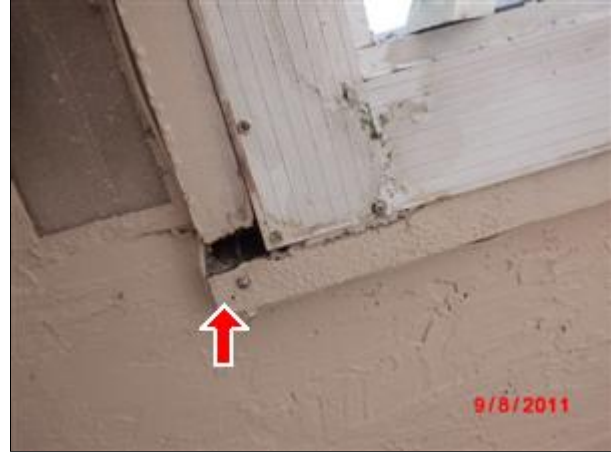
1.3 Picture 2 wood rot rear

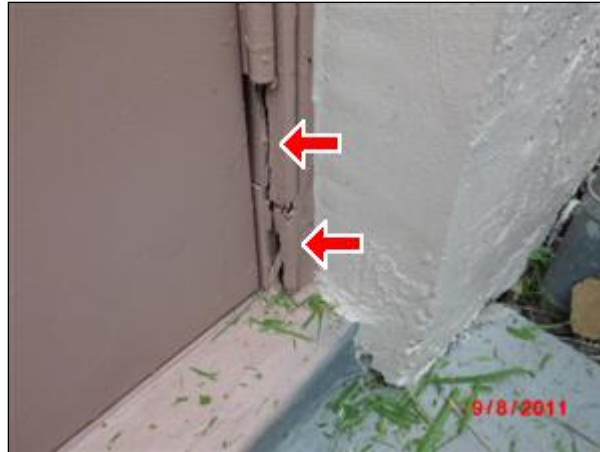
1.5 The side door rusted and rotted out frame both inside and out recommend repairs.

1.5 Picture 1 side door rotted

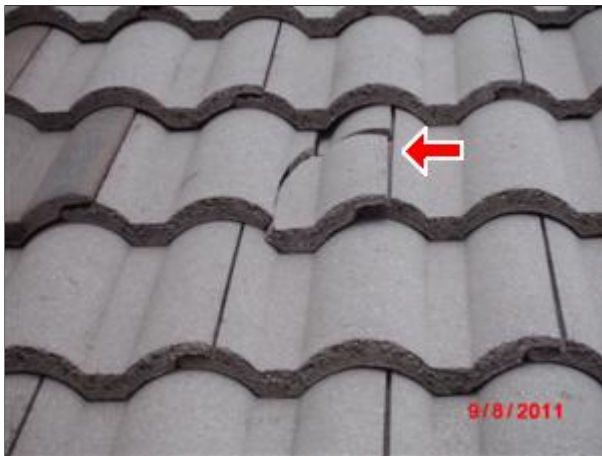
2.0 The roof at time of inspection is free from leaks however repairs are needed to maintain the roof The left side approaching the front stoop one end tile loosely hanging. There are approximately 12 to 15 broken or crack tiles in the field. Recommend repairs by qualified roofer.

2.0 Picture 1 broken tiles front

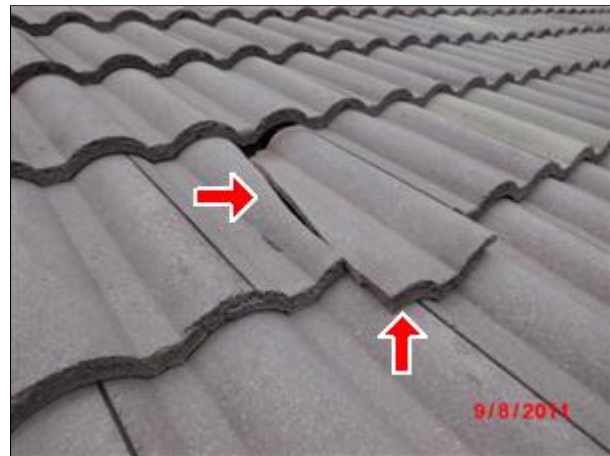
2.0 Picture 2 broken tiles

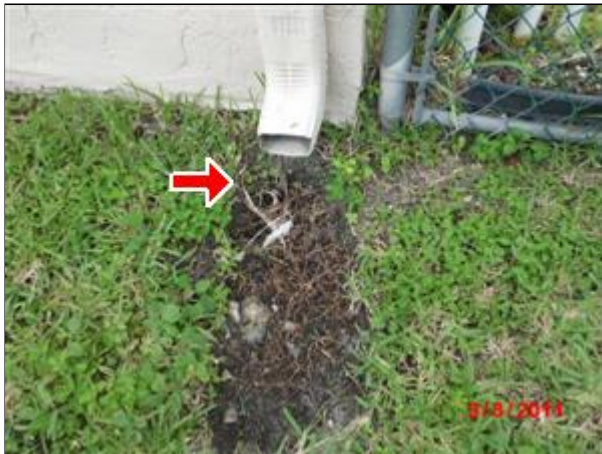
2.4 The gutters are missing splash stones. The gutter top left side facing home is loose and could fall off at any time recommend repairs. The gutters need to be cleaned and seal around the joints.

2.4 Picture 1 missing splash stone

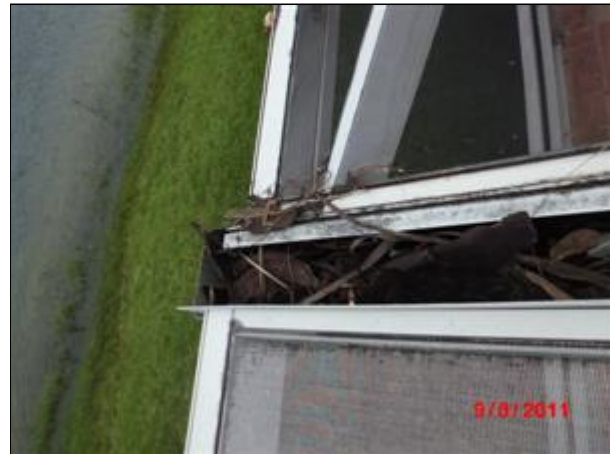
2.4 Picture 2 clogged gutter

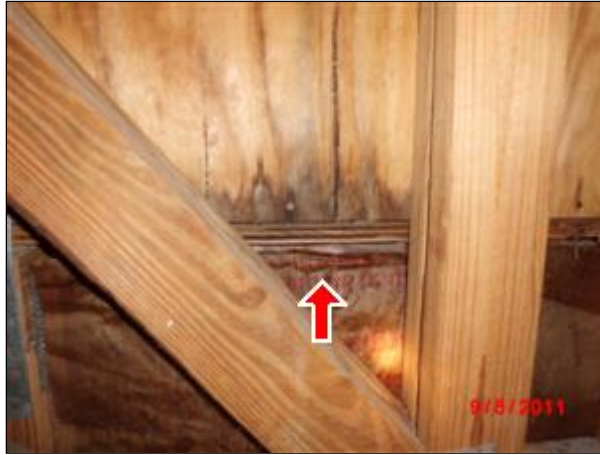
2.5 Old water stain observed from the attic access inside the garage to the area that was once leaking that caused the water stains to the ceiling no present leaks observed.

2.5 Picture 1 old water stain attic garage

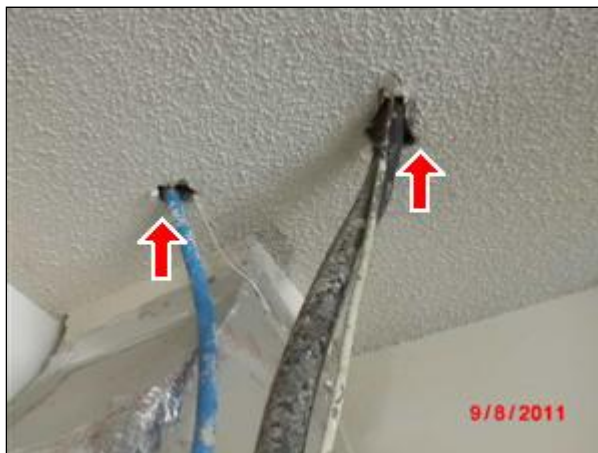
3.0 There are old water stains observed inside the attic which is from previous old roof leak. Seal all opening to ceiling and attic for fire rating.

3.0 Picture 1 sela around pipes

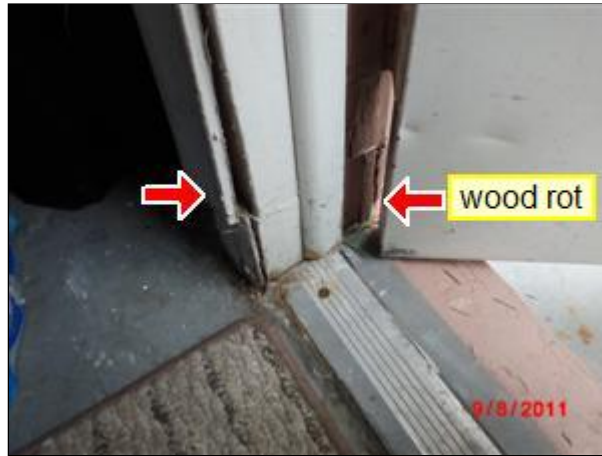
3.3 Wood rot to the side door bottom of track and to door frame both inside and out.

3.3 Picture 1 rotted door frame

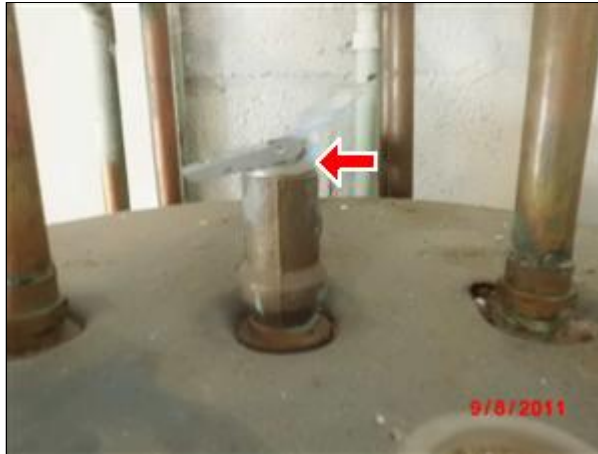
5.3 The water heater is rated marginal due to its age beyond its design life and will likely need replacement soon. The PSI valve is stuck and does not operate recommend repairs.

5.3 Picture 1 PSI valve

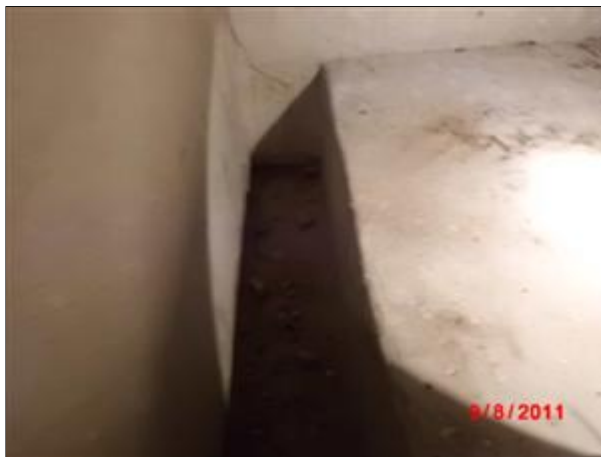
7.0 Dirty filter and coils recommend cleaning and service, unit is working. Temperature differential not within industry standards Recommend further evaluation and repairs by a qualified HVAC technician. Recommend clean out the return vent box also to remove the debris and construction dirt.

7.0 Picture 1 Dirty return vent

REcommend service to the unit that is located inside the attic above the master bedroom.

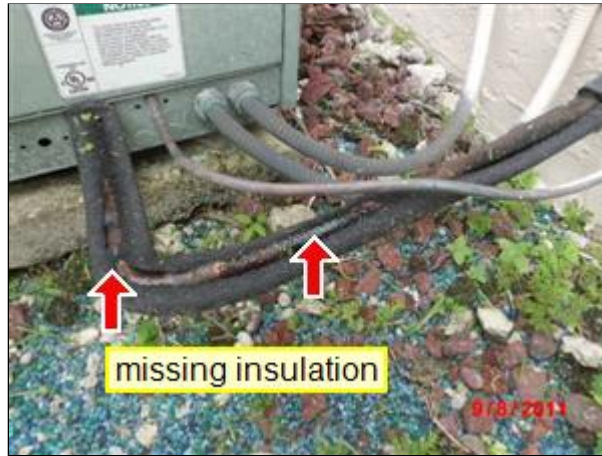
7.3 Both condensers need to be service and clean and the expose copper pipes need to be insulated for proper cooling.

7.3 Picture 1 insulation damage

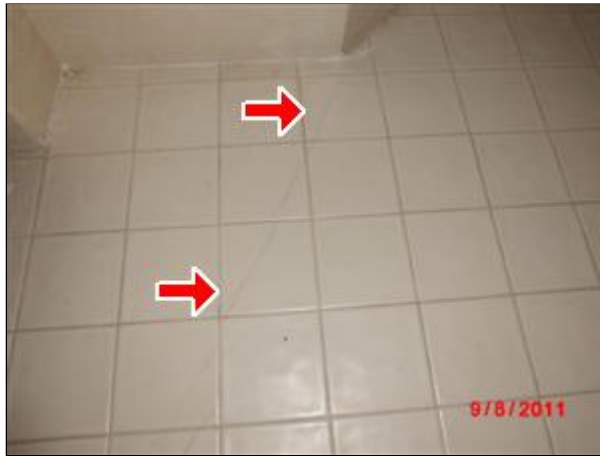
10.2 There are 6 to 8 tiles with hair line cracks from age and settlement over time no present concern.

10.2 Picture 1 crack tiles

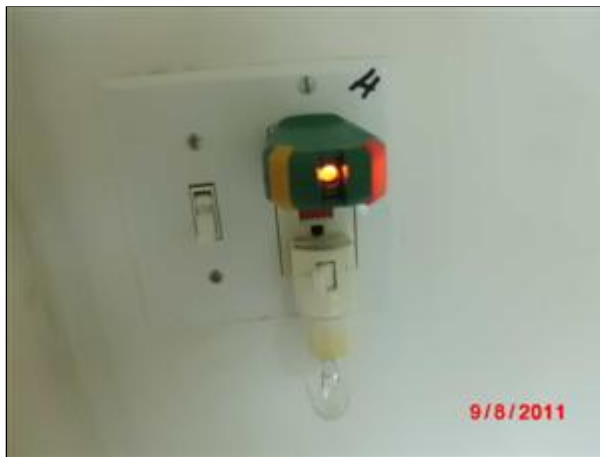
10.4 The GFCI outlet is hot neutral reverse recommend correction.

10.4 Picture 1 hot/neutral reverse

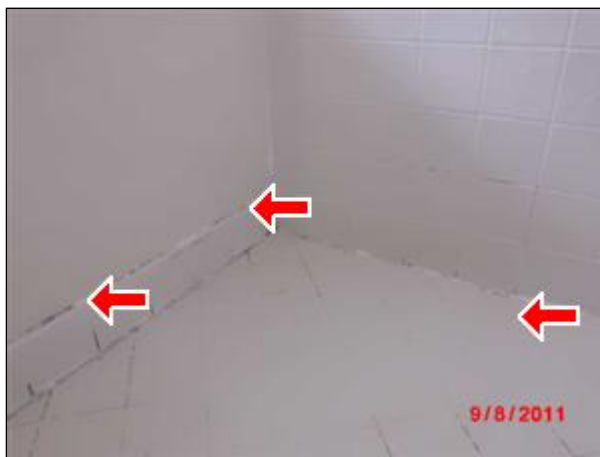
10.8 Recommend clean grout lines and re-grout shower stall no loose tiles or moisture intrusion to the tiles noted and repairs are for preventive means. The present condition is from use and lack of maintenance.

10.8 Picture 1 shower stall

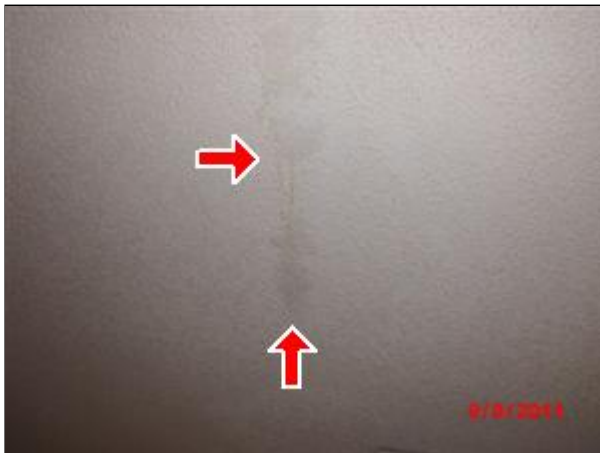
12.0 There are old water stains to the ceiling two places which was caused by the air handler that is located inside the attic. The air handler leaked at one time and the condensate line to the condenser was sweating prior to insulation replacement and dripped onto the ceiling by the air vent/register. Re-paint the ceiling.

12.0 Picture 1 a/c leak from attic

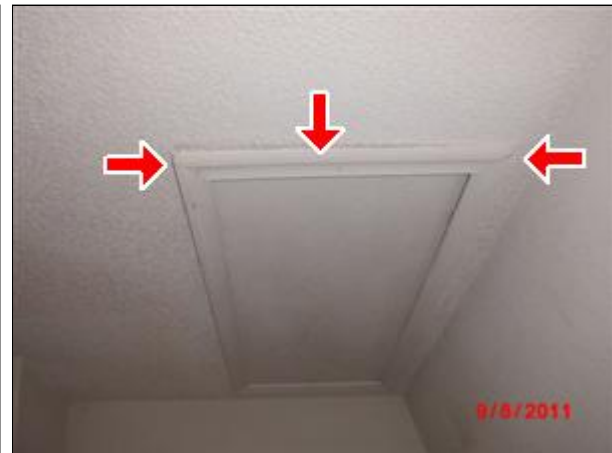
12.0 Picture 2 seal attic access

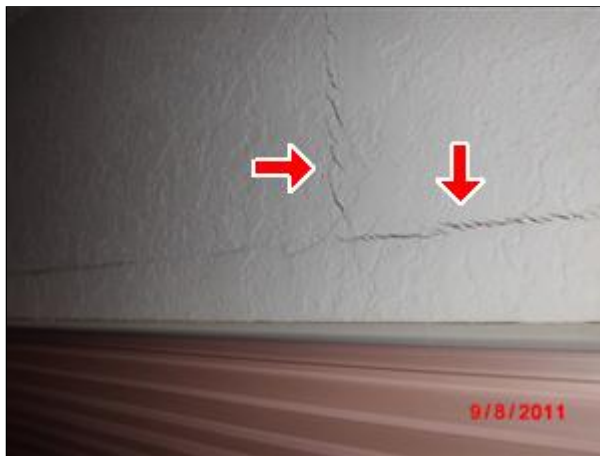
14.1 The corner flashing above the window is separating from the wall and hairline crack above window no leaks and considered a minor repair when room is to be re-painted.

14.1 Picture 1 corner flashing lifting

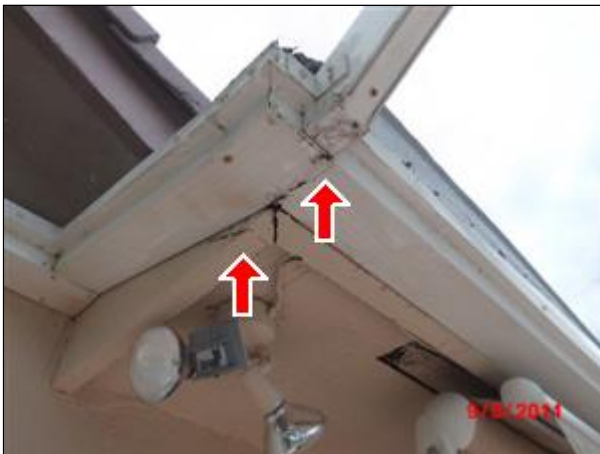
The both corners of the rear porch where the gutter and screen is attached to is rotted out from leaking gutters recommend repairs.

1.3 Picture 1 wood rot leaking gutter

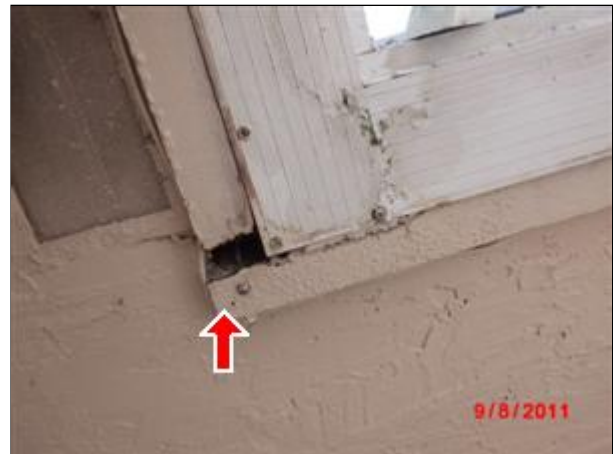
1.3 Picture 2 wood rot rear

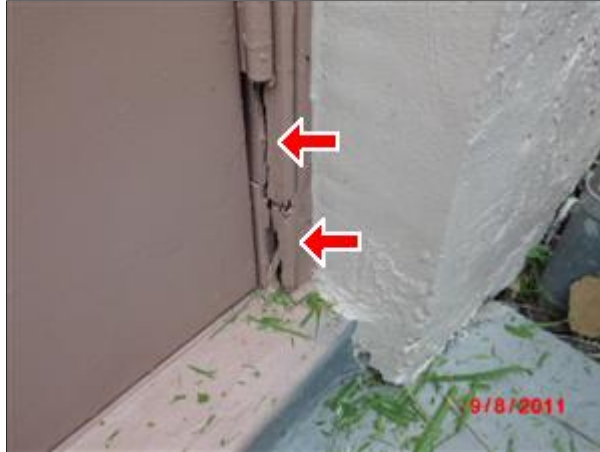
The side door rusted and rotted out frame both inside and out recommend repairs.

1.5 Picture 1 side door rotted

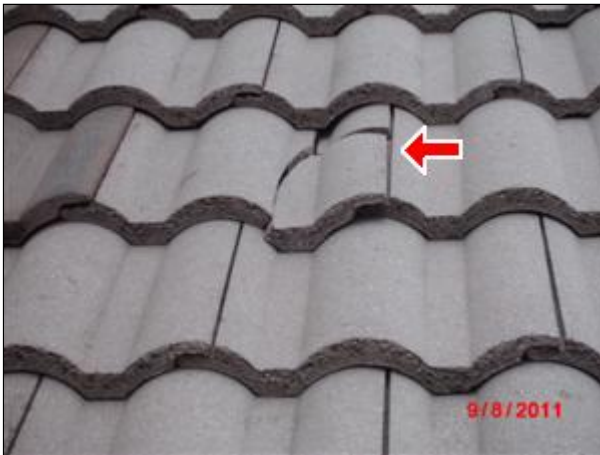
The roof at time of inspection is free from leaks however repairs are needed to maintain the roof. The left side approaching the front stoop one end tile loosely hanging. There are approximately 12 to 15 broken or crack tiles in the field. Recommend repairs by qualified roofer.

2.0 Picture 1 broken tiles front

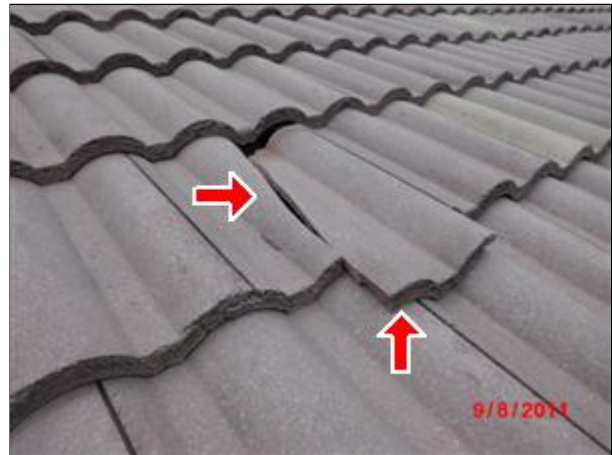
2.0 Picture 2 broken tiles

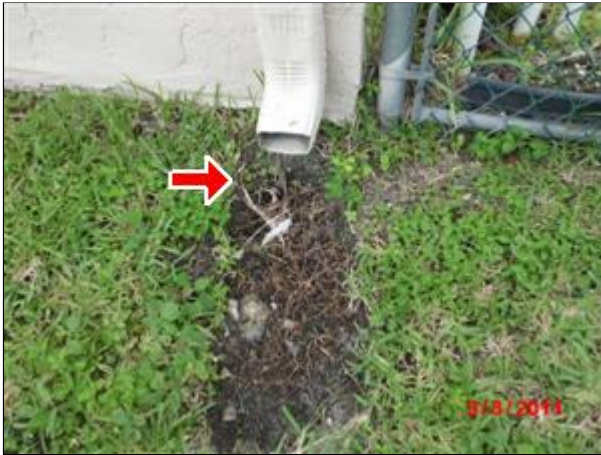
The gutters are missing splash stones. The gutter top left side facing home is loose and could fall off at any time recommend repairs. The gutters need to be cleaned and seal around the joints.

2.4 Picture 1 missing splash stone

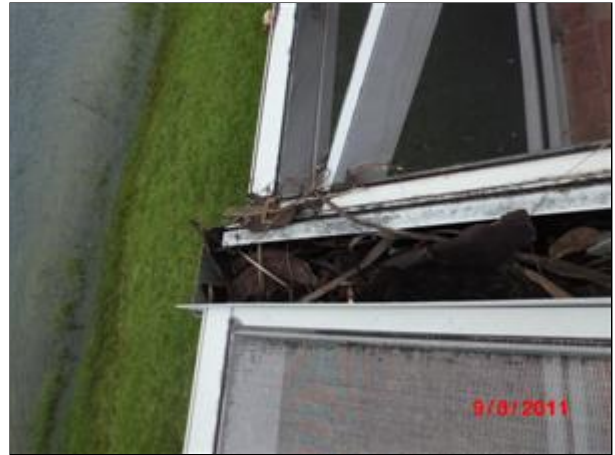
2.4 Picture 2 clogged gutter

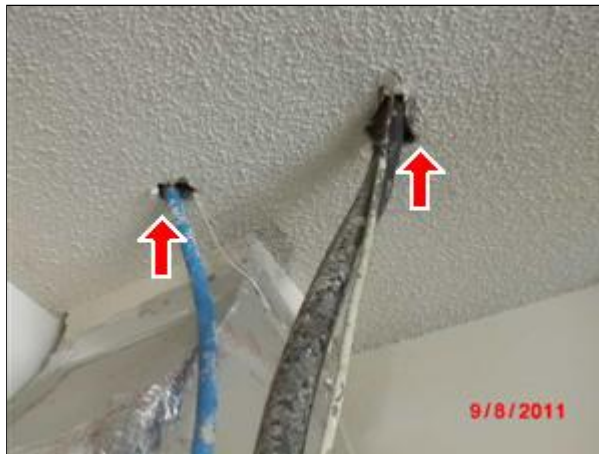
There are old water stains observed inside the attic which is from previous old roof leak. Seal all opening to ceiling and attic for fire rating.

3.0 Picture 1 sela around pipes

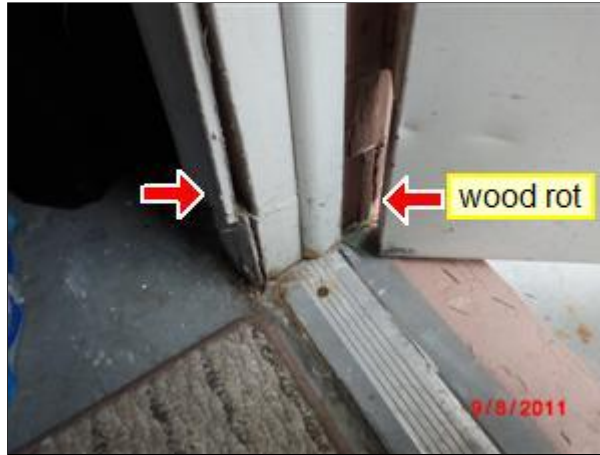
Wood rot to the side door bottom of track and to door frame both inside and out.

3.3 Picture 1 rotted door frame

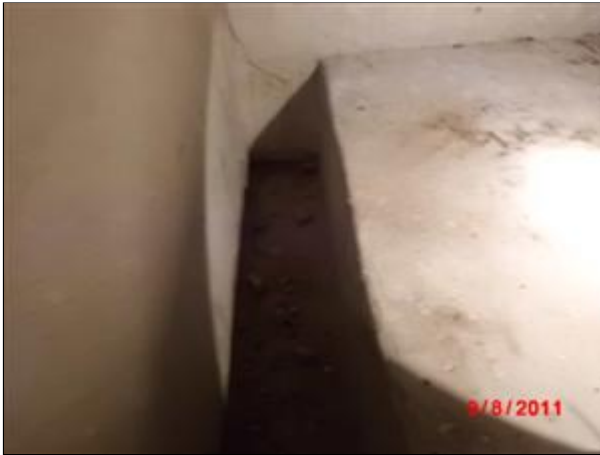
Dirty filter and coils recommend cleaning and service, unit is working. Temperature differential not within industry standards Recommend further evaluation and repairs by a qualified HVAC technician. Recommend clean out the return vent box also to remove the debris and construction dirt.

7.0 Picture 1 Dirty return vent

REcommend service to the unit that is located inside the attic above the master bedroom.

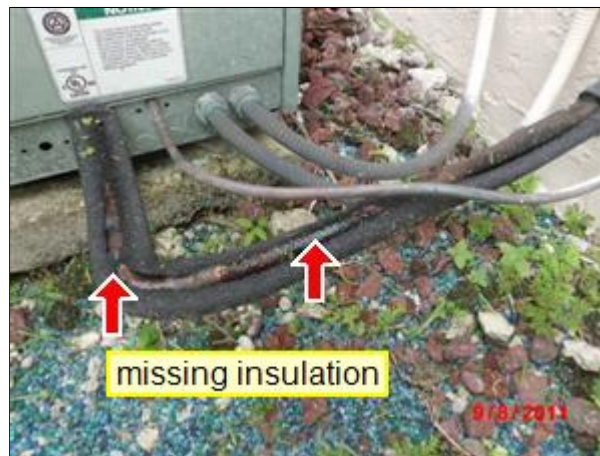
Both condensers need to be service and clean and the expose copper pipes need to be insulated for proper cooling.

7.3 Picture 1 insulation damage

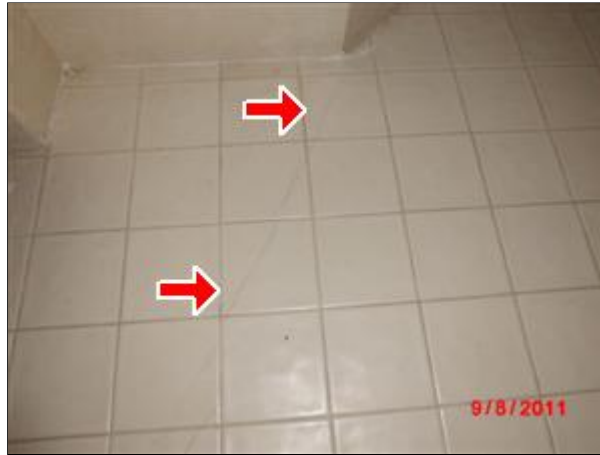
There are 6 to 8 tiles with hair line cracks from age and settlement over time no present concern.

10.2 Picture 1 crack tiles

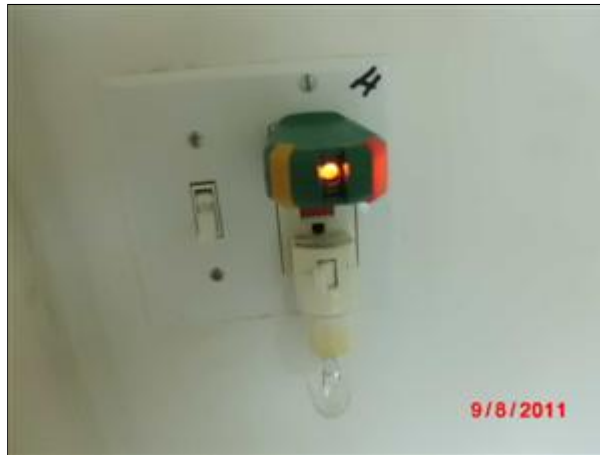
The GFCI outlet is hot neutral reverse recommend correction.

10.4 Picture 1 hot/neutral reverse

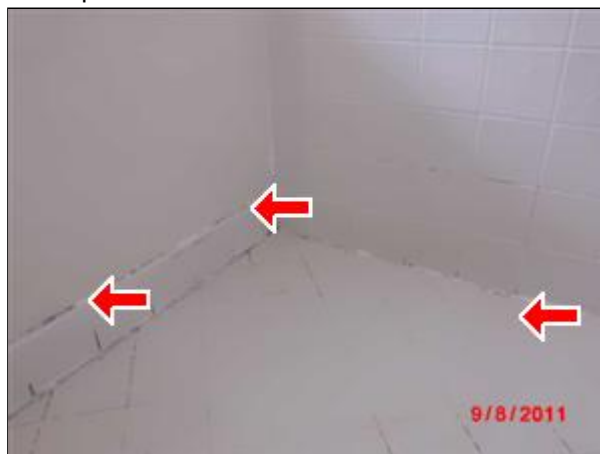
Recommend clean grout lines and re-grout shower stall no loose tiles or moisture intrusion to the tiles noted and repairs are for preventive means. The present condition is from use and lack of maintenance.

10.8 Picture 1 shower stall

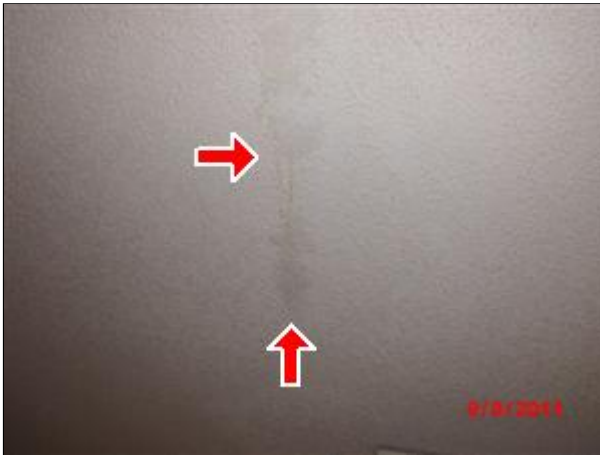
There are old water stains to the ceiling two places which was caused by the air handler that is located inside the attic. The air handler leaked at one time and the condensate line to the condenser was sweating prior to insulation replacement and dripped onto the ceiling by the air vent/register. Re-paint the ceiling.

12.0 Picture 1 a/c leak from attic

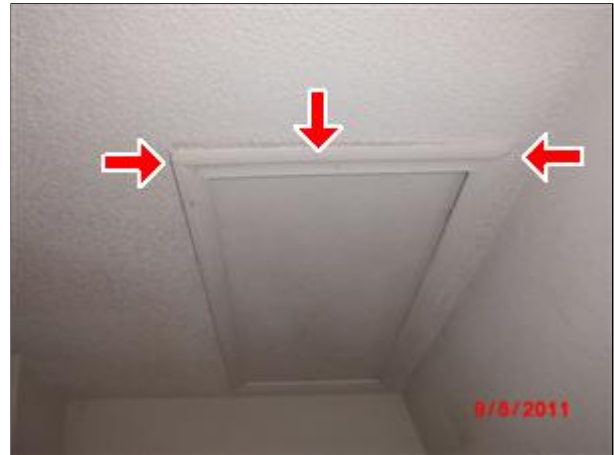
12.0 Picture 2 seal attic access

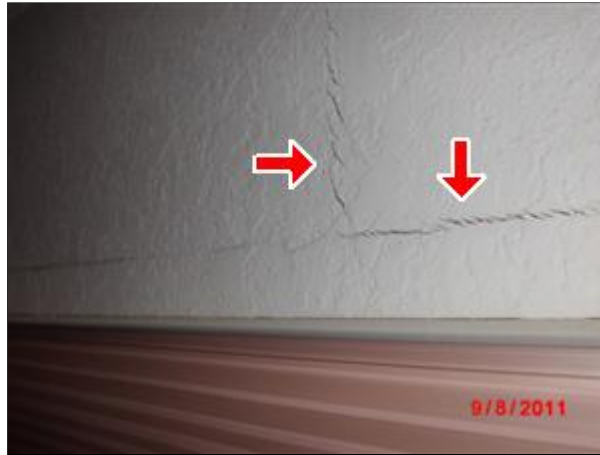
The corner flashing above the window is separating from the wall and hairline crack above window no leaks and considered a minor repair when room is to be re-painted.

14.1 Picture 1 corner flashing lifting
