Home Inspection Report

Vernon, WI 53189

Inspected by:
Ryan Eigenfeld
National Property Inspections
Inspection Date: 6/22/2023

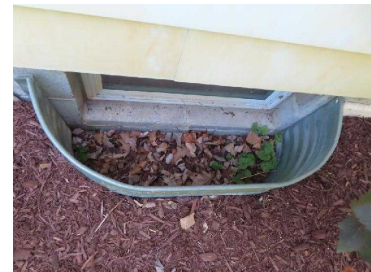
Recommend maintain dirt as needed to provide proper drainage away from the building.

Recommend clean debris

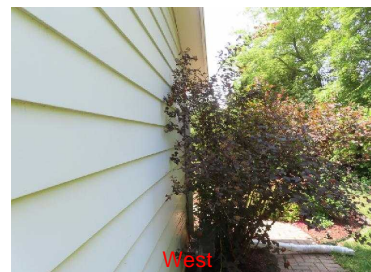
| 11. Maintenance | Trees/Shrubs at Building: Bushes, Vegetation |

- Recommend trim bushes away from the house.

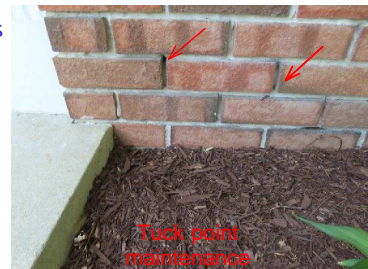
Type: Aluminum siding, Brick veneer
required.

Tuck point maintenance is

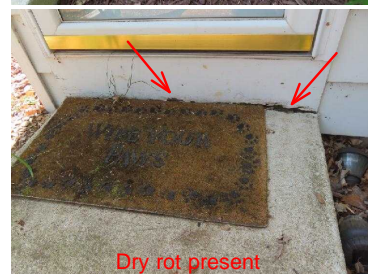
There is dry rot present at the North exterior door wood trim. Recommend a qualified contractor inspect and repair/ replace as needed

Trim: Wood, Aluminum There is dry rot present at the North exterior door wood trim. Recommend a qualified contractor inspect and repair/ replace as needed

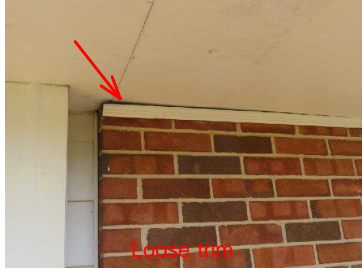
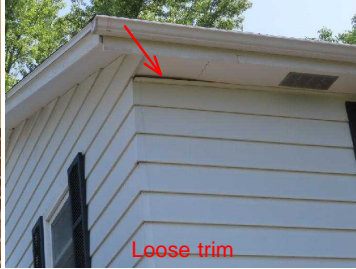
Soffit/ Fascia: Aluminum, Wood

There is loose trim present on the South side.

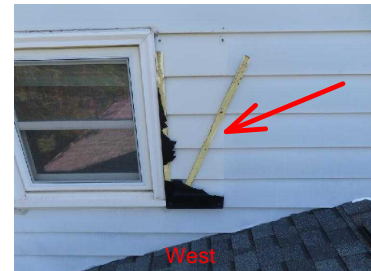
Shutter: Plastic

The shutter is damaged.

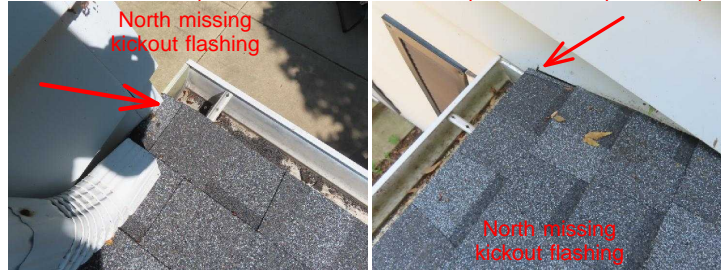
Recommend add proper kick out flashings where missing.

Flashing: Metal, Rubber Recommend add proper kick out flashings where missing. Recommend a qualified contractor inspect and repair/ replace as needed.

Recommend a qualified contractor inspect and repair/ replace as needed.

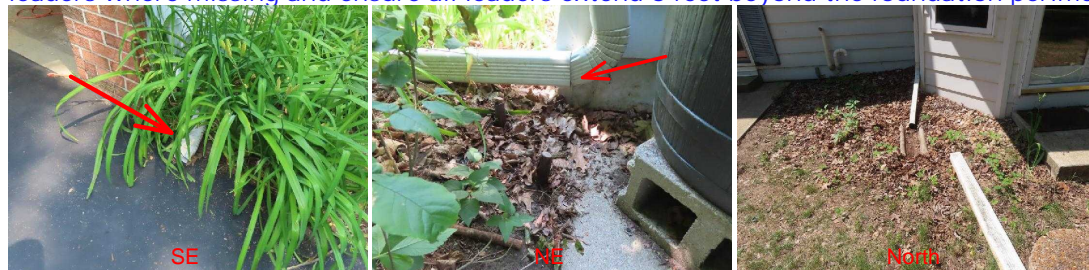
Leaders/Extensions: Aluminum, Corrugated plastic

Recommend add proper aluminum leaders where missing and ensure all leaders extend 6 feet beyond the foundation perimeter.

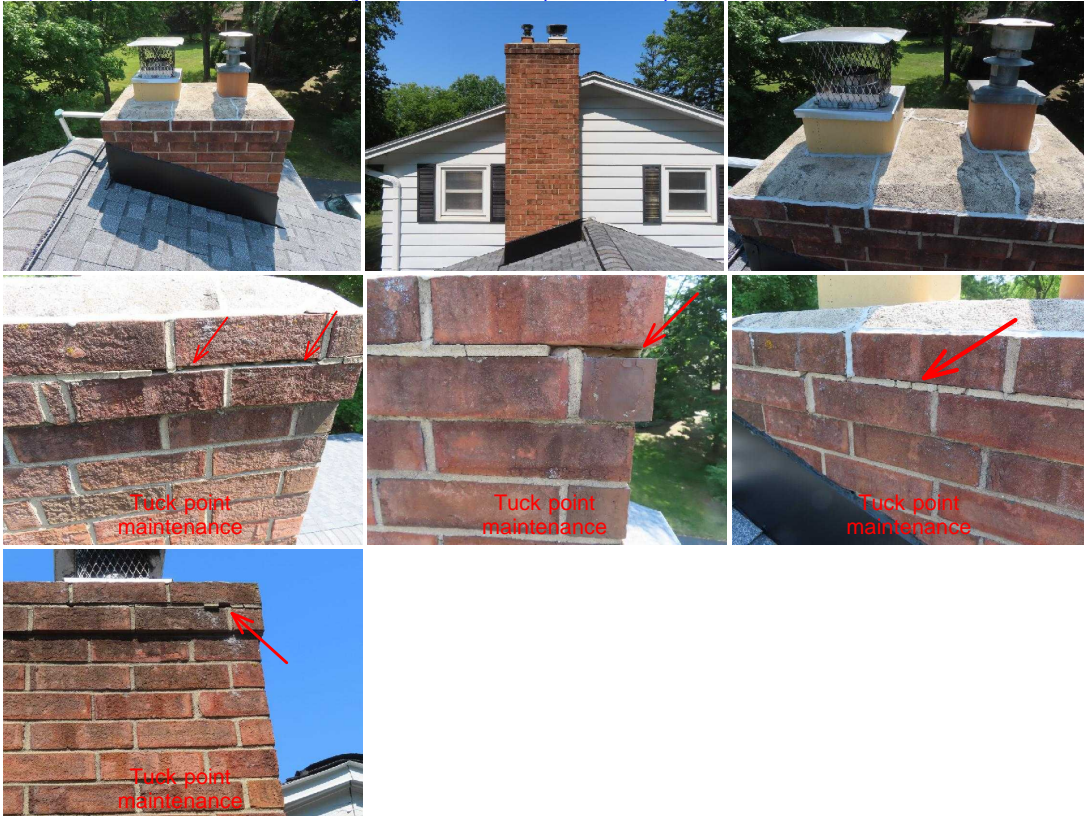
Chimney Chase/Cap/Flue: Brick chase, Concrete cap, Clay flue, Metal cap
cracks present in the mortar joints which require tuck point maintenance.

There are

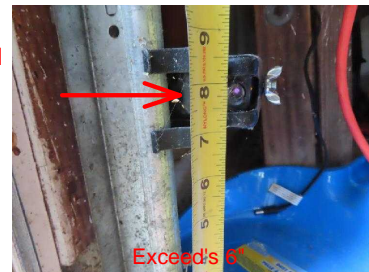
3. Defective Overhead Door Operation/Opener: Lift Master

Recommend lower light beam safety sensor eyes to within 6" of the ground for safety.

Attached Attached Garage Overhead Door Operation/Opener: Lift Master Recommend lower light beam safety sensor eyes to within 6" of the ground for safety.

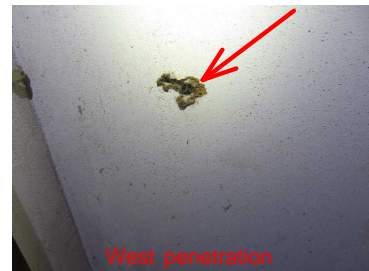
6. Defective Fire Break Ceiling/Walls: Fire rated material

There are penetrations in the fire break wall to the home that should be properly repaired.

Attached Attached Garage Fire Break Ceiling/Walls: Fire rated material There are penetrations in the fire break wall to the home that should be properly repaired.

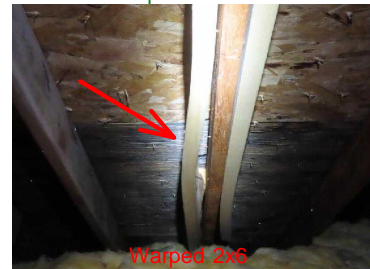
4. Needs Repair Roof Framing: Rafters There are sistered 2x6 boards attached to several of the rafters. A sistered board on the North side is warped/twisted and should be properly secured as needed. It was stated the additional 2x6's were installed to help support the possible installation of solar panels at a later date. Recommend a qualified contractor inspect and repair/ replace as needed.

Main Attic Roof Framing: Rafters There are sistered 2x6 boards attached to several of the rafters. A sistered board on the North side is warped/twisted and should be properly secured as needed. It was stated the additional 2x6's were installed to help support the possible installation of solar panels at a later date. Recommend a qualified contractor inspect and repair/ replace as needed.

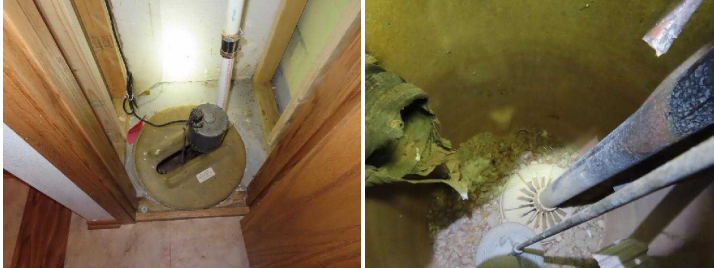
Gas Service Line Supports: Metal
Sump Pump / Exterior Discharge: Pedestal
operated. The unit maybe nearing the end of its functional life.

The sump pump motor was noisy when

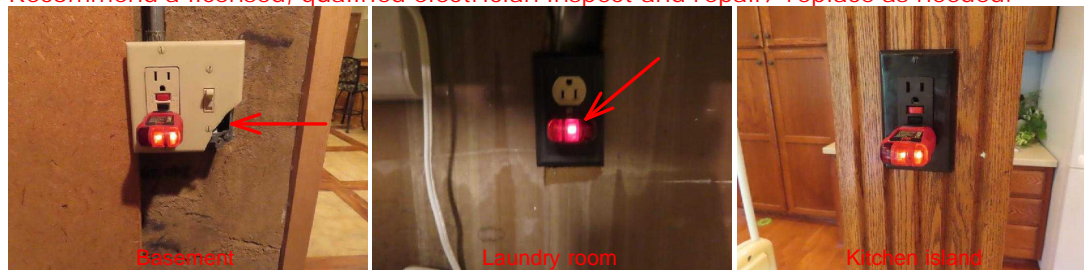
3. Functional Electrical Mast: Underground utilities
4. Defective Electrical Outlets/Components: 110 V, 110 V GFCI
light switch has a broken cover plate.

The Basement electrical room

The 2nd floor NW and SE Bedroom has loose outlets.

Note: The Garage electrical switch and lights were not operable. Suspect burned out bulbs. Recommend a licensed, qualified electrician inspect and repair/ replace as needed.

Electrical Outlets/Components: 110 V, 110 V GFCI The Basement electrical room light switch has a broken cover plate.

The Laundry room West outlet has an open ground present.

The Kitchen island GFCI did not properly trip when tested.

The outlets in the 1/2 Bathroom, Garage and Exterior are not GFCI protected at locations which today's standards require, which is common for a property of this age. Consider updating to GFCI protected outlets for current standards and safety.

The 2nd floor NW and SE Bedroom has loose outlets.

Note: The Garage electrical switch and lights were not operable. Suspect burned out bulbs. Recommend a licensed, qualified electrician inspect and repair/ replace as needed.

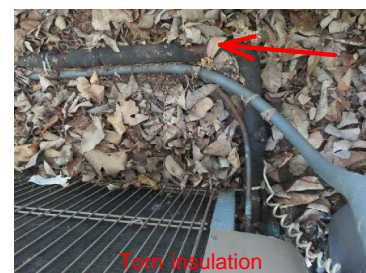
7. Approximate Age: 22 years old
8. Fuel Type: 240 VAC
9. Functional Electrical Disconnect: Fused
10. Temperature Differential: 68-51 = 17 Degrees
11. Maintenance Refrigerant Lines: Serviceable condition missing insulation observed.

There is torn/

Main AC System Refrigerant Lines: Serviceable condition [There is torn/ missing insulation observed.](#)

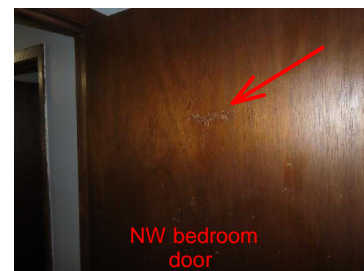
Doors: Wood The 2nd floor NW bedroom door has minor damage present.

Living Room, Kitchen, Dining Areas, Bedrooms, Bathrooms, Basement Rec Room Finished
 Room Doors: Wood [The 2nd floor NW bedroom door has minor damage present.](#)

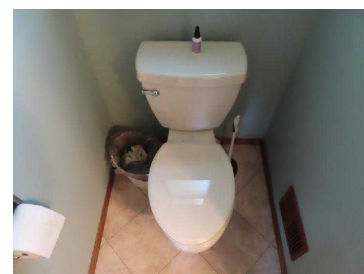
| 6. Defective | Toilets: Standard The toilet is loose at the floor. Recommend a qualified, licensed plumbing contractor inspect and repair/ replace as needed. |

1st Floor - 1/2 Bathroom Toilets: Standard The toilet is loose at the floor. Recommend a qualified, licensed plumbing contractor inspect and repair/ replace as needed.

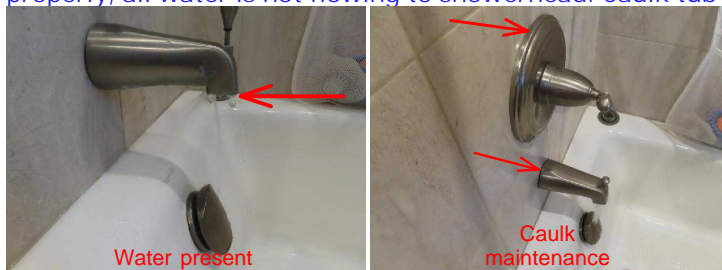
| 10. Maintenance | Fixtures/Plumbing: PVC, Brush Nickel faucet The shower diverter is not functioning properly, all water is not flowing to showerhead. Caulk tub diverter and/ or faucet as needed. |

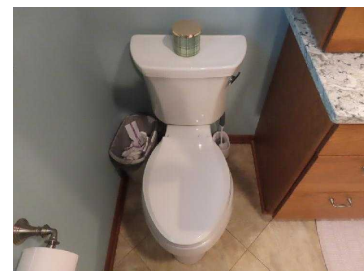
| 12. Defective | Toilets: Standard The toilet is loose at the floor. Recommend a qualified, licensed plumbing contractor inspect and repair/ replace as needed. |

2nd Floor - Full Bathroom Toilets: Standard The toilet is loose at the floor. Recommend a qualified, licensed plumbing contractor inspect and repair/ replace as needed.

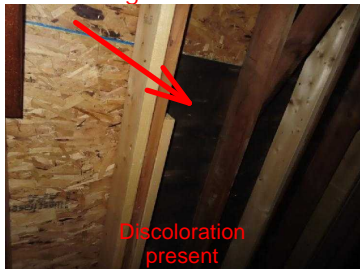
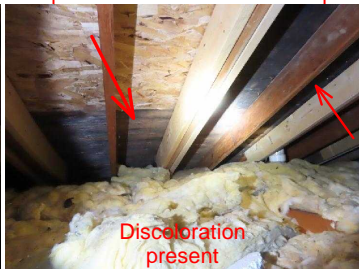
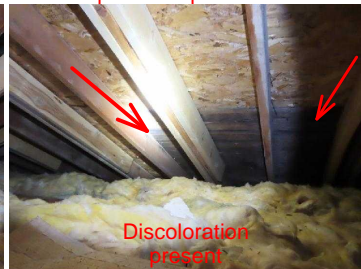
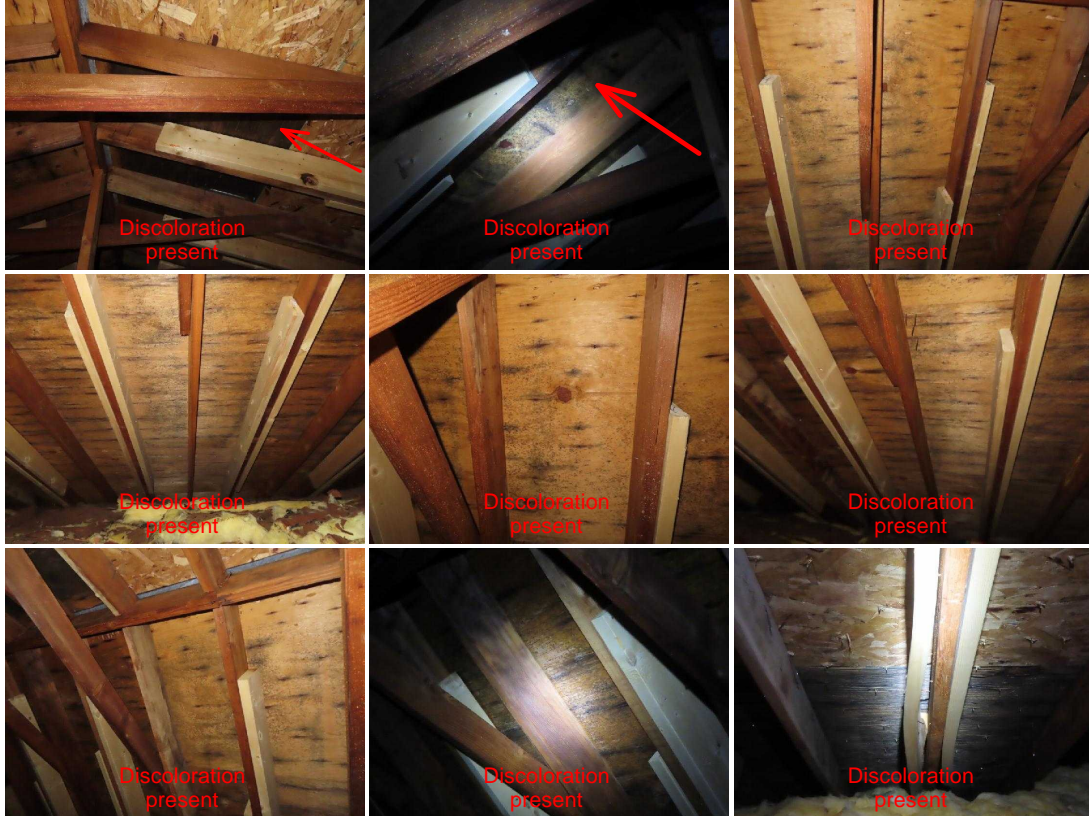
| 2. Defective | Mildew/Microbial Growth: Attic Sheathing Recommend proper cleaning and removal of mildew. Mildew/ microbial growth may pose a health hazard and should be properly re-mediated. Lab testing of suspected mildew/ microbial growth is required to determine the presence of mildew/ microbial growth. Recommend a qualified contractor inspect and repair/ replace as needed. |

Environmental Mildew/Microbial Growth: Attic Sheathing Recommend proper cleaning and removal of mildew. Mildew/ microbial growth may pose a health hazard and should be properly re-mediated. Lab testing of suspected mildew/ microbial growth is required to determine the presence of mildew/ microbial growth. Recommend a qualified

Mildew/Microbial Growth: (continued)
contractor inspect and repair/ replace as needed.

5. Further Evaluation Sheathing: OSB, Plywood There is mildew present that should be properly cleaned and removed. See Environmental section.

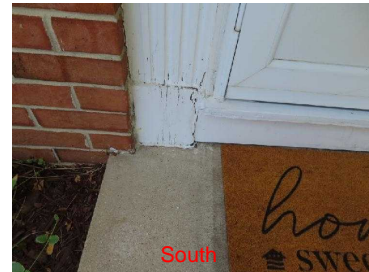
Peeling Paint: Exterior Components
paint present on the exterior wood components.

There is minor peeling
