**Second Look DBA National Property inspections DBA
National Property Inspections**

Inspection Date:
01/21/2019

Pre-Inspection Agreement

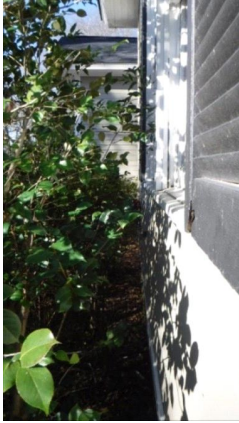
Keeping vegetation trimmed around the house away from the siding and windows will help prevent moisture, insect and other deleterious issues from developing..

Landscaping: Shrubbery against siding

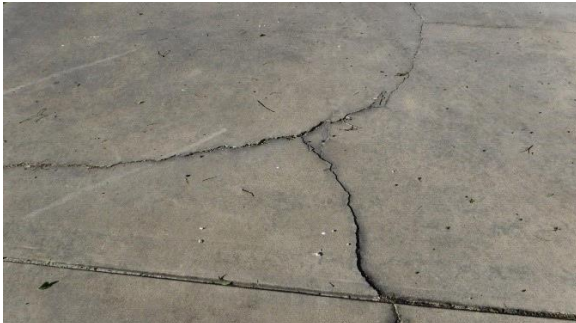
Noted cracks in the driveway are common and should be filled with crack sealer to help keep from further deterioration.

Driveway: Cracks in concrete

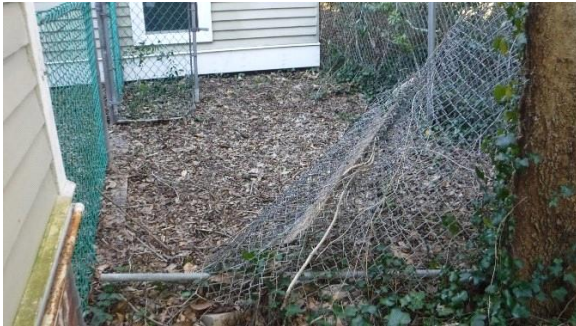
The chain link fence next to the house on the right side is down, missing support posts and top railing, and needs repairs. Recommend further evaluation and repairs by a licensed fencing contractor.

Fences / Gates: Broken fencing- right side of house

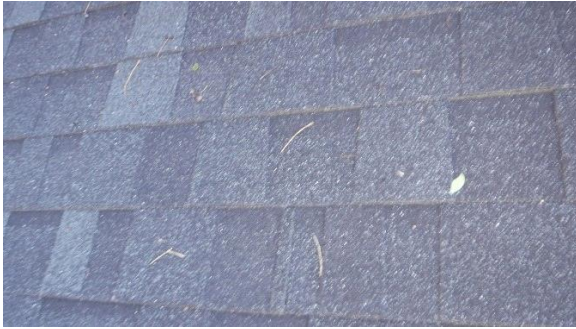
Roofing: Shingles- close up

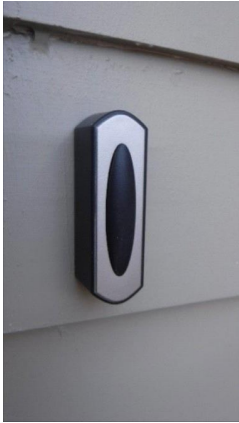
The rear door bell does not operate. Recommend further evaluation and repairs by a licensed electrician.

Ext Surface Misc Electrical Item: Rear door bell button

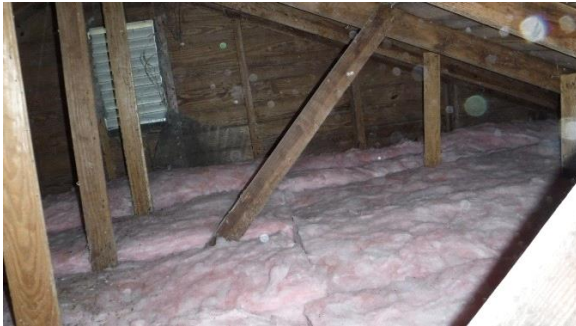
Main house-Attic insulation value: 12-14 inches= R 42
Bonus room- 8 Inches = approx. R30

Attic Insulation: Batt insulation over bonus room

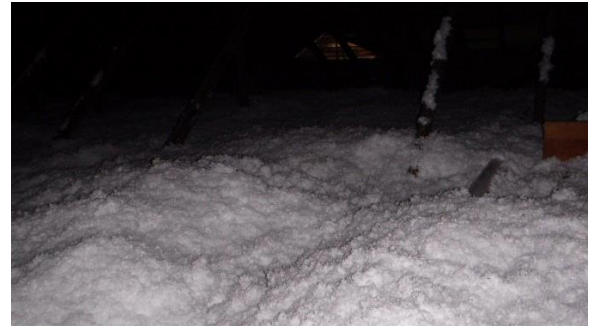
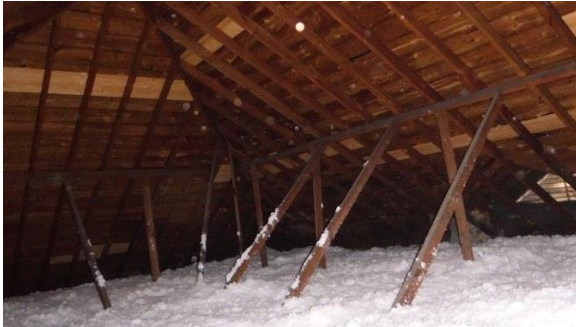
Attic Insulation: Blown insulation over main house

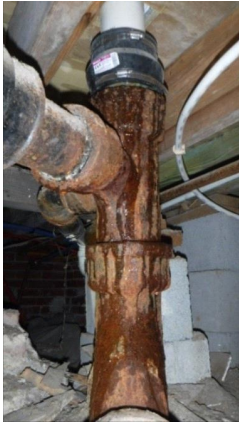
There is a drain line leak under the rear right corner bathroom in the crawl space. Recommend repairs by a licensed plumber.

Plumbing: Drain line leak in crawl space

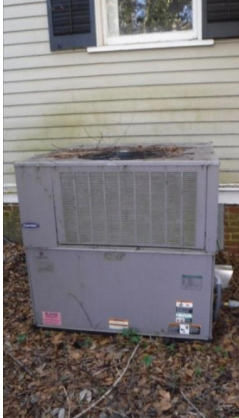
The HVAC unit failed to operate using its normal controls, on the day of the inspection. Recommend further evaluation and repairs by a Licensed HVAC contractor.

Heating- Main house: Gas Pack- does not operate

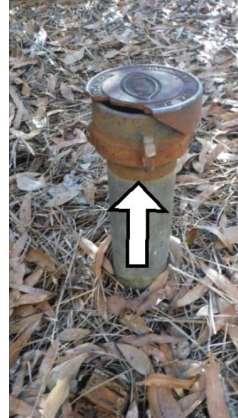
- There is underground oil tank located on the left side of the house. Recommend removing any residual heating oil and filling the tank with sand to avoid future collapse.

Heating- Main house: Underground oil tank

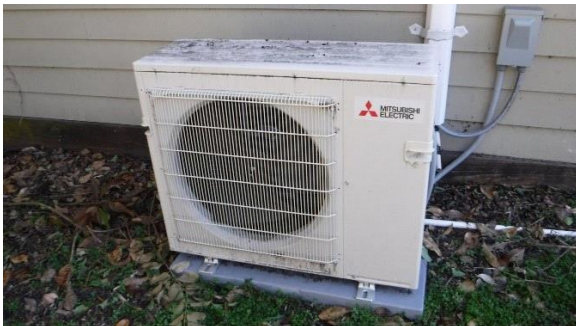
Heating- Rear additions: Mini Split

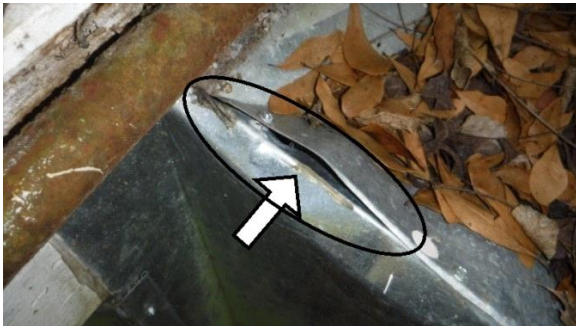
The metal shroud protecting the ductwork where it enters the house has a hole that should be sealed to properly protect the inside ductwork from moisture (rain) intrusion. Recommend sealing the shroud by ac licensed contractor. .

HVAC Distribution: Exterior ductwork shroud

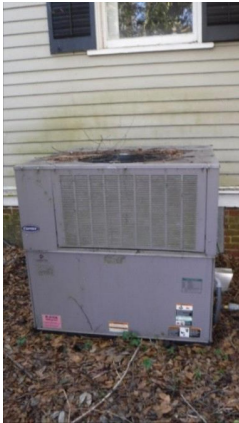
Ambient temperature was too cold to inspect Cooling portion of HVAC unit. I always recommend a seasonal "tune up" by a licensed HVAC contractor to keep the A/C unit(s) operating at their peak performance condition. If there are any potential deficiencies on the horizon, they will often be able to fix small irregularities now that could turn into large problems later.

Cooling- Main House: Gas Pack

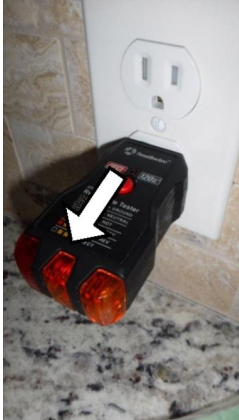
There are three prong counter top receptacle outlets that are missing their ground connection (open ground condition.) and are not GFCI protected. Recommend further evaluation and repairs by a licensed electrician.

Kitchen: Countertop outlets- open ground connections

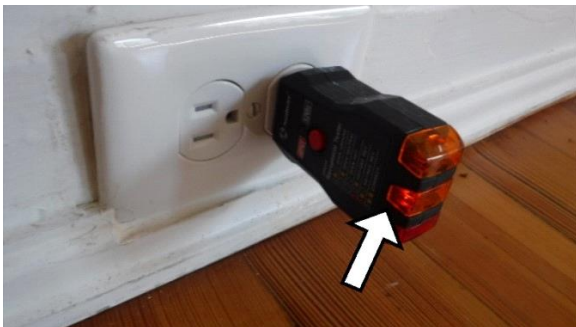
There are three prong receptacle outlets that have open ground conditions. Recommend further evaluation and repairs by a licensed electrician.

Living room: Electrical outlets- have open ground connections

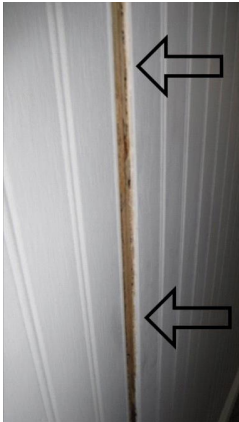
Some of the wall paneling has separated between panels. Recommend repairs by a licensed contractor.

Rear bonus room: Loose wall paneling

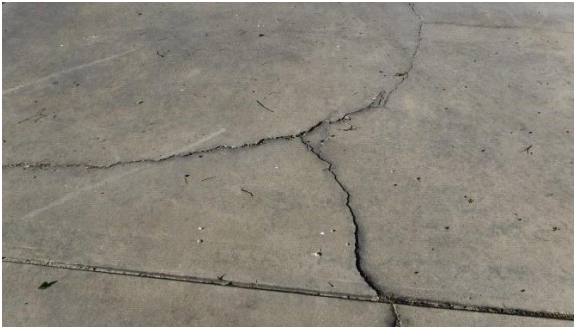
Noted cracks in the driveway are common and should be filled with crack sealer to help keep from further deterioration.

DRIVEWAY: Cracks in concrete

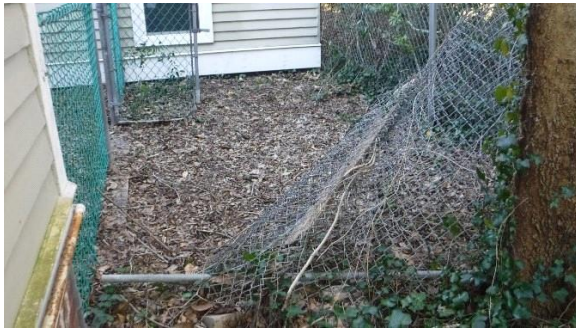
The chain link fence next to the house on the right side is down, missing support posts and top railing, and needs repairs. Recommend further evaluation and repairs by a licensed fencing contractor.

FENCES / GATES: Broken fencing- right side of house

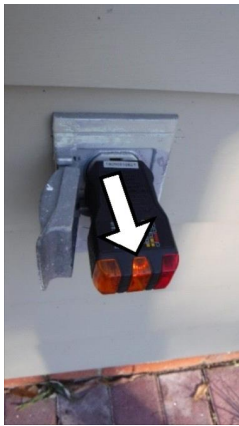
The rear exterior outlet has an open ground connection and is not GFCI protected. Recommend further evaluation and repairs by a Licensed electrician.

EXTERIOR SURFACE: Exterior electrical outlet- open ground connection

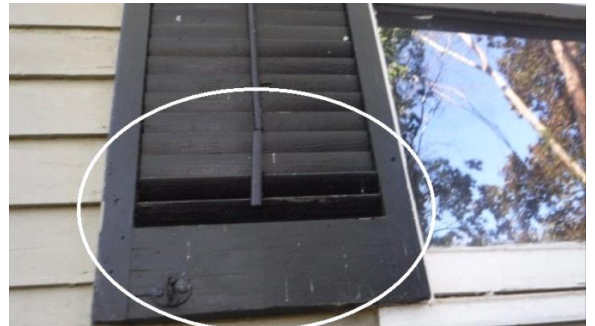
Some of the window shutters are deteriorating and need repairs. Recommend further evaluation and repairs by a licensed contractor.

WINDOWS: Deteriorating window shutters

WINDOWS: Broken/ deteriorating window shutters

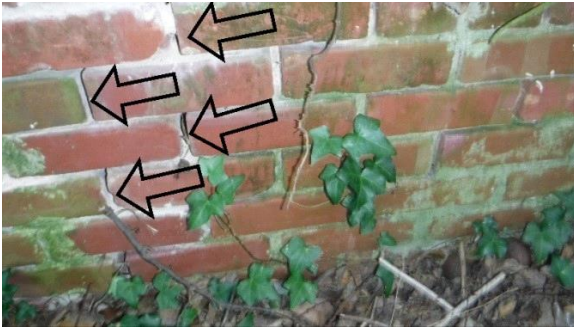
Missing and loose brick mortar is noted in several locations around the house. Recommend further evaluation and repointing loose mortar joints to maintain foundation wall integrity, by a licensed brick mason.

EXTERIOR FOUNDATION: Loose/missing mortar between bricks

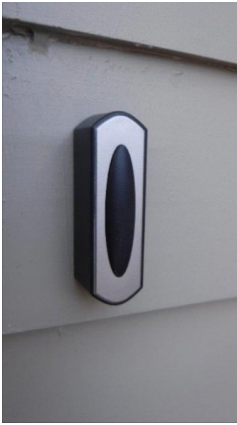
The rear door bell does not operate. Recommend further evaluation and repairs by a licensed electrician.

EXT SURFACE MISC ELECTRICAL ITEM: Rear door bell button

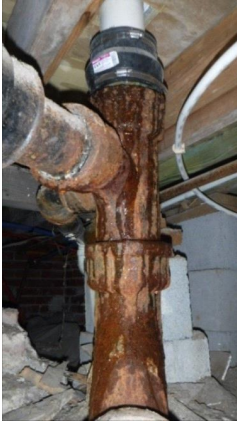
There is a drain line leak under the rear right corner bathroom in the crawl space. Recommend repairs by a licensed plumber.

PLUMBING: Drain line leak in crawl space

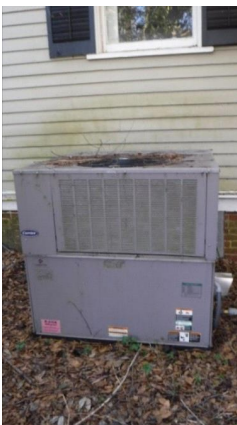
The HVAC unit failed to operate using its normal controls, on the day of the inspection. Recommend further evaluation and repairs by a Licensed HVAC contractor.

HEATING- MAIN HOUSE: Gas Pack- does not operate

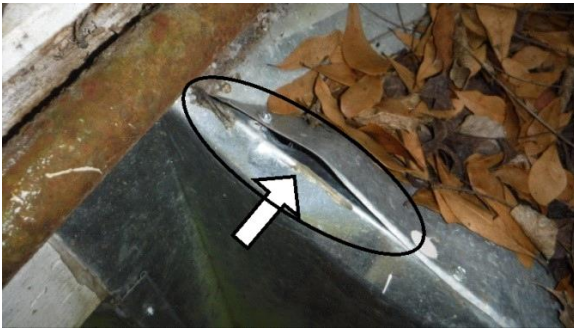
The metal shroud protecting the ductwork where it enters the house has a hole that should be sealed to properly protect the inside ductwork from moisture (rain) intrusion. Recommend sealing the shroud by ac licensed contractor. .

HVAC DISTRIBUTION: Exterior ductwork shroud

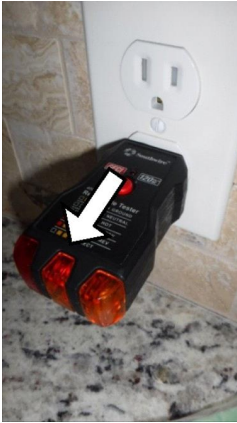
There are three prong counter top receptacle outlets that are missing their ground connection (open ground condition.) and are not GFCI protected. Recommend further evaluation and repairs by a licensed electrician.

KITCHEN: Countertop outlets- open ground connections

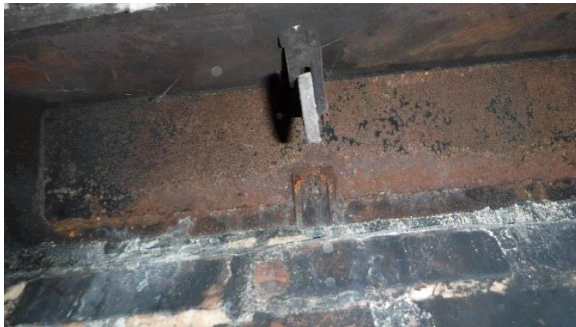
Recommend not using the fireplaces in current conditions, as they are not lined, their dampers are stuck in the closed position and do not open properly. Cracks in fire bricks, cracks in base concrete and loose mortar noted. Recommend further evaluation and repairs by a licensed fireplace contractor.

FIREPLACE: Dampers- do not open

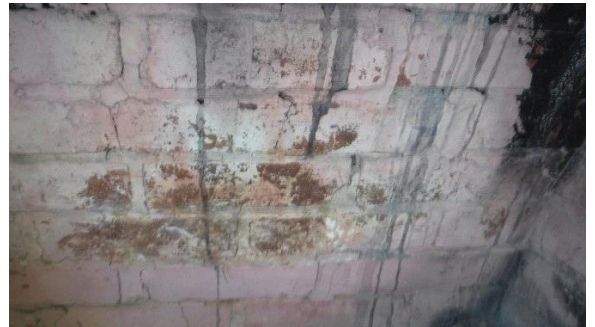
FIREPLACE: Loose/ missing mortar between bricks

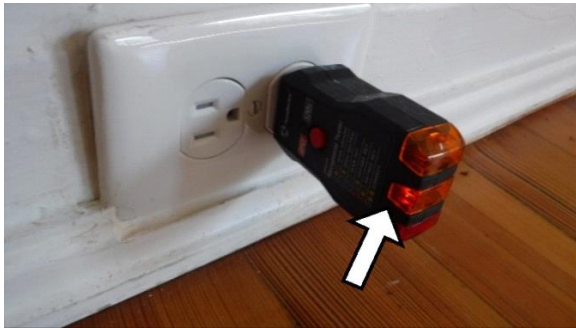
There are three prong receptacle outlets that have open ground conditions. Recommend further evaluation and repairs by a licensed electrician.

LIVING ROOM: Electrical outlets- have open ground connections

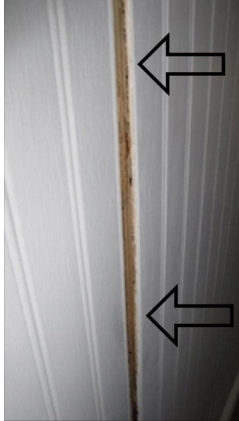
Some of the wall paneling has separated between panels. Recommend repairs by a licensed contractor.

REAR BONUS ROOM: Loose wall paneling
