National Property Inspections

Tim Smith, 123 Main Street, Pensacola, FL, 32501

Wednesday, September 25, 2019

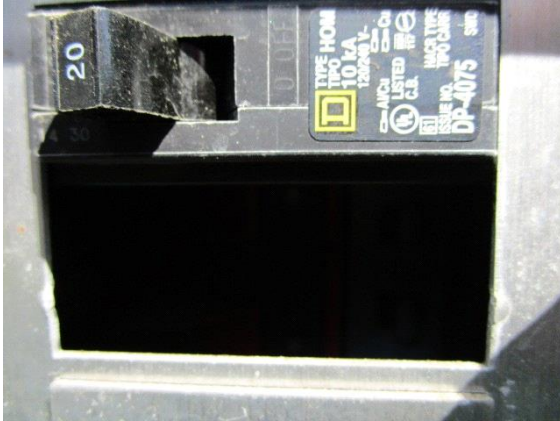
Missing knockout in main panel is a safety hazard. Recommend knockout installation by qualified electrician for safety.

Missing Breakout

DEFECTIVE

Missing knockout in main panel is a safety hazard. Recommend knockout installation by qualified electrician for safety.
