INSPECTION REPORT

[Address]

Nokomis FL 34275

NOVEMBER 25, 2020

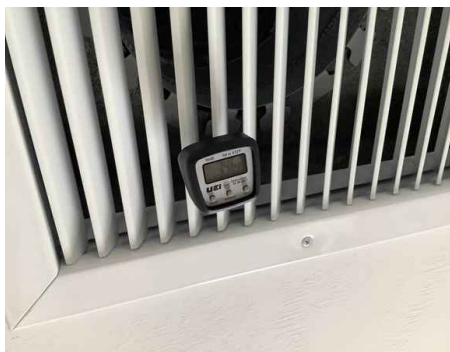
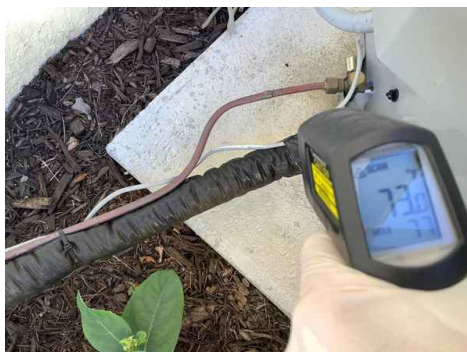
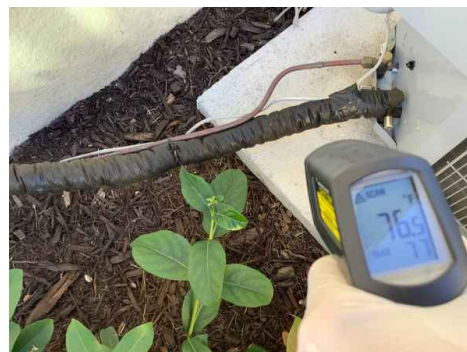
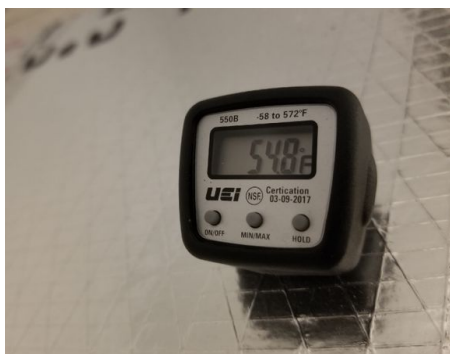
General: Temperature Differential

20 Degrees

This is the number of degrees the system is cooling (or heating) the house air. Normal range for this number is 14-24 degrees when operating the system during hot weather, lower when ambient temperatures are lower. The test results were measured using a digital thermometer. The system functioned as expected when tested and appeared to be serviceable at the time of the inspection. As with all mechanical equipment, the unit may fail at any time without warning. The inspector cannot determine future failures.

General: Normal Operation

The air conditioning system responded to the controls and appeared to operate in a satisfactory manner.

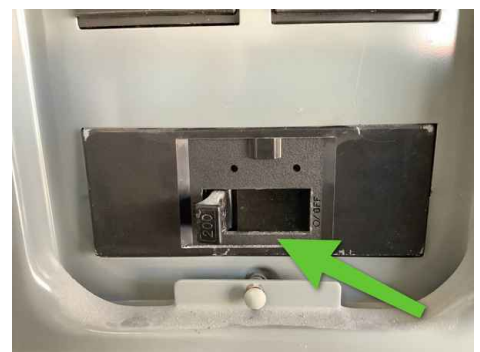
Electric Panel: Location of Main Disconnect
Bottom of Panel

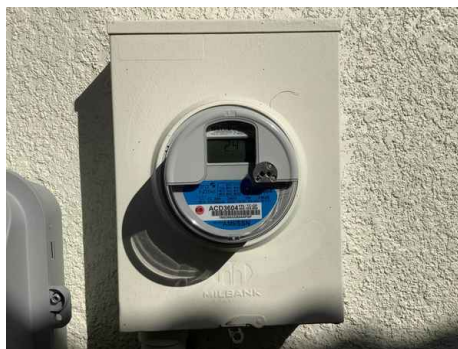
Meter: Meter base

Service Wires: Service entrance wires

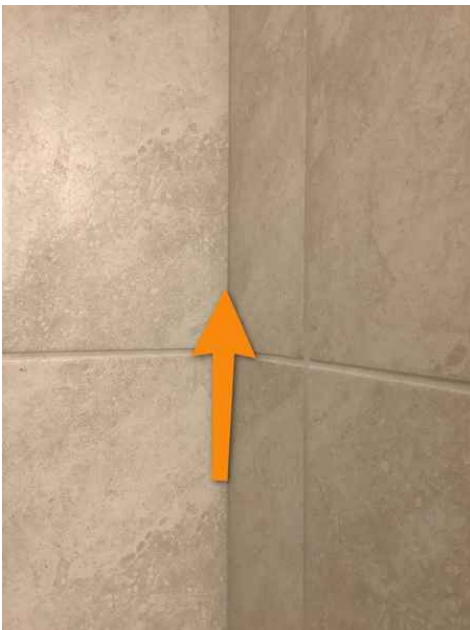
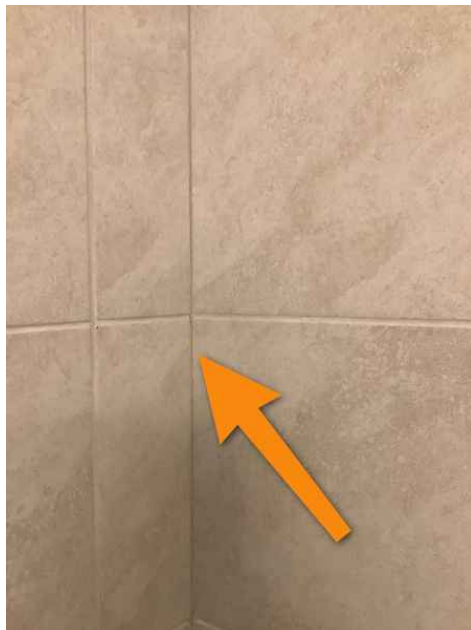
10.1.2 Bathub

GROUT DETERIORATED

Grout at the tiles around the bathtub is damaged or deteriorated. This can allow water to intrude behind the tiles causing loose tiles and microbial growth issues. For example, deteriorated or missing grout, cracked, missing or loose tiles, etc. A qualified contractor should evaluate and repair tile and/or grout as necessary.

Contact a qualified professional.

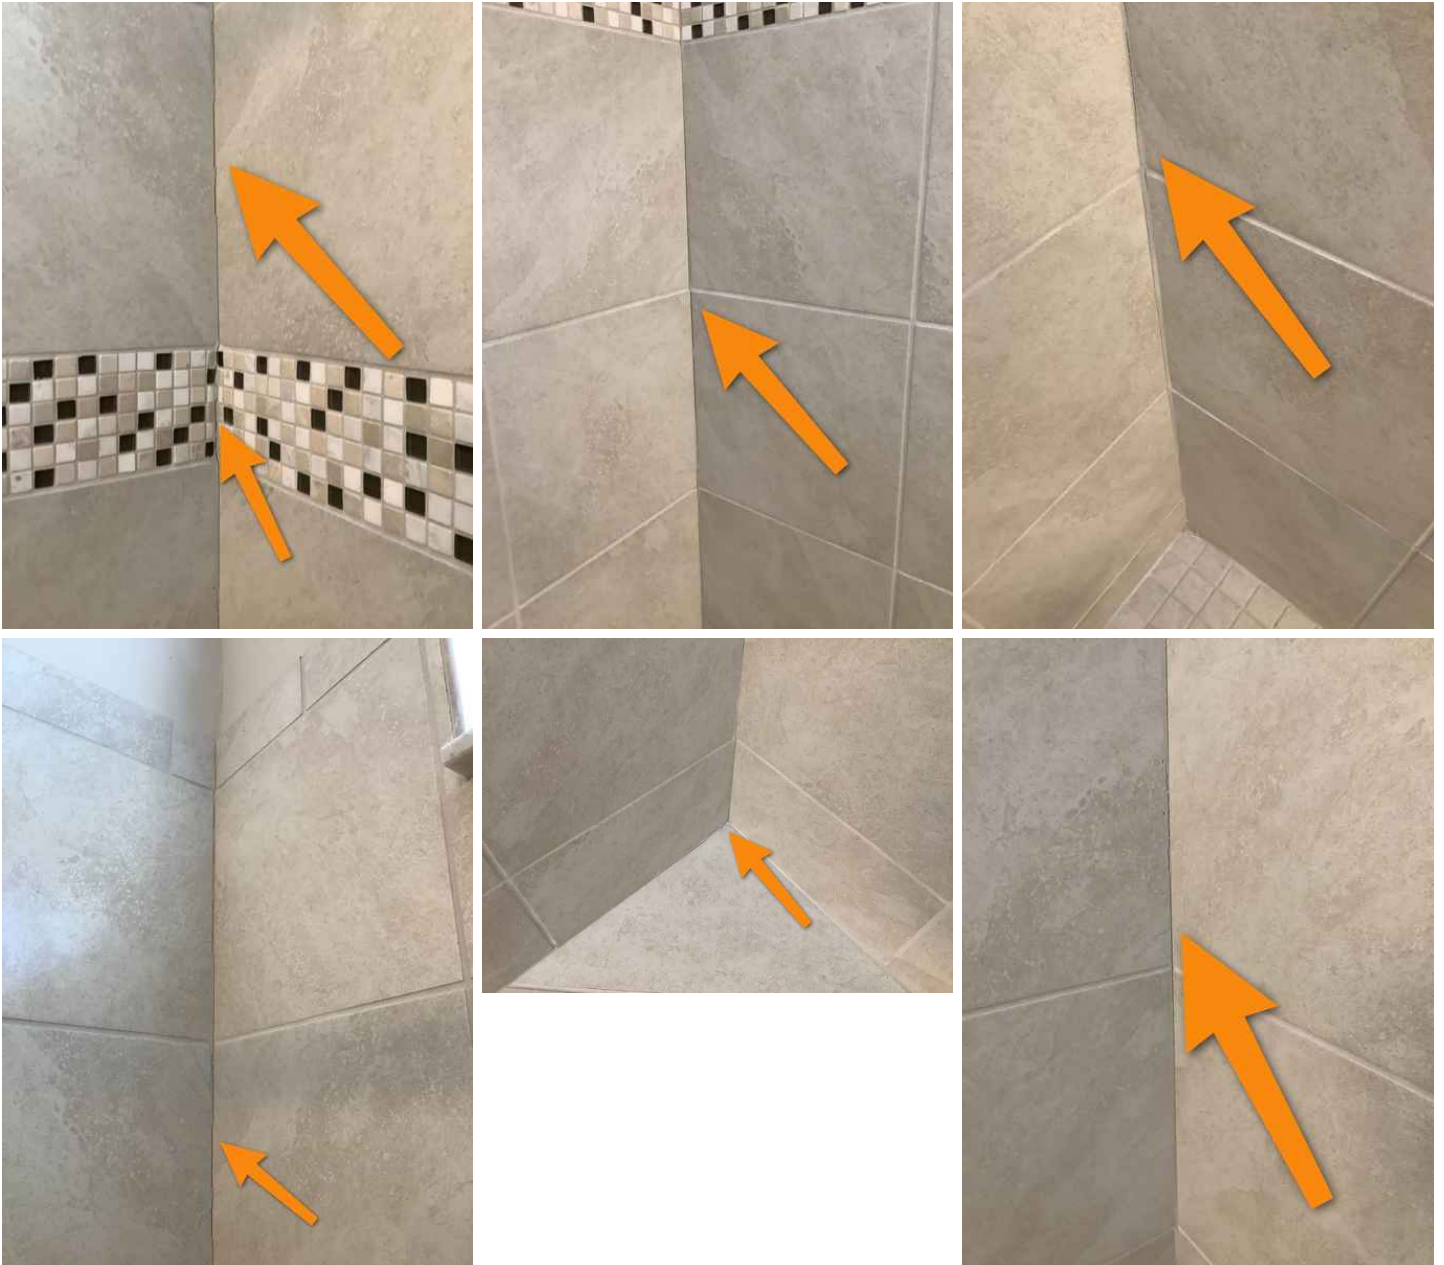
10.5.1 Flooring

CRACKED TILES

Tile is damaged and/or deteriorated in one or more areas. A qualified contractor should evaluate and make repairs as necessary. For example, replacing broken tiles.
