**Property Inspector Pros DBA  
National Property Inspections**

**Sample**

Saturday, August 22, 2020

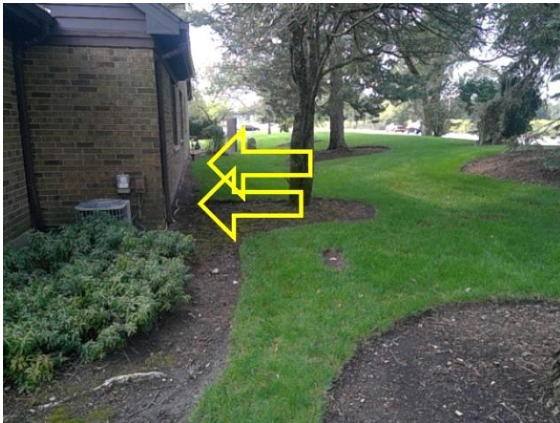
The grading on this property was positive, near level and negative. This condition may allow water to accumulate around the house during rains and has the potential to allow water to enter the dwelling. Monitor condition during rains as improvements in grading/drainage may be needed.

Grading / Drainage: Negative slope.

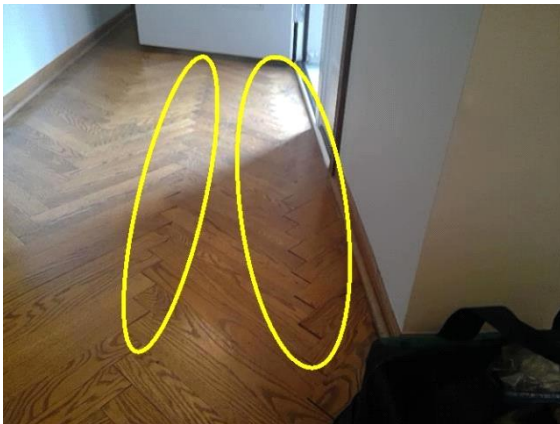
Floors were uneven and sloped. This may indicate improper settlement or deterioration of the framing. Recommend further evaluation/repair by qualified contractor(s).

Entrance/Dining Room: Floor uneven and popping up.

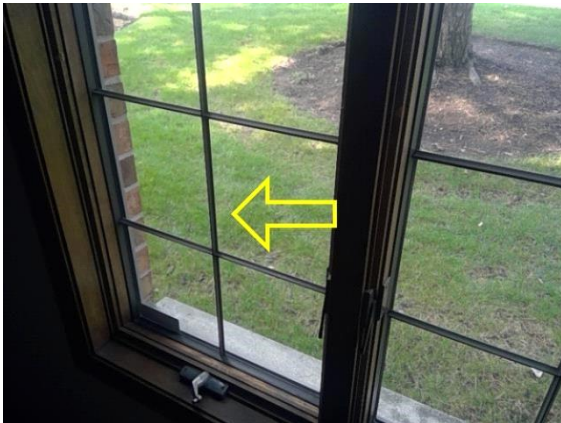
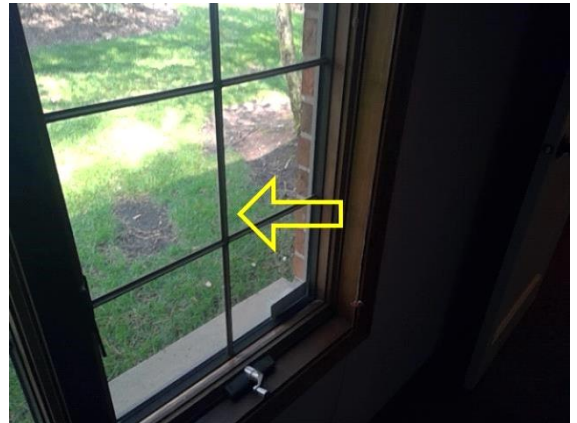
Screens:

Several screens missing throughout the house.  
Some screens were stored in the attic.  
Recommend replacing missing screens.

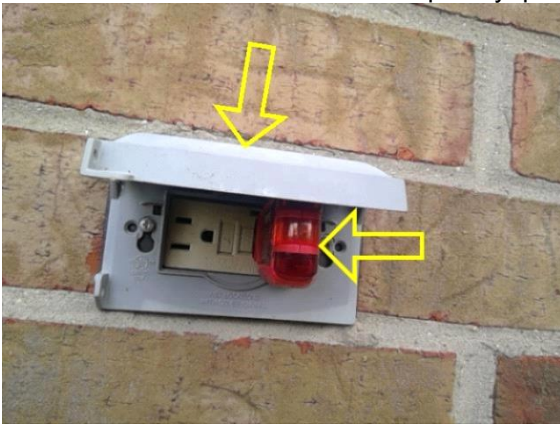
EXTERIOR SURFACE:

Recommend replacing with a weather cap cover that accommodates plug.

Recommend further evaluation/repair by qualified contractor.

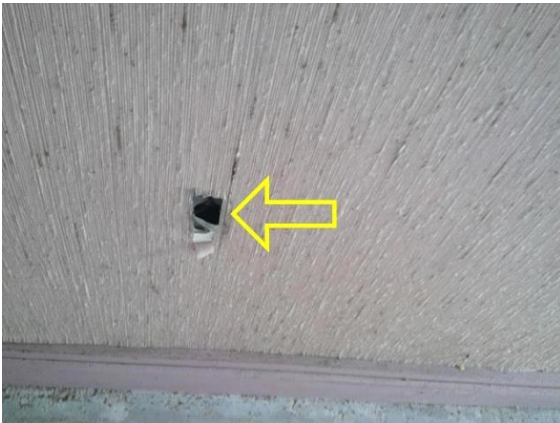
GARAGE/CARPORT:

Hole/opening needs to be covered.

Recommend further evaluation/repair by qualified contractor(s).

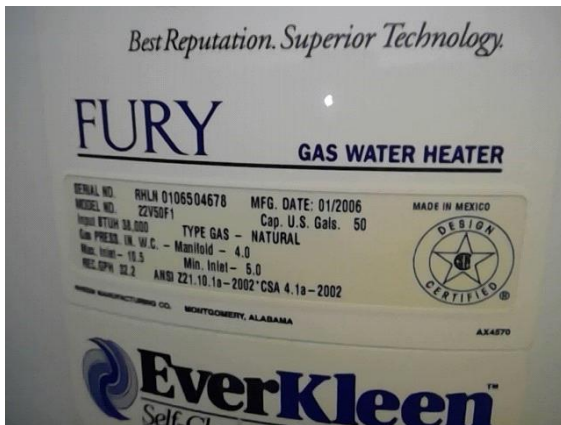
WATER HEATER:

Most water heaters have a life span of ten to twelve years. Unit was functional, but was rated marginal due to its age. Ultimately, you should consider budgeting for replacement of the hot water heater in the foreseeable future.

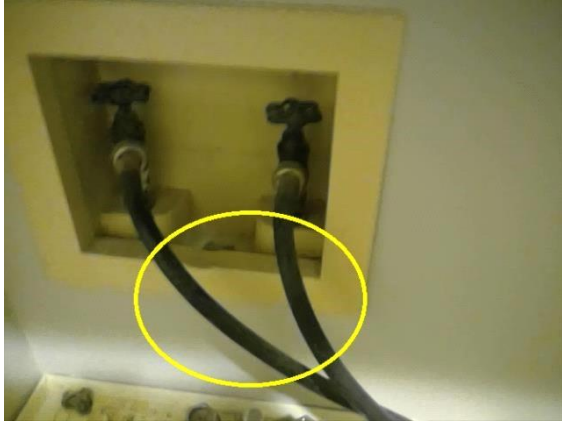
LAUNDRY FACILITIES:

Black rubber feeder hoses could burst. Recommend replacing with one-piece braided type hoses.

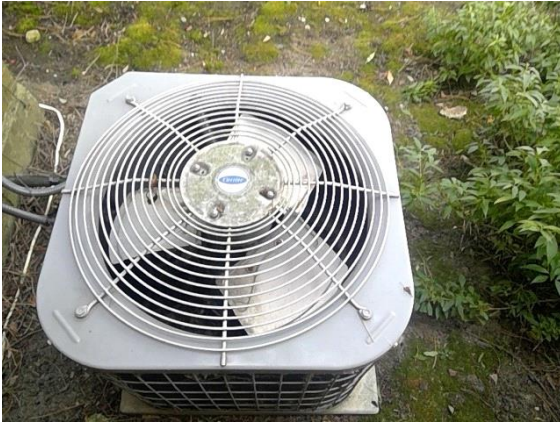
COOLING:

Rated marginal due to age of unit. Budget for eventual replacement.

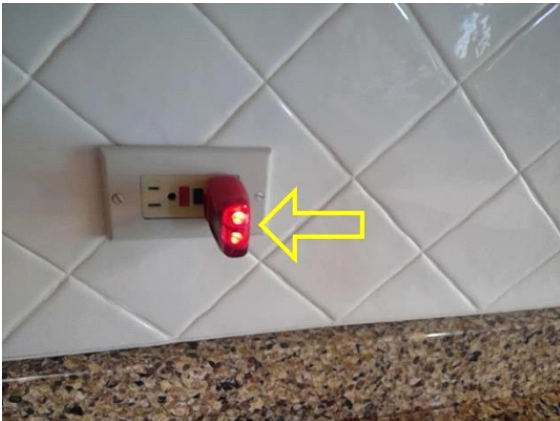
KITCHEN:

A Ground Fault Circuit Interrupter (GFCI) electrical outlet in the kitchen did not respond to the test button.

Recommend further evaluation/repair by qualified contractor(s).

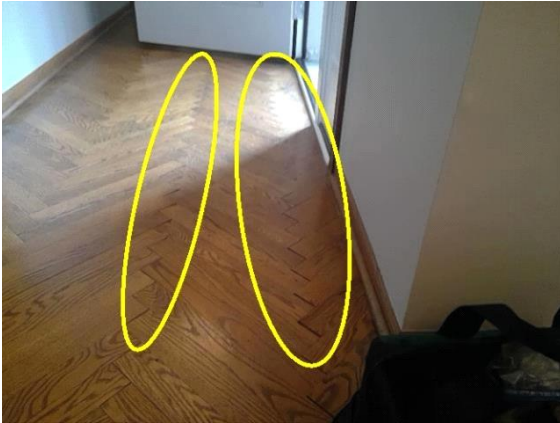
Floors were uneven and sloped. This may indicate improper settlement or deterioration of the framing. Recommend further evaluation/repair by qualified contractor(s).

ENTRANCE/DINING ROOM: Floor uneven and popping up.

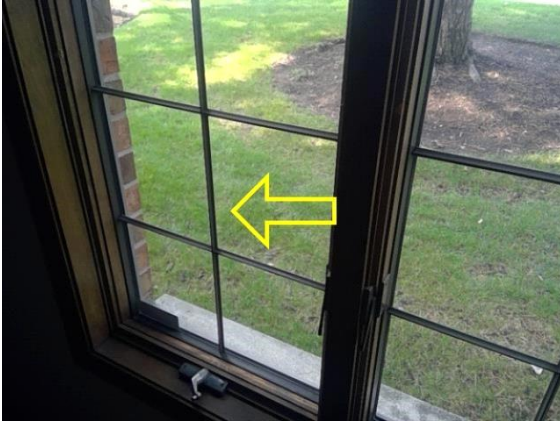
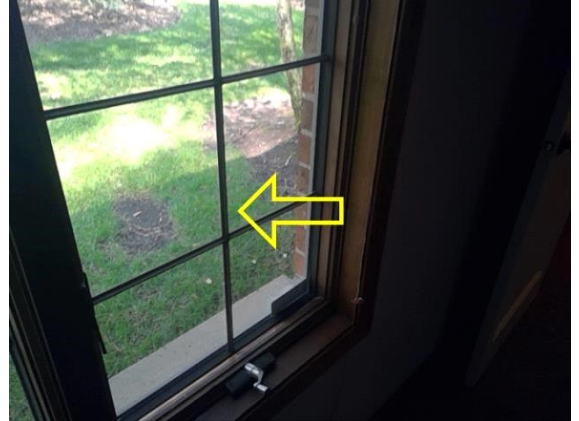
SCREENS:

Several screens missing throughout the house.  
Some screens were stored in the attic.  
Recommend replacing missing screens.
