National Property Inspections

Sample

Friday, December 5, 2014

GENERAL INFORMATION

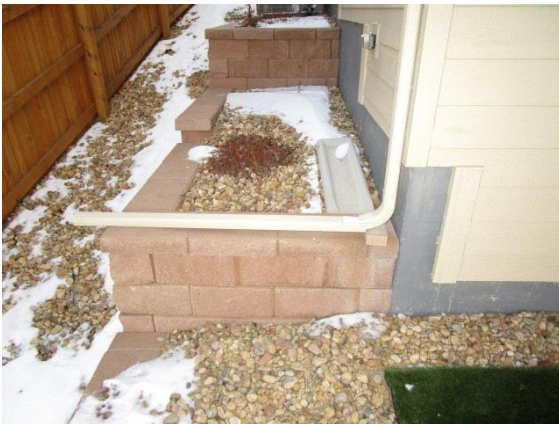
Gutters/Down Spouts:

Viewed gutters from ground only.

Subsurface drainage system noted. Inspecting subsurface drains is beyond the scope of this general home inspection.

Missing extensions at downspouts.

Recommend installing downspout extensions to divert water 4 to 6 feet away from the foundation.

Monitor gutters during rainfall to ensure that no water is dripping next to the foundation and that all water is being diverted 4-6 feet away from the foundation.

Ensure that the back side of the gutter is fastened to the fascia board as needed and that the gutters and downspouts are cleaned out on a regular basis to reduce the risk of dripping water and/or overflowing troughs.

A complete roof gutter system may help reduce the risk of weather deterioration, recommend contacting a professionally qualified gutter company to evaluate and repair as necessary.

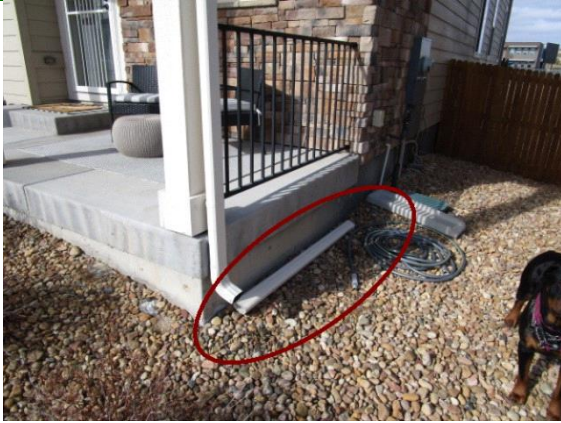
Gutters/Down Spouts: Detached downspout

Reconnect the detached downspouts and extensions.

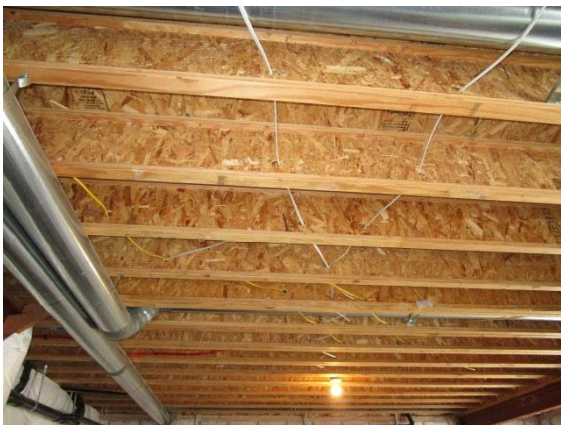
Under Floor Framing & Support:

All framing under the floor was acceptable at time of inspection.

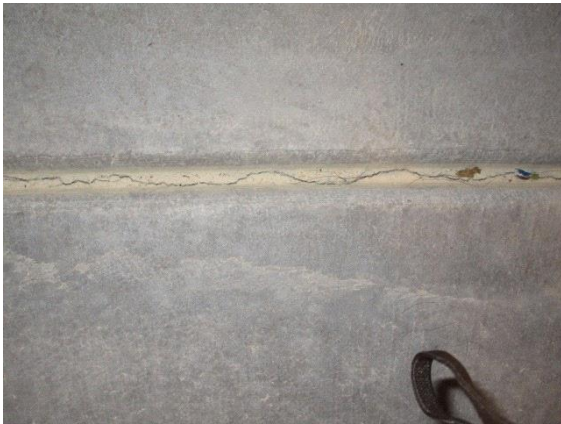
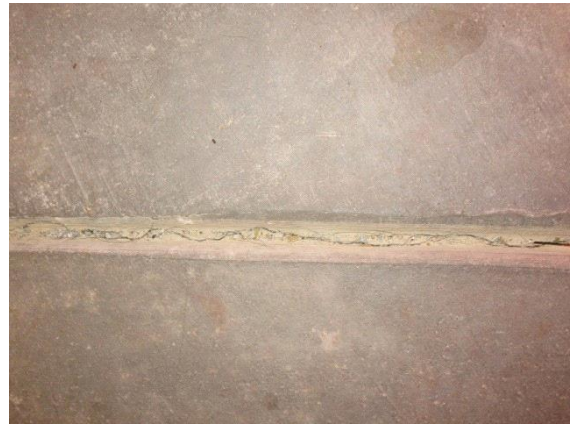
Floor/Slab:

Cracks

Small cracks visible. Typical for concrete slabs but should not be structurally significant. Recommend monitoring cracks for movement.

Typical cracks noted. Recommend sealing. Monitor regularly and evaluate/repair as required.

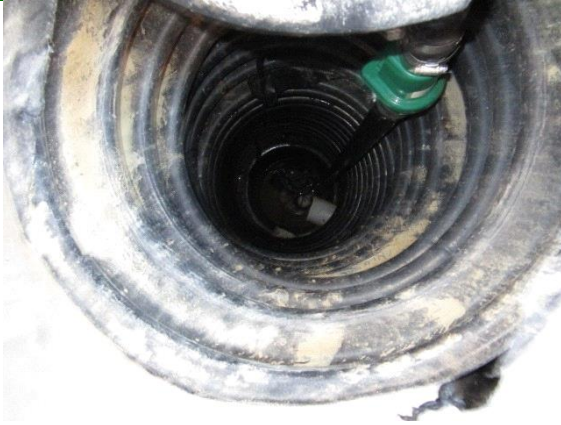
Sump/Sump Pump:

Operated sump pump by adding water to sump pit. Water discharged to exterior. Pump did not exhibit any excessive noise.

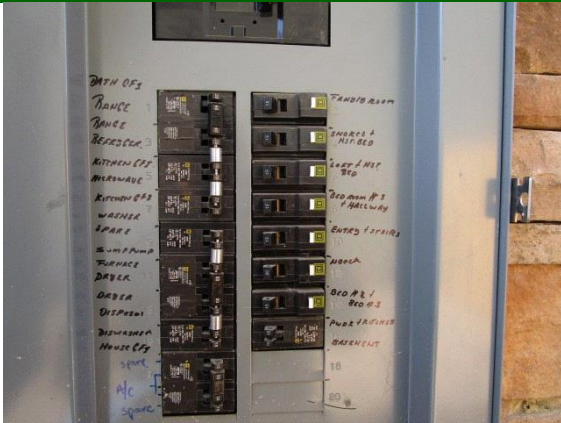
Electrical:

Brand: SquareD

200 AMP

AFC (Arc Fault Circuit Interrupter) breakers present but not inspected due to owner's possessions plugged into receptacles.

*Smoke Detectors / GFCI's checked with test button only. Monthly Test Recommended.

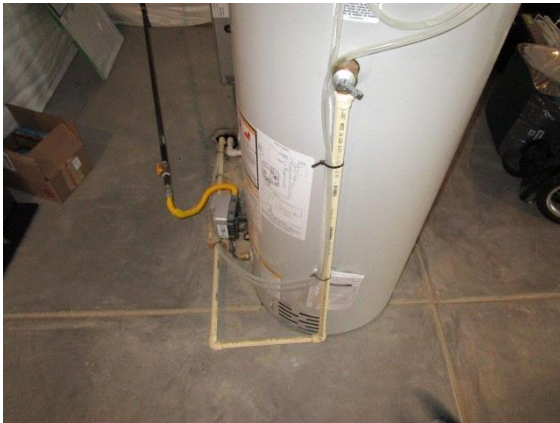
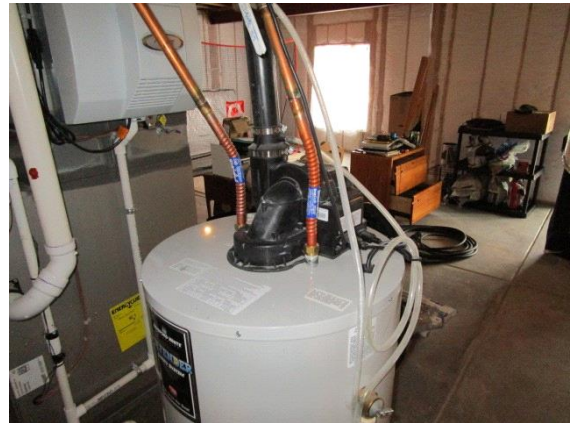
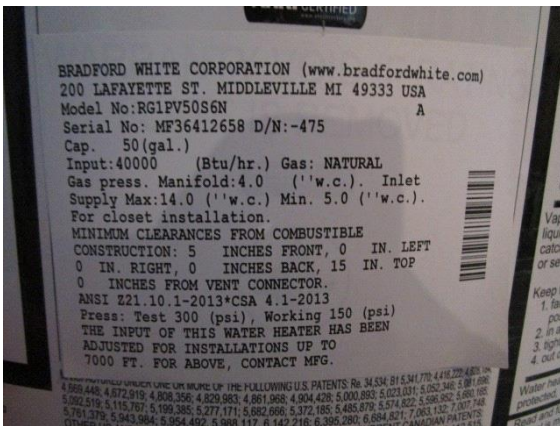
Water Heater:

Brand: Bradford White
SerialNo: MF36412658

Model: RG1PV50S6N

Size: 50 Gallon(s)

The operation and installation of the water heater appeared to be satisfactory at time of inspection. Routine maintenance such as draining the water heater could prolong its lifespan. Always refer to manufactures' specifications before doing any maintenance on your water heater.
