**JCM Property Ventures, LLC DBA
National Property Inspections**

Sample Report

Inspection Date:
06/06/2023

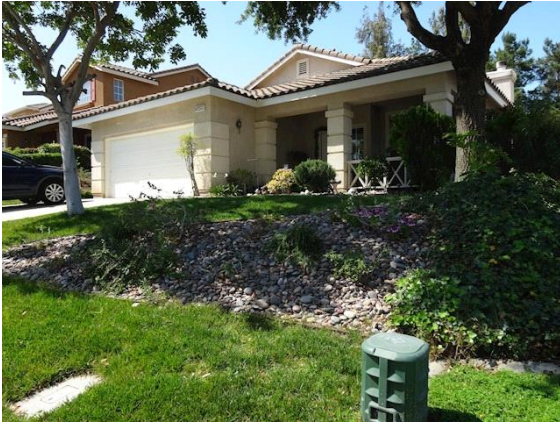
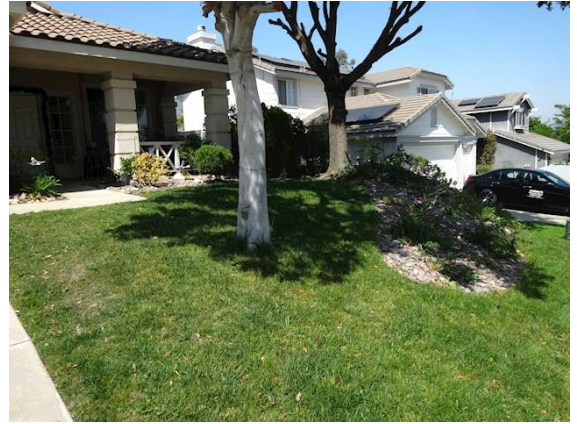
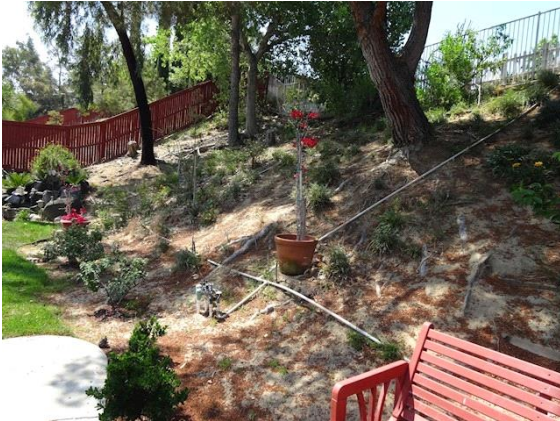
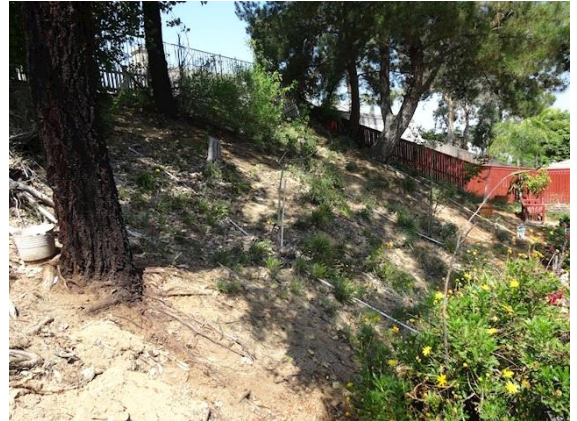
Appeared to be a positive slope around all sides of the home.

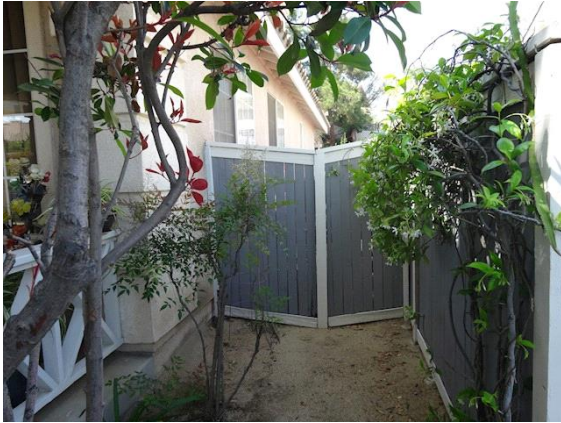
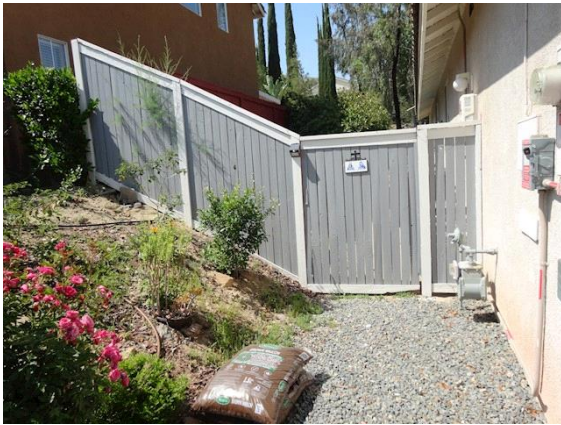
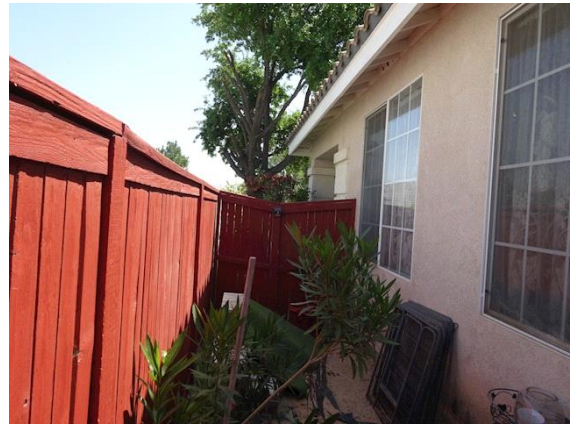
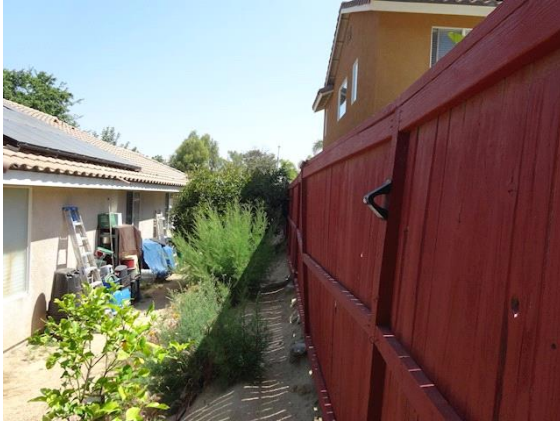
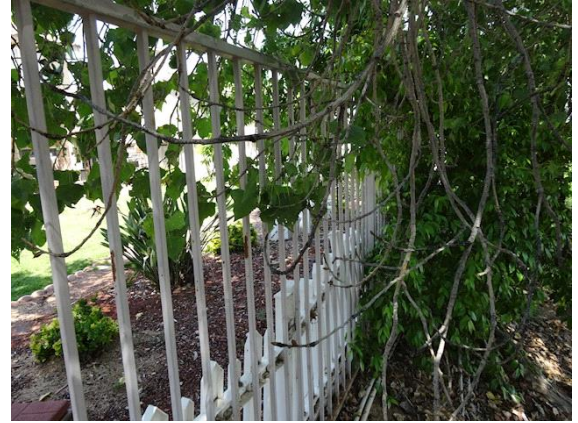
Several areas of wood rot observed on the wood fence. Correct as necessary.

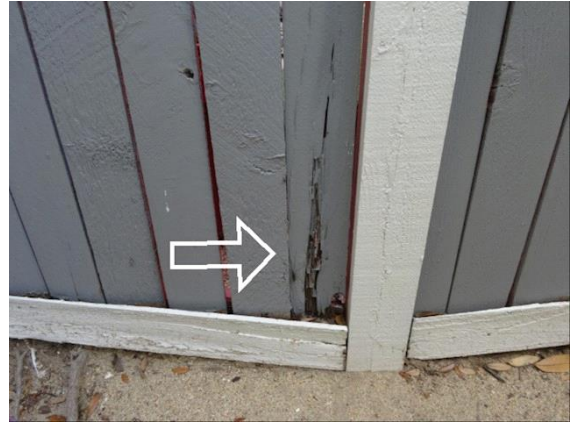
Fences / Gates: Area of wood rot to fence slat.

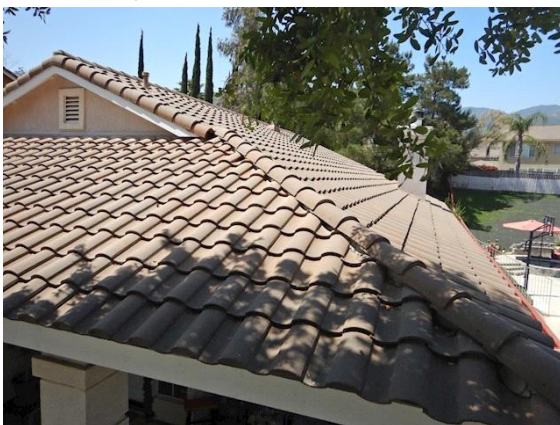
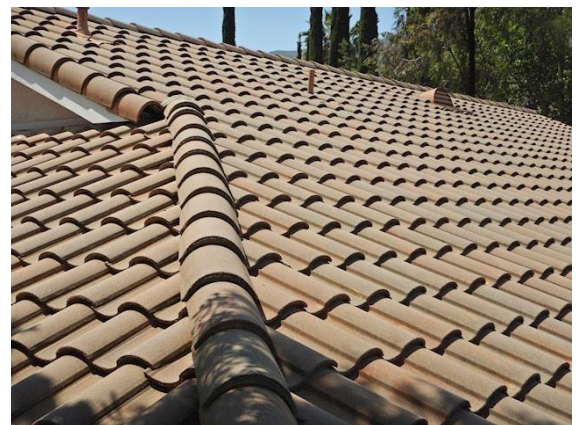
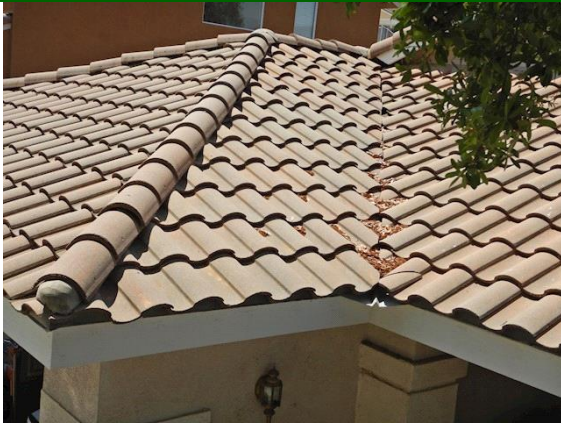
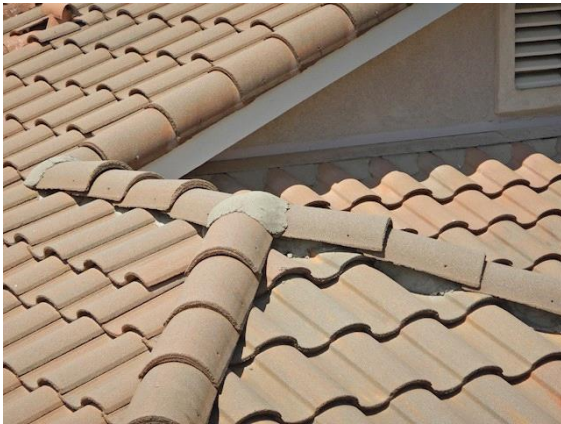
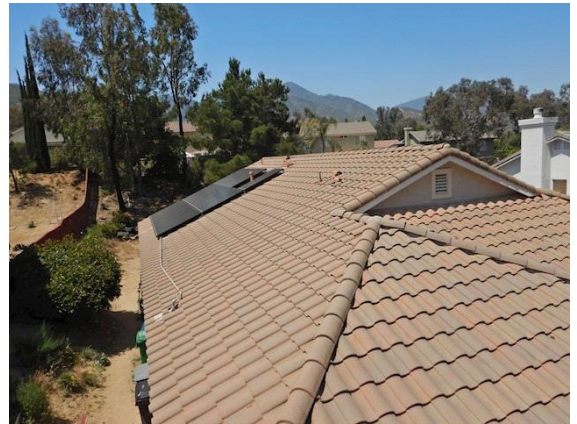
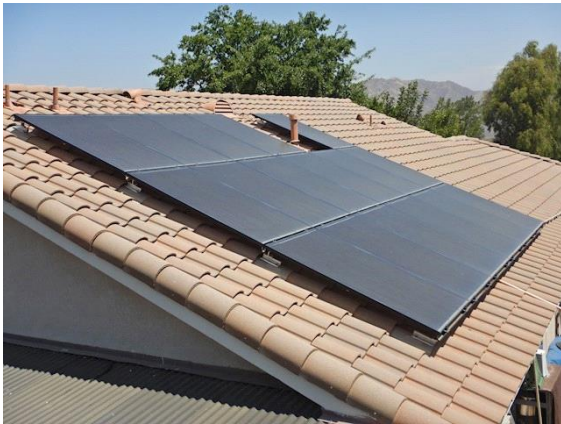
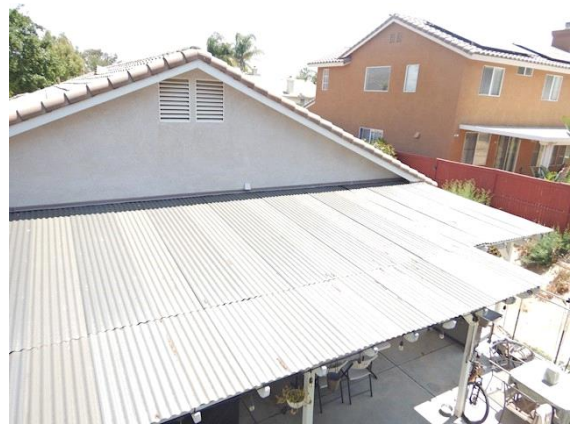
Overall the roof was in acceptable condition with no active leaks noted on day of inspection. Recommend monitoring for future deterioration and repair/replace as required. Solar panels were present on roof, but are not within the scope of the inspection and were not inspected.

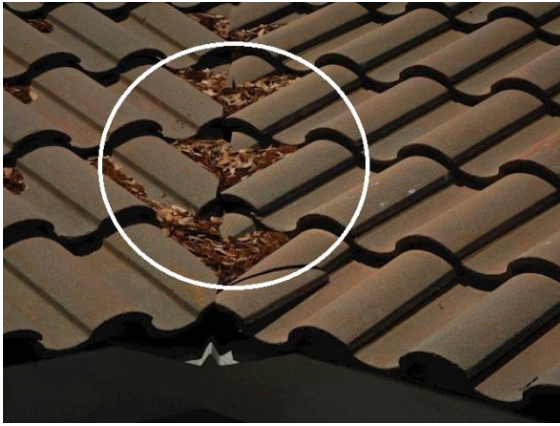
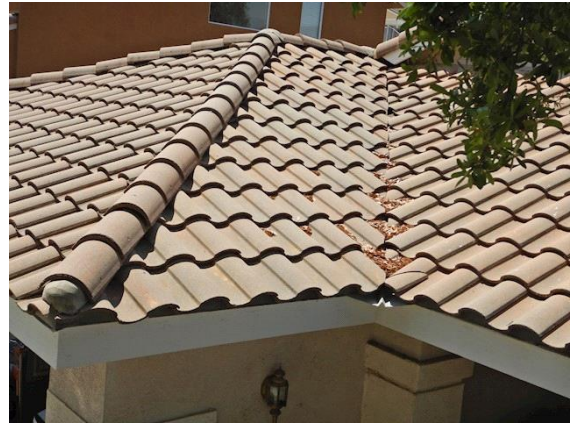
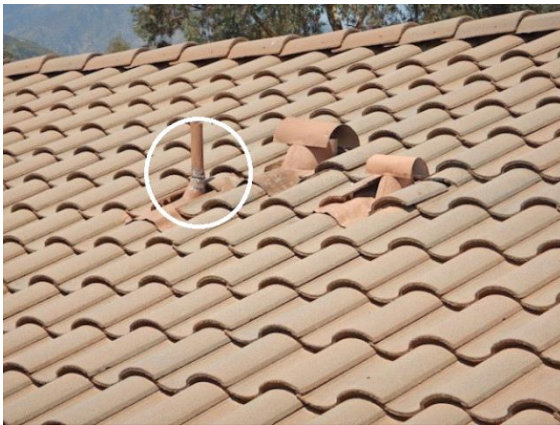
Minor debris accumulation in one or more valleys. Debris should be cleared to allow for proper runoff. Plumbing boot on vent has deteriorated and may allow for water intrusion. Repair or Replace as necessary.

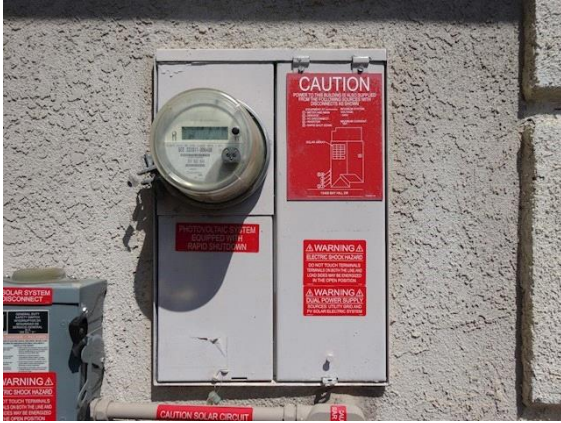
Front cover on panel not clearly labeled to identify what breakers supply what circuits. For additional safety, recommend identification and labeling of all specific breaker functions.

Electrical: Main Panel

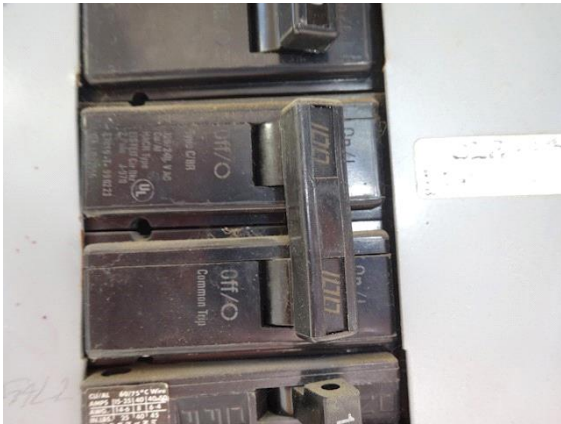
Electrical: Main breaker 100 amp

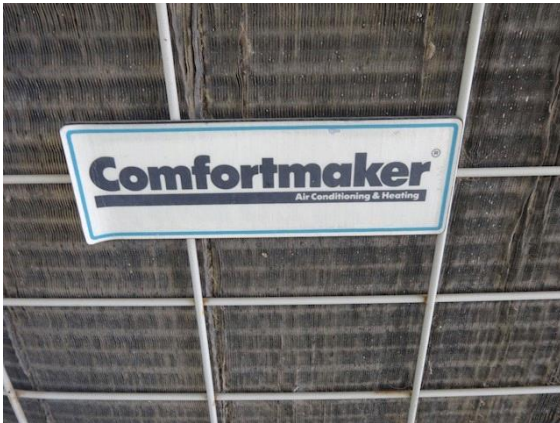
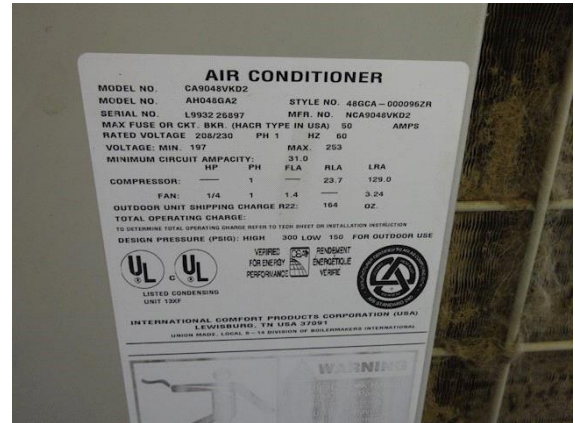
The air conditioning system responded to the controls and appeared to operate in a satisfactory manner.

Due to the age of unit, be aware that it could need repairs or replacing at any time.
