Uberprüfen, LLC DBA
National Property Inspections

Joann L

Thursday, February 7, 2019
Inspector
Gary Dehm
541-550-9360
gary.dehm@npiinspect.com
OR CCB# 220886/OCHI# 2146

Summary

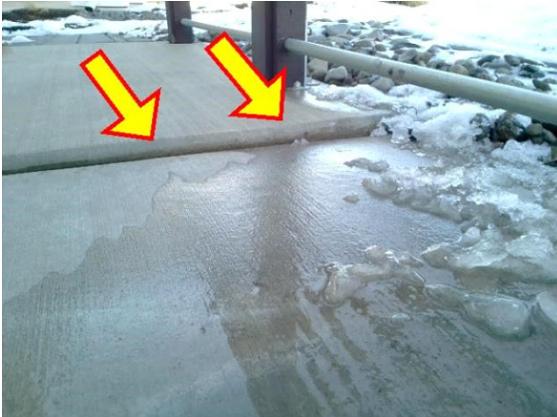
Repair/Replace concerns: Heaving concrete slab at front walk of home, trip hazard. Advise repair/replace by qualified contractor. Review drainage is proper to limit water accumulation in this area as is a negative slope from street toward the front of the home.

WALKS / STEPS: lifting/heaving, trip hazard

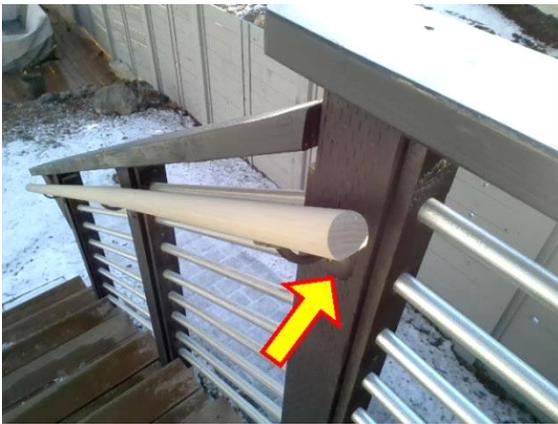
1. Handrail needs terminated to the deck, to prevent a falling hazard.
2. Advise shielding of "riser" sections of steps to protect from a fall hazard.
3. Deck fascia board pulling/warping and caulk has failed.

DECKS / BALCONY: hand rail needs properly terminated

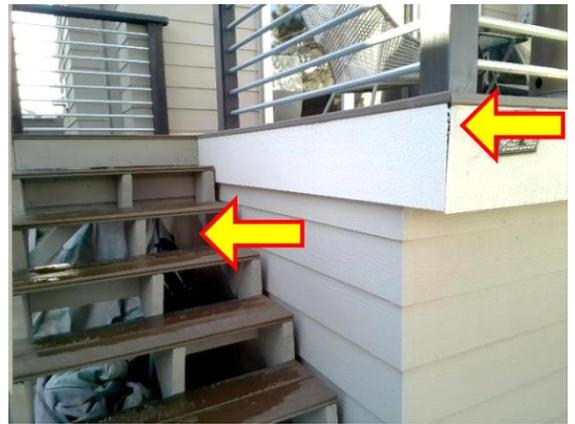
DECKS / BALCONY: Riser boards needed for steps; fascia board warped, caulk failed

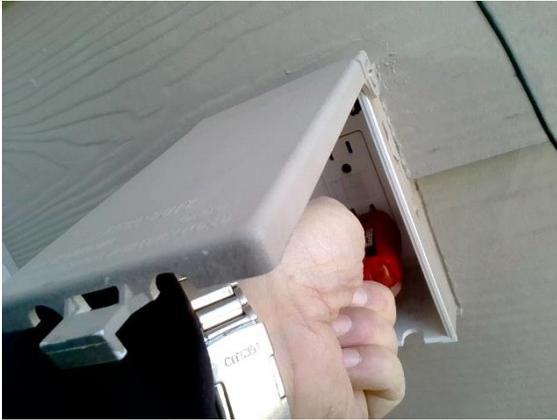
- 1. Exterior outlets, at front door and South patio, extremely difficult to insert plugs into. Advise further evaluation by qualified contractor and replace if necessary.**
- 2. Soffit panel, off South porch is bowed Advise further evaluation by qualified contractor to correct and/or secure properly.**

EXTERIOR SURFACE: Very difficult to plug tester into, front entry

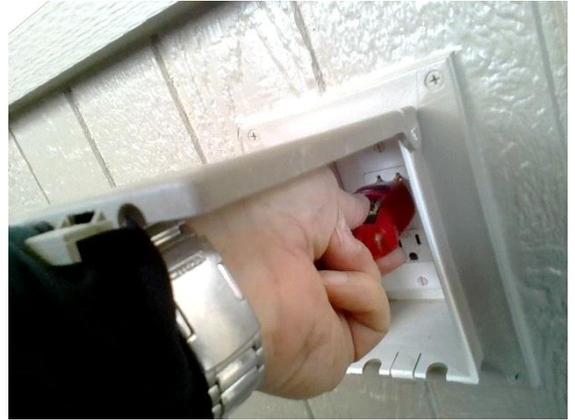
EXTERIOR SURFACE: Very difficult to plug tester into, South patio deck

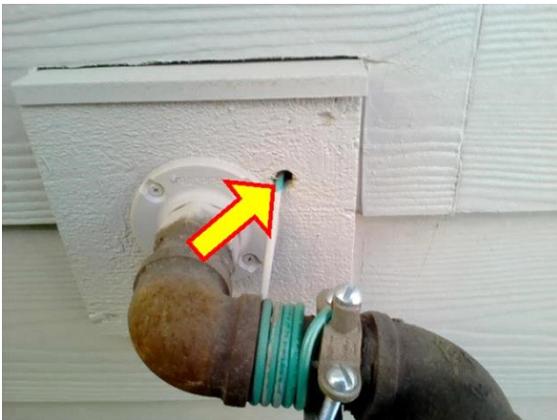
EXTERIOR SURFACE: open penetration, should be sealed, North side of home

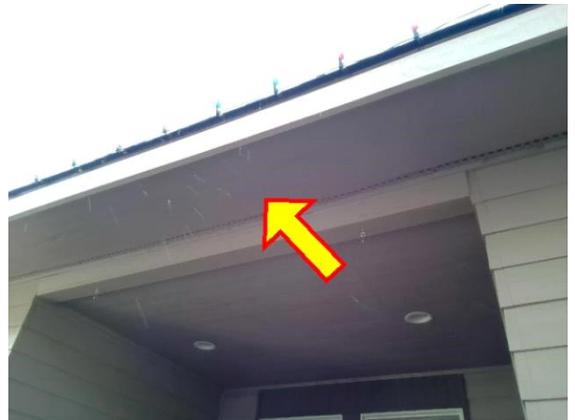
EXTERIOR SURFACE: soffit board bowed

- 1. Exterior outlets, at front door and South patio, extremely difficult to insert plugs into. Advise further evaluation by qualified contractor and replace if necessary.**
- 2. Soffit panel, off South porch is bowed Advise further evaluation by qualified contractor to correct and/or secure properly.**

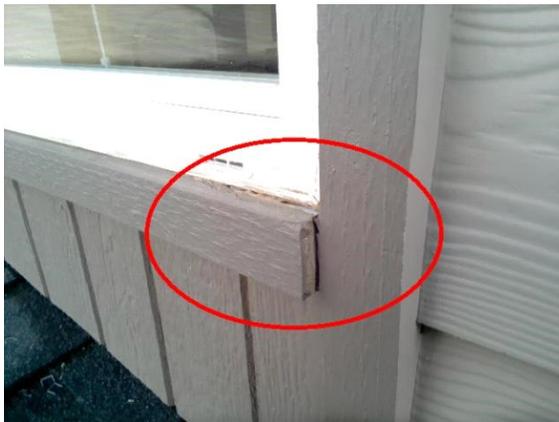
1. Caulking failed/failing top edge of upstairs bathroom window, SW corner.
2. Window trim board bowed, popping loose--see picture. Advise repair by qualified contractor.

WINDOWS: SW 2nd story bathroom window, window trim board bowed, not attached correctly.

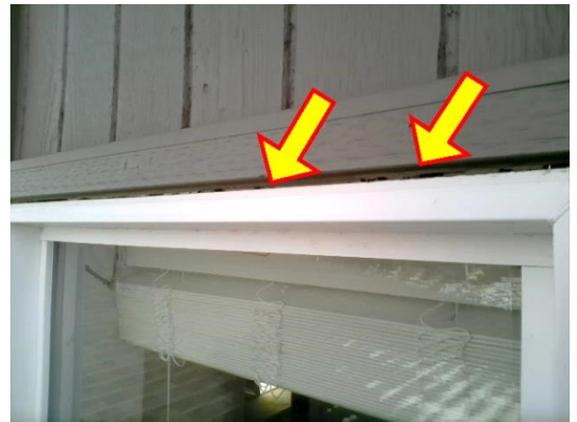
WINDOWS: SW 2nd story bathroom window caulk failing

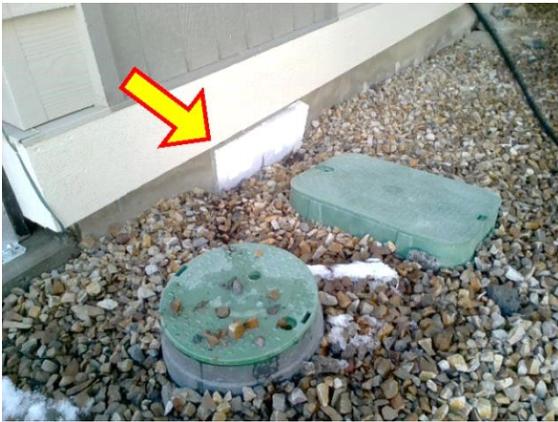
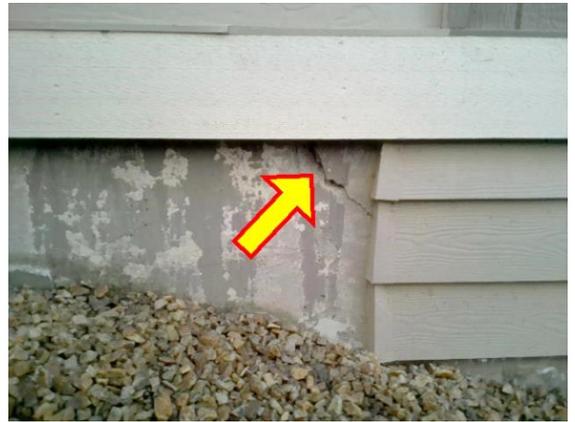
FOUNDATION:

- 1. South foundation wall, diagonal crack noted, advise appropriate sealant to seal crack from water intrusion.**
- 2. Foundation vent at SW corner at/below grade and susceptible to water intrusion. Advise placement of vent well protector to help divert water away from entering the crawl space. See picture.**

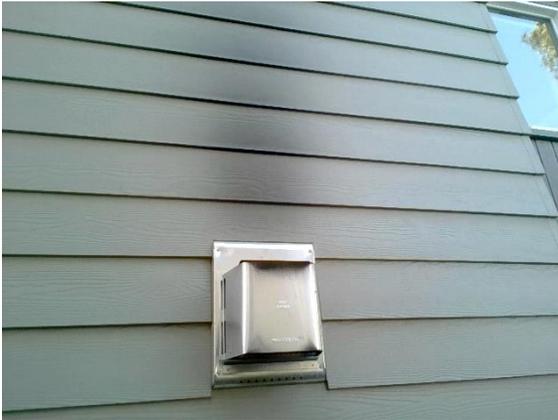
CHIMNEY:

Repair/Replace concerns: Advise cleaning/service due to soot buildup on glass and exterior wall of home. See pictures. Heavy soot build up noted on interior glass surface of fireplace too. Combustion and drafting should be evaluated and adjusted, if needed.

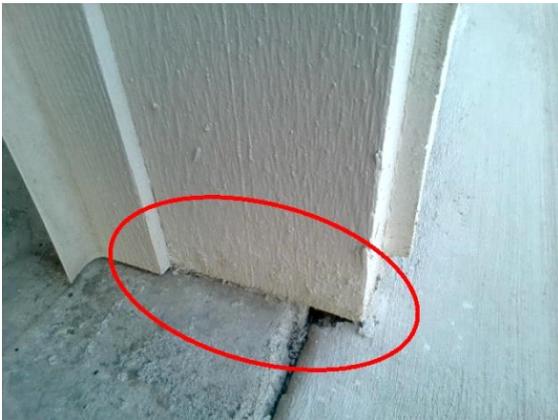
Repair/Replace concerns: Garage trim boards in contact with concrete/ground and are susceptible to water damage as water. Appropriate cut back not done on both sides of garage door trim.

GARAGE/CARPORT: wood trim not cut back for water drainage

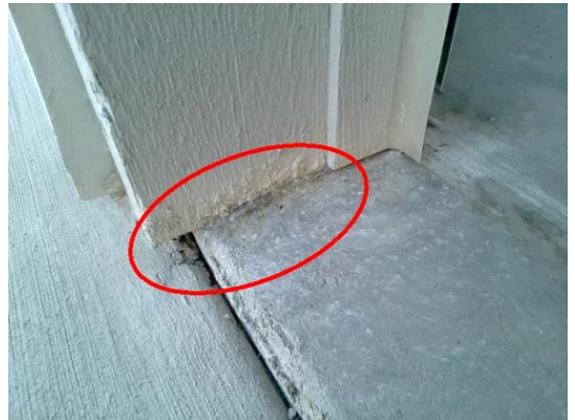
GARAGE/CARPORT: wood trim not cut back for water drainage, wood susceptible to water damage/rot

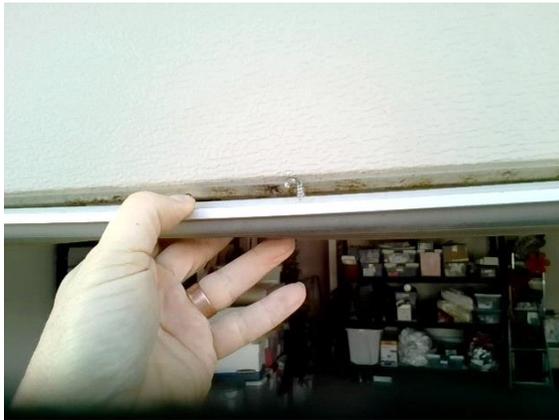
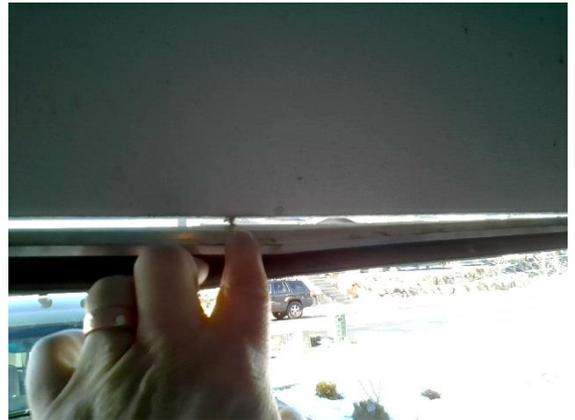
OVERHEAD GARAGE DOORS:

Repair/Replace concerns: weather strip detached/loose, see picture, advise repair to prevent water intrusion into garage when door closed.

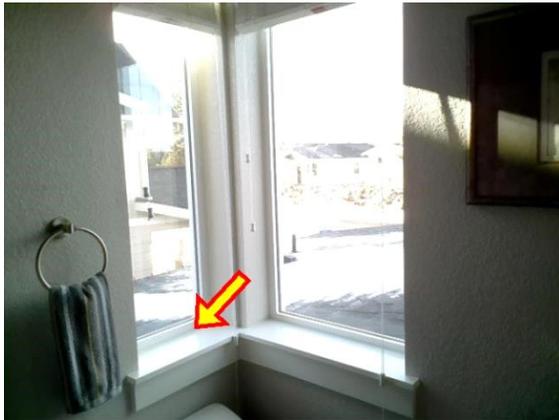
Marginal/Be aware: caulking touch up needed interior windows--see picture

BATHROOM 2/ UP: caulking touch up needed here

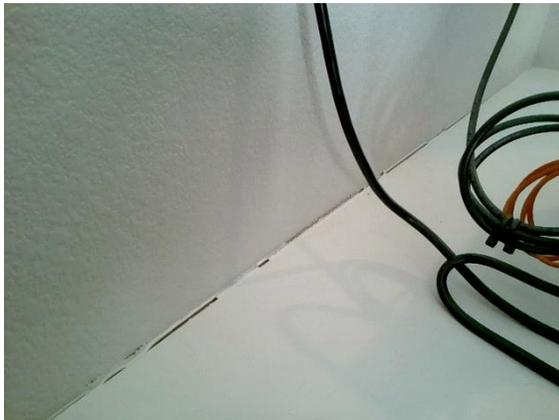
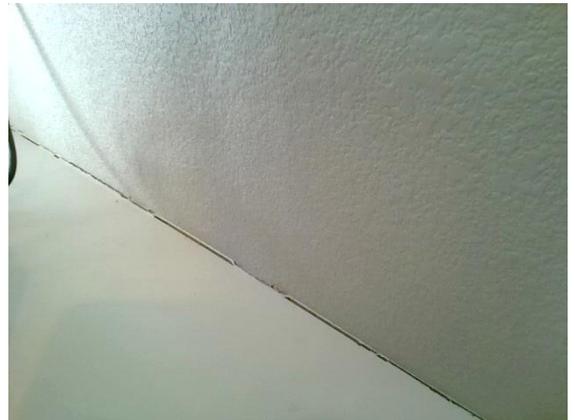
LIVING ROOM/ MAIN:

Repair/Replace concerns: Entertainment shelf caulking has pulled away, large open gaps on Left side and along back interior wall. Advise re caulking.

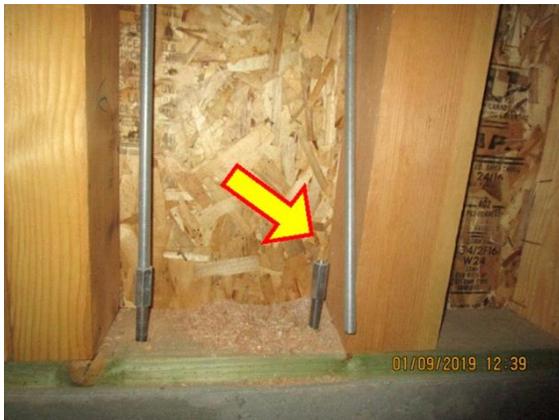
Repair/Replace concerns: 1. One of the homes foundation tie down bolts not attached. Advise further evaluation by qualified contractor to repair. See picture.

INTERIOR FOUNDATION: Location: East wall, to South side of home, anchor bolt unattached.

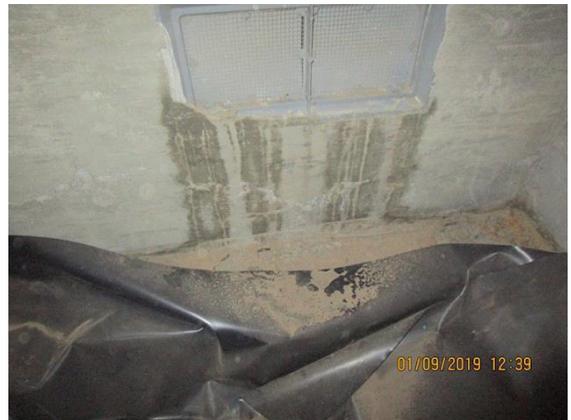
Marginal/Be aware: evidence of previous water intrusion at South foundation vent, midway of wall. No current water noted. Suspect condition has been remedied by addition of vent well protector.

INTERIOR FOUNDATION: Evidence of previous water intrusion, South foundation wall vent

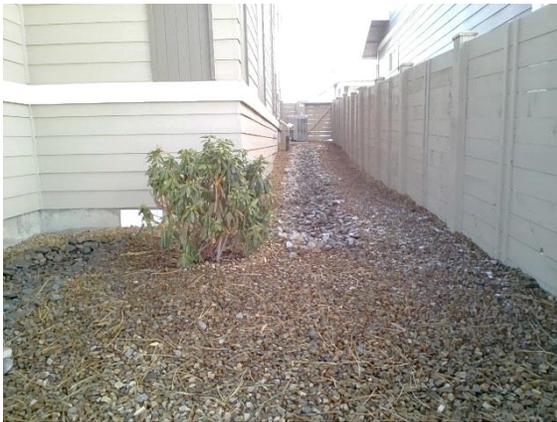
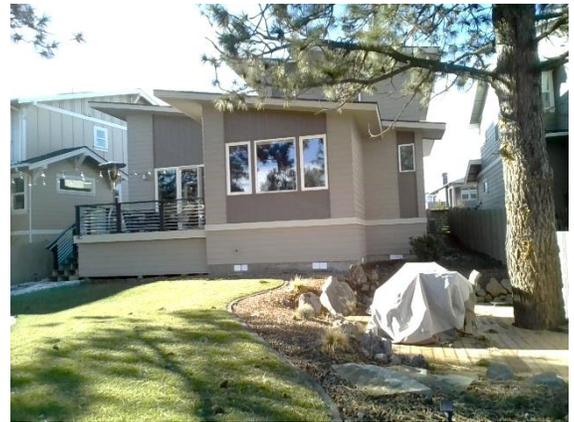
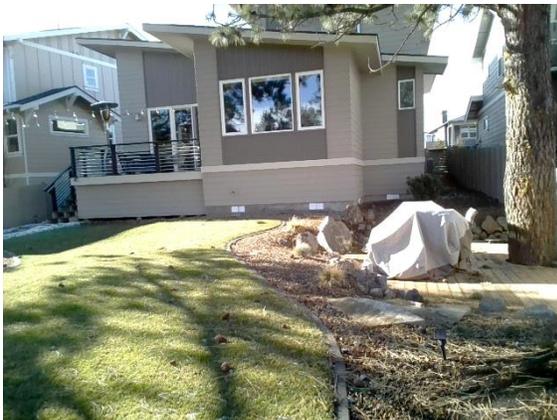
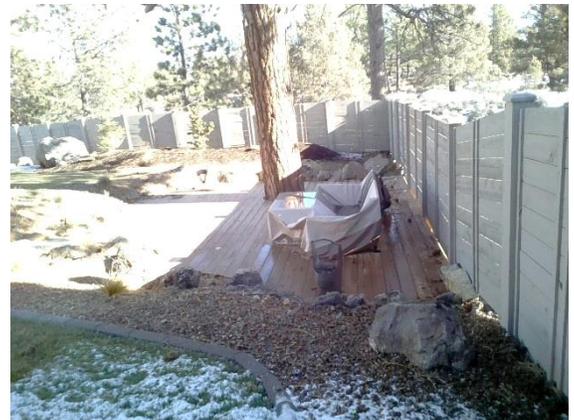
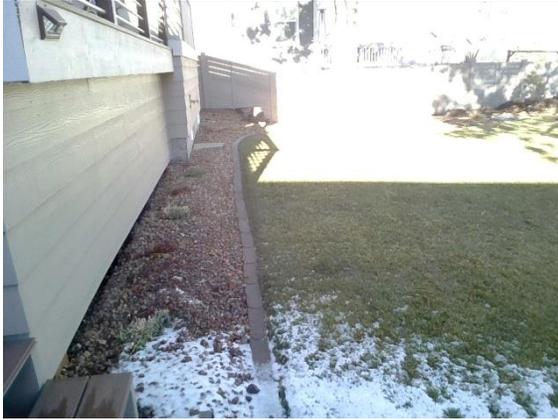
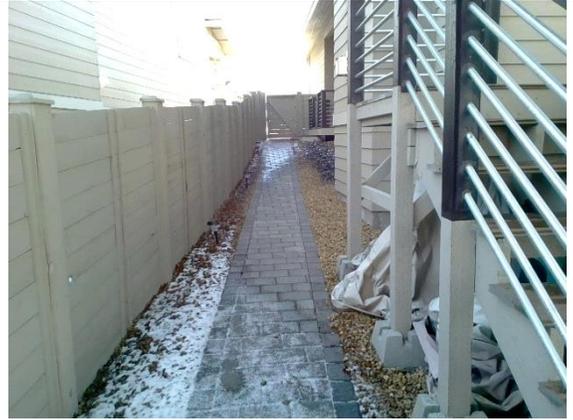
Marginal/Be aware: Monitor drainage along North, South and West sides of home. Slope is from West to East, Negative slope toward front of home, positive slope to the rear of the home. Believe this may be contributing to heaving of the front patio/entry of the home. See "Walks and Steps" section.

Marginal/Be aware: Monitor drainage along North, South and West sides of home. Slope is from West to East, Negative slope toward front of home, positive slope to the rear of the home. Believe this may be contributing to heaving of the front patio/entry of the home. See "Walks and Steps" section.

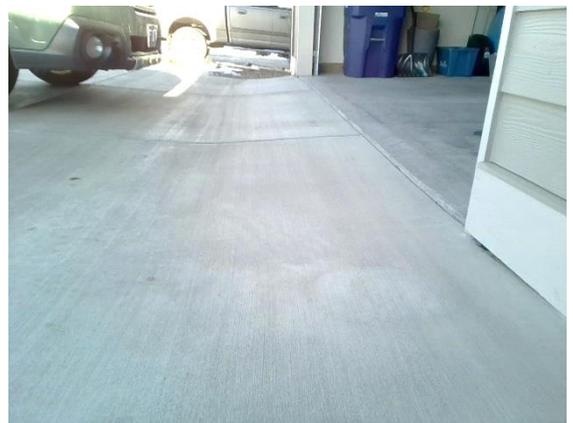
Driveway:

The driveway was concrete and had the proper expansion joints to help prevent cracking. The concrete driveway had no visual flaws or defects and was in acceptable condition.

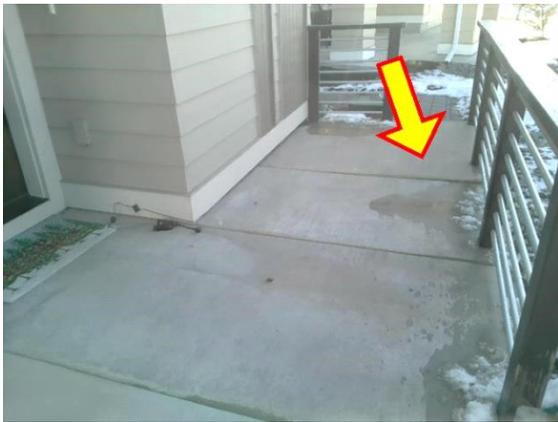
Repair/Replace concerns: Heaving concrete slab at front walk of home, trip hazard. Advise repair/replace by qualified contractor. Review drainage is proper to limit water accumulation in this area as is a negative slope from street toward the front of the home.

Walks / Steps: This section of concrete heaving/lifting

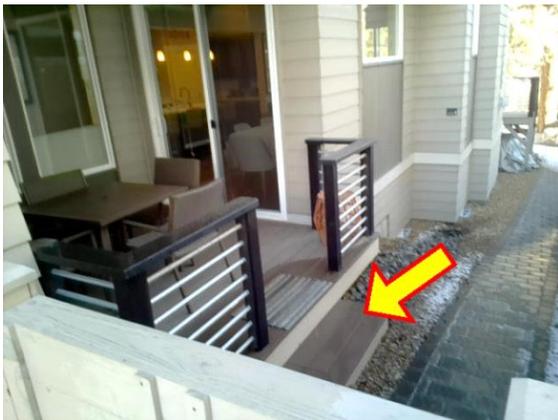
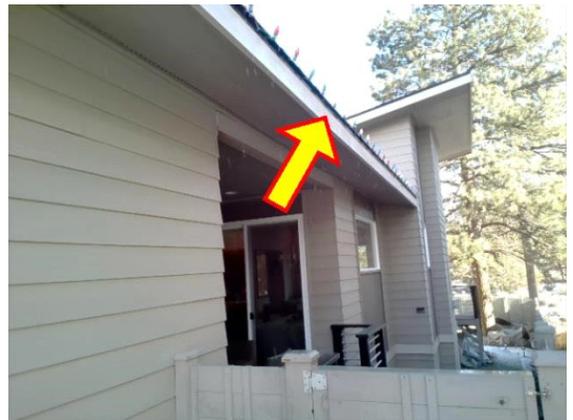
Gutters/Down Spouts:

Repair/Replace concerns: No gutters on South side, runoff, on to porch below and steps off of porch, want to minimize slip hazards with run off and ice accumulation in winter months. See pictures.

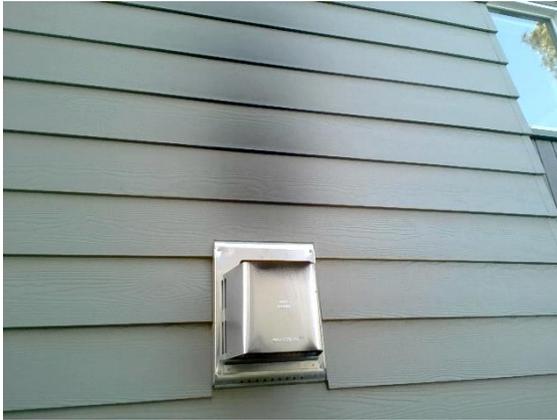
Chimney:

Home has a direct vent out South wall for gas log fireplace. Sooty buildup noted on exterior wall surface. Advise having unit serviced and cleaned by qualified contractor.

Repair/Replace concerns: Advise cleaning/service due to soot buildup on glass and exterior wall of home. See pictures. Heavy soot build up noted on interior glass surface of fireplace too. Combustion and drafting should be evaluated and adjusted, if needed.

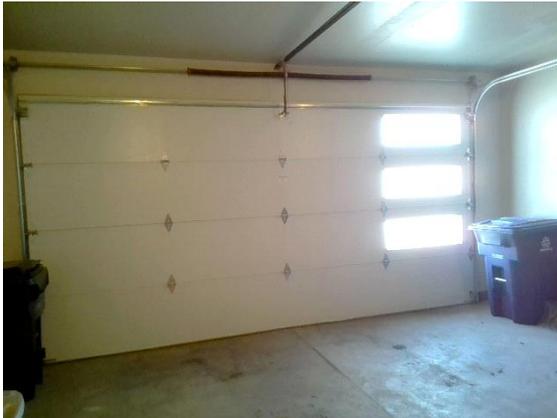
Overhead Garage Doors:

Repair/Replace concerns: weather strip detached/loose, see picture, advise repair to prevent water intrusion into garage when door closed.

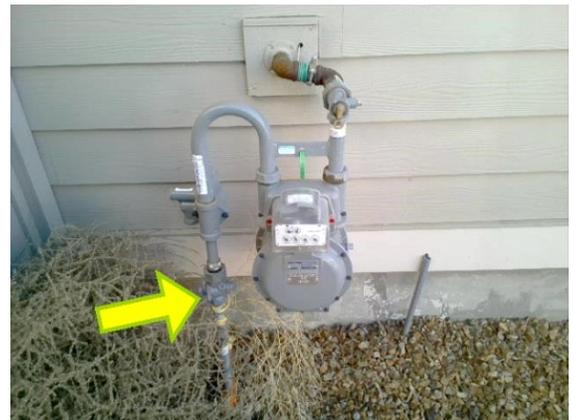
Plumbing: shut off for natural gas here.

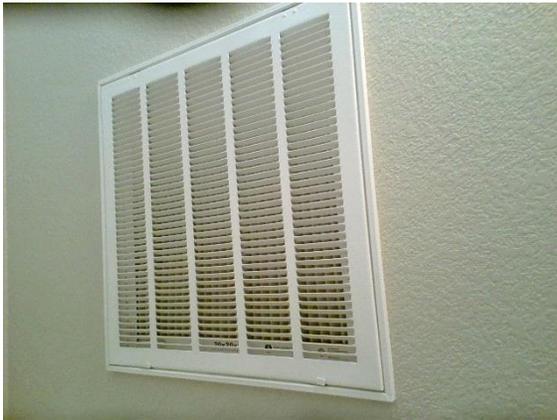
Heating Distribution: Air filter replacement here.

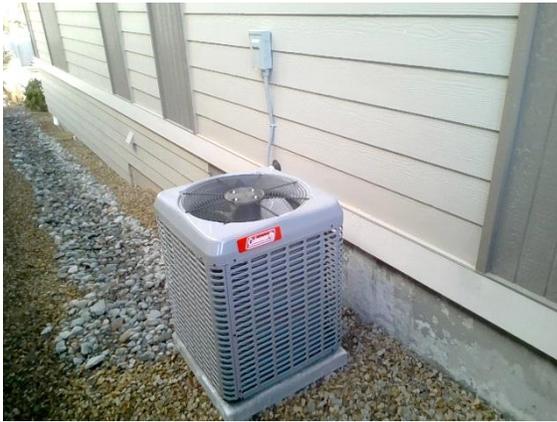
Cooling:

A/C unit should not be tested in cool mode with temperature below 60 degrees for fear of damaging compressor. Recommend checking when ambient air is warmer. The temperature splits could not be properly tested with the low temperatures, even if it was safe to operate.

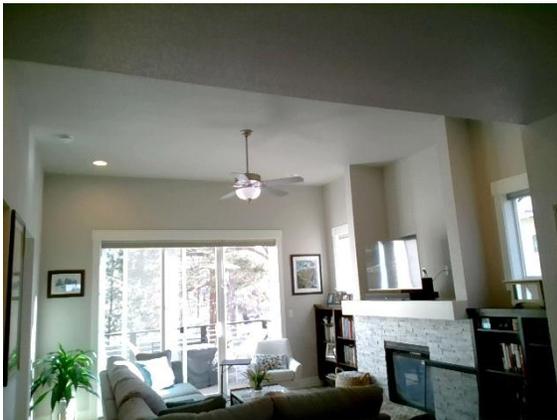
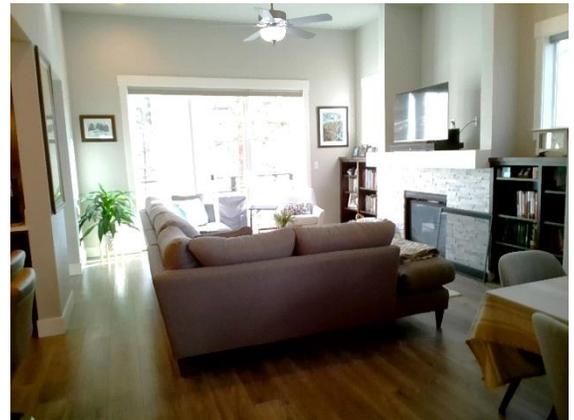
Living Room/ Main:

Repair/Replace concerns: Entertainment shelf caulking has pulled away, large open gaps on Left side and along back interior wall. Advise re caulking.

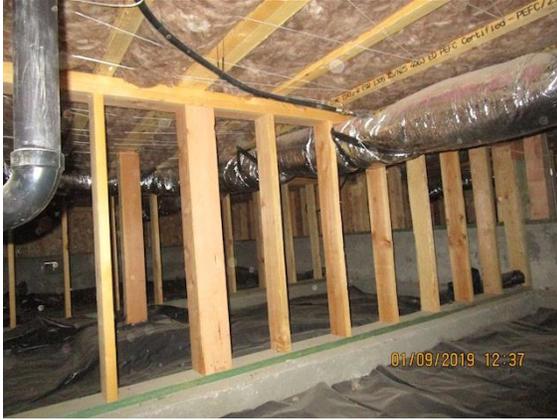
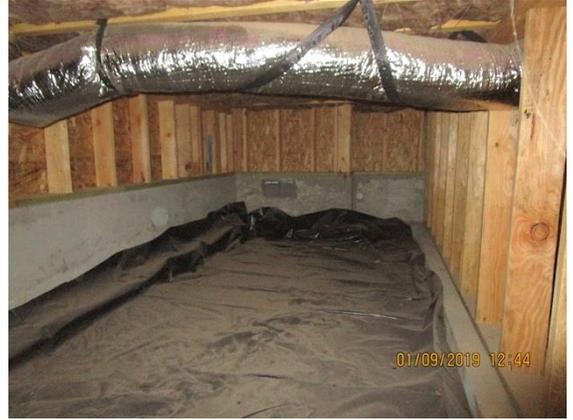
Interior Foundation:

Marginal/Be aware: evidence of previous water intrusion at South foundation vent, midway of wall. No current water noted. Suspect condition has been remedied by addition of vent well protector.

Repair/Replace concerns: 1. One of the homes foundation tie down bolts not attached. Advise further evaluation by qualified contractor to repair. See picture.
