RESIDENTIAL INSPECTION

**1234 Main Street
Inman, 29349**

Buyer Name
04/22/2025 9:00AM

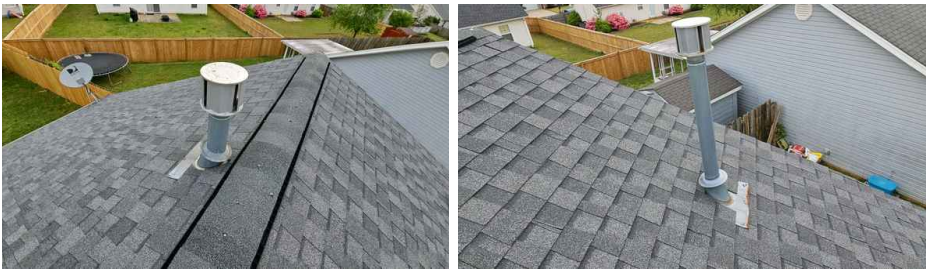
2.3.1 Roof Penetrations

FLASHING MATERIAL WAS DAMAGED

The metal flashing material around the furnace and water heater exhaust vent pipes was rusted and had exposed nails. This condition may increase the risk of water penetration and compromise the sealing of the vent pipes, potentially leading to damage or inefficiency in the venting system. Recommend further evaluation by a qualified contractor to replace the flashing and address the exposed nails as necessary.

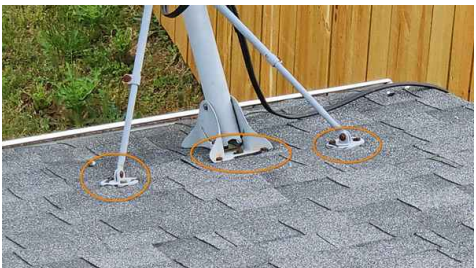
2.3.2 Roof Penetrations

SATELLITE DISH MOUNTING ISSUES

The satellite dish mounting has rusted bolts, which may compromise the stability and safety of the installation and possibly lead to water penetration through the shingles. Recommend qualified technician inspect the mounting system to determine the best method to repair/replace satellite dish mounting system.

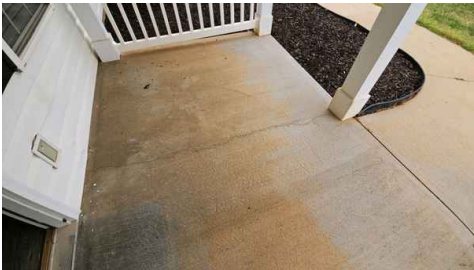
3.3.1 Stairs, Porches, Patios & Decks

MINOR CRACKING

Minor cracks were noted on the front porch. This condition may indicate normal settling or weather-related wear, but if left unaddressed, it could potentially expand or lead to further deterioration over time. Recommend further evaluation by a qualified contractor to assess and repair the cracks as necessary.

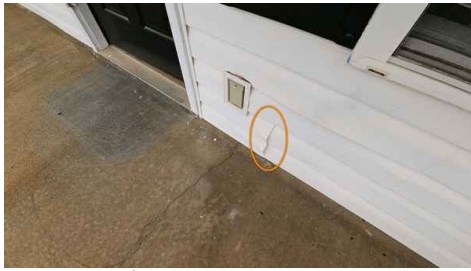
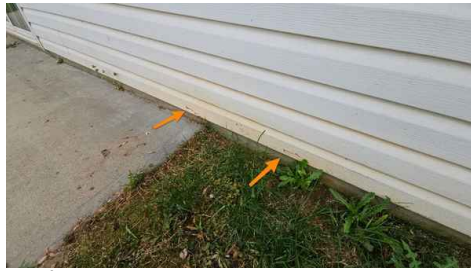
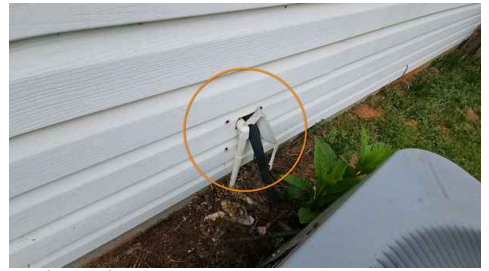
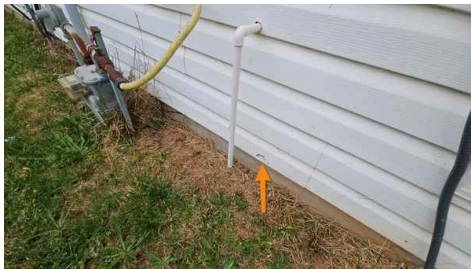
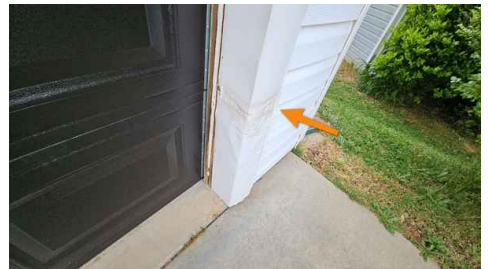
3.4.1 Siding, Flashing & Trim

DAMAGED WALL-COVERING MATERIAL

There are several areas of damaged vinyl siding around the house. These conditions can allow moisture intrusion, potentially leading to water damage and mold growth within the walls. It is essential to address this issue promptly by repairing or replacing the damaged section of siding to restore the home's exterior protection. Recommend consulting a qualified contractor to assess the damage and perform the necessary repairs.

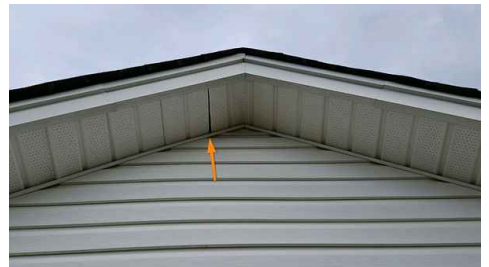
3.5.1 Eaves, Soffits & Fascia

DAMAGE OBSERVED AT SOFFIT

One area of loose soffit observed above the front porch. Loose soffit can be damaged further in high winds and potentially allow for pest intrusion. Correction and further evaluation is recommended.

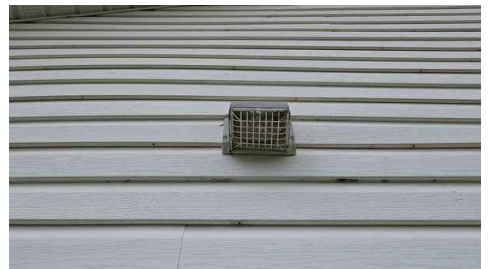
3.6.1 Exhaust Hoods

The dryer hood was observed to have a screen installed.

This condition may restrict airflow and trap lint, potentially reducing the efficiency of the dryer and creating a fire hazard over time.

Recommend further evaluation by a qualified contractor to remove the screen and ensure proper ventilation.

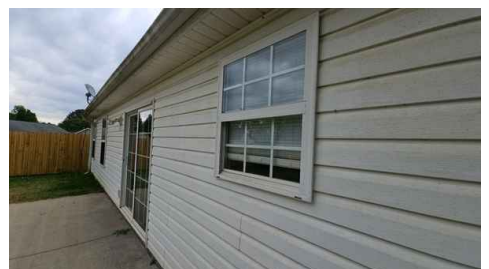
3.7.1 Windows

MISSING WINDOW SCREEN

A screen was missing from the kitchen window.

This condition may reduce ventilation efficiency or allow pests to enter the home, potentially impacting comfort and cleanliness. Recommend further evaluation by a qualified contractor to replace or install a new screen as necessary.

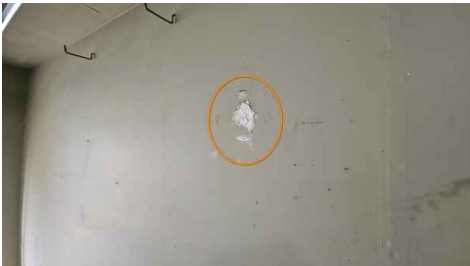
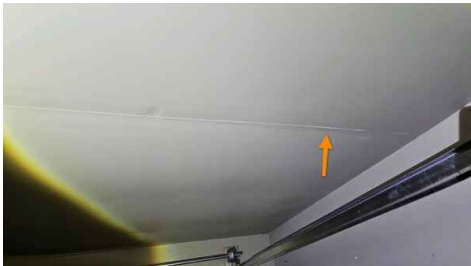
DAMAGED DRYWALL

Garage wall had damaged drywall. One hole that had been previously repaired and one joint where the tape appears to be separating. This does not appear to pose any structural or safety issue but could deteriorate further causing a breach in the firewall protection between the garage and home. Recommend further evaluation and repair by a qualified contractor.

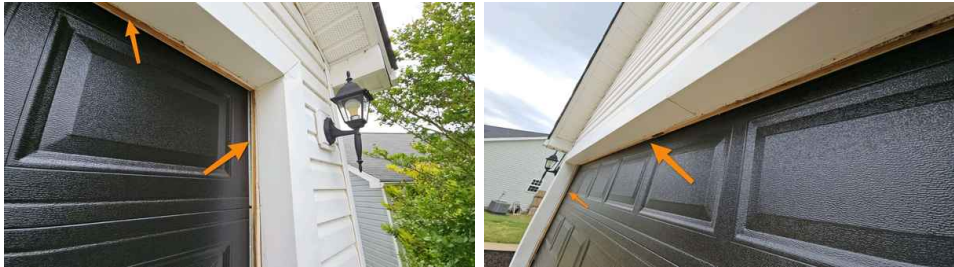
5.3.1 Garage Vehicle Door

WEATHER STRIPPING AT GARAGE DOOR IN POOR CONDITION

The weatherstripping on the garage door was missing.
This condition may allow air, moisture, or pests to enter the garage, potentially affecting energy efficiency and cleanliness.
Recommend further evaluation by a qualified contractor to install new weatherstripping as necessary.

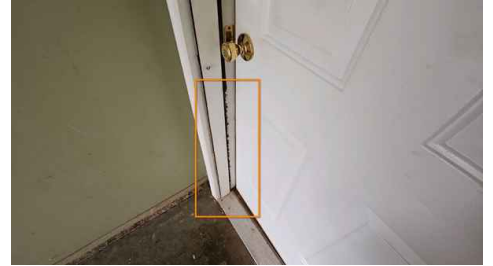
5.4.1 Occupant Door (From garage to inside of home)

DEFECT AT DOOR BETWEEN GARAGE AND HOUSE

The weatherstripping on the door from the garage into the house was damaged.

This condition may allow air, moisture, or pests to infiltrate the home, potentially compromising energy efficiency and indoor comfort.

Recommend further evaluation by a qualified contractor to replace the damaged weatherstripping as necessary.

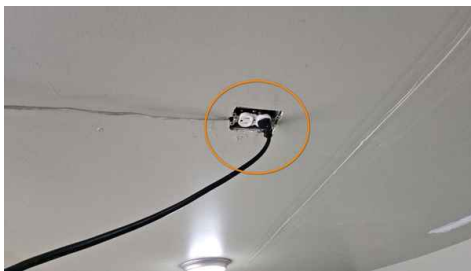
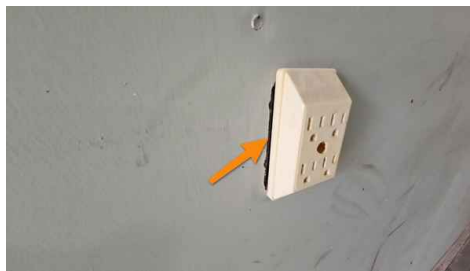
5.5.1 Electric in Garage

ELECTRICAL DEFECT IN GARAGE

One outlet was not ground fault protected and had a four-way converter installed without a cover underneath. The garage door outlet was also missing a cover.

This condition may present a safety hazard, increasing the risk of electrical shock or damage to connected devices.

Recommend further evaluation by a licensed electrician to install ground fault protection, replace the outlet, and ensure proper coverage as necessary.

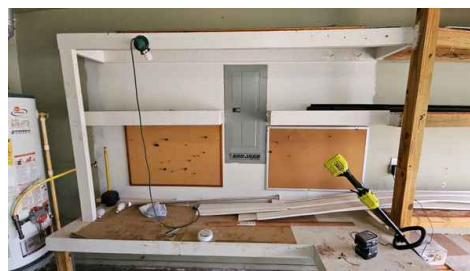
IMPROPER CLEARANCE TO PANEL

Improper clearance in front of electric panel. The panel is blocked and is not safely accessible in case of an emergency and the breakers need to be shut-off . This has created an unsafe condition and unsafe access to the panel. Today's standards require 3 feet wide x 3 feet deep by 6 feet high for safe working clearance. Recommend the homeowner or a qualified contractor taking the corrective steps necessary to allow for safe access to the main panel.

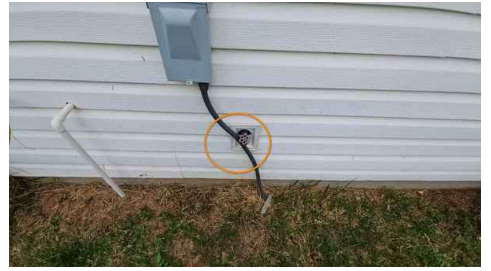
7.6.1 Electrical Defects

HVAC CONDUIT / FAUCET

The conduit for the HVAC was pressed against the exterior faucet. This condition may cause undue stress or damage to either component over time, potentially leading to functional or maintenance issues.

Recommend further evaluation by a qualified contractor or HVAC technician to adjust the conduit and ensure proper clearance as necessary.

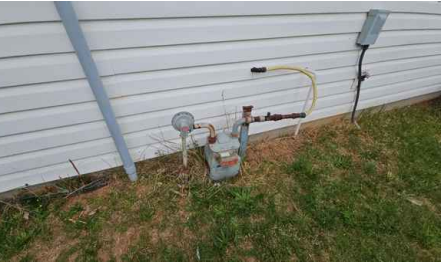
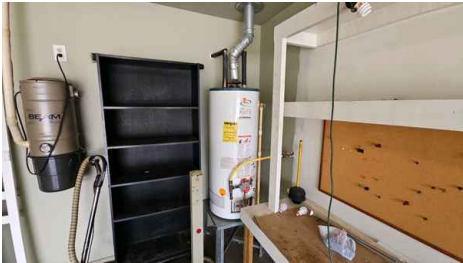
Hot Water Source #1: Age
22 Years

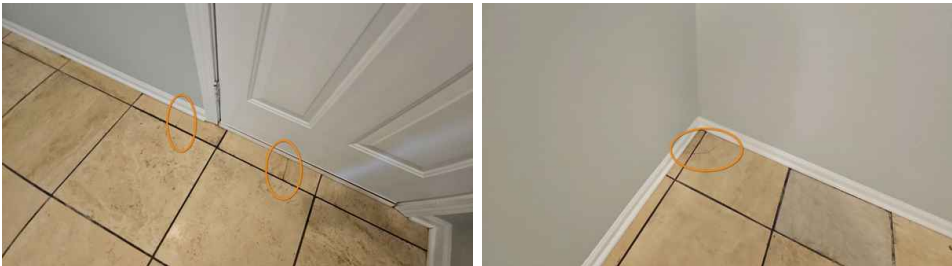
Minor cracks were present in the ceramic tile in the laundry room. This condition may worsen over time with normal wear and tear, potentially leading to further damage or the need for replacement. Recommend further evaluation by a qualified contractor to assess and repair or replace the affected tiles as necessary.

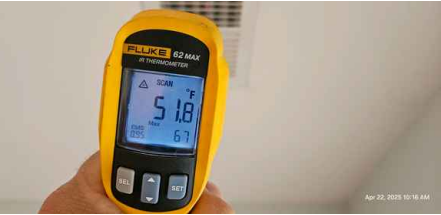
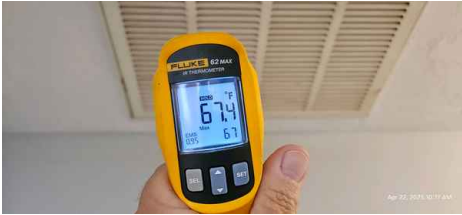
HVAC System Information: Cooling Supply Temperature
51.8 Degrees F

HVAC System Information: Cooling Return Temp
67.4 Degrees F

HVAC System Information: Cooling Performance
Within Industry Standards

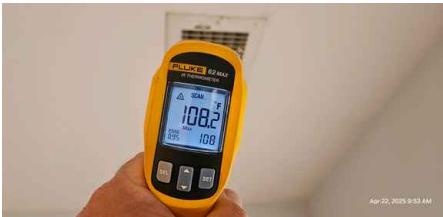
HVAC System Information: Heat Supply Temperature (HP or Gas)
108.2 Degrees F

The temperature of the air after being conditioned by the HVAC unit.

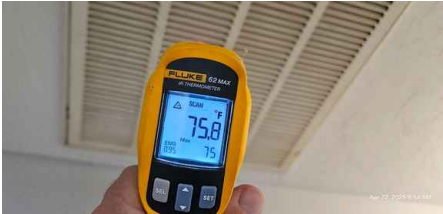
HVAC System Information: Heat Return Temperature (HP or Gas)
75.8 Degrees F

Room temperature air which is returning to the HVAC unit.

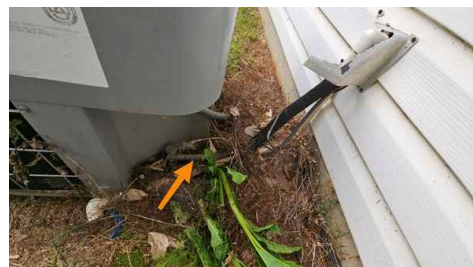
REFRIGERANT LINE INSULATION MISSING OR DAMAGED

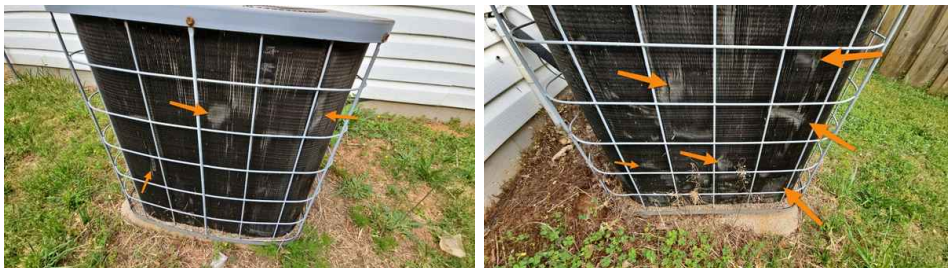
FINS DAMAGED

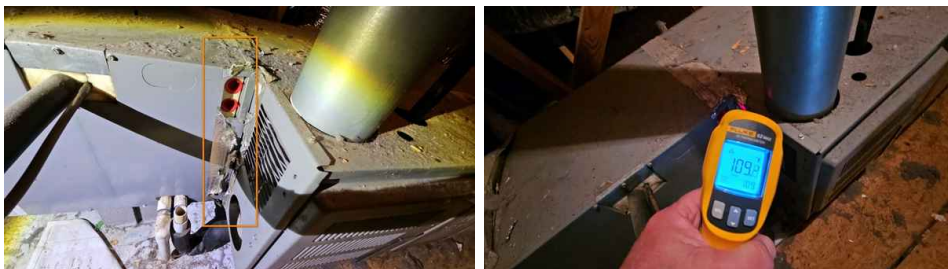
10.4.1 Ductwork

DUCT(S) NOT SEALED

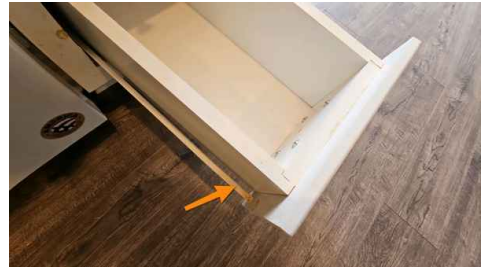
This condition may cause difficulty in opening or closing the drawer, potentially leading to increased wear on the slide or damage to the drawer components over time.

Recommend further evaluation by a qualified appliance technician to secure or replace the drawer slide as necessary.

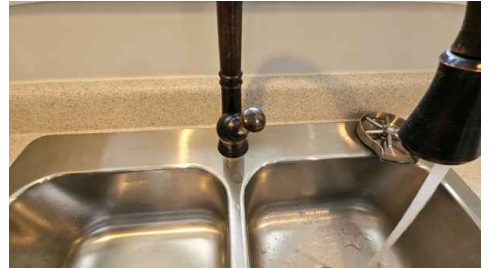
11.5.1 Kitchen Sink

This condition may cause confusion during use and could lead to unintended scalding or difficulty in temperature control.

Recommend further evaluation by a licensed plumber to correct the connections as necessary.

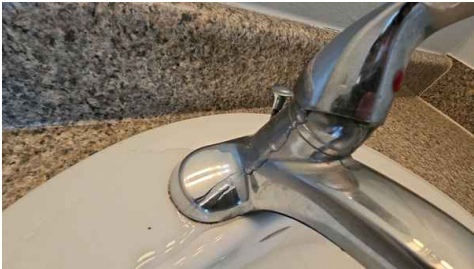
Master Bathroom

The sink fixture in the master bathroom was leaking around the handle when water was turned on. This condition may lead to wasted water and increased utility costs, as well as potential damage to the fixture or surrounding surfaces over time. Recommend further evaluation by a licensed plumber to repair or replace the fixture as necessary.
