RESIDENTIAL INSPECTION

1234 Main Street
Inman, 29349

04/22/2025 9:00AM

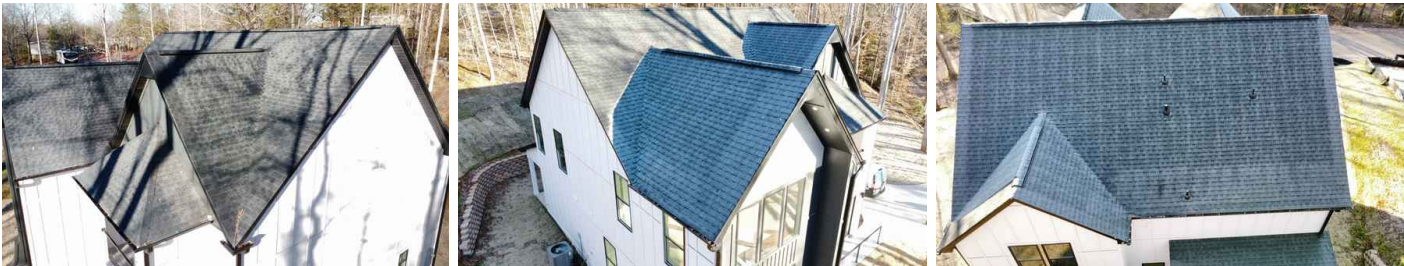
Flashing: Material
Metal

Flashing appears to be in good condition.

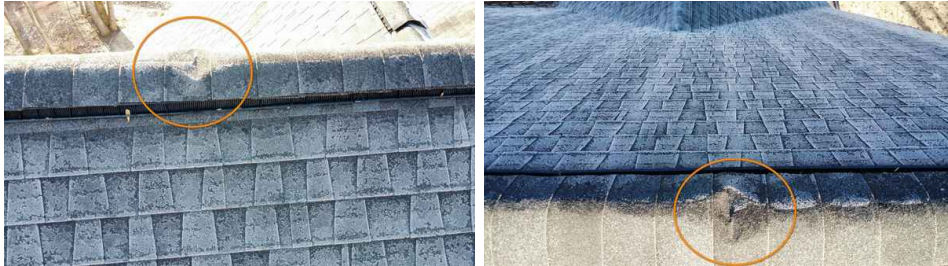
2.1.1 Coverings
CRACKED ROOF-COVERING MATERIAL

It was determined that one of the shingles on the main ridge vent towards the right side of the roof is cracked and damaged.

This condition could allow water penetration, which may lead to leaks and subsequent damage to the roof decking or attic space. Prolonged exposure to the elements may worsen the damage.

It is recommended to replace the cracked and damaged shingle promptly and verify the integrity of the ridge vent underneath the damaged shingle to maintain the integrity of the roof and prevent potential water intrusion.

Contact a qualified roofing professional.

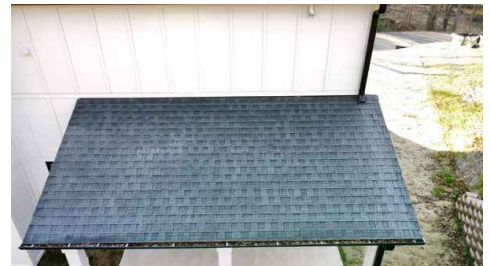
2.4.1 Gutters & Downspouts

The gutters on the back of the house have a fair amount of leaves. This condition can impede proper water flow, potentially causing water to overflow and damage the roof, fascia, and foundation.

Standing water can also attract pests and contribute to the deterioration of the gutters.

It is recommended to have the gutters cleaned immediately and establish a regular maintenance schedule to prevent future clogs and protect the home from water damage.

Contact a qualified professional.

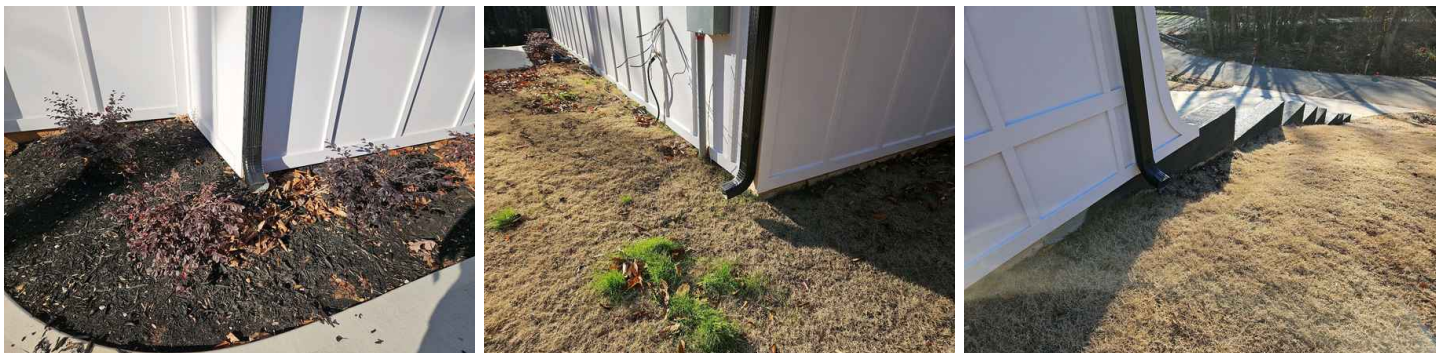
2.4.2 Gutters & Downspouts

One or more downspouts drain too close to the home's foundation. This can result in excessive moisture in the soil at the foundation, which can lead to foundation/structural movement. Recommend a qualified contractor adjust downspout extensions to drain at least 6 feet from the foundation. A handy homeowner should be able to do this project.

Contact a qualified professional.

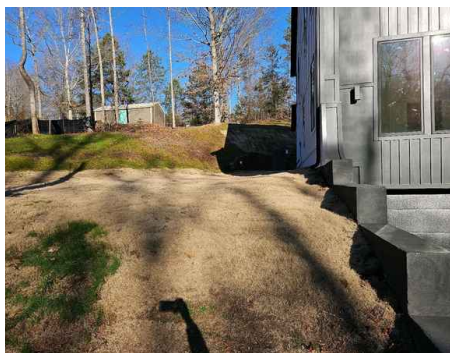
Positive Slope

The grade around the structure should deter water at least 4 feet away from the foundation around entire perimeter. Landscape shrubbery should be kept at least 4 feet away from foundation to prevent water drainage from contacting the area around the foundation.

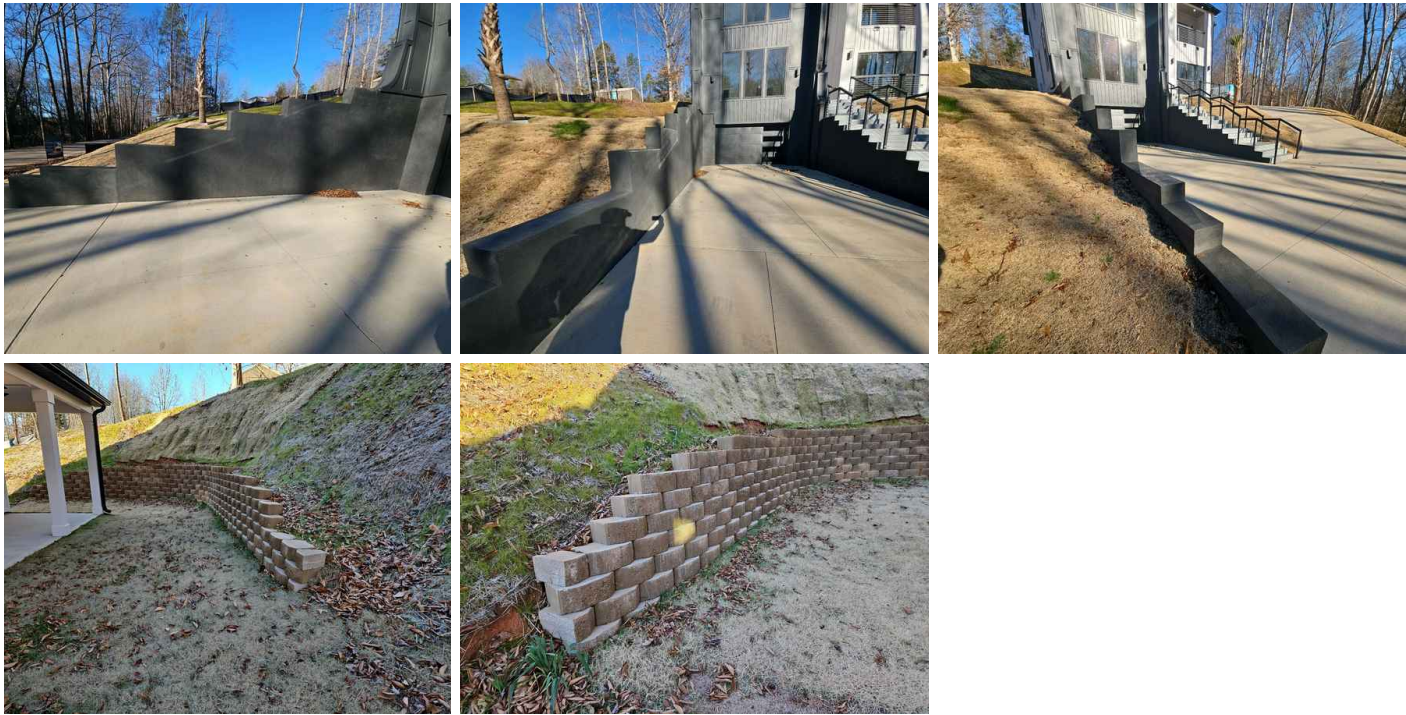
Retaining walls appeared to be functioning as designed and in good condition at the time of the inspection.

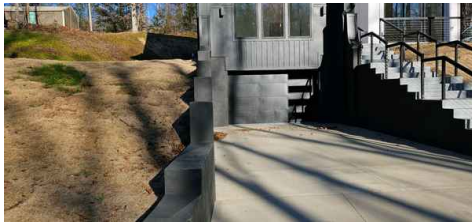
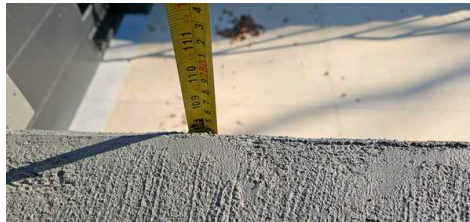
3.2.1 Vegetation, Surface Drainage, Retaining Walls & Grading

This condition poses a significant safety risk, as there is a potential for falls from such a height, especially in areas with foot traffic or during adverse weather conditions.

It is recommended to install a safety rail along the retaining wall to prevent accidental falls and to ensure compliance with safety regulations.

Contact a qualified general contractor.

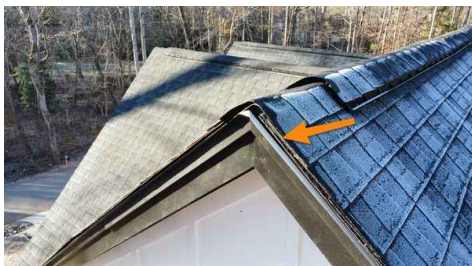
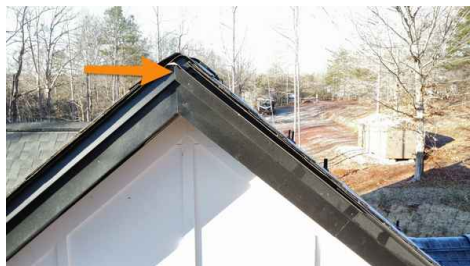
3.4.1 Siding, Flashing & Trim

FLASHING DEFECT

It was determined that the drip edge flashing on the right side near the roof peak is loose.

This condition can allow water to infiltrate the roof system, potentially causing water damage to the underlying structure and insulation. This can lead to costly repairs if left unaddressed.

It is recommended to have a qualified roofing contractor secure or replace the loose flashing to prevent further damage and ensure the roof remains watertight.

Contact a qualified siding specialist.

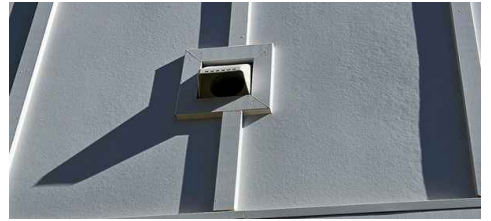
3.10.1 Exhaust Hoods

MISSING COVER

It was determined that one exhaust vent on the left side of the house is missing its hinged cover.

This condition could allow debris, pests, or water to enter the vent, potentially causing blockages or damage to the exhaust system. It may also lead to decreased efficiency or function of the system.

It is recommended to replace the missing hinged cover to protect the vent from external elements and ensure proper ventilation.

Contact a qualified general contractor.

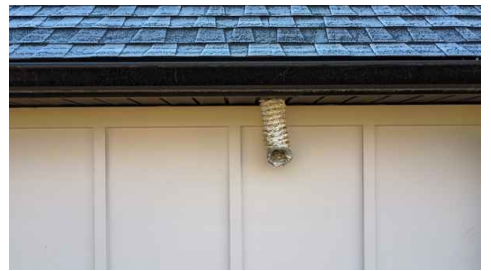
3.10.2 Exhaust Hoods

MISSING VENT

It was determined that one vent on the rear of the house is missing its vent cover, with the hose hanging through the soffit above the back porch roof.

This condition could allow debris, pests, or water to enter the vent, potentially causing blockages, damage to the hose, or issues with the ventilation system. It may also lead to inefficient airflow or air quality concerns.

It is recommended to replace the missing vent cover and properly secure the hose to ensure proper ventilation and prevent further damage.

Contact a qualified general contractor.

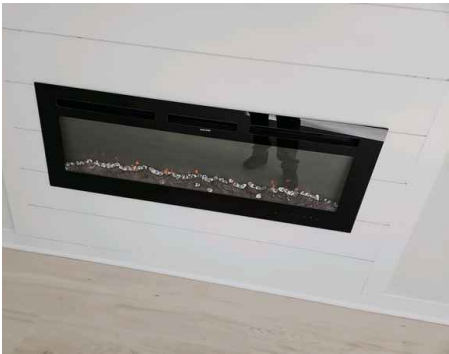
1st Floor Living Room

Fireplace: Type

Electric

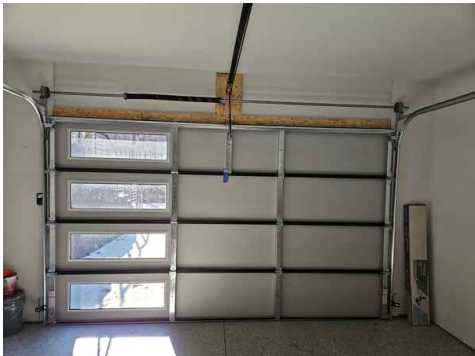
MISSING SAFETY LABELS

The garage door is missing safety labels. The only labels in place are for the optical sensors. This condition may result in the lack of important safety warnings and instructions, potentially leading to improper use or safety hazards during operation. It is recommended to have the safety labels applied to the garage door to ensure compliance with safety regulations and provide clear guidance for proper use.

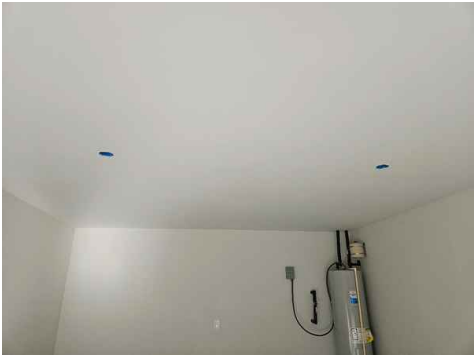
5.5.1 Electric in Garage

MISSING LIGHT FIXTURES

The light fixtures in the garage are missing. This condition results in insufficient lighting, which could create a safety hazard, particularly when navigating the garage in low visibility or emergency situations. It is recommended to install proper light fixtures to ensure adequate illumination and improve safety in the garage area.

Recommendation
Contact a qualified general contractor.

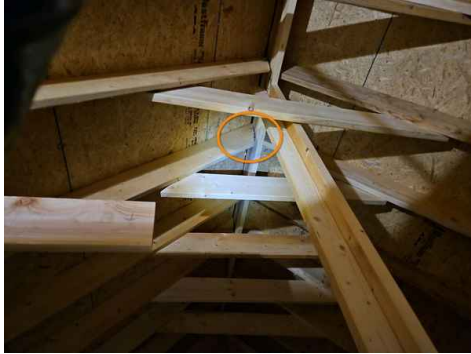
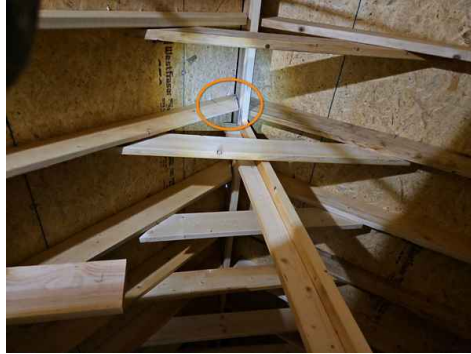
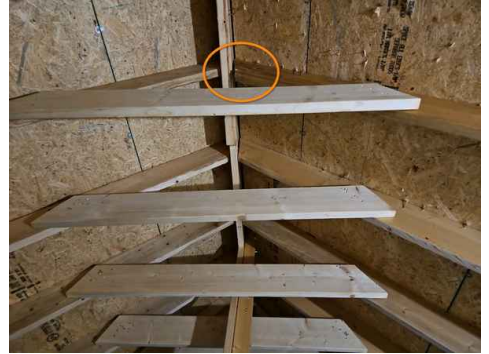
This condition can affect the structural integrity of the roof, potentially leading to instability or uneven load distribution. Over time, this could result in sagging or additional damage to the roof system.

It is recommended to have a qualified contractor assess the issue and properly realign or reinforce the rafters to ensure the roof structure is secure and stable.

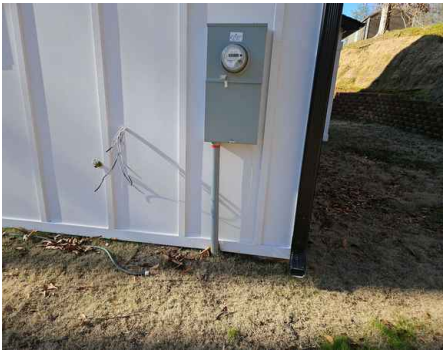
Meter Base & Service-Entrance Conductors: Type of Electrical Service

Below Ground

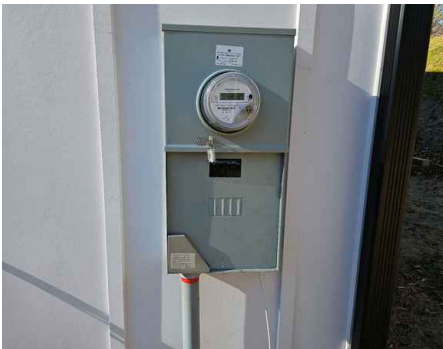
Main Service & Grounding, Main Overcurrent Device: Main Panel Location

Outside

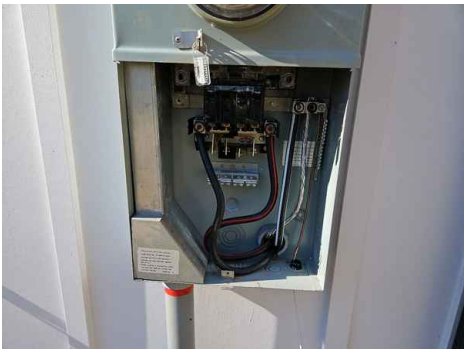
Main Service & Grounding, Main Overcurrent Device: Panel Manufacturer

GE

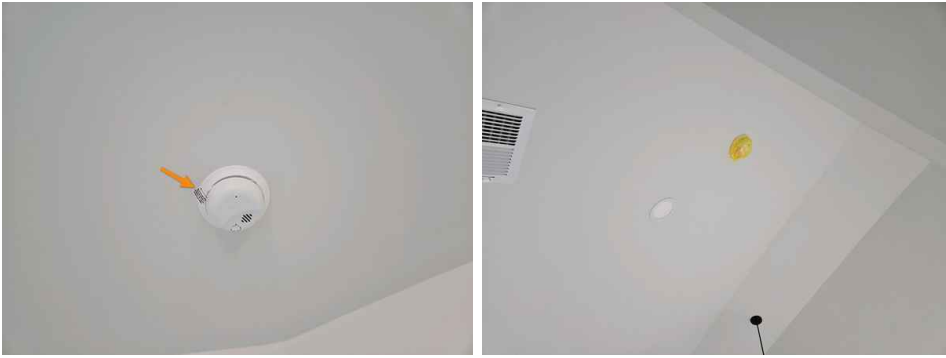
This condition prevents the smoke detectors from being fully operational, which could delay detection of smoke or fire in the event of an emergency, posing a safety risk.

It is recommended to remove the covers or plastic strips and test the smoke detectors to ensure they are functioning properly. If any issues persist, they should be replaced or repaired immediately.

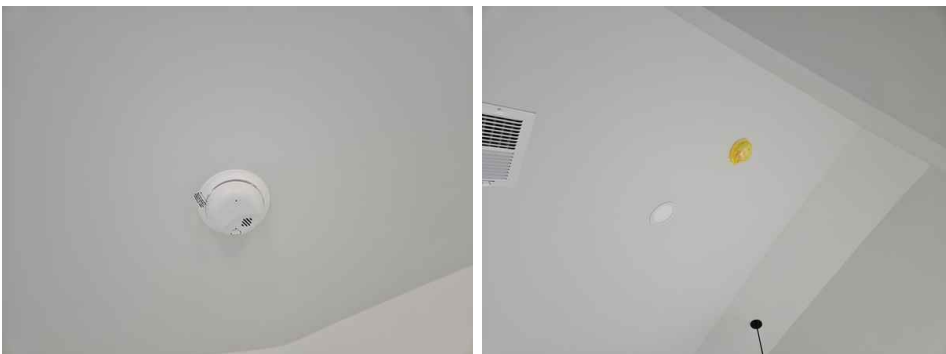
7.5.1 Smoke Detectors

NOT ALL SMOKE/CO DETECTORS TESTED

Contact a handyman or DIY project

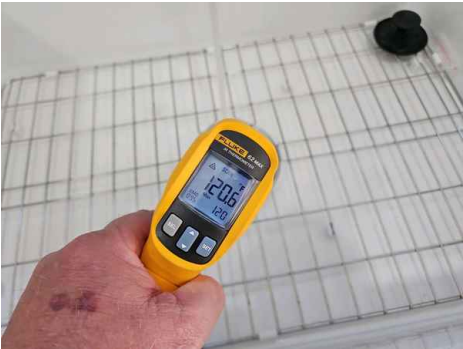
Hot Water Source #1: Type of Hot Water Source
Electric Hot Water Tank

Hot Water Source #1: Manufacturer
Bradford White

Water temperature should be set no higher than 130 degrees F to prevent scalding.
It is recommended to adhere to the manufacturer's guidelines for regular maintenance, including flushing and servicing, to ensure optimal performance and longevity of the unit.

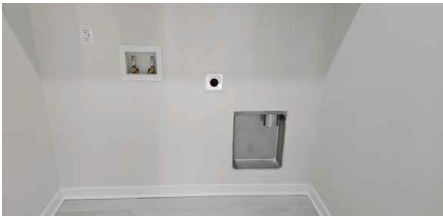
Appliances: Dryer Vent

The dryer vent was inspected to ensure it terminated to the exterior of the home and that no damage was present to the visible portions.

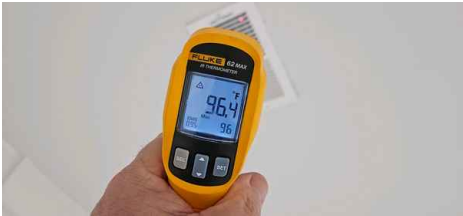
HVAC System Information: Heat Supply Temperature (HP or Gas)
96.4 Degrees F
The temperature of the air after being conditioned by the HVAC unit.

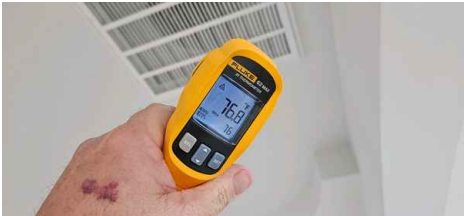
HVAC System Information: Heat Return Temperature (HP or Gas)
76.8 Degrees F
Room temperature air which is returning to the HVAC unit.

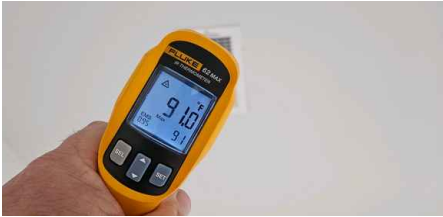
HVAC System Information:
Auxilliary and/or Emergency
Performance (HP)
91 Degrees

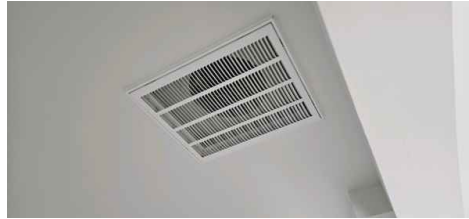
1st Floor Dining Room

This condition can cause strain on the unit's components, leading to potential mechanical failure, reduced efficiency, or premature wear and tear over time.

It is recommended to have the HVAC unit properly leveled to ensure optimal performance and prevent damage to the system.

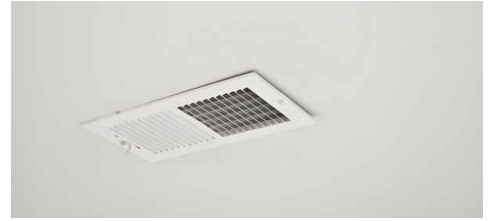
LOOSE VENT

Contact a qualified professional.

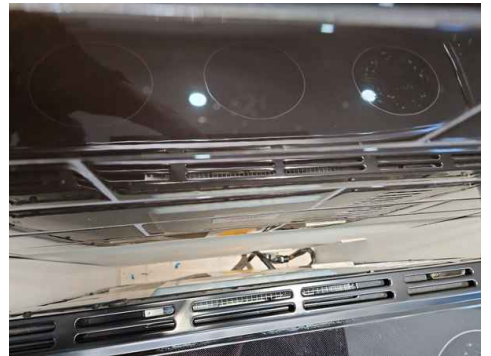
11.9.1 Range/Oven/Cooktop

MISSING ANTI-TIP

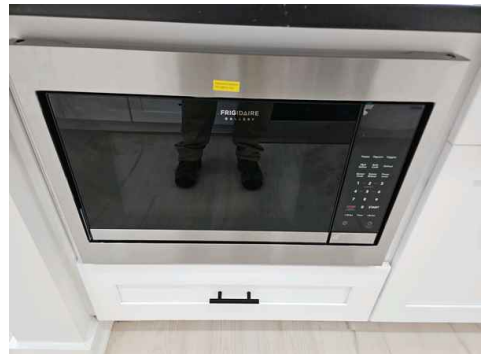
11.10.1 Built-in Microwave

DID NOT TURN ON
