**Randolph Property Inspections DBA
National Property Inspections**

John Client, 1234 Test Street, Lake Forest, CA, 92630

Inspection Date:
10/11/2021

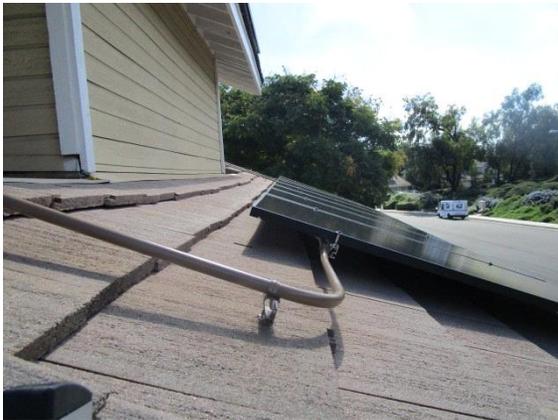
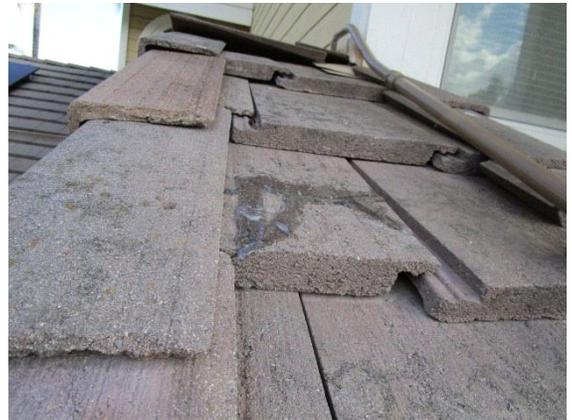
- Overall the roof covering is in functional and acceptable condition. Roof appears to be shedding water as designed. No active interior leaks detected. No visible wind or hail damage.
- There appeared to be some isolated installation debris (abandoned roofing nails) scattered on front slope of the roof. Recommend further review and removal of any installation debris.
- Microbial growth noted on the Southeast side of roof. Recommend further evaluation/repair by qualified roofer/contractor(s).

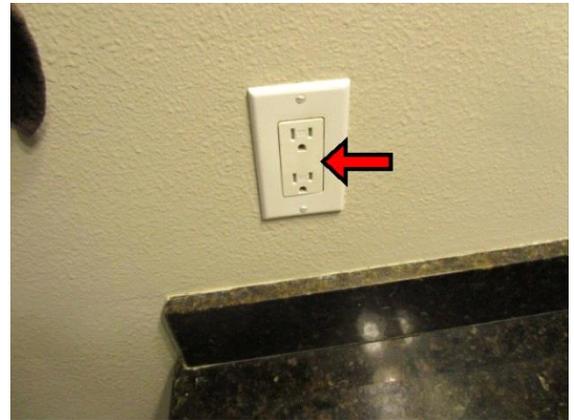
- GFCI circuitry not present. Recommend upgrading to current standard.
- Exhaust vent was dusty. Recommend the vent be cleaned/replaced function properly.
- Recommend further evaluation/repair by qualified contractor(s).

Bathroom Main Floor: Bathroom: GFCI circuitry not present

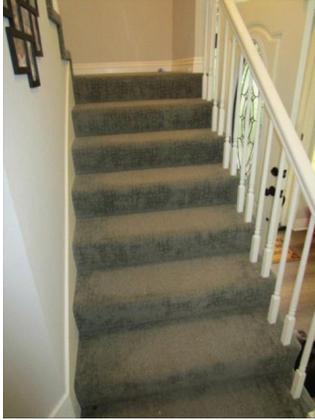
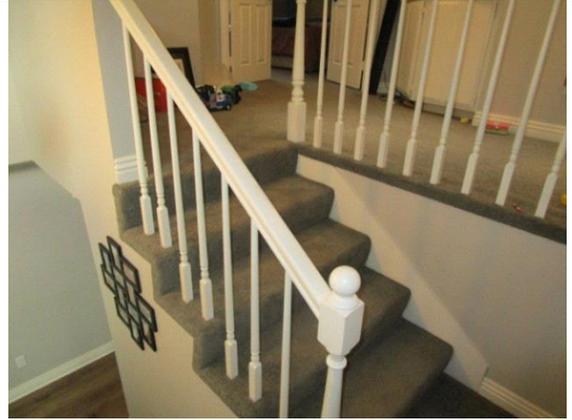
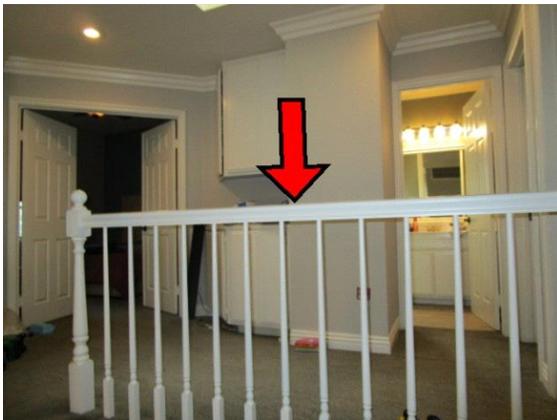
Railing / Handrail Loose

Loose handrail noted. Recommend further evaluation/repair by qualified contractor(s).
