## RESIDENTIAL HOME INSPECTION REPORT

1234 Main Street  
Elgin, OK 73538

Buyer Name  
12/07/2022 9:00AM

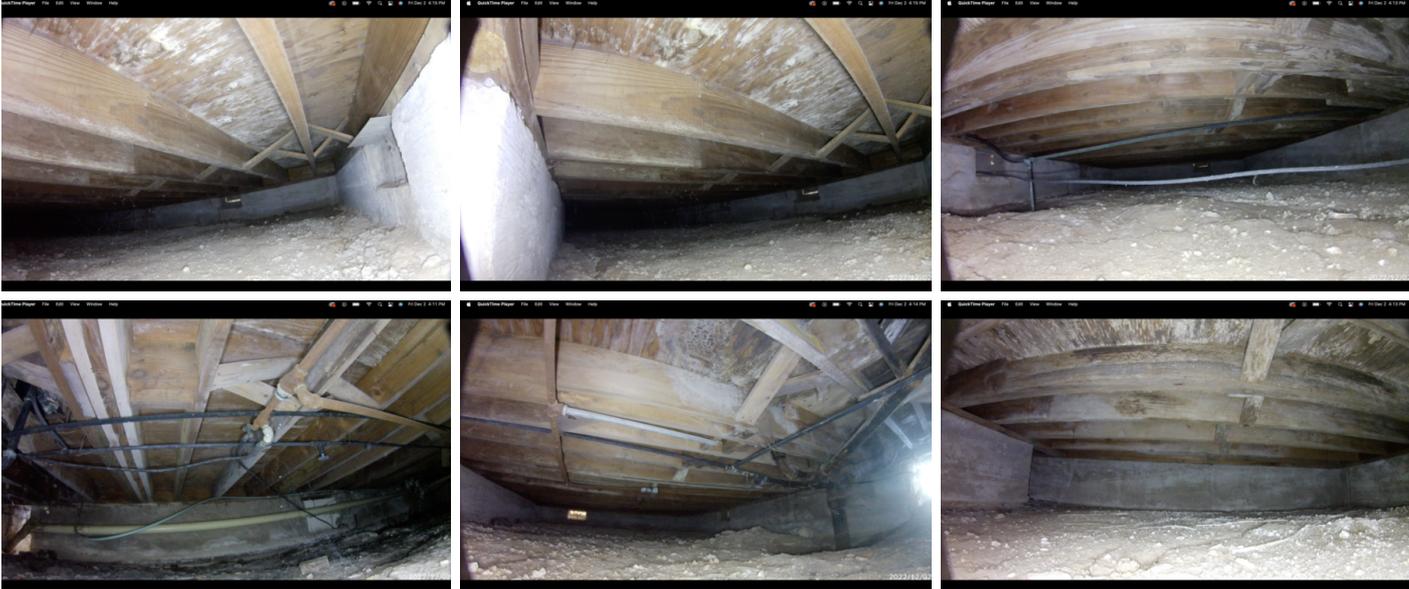
**Foundations: Crawl Space Views**

Limited inspection of crawl space with remote inspection crawler/camera due to working access and clearance. This can limit inspection in some areas of structural, electrical, and plumbing components located in the crawlspace as well as any potential leaks or termite issues.

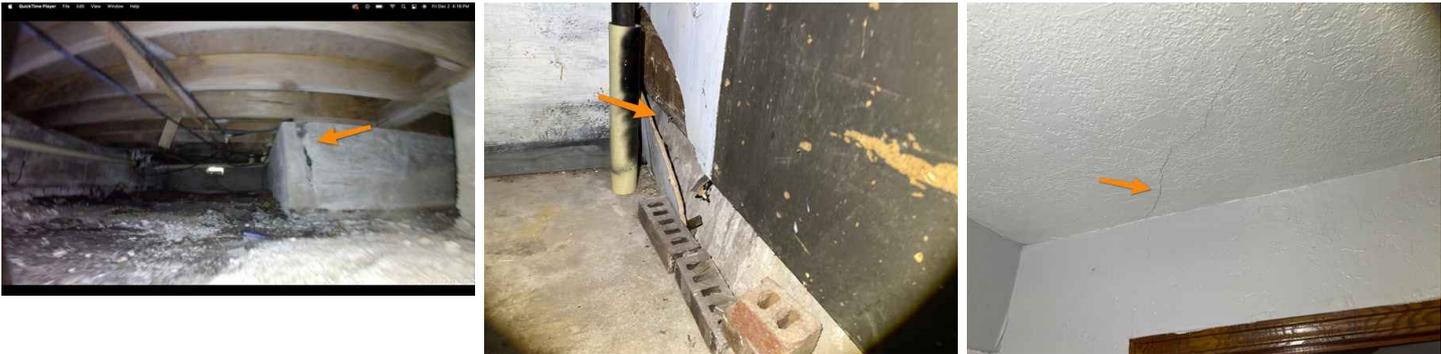
2.1.1 Foundations

**Foundation Needs Further Evaluation:** Some movement or settlement can be expected with an older home. The foundation is concrete supporting walls. No added piers have been installed for leveling or support. There is a concrete stem wall at the garage and right side bathroom that is cracked and starting to lean. This appears to have had movement or settlement that may be beyond normal. A foundation contractor should be consulted on the current integrity of the foundation and any repairs that may be necessary (If Any). The observations made to support the rendering of this opinion are listed but not limited to the following:

- Concrete supporting wall has a wide crack at the corner and the section of wall is leaning somewhat. The leaning can also be seen from the interior foundation wall at the garage.
- Noted associated interior wall and stress cracking located at the bathroom.

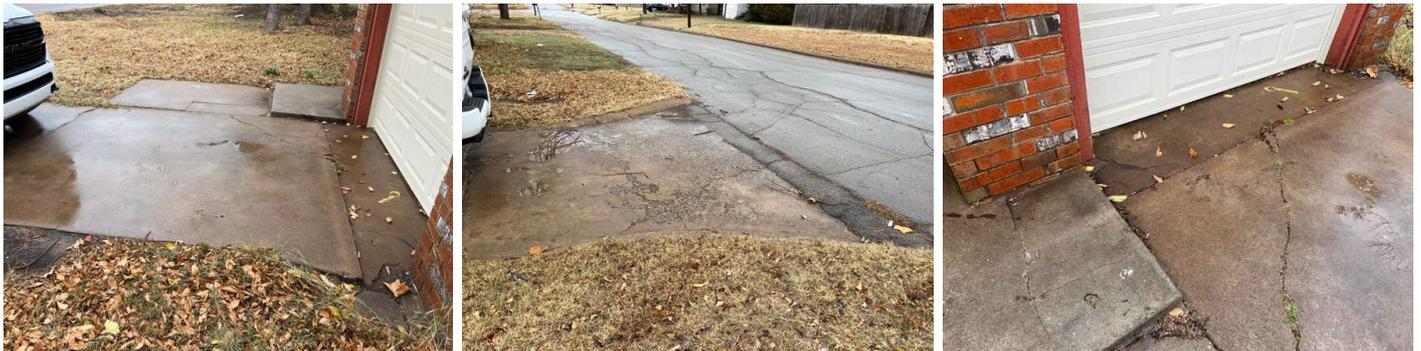
- Minor cracks and/or deficiencies were observed in the driveway and flatwork common with age of home. Driveways can commonly need ongoing maintenance over time.
- Some slight settlement was observed near the garage door and corner of the home.

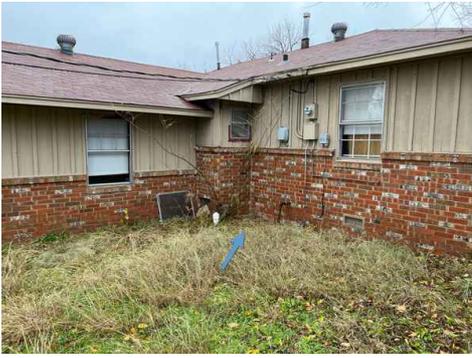
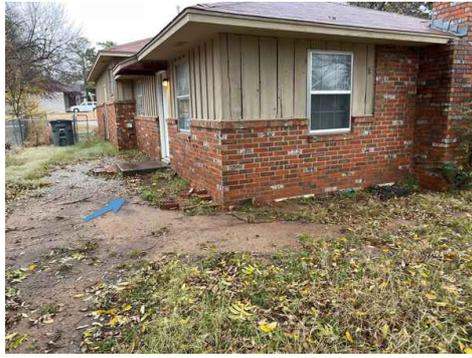
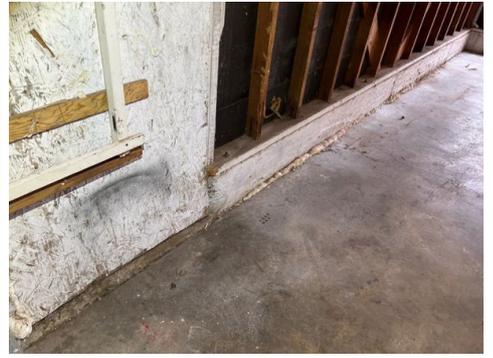
#### 3.1.1 Grading and Drainage

- Marginal site drainage or erosion was observed around the structure at points. Proper drainage can help to prevent water from standing and/or ponding next to the foundation beam. Corrective measures such as soil backfill, corrective grading, or surface drains could be needed if the water stands within 10-feet of the foundation perimeter beam for more than 24-hours. Installation of gutters and downspout extensions around the perimeter of the home can also help with the control of water around the perimeter of the home.
- **Note:** There is evidence of possible previous water intrusion at the right side of the garage- foam sealant has been added at the interior foundation wall. Recommend asking seller about any previous issues.

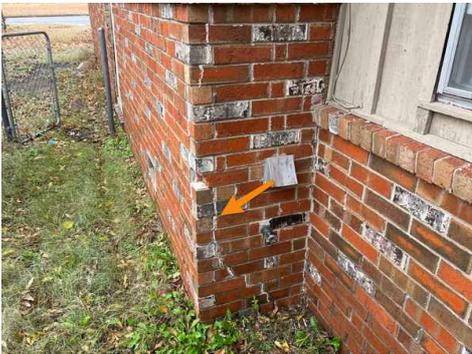
Right

- Mortar improvements are recommended for the exterior masonry veneer on the structure. (All points may not be pictured)

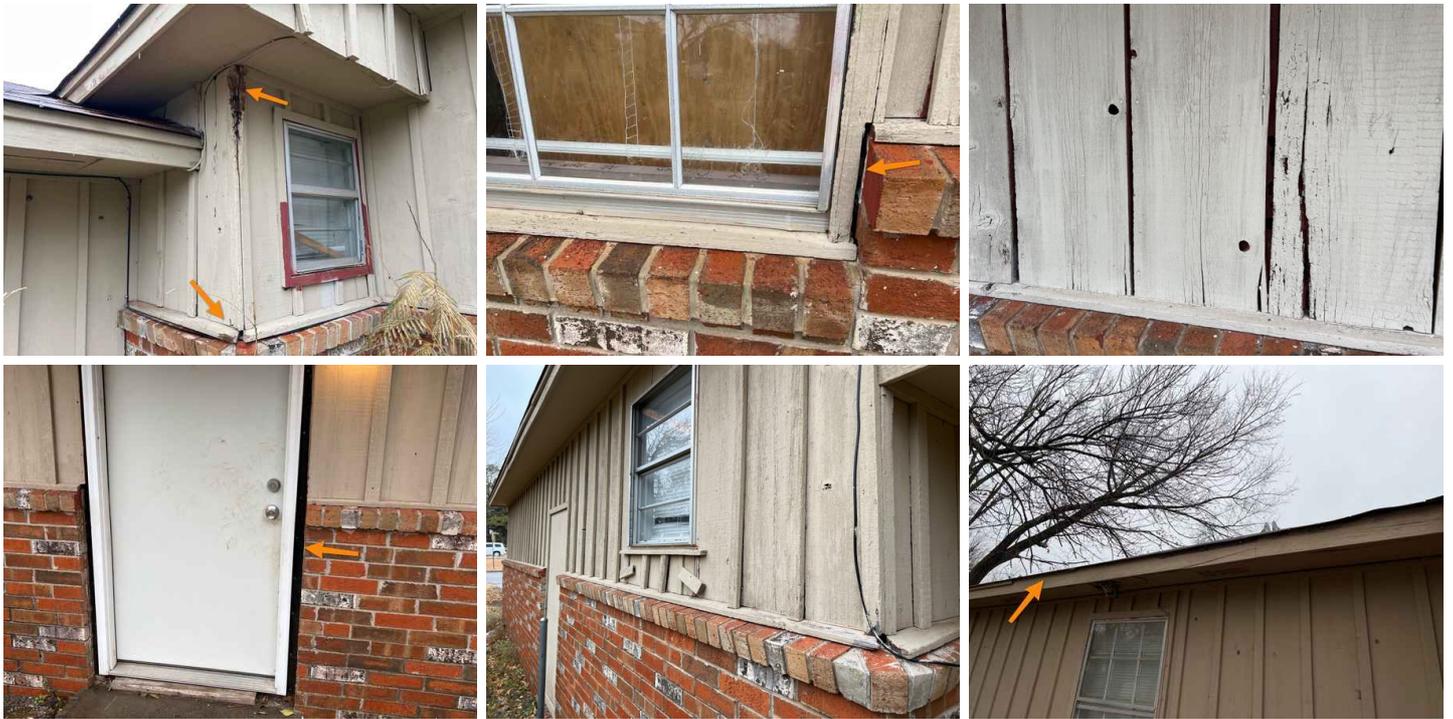
3.2.2 Exterior Walls

**SIDING DETERIORATION / DAMAGE**

- The exterior composite wood siding and/or trim has some deterioration and/or damage on the structure around the perimeter of the home. (All areas may not be pictured) Recommend repair or replacement as needed by contractor. Recommend all potential water intrusion areas are sealed.

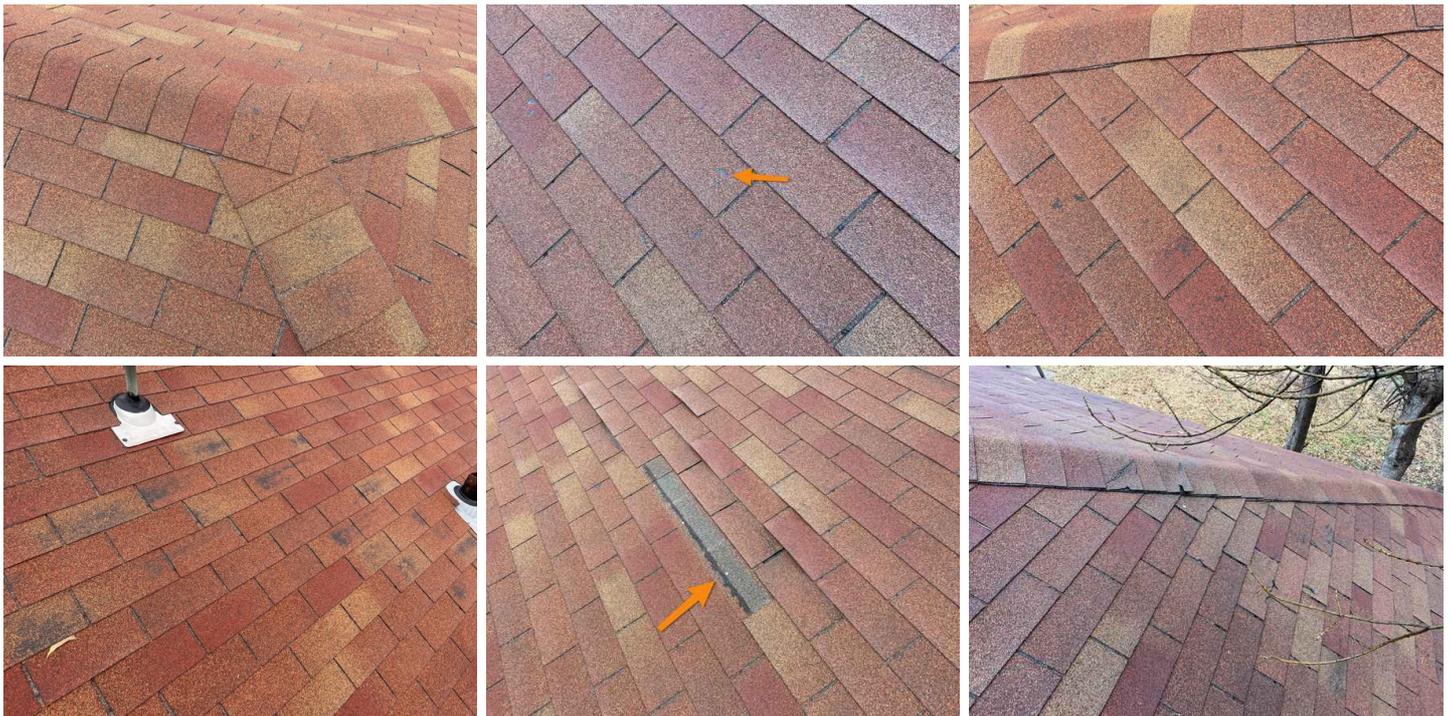
#### HAIL DAMAGE

- The roofing material was observed to have some areas of shingle surface damage or possible impact damage at various locations. The impact damage may have been caused by a previous hailstorm. Recommend the roof be further evaluated and repairs or replacement if/as determined by roofing contractor.

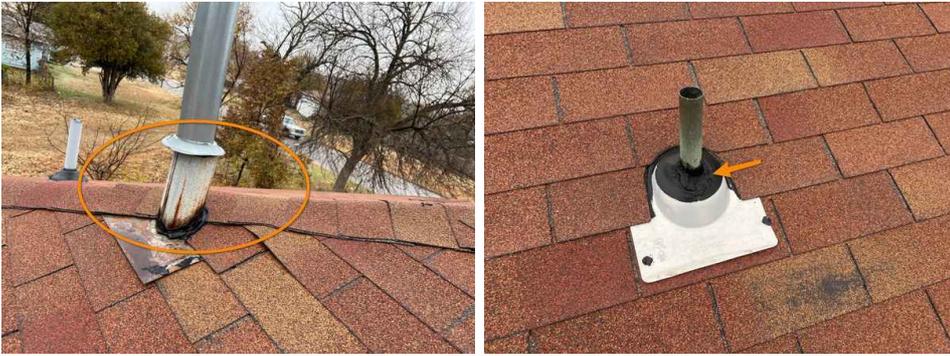
### 4.1.2 Roof Covering Materials

#### FLUE STORM COLLAR NEEDS SEALED

- The storm collar at the roof level gas equipment vent pipe needs to be properly positioned and sealed to help prevent water intrusion into the structure.
- The rubber plumbing boot is damaged and has been sealed with tar. This is a temporary fix and is recommended to replace the boot.

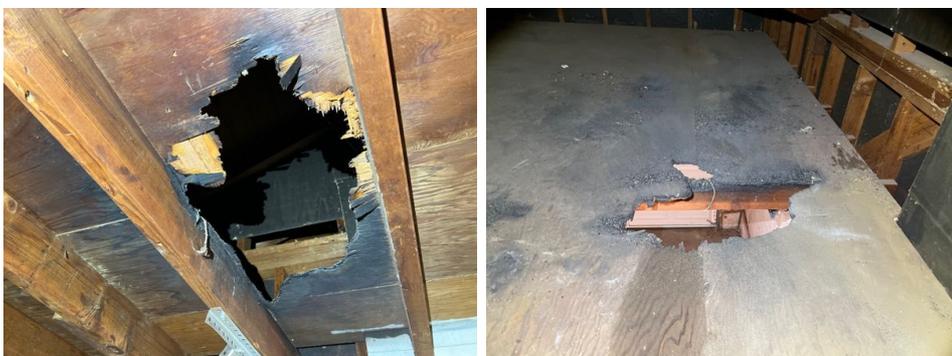
### EVIDENCE OF PREVIOUS FIRE IN ATTIC

Noted evidence of previous fire in attic space and garage ceiling. This appears to involve a small area at the ceiling and the electrical wiring has been cut and no longer in use. No significant structural damage was observed. Recommend asking seller for more information.

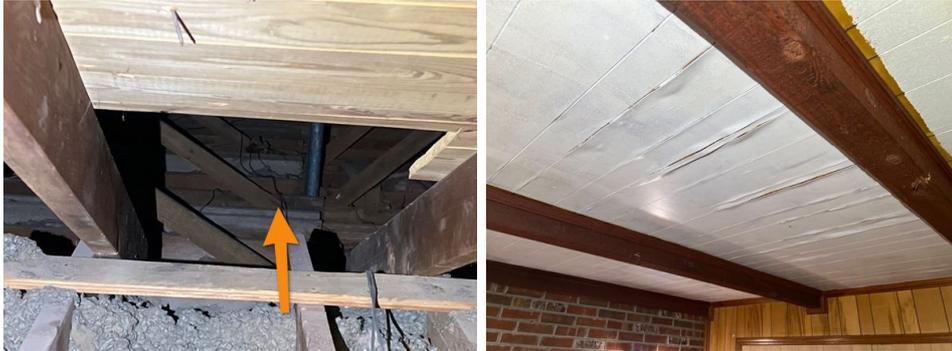
6.2.1 Insulation

### ATTIC FLOOR INSULATE MISS

- The attic floor insulation was observed to be missing or lower than typical over the rear addition. Limited access to the area. Recommend adding insulation for better efficiency. The wood veneer paneling underneath is showing signs of damage and curling.
- Note: No active moisture was observed with infrared camera.

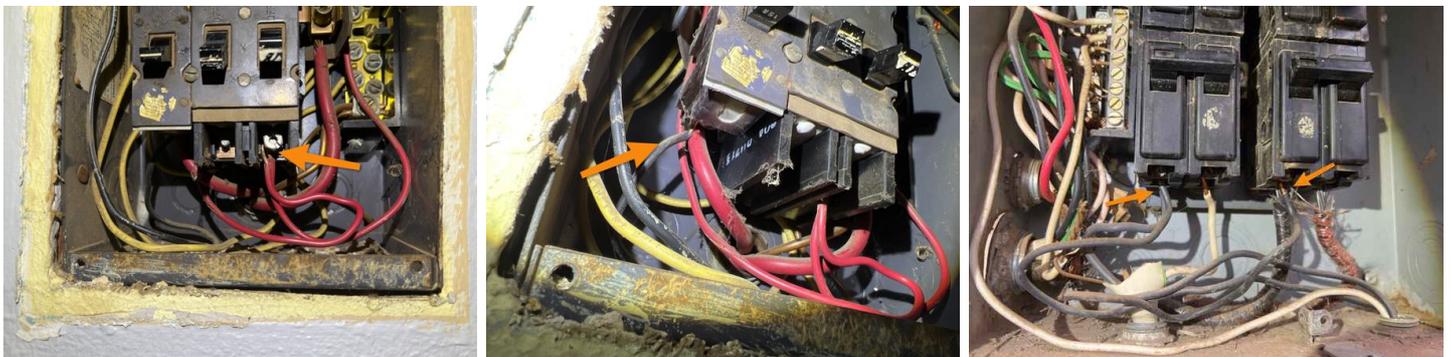
Recommend the electrical system be checked and certified by a Qualified Licensed Electrician. The observations made to support the rendering of this opinion are listed but not limited to the following:

- One or more of the breakers in the electrical cabinet were observed to be double lugged (i.e. two wires under one screw). The breakers in place are not listed or labeled for this type of installation and should be further evaluated and corrected as necessary.
- There was no main disconnect observed in the panel box. This may be an "as-built" condition and does not meet current building practices.

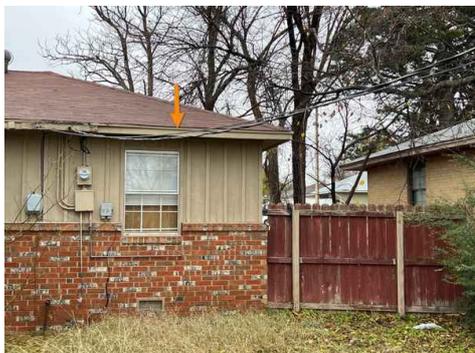
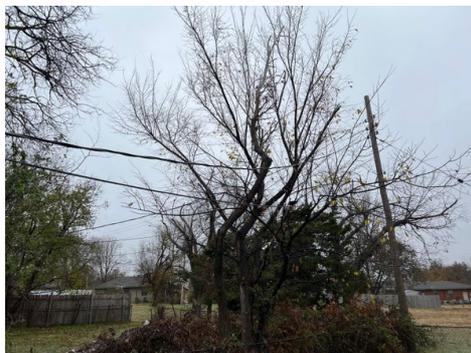
7.1.2 Service Entrance and Panels

### **SERVICE WIRE HANG LOW TO GROUND**

- The electrical service wires hang too low across the back yard area. The electrical service wires from the service pole to the structure should clear the ground, decks or platforms by a minimum of 10-feet. This is an "as built" condition and does not meet today's building practices but may have been acceptable at time of installation.
- The tree branches should be trimmed away from the overhead service wires.

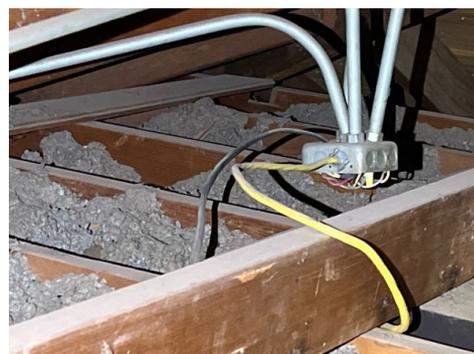
7.2.1 Distribution

**OPEN J-BOX ATTIC**

- Open electrical junction boxes were observed in the attic area. All open junction boxes and exposed wiring should be properly enclosed.

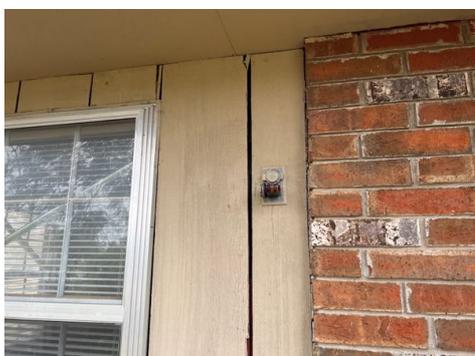
Exterior

**MISSING GFCI IN WET / DAMP AREAS**

- Although not typical for age of home, some of the receptacles in the wet/damp areas do not appear to have ground fault circuit interrupter (GFCI) protection. Under current electrical standards all of the exterior receptacles, all kitchen counter top receptacles, all bathroom receptacles, all laundry room receptacles, all garage receptacles, dishwasher receptacle, receptacle in cabinet under kitchen sink, any receptacle within 6-feet of the sink should have GFCI protection. Recommend upgrading as needed by electrical contractor.

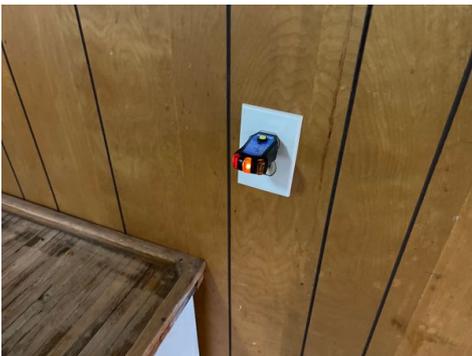
Kitchen

### REVERSE POLARITY RECEPTACLE

- One or more of the receptacles appear to have reversed polarity (i.e. it is wired backwards). This receptacle(s) and the circuit should be investigated and improved as necessary.

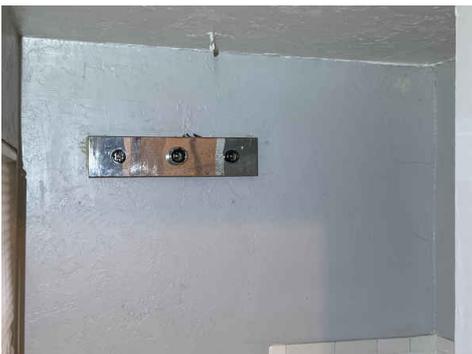
Bathroom

### LIGHT NO WORK PROPERLY (BULB)

- One or more of the light fixtures are not operating at time of inspection. Recommend changing bulb and further repair by electrical contractor if still not operating. Some exterior lights may operate on sensor. All lights may not be pictured. Recommend ensuring all lights are working throughout the structure as needed.

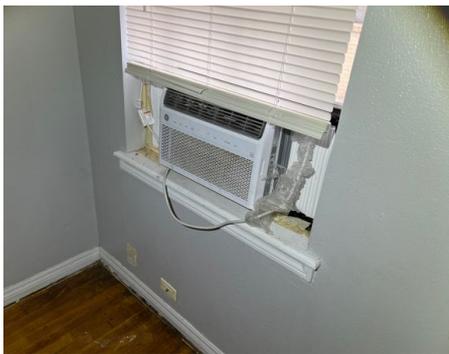
### Cooling Equipment: Window Units Not Inspected

Multiple portable window cooling/heating units are present but are not inspected.

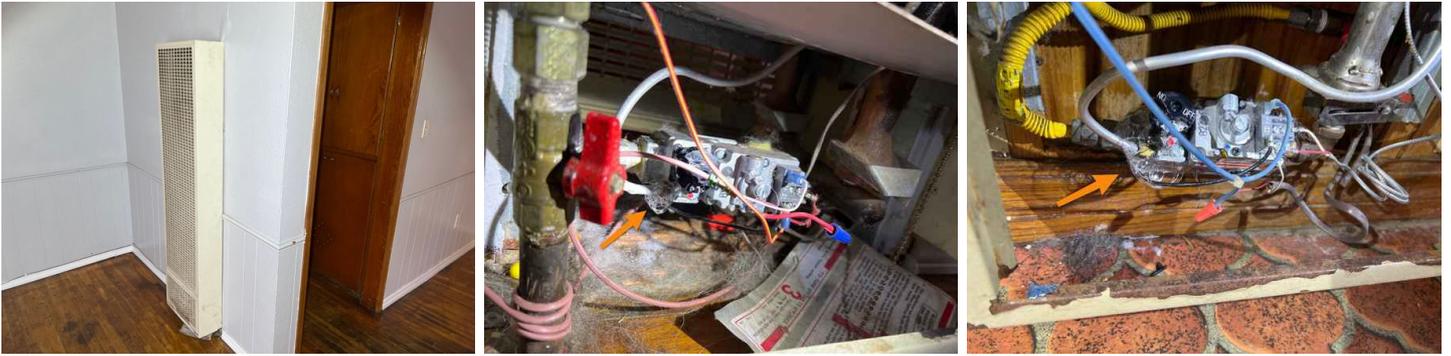
- The gas wall heater units at the front family room and rear addition are in need of repair and were not operated. Gas company turned on gas and could not light pilot flames due to gas leak detected at or around the gas pilot assembly. Recommend repair as needed by HVAC or plumbing contractor as needed.

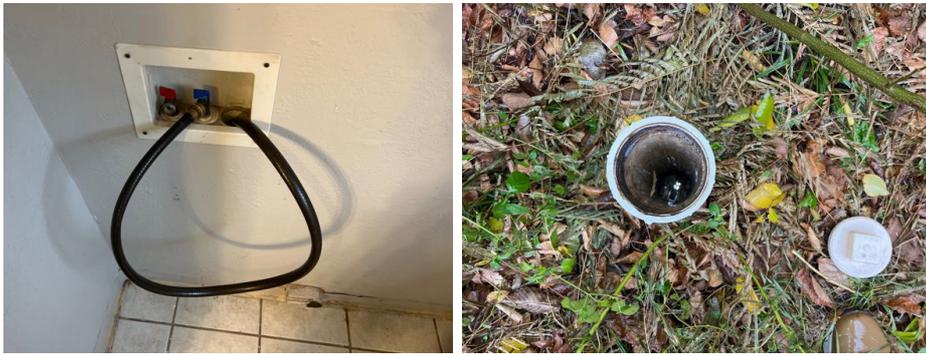
## Drains, Wastes, & Vents: Main Lateral Drain Line Limitations

**Note:** A general functional main drain assessment was performed only during routine operation of supply fixtures. **Due to limited visible accessibility, we can not determine the condition of drain lines beyond the slab penetration. A more detailed scope inspection can be performed by a licensed plumbing contractor as desired.**

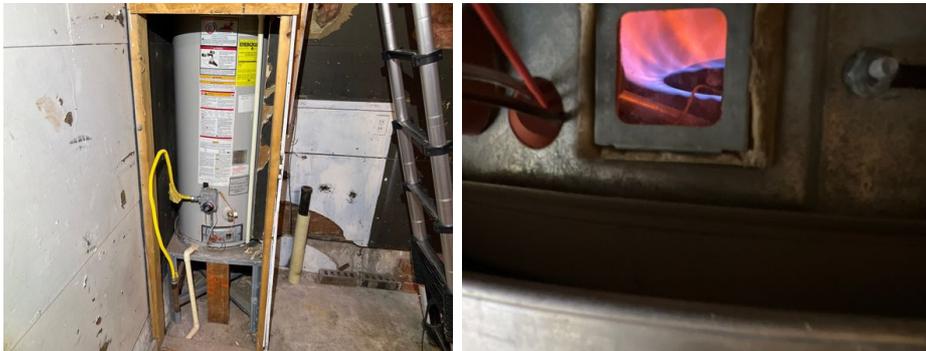
## Water Heating Equipment: Water Heater Performing

- The water heater component appears to be performing adequately at the time of this inspection. It is achieving an operation, function, or configuration consistent with accepted industry practices for its age. Hot water was not checked at individual fixtures due to gas being turned on during inspection and not enough time to heat up water. **AGE 2003**

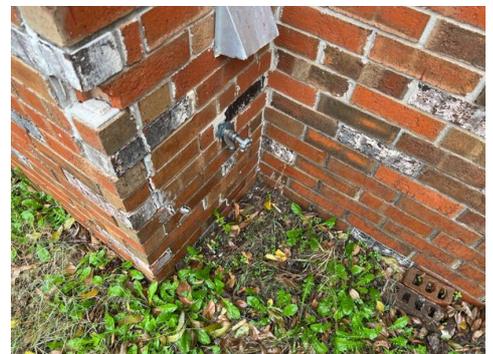
Right

- The exterior water hose bibb (faucet) is inoperative for undetermined reason. Recommend repair by plumbing contractor.

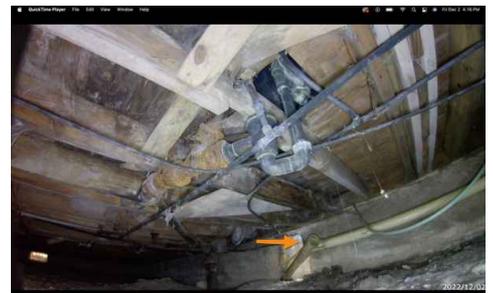
9.2.1 Drains, Wastes, & Vents

### CLEANOUT COVER MISSING EXTERIOR WALL

- The drain clean-out cover is missing in the crawl space. This could allow waste water to back flow into the crawl space.

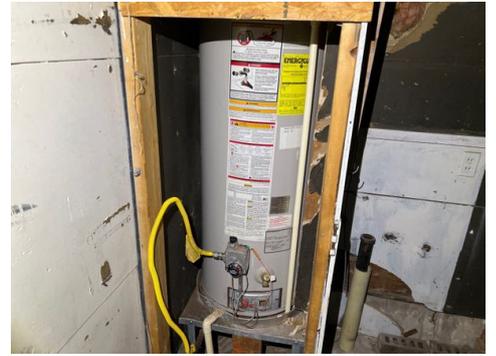
9.3.1 Water Heating Equipment

### RUMBLING WATER HEATER

- The water heater is making a rumbling noise when operated. This is a good indicator that there is sediment in the bottom of the water heater tank. Cleaning and servicing is recommended.

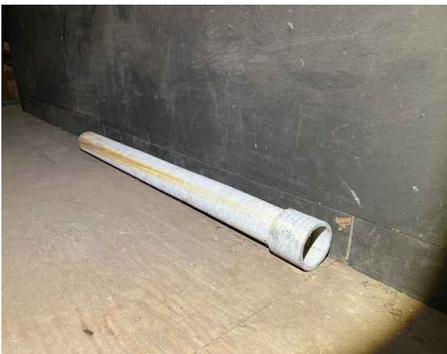
Garage Attic

#### **Walls (Interior): Older Home Building Materials**

**NOTICE:** It is common in older homes of this age for building materials to possibly contain lead based paint or a percentage of asbestos in building materials such as "popcorn" ceiling texture, siding, or abandoned transit pipe. This is beyond the scope of a general home inspection. Recommend further evaluation by contractor before removing or renovations are performed. This is for your information.

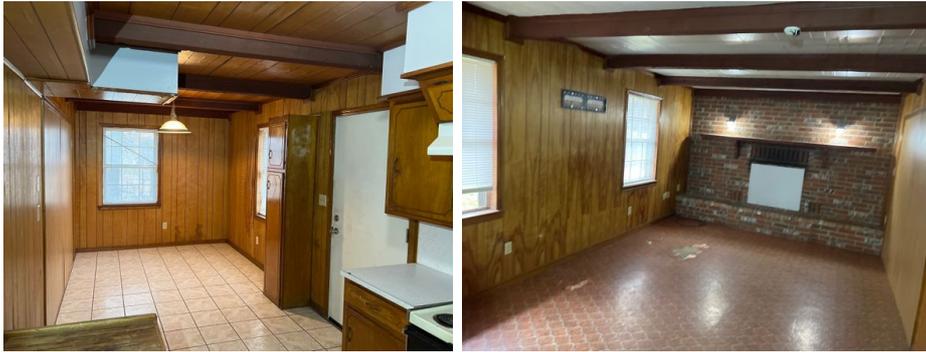
### Walls (Interior): Older Home Changes to Original Construction or Systems

**Note:** In the inspectors opinion, the property was observed to have signs of repairs, renovation, change-outs or additions to the original construction. This work may or may not have been performed by a licensed contractor(s) with proper permits and code inspections, or in workmanlike manner, etc. The home inspector does not check with local jurisdictions on permitted work for the property. This is for your information.

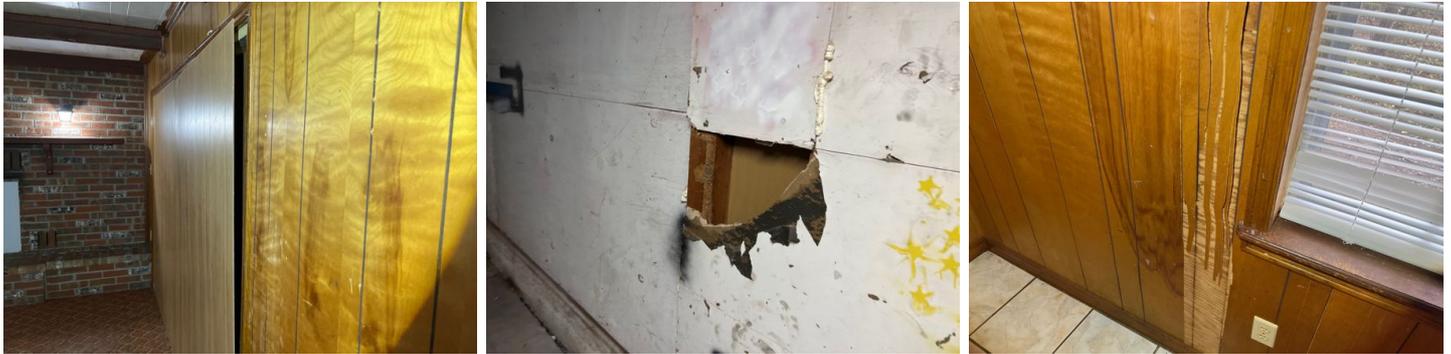
#### INTERIOR WALL JOINT CRACKS

- Interior wall joint cracks and/or loose drywall tape or damage were observed. Recommend cosmetic repair as needed.

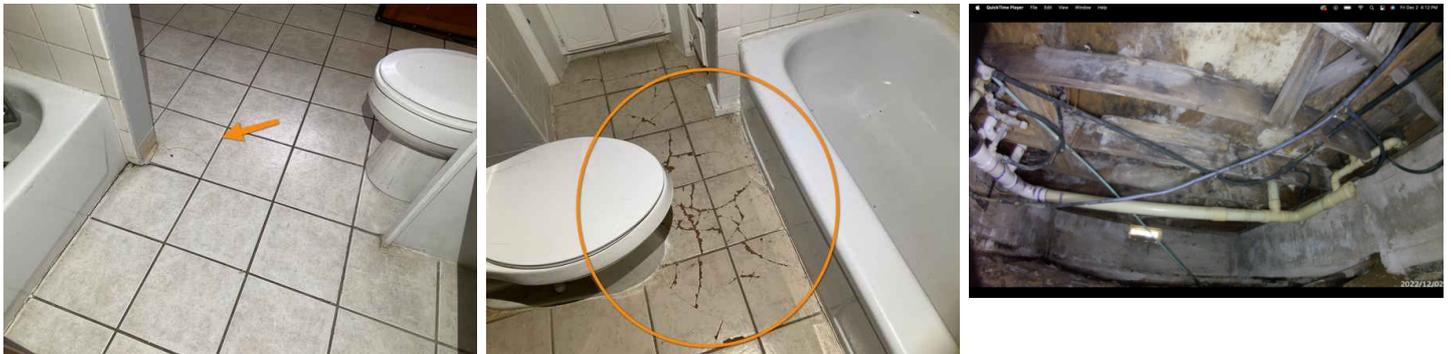
### 10.2.1 Ceilings and Floors

#### TILE CRACKED / DAMAGED

- The floor tile(s) were observed to be cracked and/or damaged at the bathroom areas. Sub floor wood damage noted under both bathrooms. The rear bathroom floor is very "soft". Recommend further evaluation and repair by contractor.

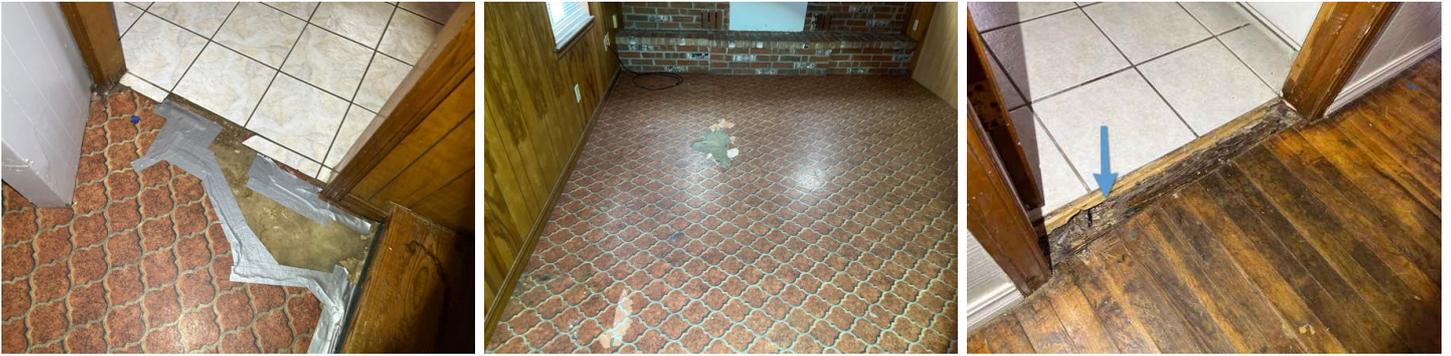
#### FLOOR COVERING DAMAGED

- The floor covering was observed to be damaged in some areas.

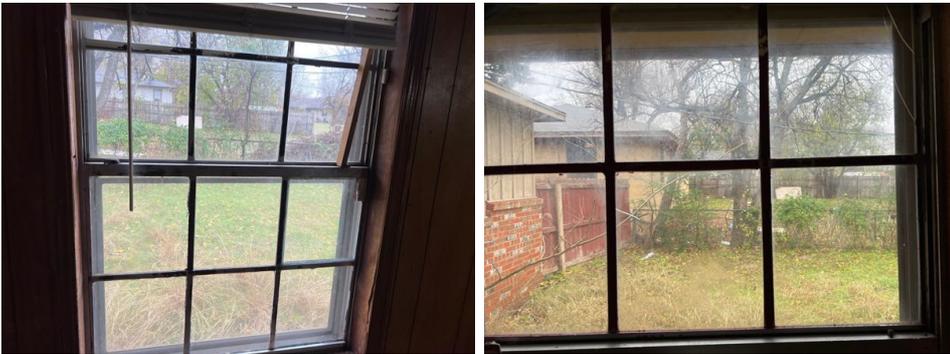
Rear Family Room

**CRACKED / BROKEN GLASS WINDOW**

- Cracked and/or broken window glass was observed. Recommend repair or replacement as necessary.

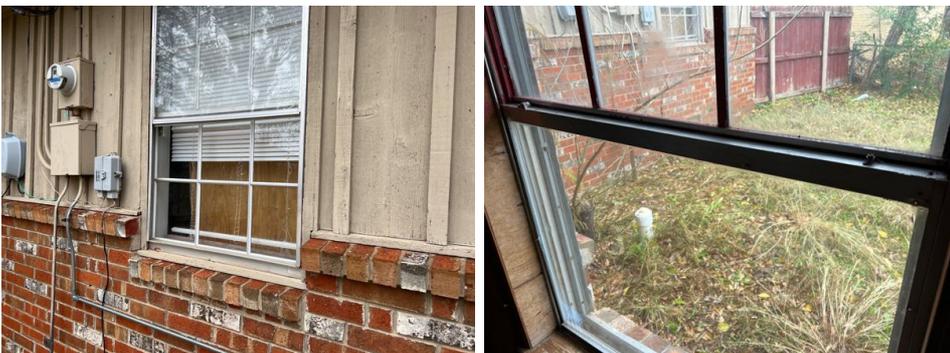
10.4.2 Windows

- One or more of the window screens were observed to be missing or damaged.
- Some locks/latches are missing or not operating properly.

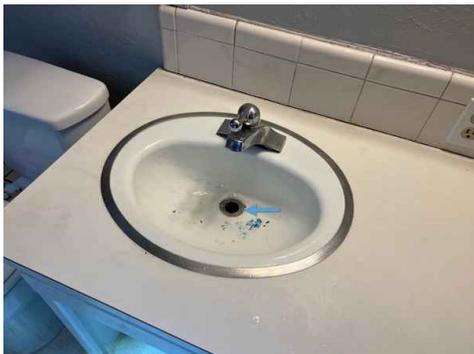
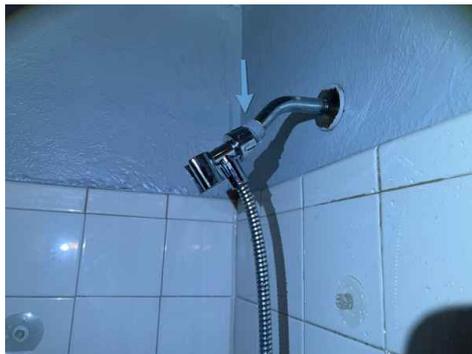
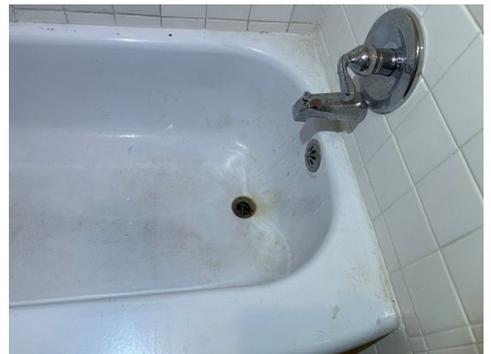
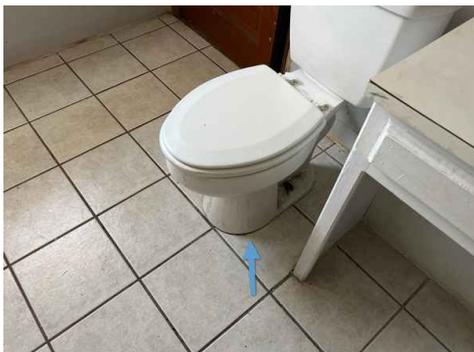
- Drain stops are missing or not operating properly at most bath fixtures.
- The shower head is leaking at the connection at the right side bathroom.
- The commode is loose at the base and needs reset and secured.

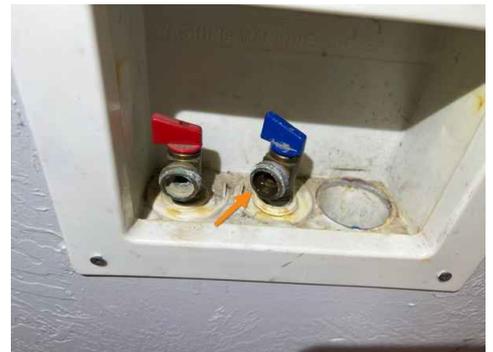
- One of the laundry connection hose bibbs has a slow leak when in the off position. Recommend repair by plumbing contractor.

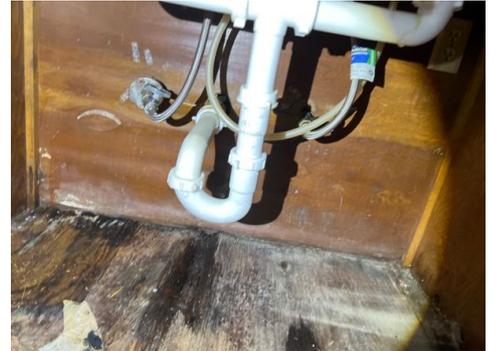
- The faucet assembly leaks water into the cabinet when operated. Recommend repair by plumbing contractor.

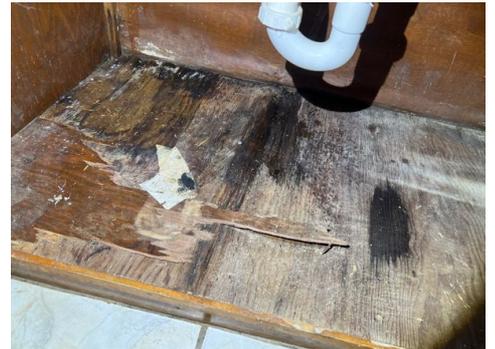
### 13.8.1 Cabinets

#### CABINET FLOOR DAMAGED

- The cabinet floor has damage or water damage and needs repair or replacement.

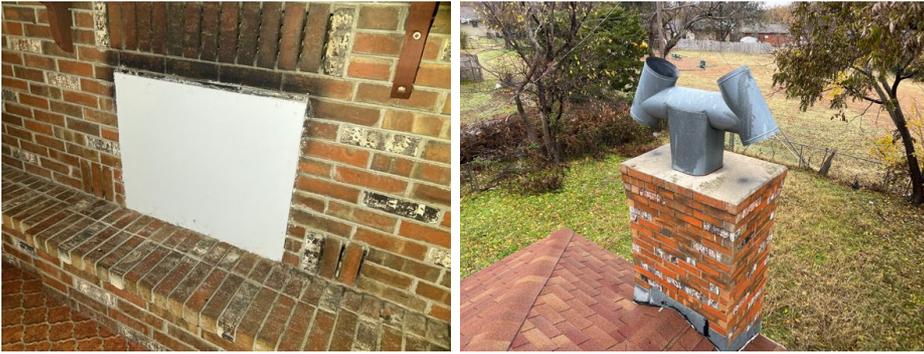
### Fireplaces and Chimneys: Fireplace Sealed

The fireplace was sealed and the interior firebox was not inspected. Recommend further inspection by chimney sweep.
