**Property Inspections Plus, Inc. DBA  
National Property Inspections**

**Commercial Sample-Homewood, IL, IL**

Inspection Date:  
11/14/2022

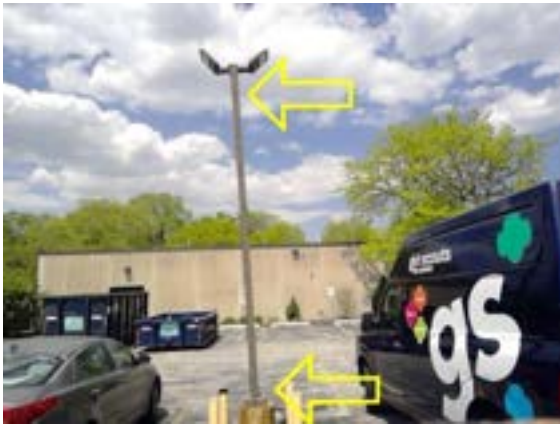
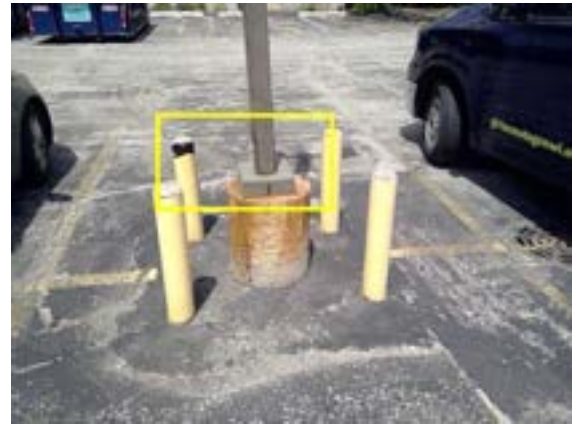
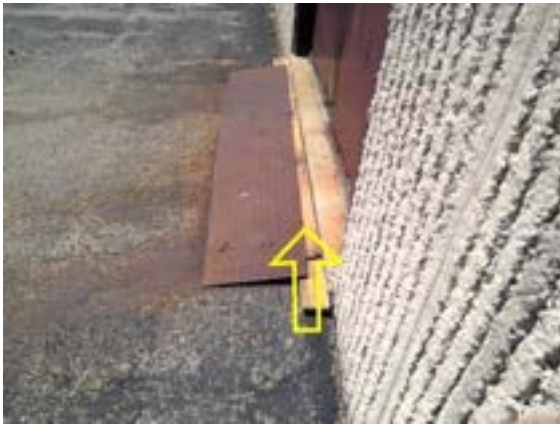
Curbs cracked, light pole base loose, loose wood beneath metal by entrance, driveway has settled away from building.

Recommend further evaluation/repair by qualified contractor(s).

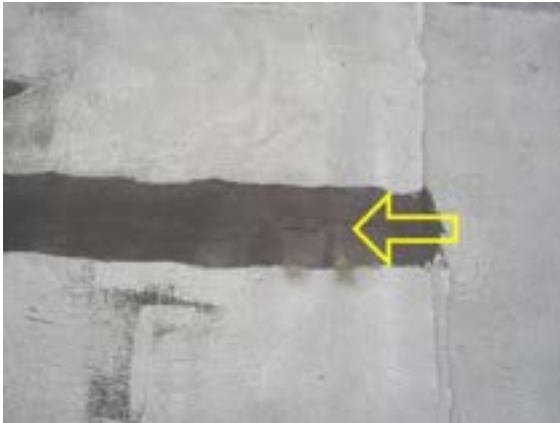
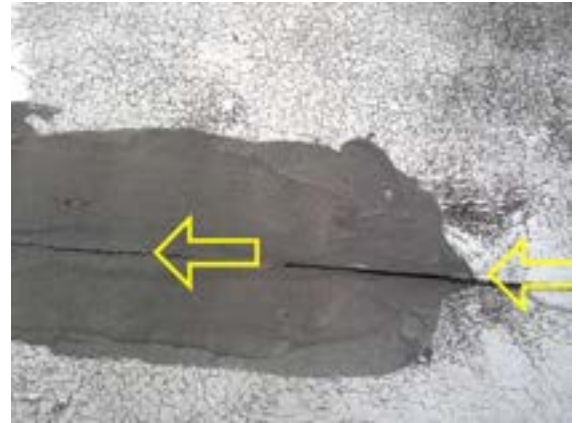
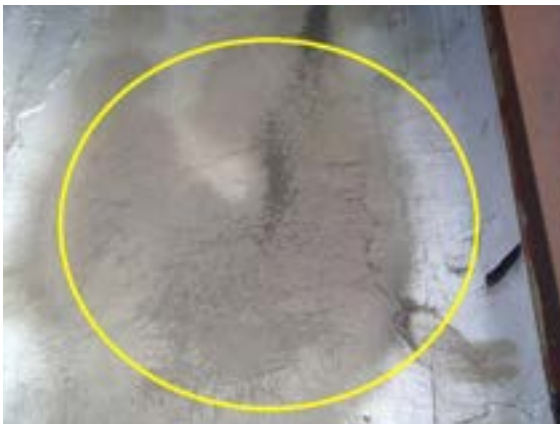
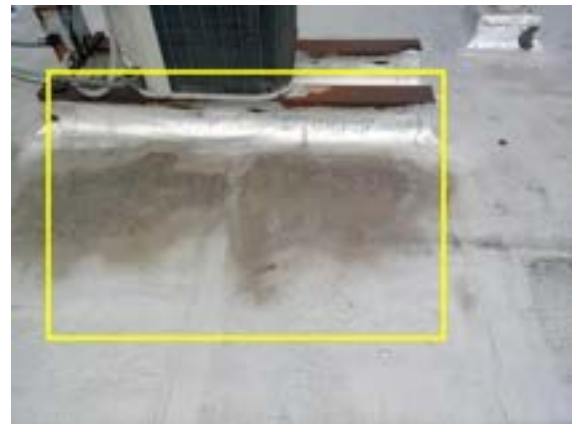
Several cracked areas, ponding and previous repairs noted.

Recommend further evaluation/repair by qualified roofing contractor(s).

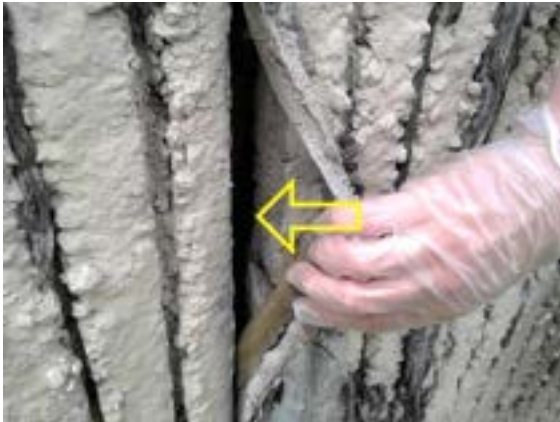
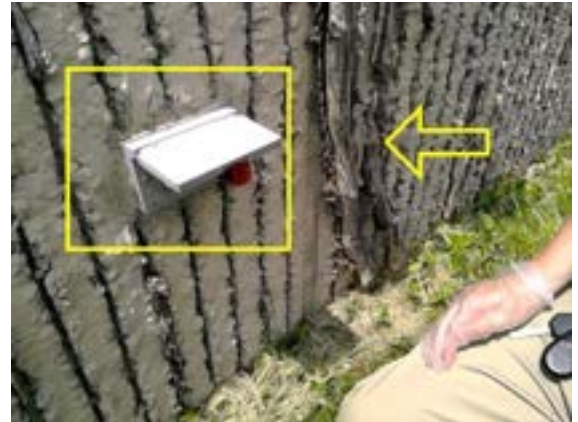
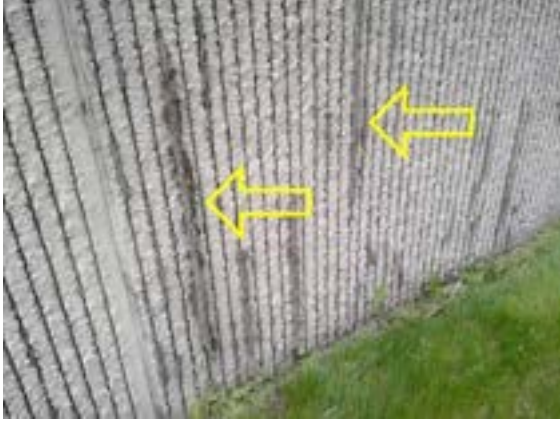
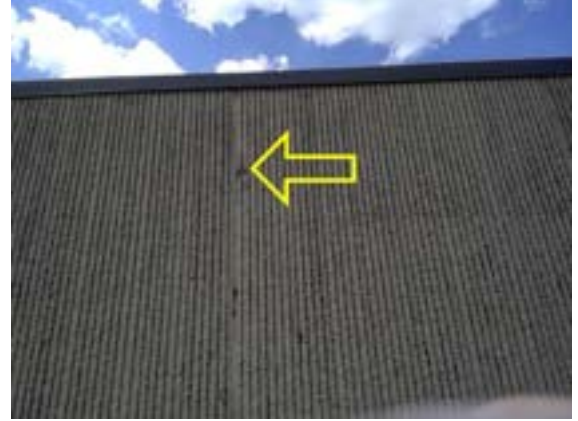
Several areas around building had loose/deteriorated seal, cracks or holes. Roots/vines stuck in siding.  
All exterior outlets inoperable and GFCI did not trip under fault conditions.  
All outlets did not have a weather cap that allows long term fixtures to be plugged in while cap is closed.  
Recommend replacing with a weather cap cover that accommodates plug.  
Recommend further evaluation/repair by qualified electrician(s).

Exterior Surface: Inoperable.

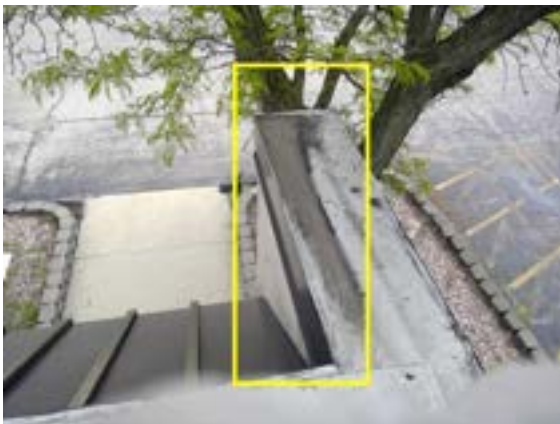
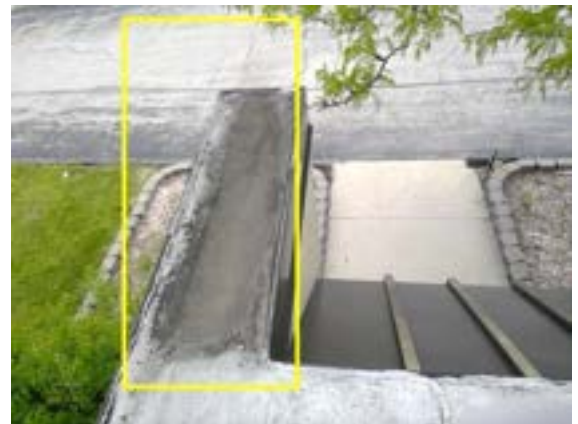
Ponding/possible leaks above entrance and other areas.  
Recommend further evaluation/repair by qualified contractor(s).

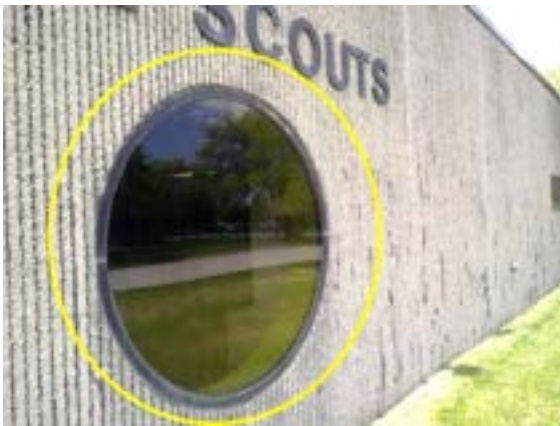
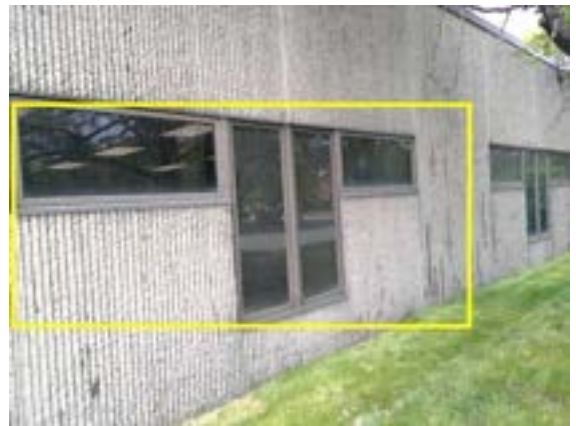
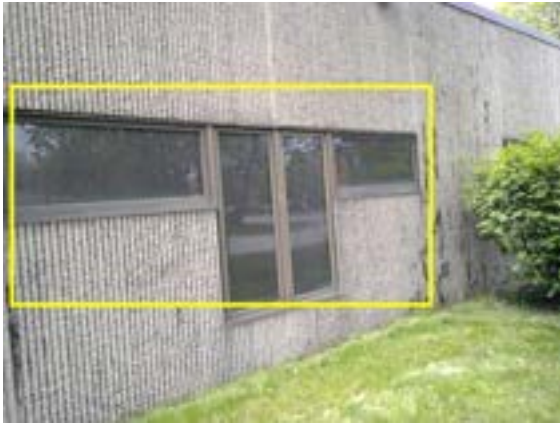
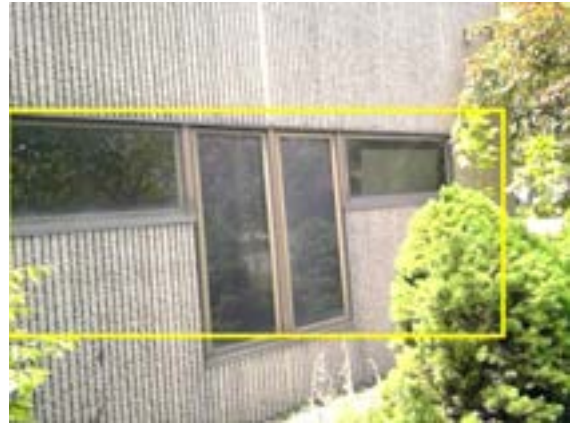
Most thermal windows around the building were fogged due to loss of thermal seal.  
Recommend further evaluation/repair by qualified window contractor(s).

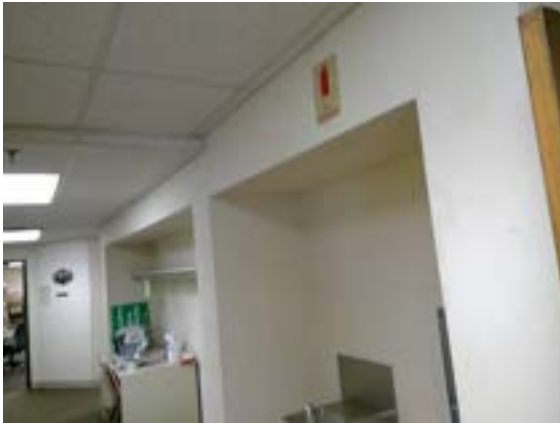
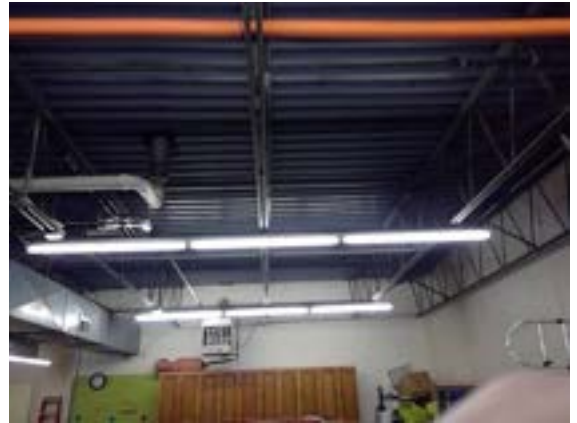
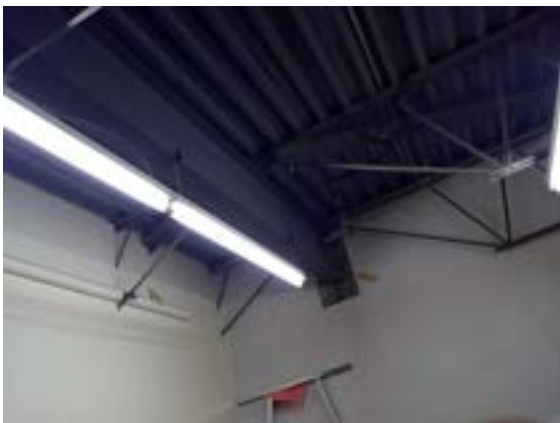
Limited access due to design and ductwork .  
Where visible, framing and decking in acceptable condition.

Leaks not always detectable.

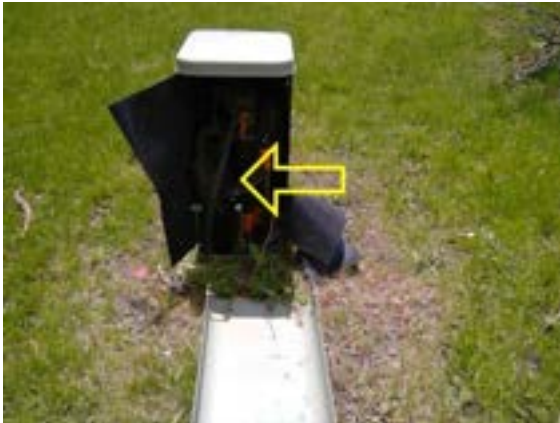
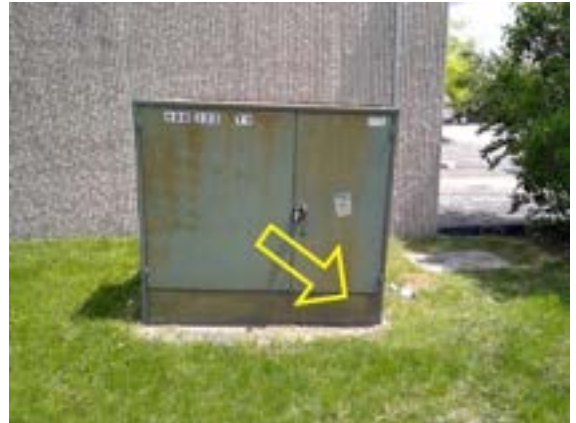
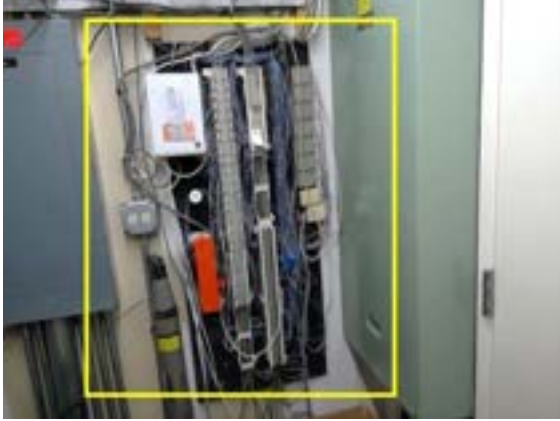
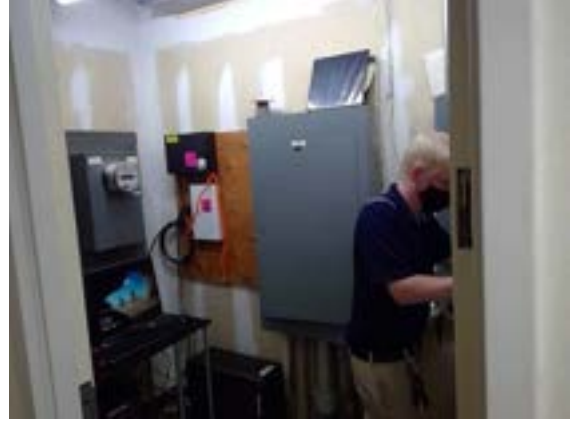
Exterior service exposed wires and cement settling.

Exposed wires interior.

Recommend further evaluation/repair by qualified electrical contractor(s).

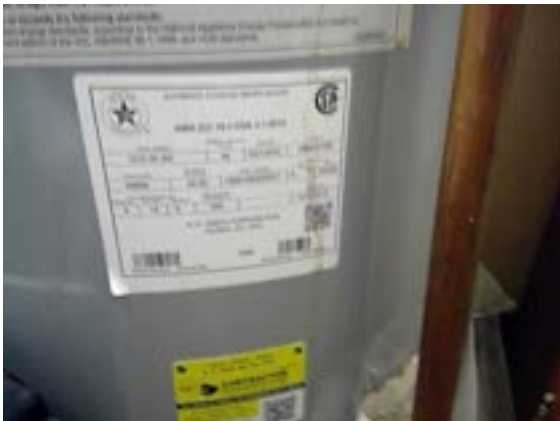
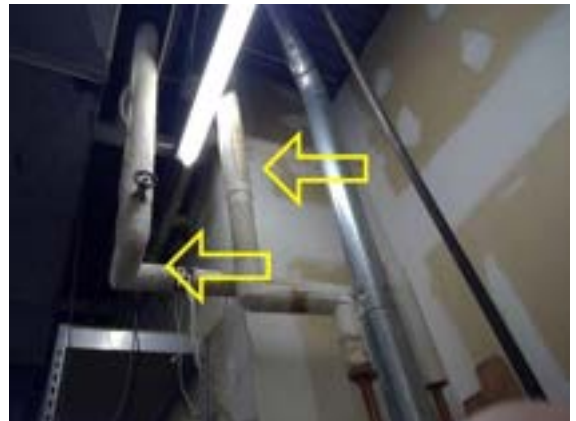
Possible asbestos pipes above water heater.  
Recommend further evaluation/repair by qualified contractor(s).

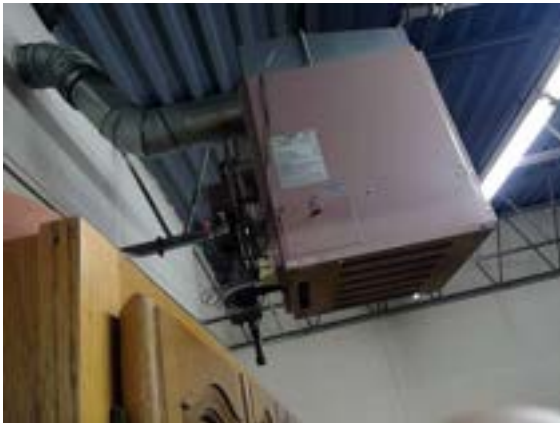
Unit inoperable.

Recommend further evaluation/repair by qualified HVAC contractor(s).

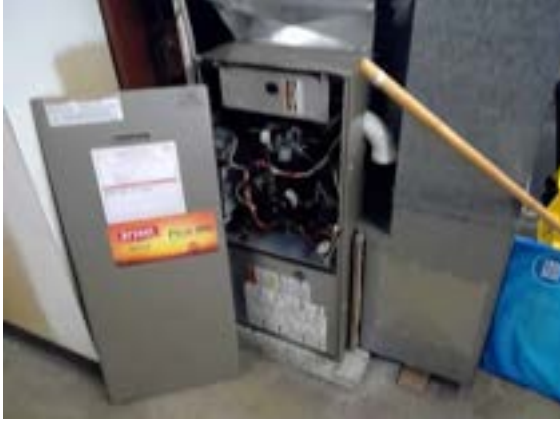
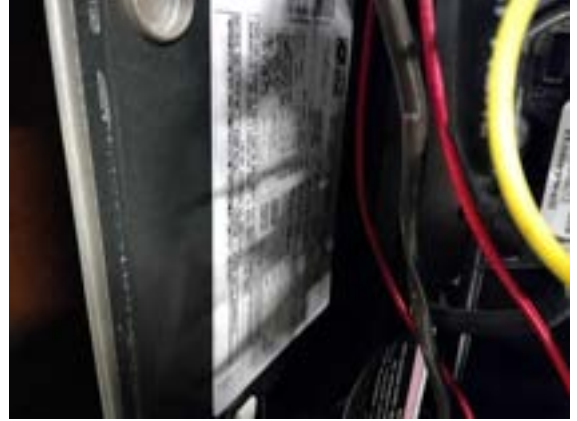
Rated fair due to age. Unit functional at time of inspection.

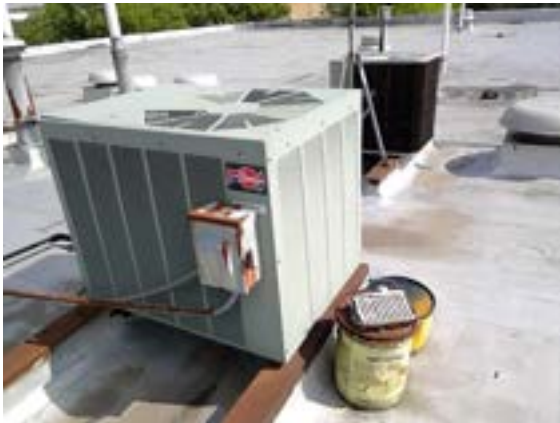
Rated marginal due to age of unit. Budget for eventual replacement.

A/C unit should not be tested in cool mode with temperature below 65 degrees for fear of damaging compressor.

Recommend checking when ambient air is warmer. The temperature splits could not be properly tested with the low temperatures, even if it was safe to operate.

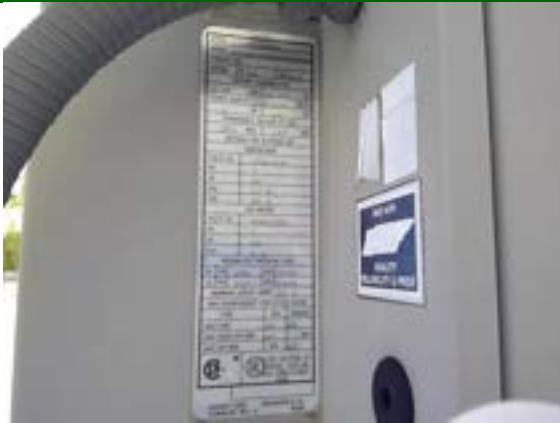
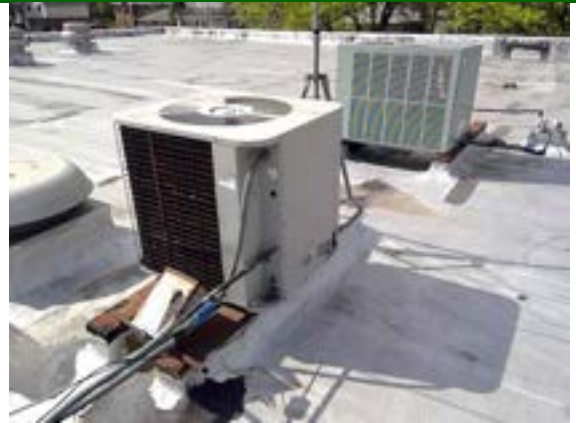
Rated fair due to age of unit. Budget for eventual replacement.

A/C unit should not be tested in cool mode with temperature below 65 degrees for fear of damaging compressor.

Recommend checking when ambient air is warmer. The temperature splits could not be properly tested with the low temperatures, even if it was safe to operate.

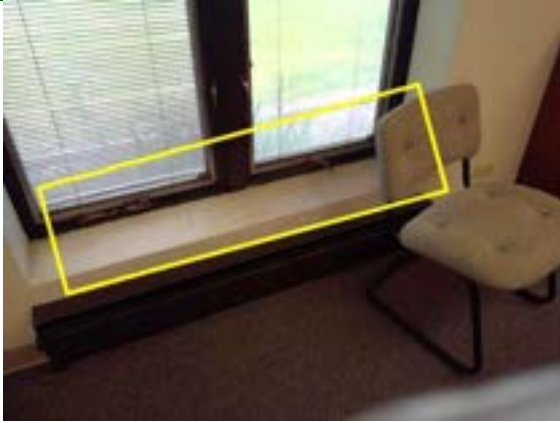
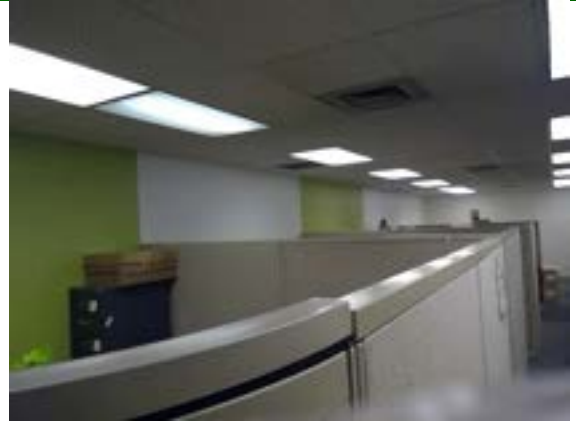
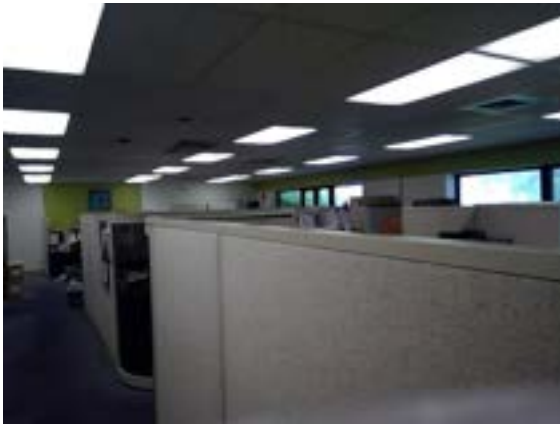
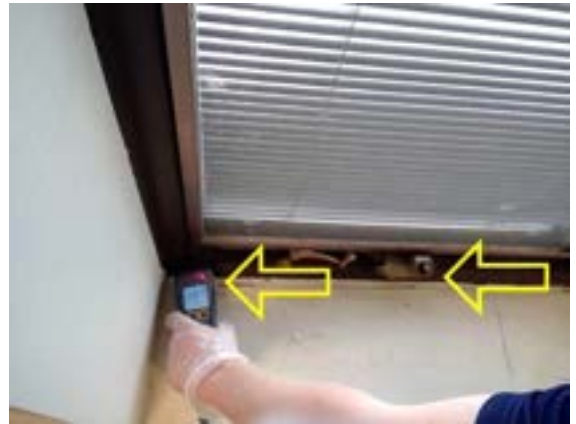
Peeling paint, inoperable windows and moisture present.  
Recommend further evaluation/repair by qualified contractor(s).

Rooms: Moisture.

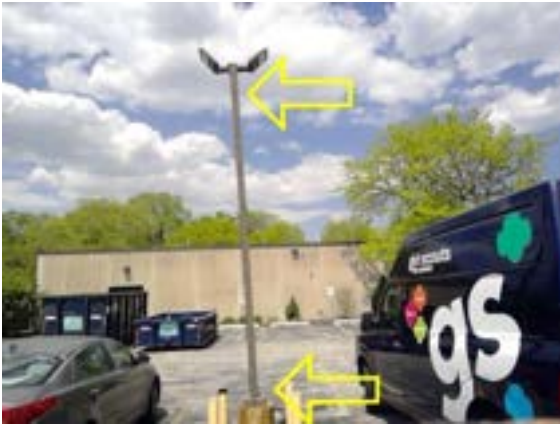
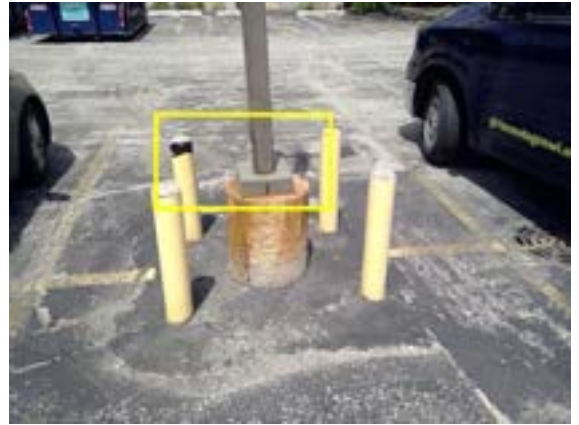
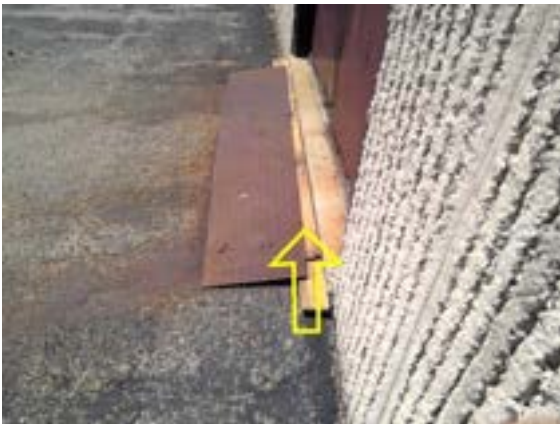
FAIR

Curbs cracked, light pole base loose, loose wood beneath metal by entrance, driveway has settled away from building.  
Recommend further evaluation/repair by qualified contractor(s).

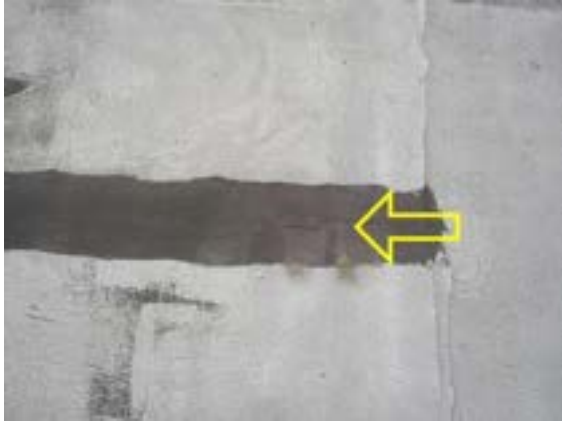
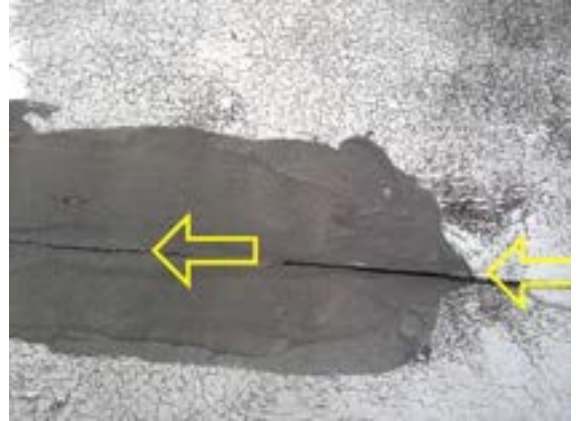
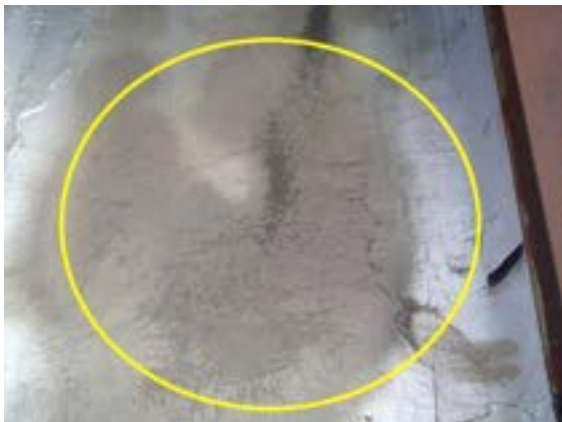
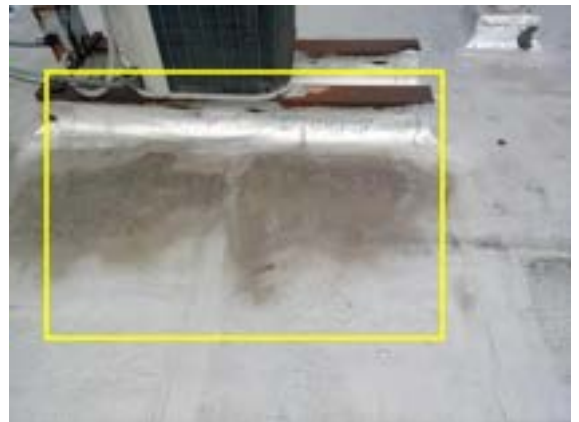
FAIR

Several cracked areas, ponding and previous repairs noted.  
Recommend further evaluation/repair by qualified roofing contractor(s).

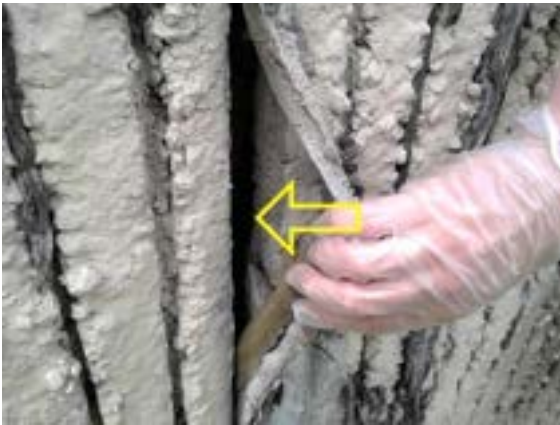
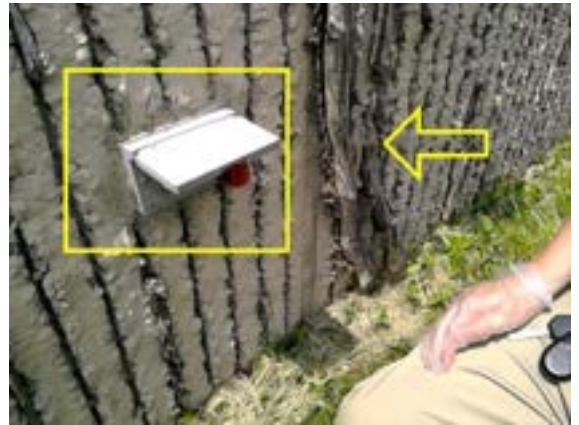
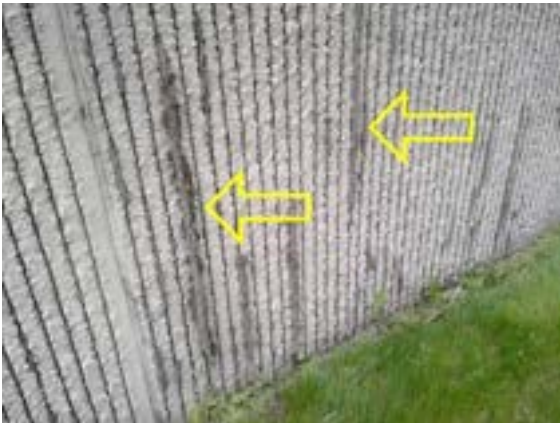
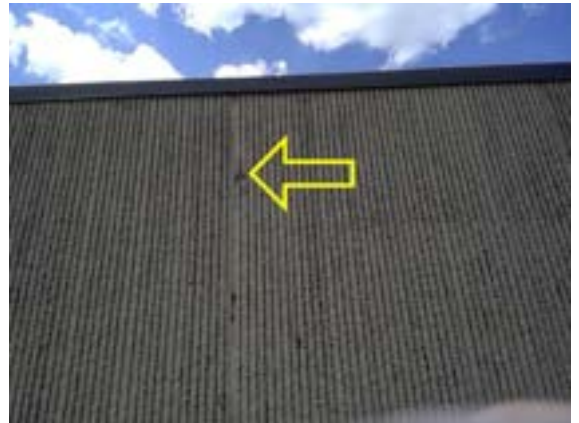
POOR

Several areas around building had loose/deteriorated seal, cracks or holes. Roots/vines stuck in siding.

All exterior outlets inoperable and GFCI did not trip under fault conditions.

All outlets did not have a weather cap that allows long term fixtures to be plugged in while cap is closed. Recommend replacing with a weather cap cover that accommodates plug.

Recommend further evaluation/repair by qualified electrician(s).

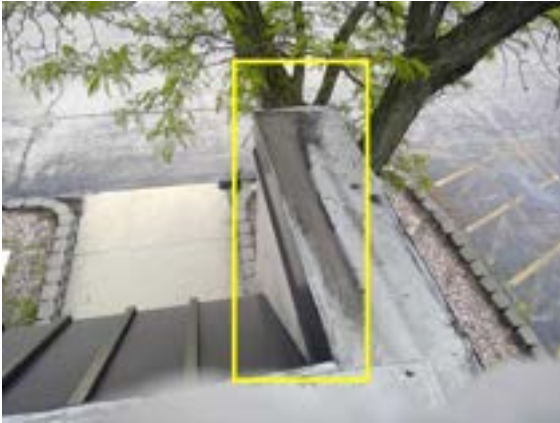
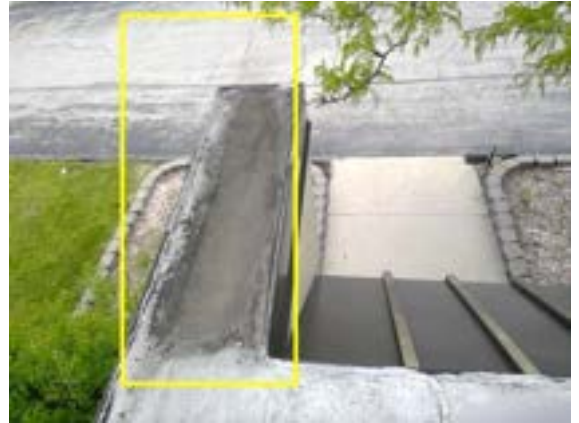
FAIR

Ponding/possible leaks above entrance and other areas.  
Recommend further evaluation/repair by qualified contractor(s).

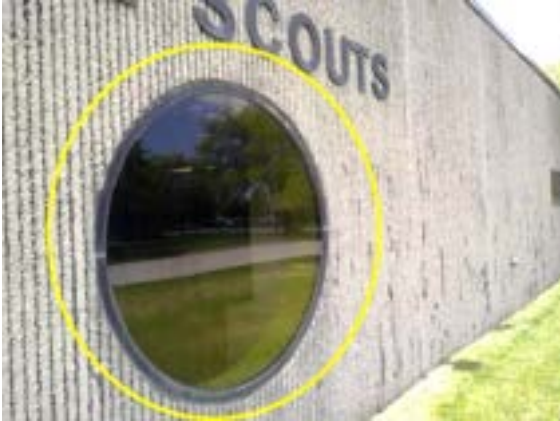
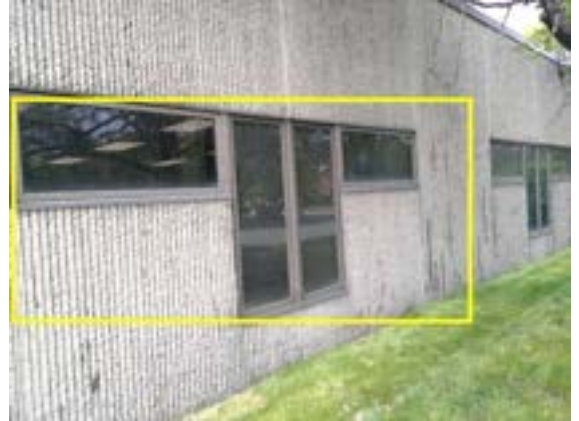
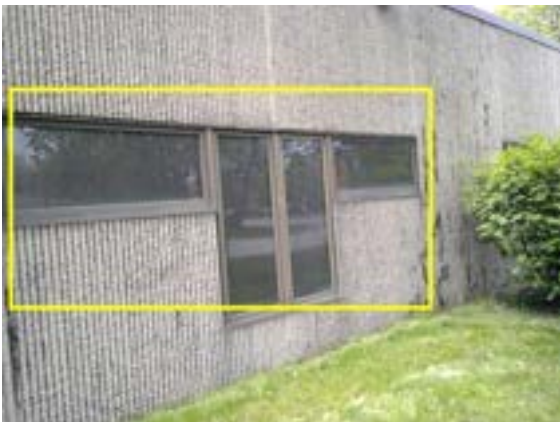
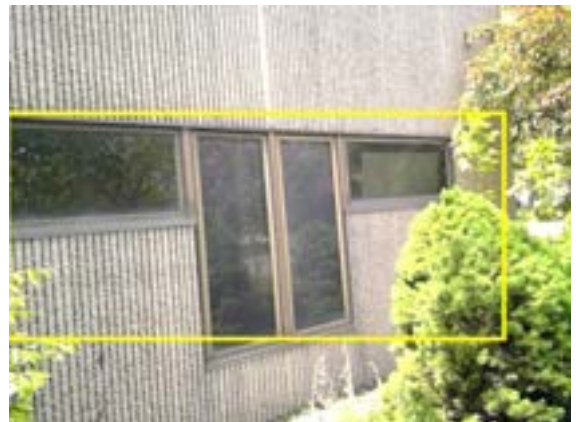
POOR

Most thermal windows around the building were fogged due to loss of thermal seal.  
Recommend further evaluation/repair by qualified window contractor(s).

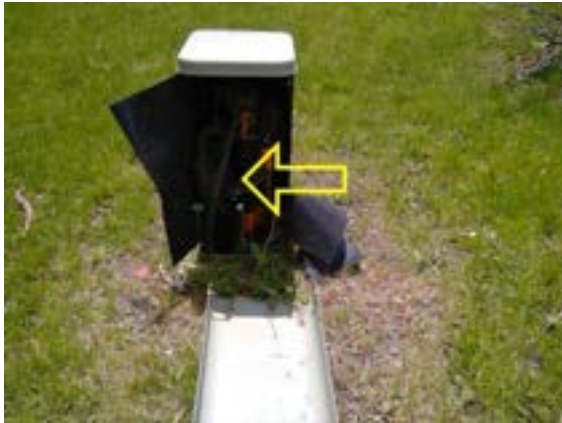
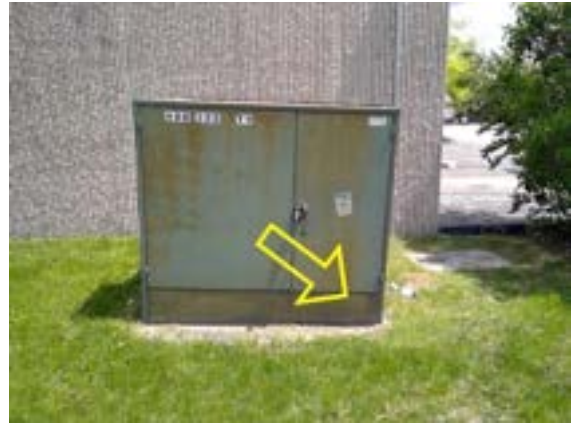
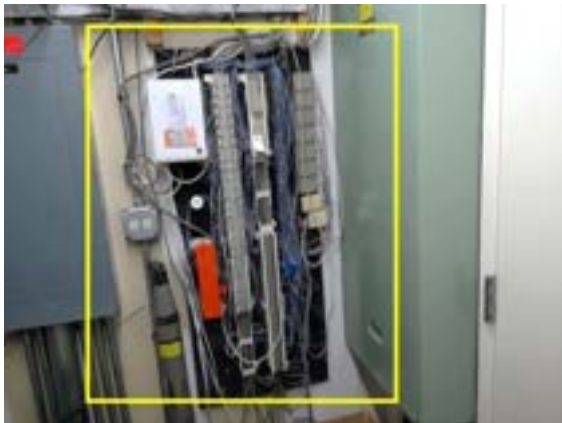
POOR

Exterior service exposed wires and cement settling.

Exposed wires interior.

Recommend further evaluation/repair by qualified electrical contractor(s).

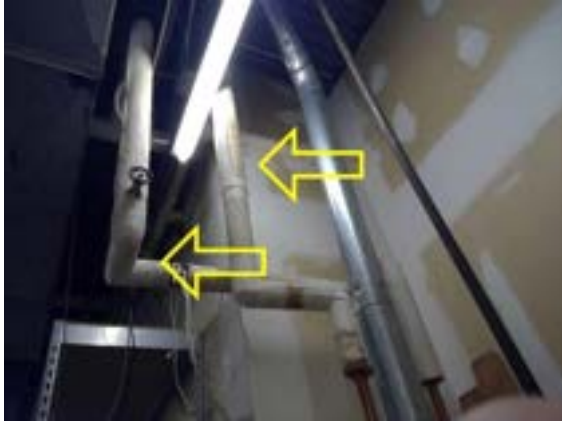
Possible asbestos pipes above water heater.  
Recommend further evaluation/repair by qualified contractor(s).

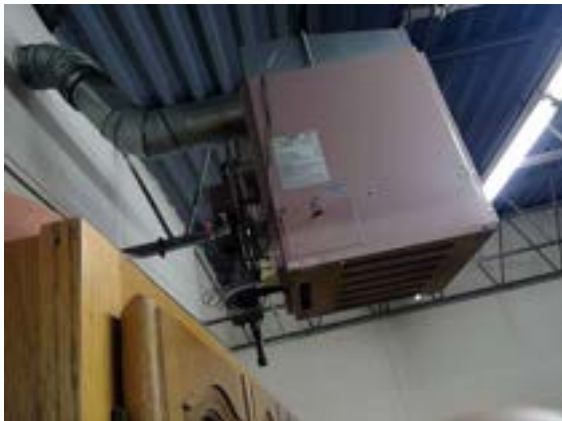
POOR

Unit inoperable.  
Recommend further evaluation/repair by qualified HVAC contractor(s).

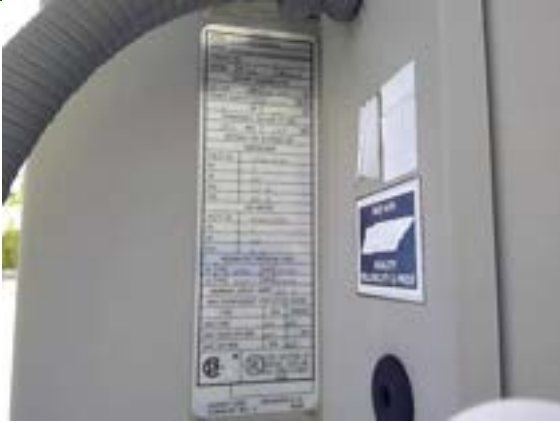
Rated fair due to age of unit. Budget for eventual replacement.

A/C unit should not be tested in cool mode with temperature below 65 degrees for fear of damaging compressor. Recommend checking when ambient air is warmer. The temperature splits could not be properly tested with the low temperatures, even if it was safe to operate.

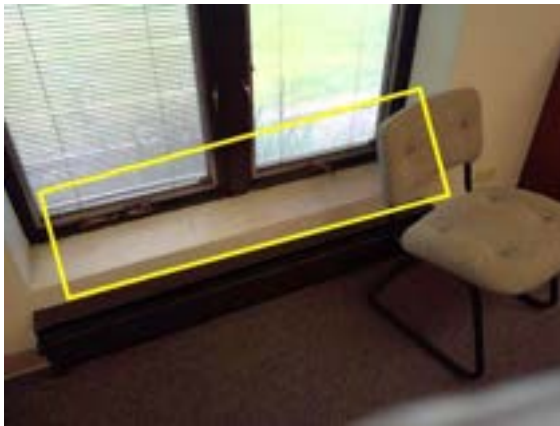
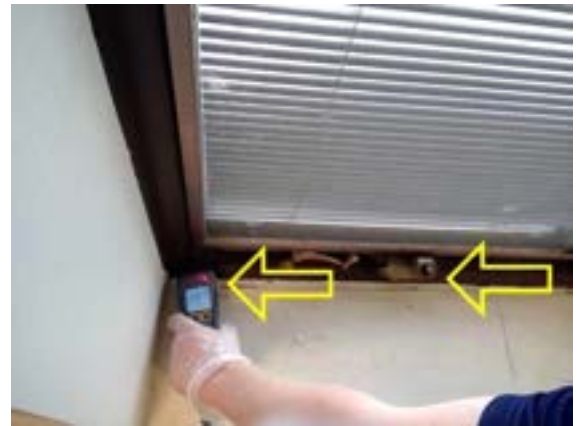
POOR

Peeling paint, inoperable windows and moisture present.  
Recommend further evaluation/repair by qualified contractor(s).

ROOMS: Moisture.
