**Property Inspections Plus, Inc. DBA
National Property Inspections**

Commercial Multi Family

Inspection Date:
10/02/2024

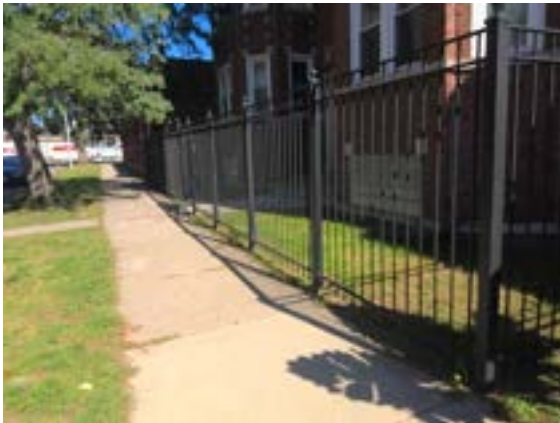
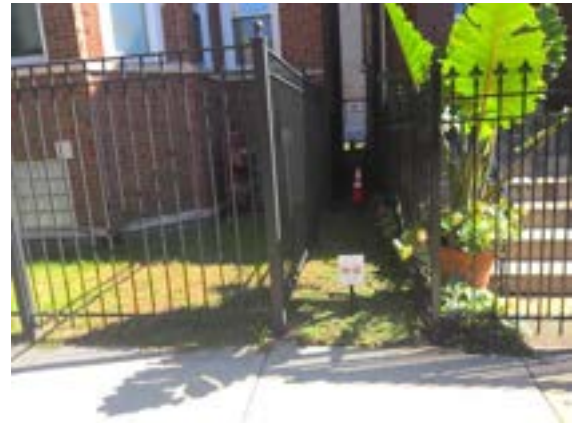
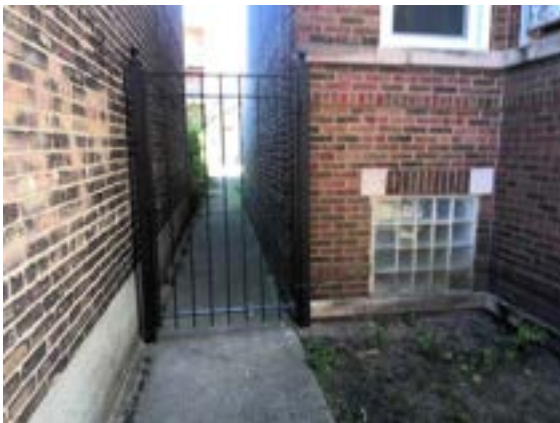
Appeared to be a positive or near level slope around the home.

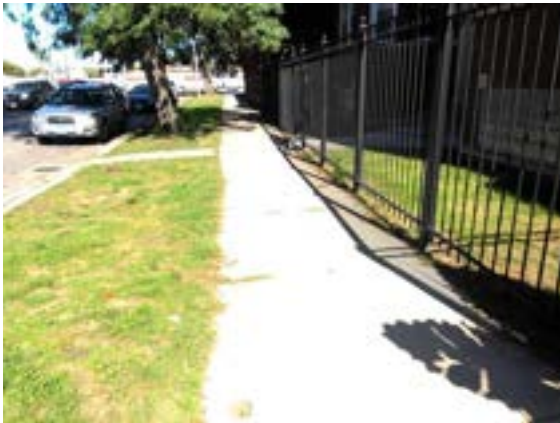
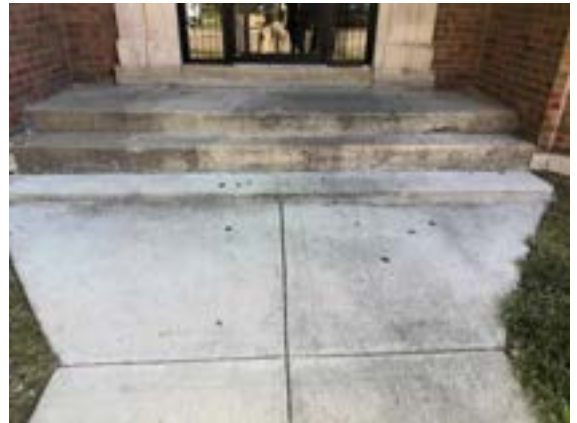
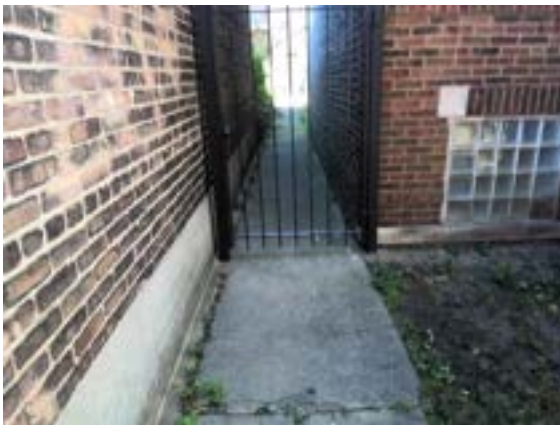
Walkways/steps to the property were in good condition at time of the inspection.

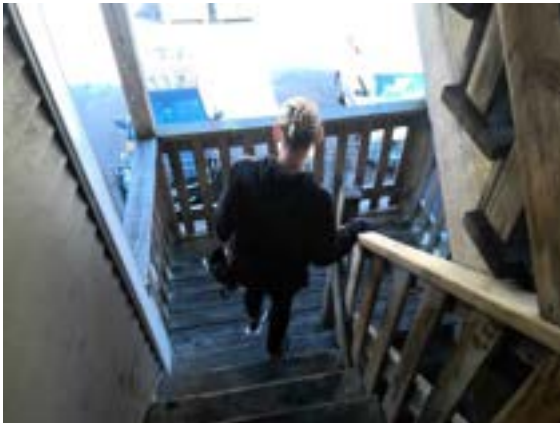
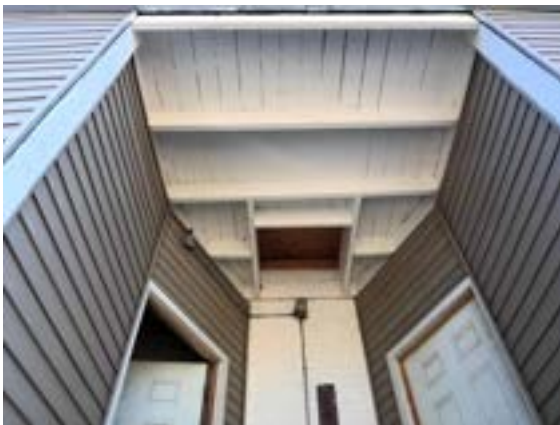
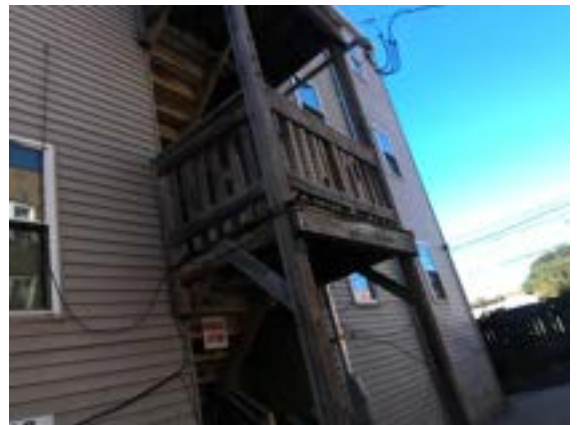
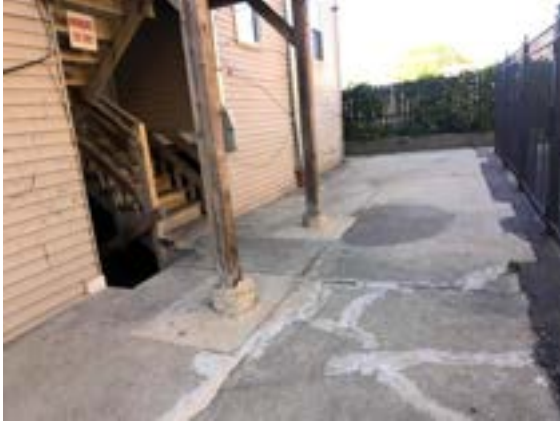
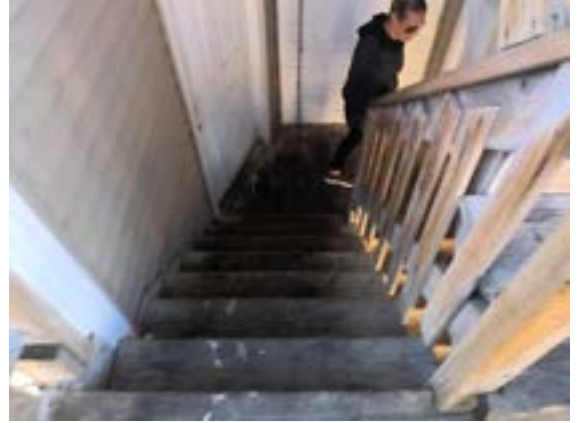
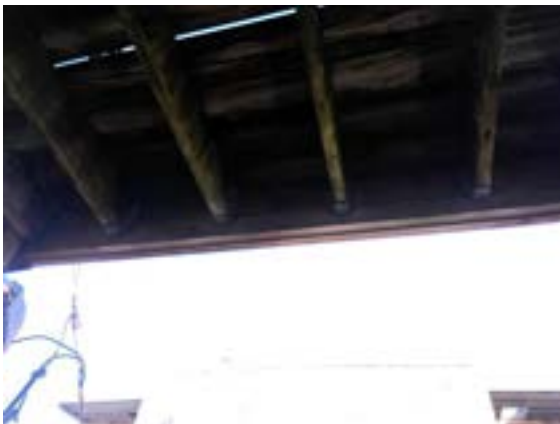
Deck/balcony and all related components appeared to be acceptable at time of inspection.

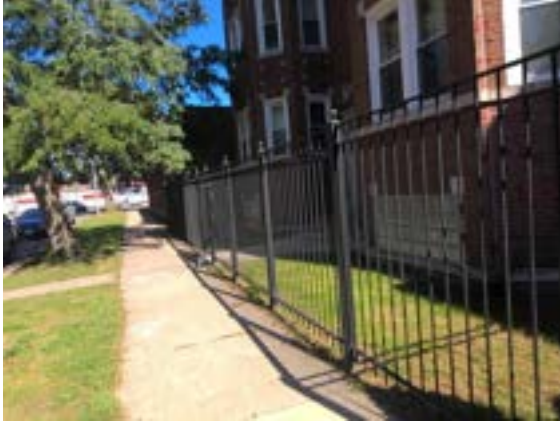
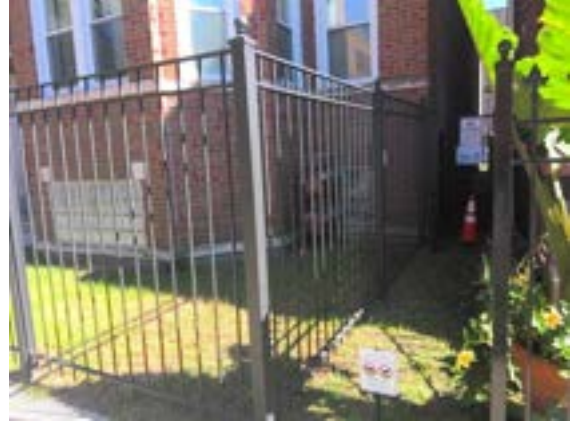
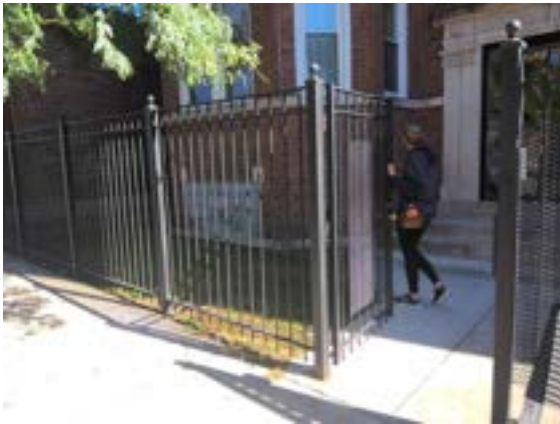
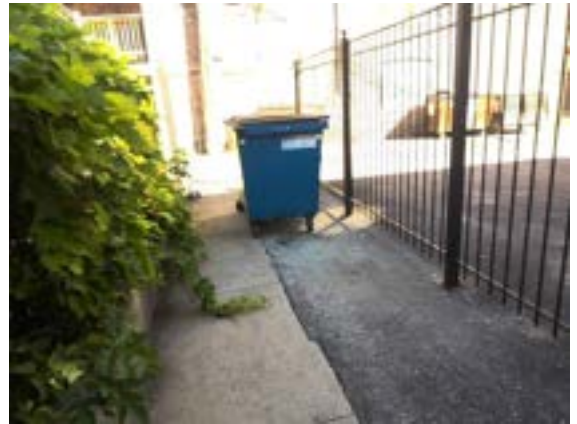
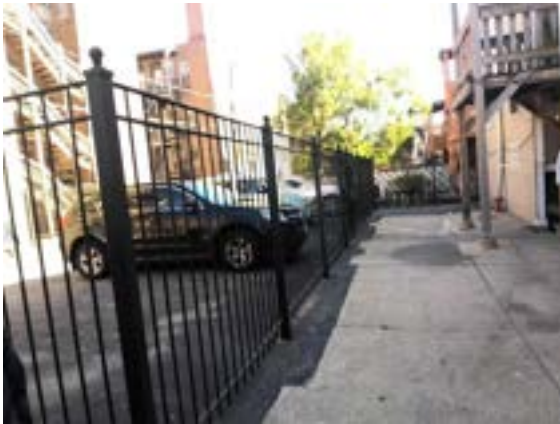
Fence(s) was in generally good condition with operational gate(s).

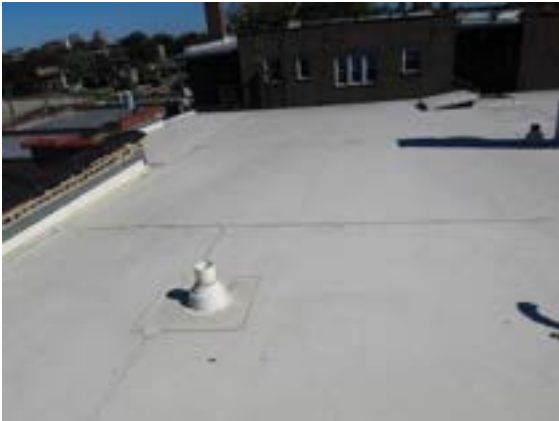
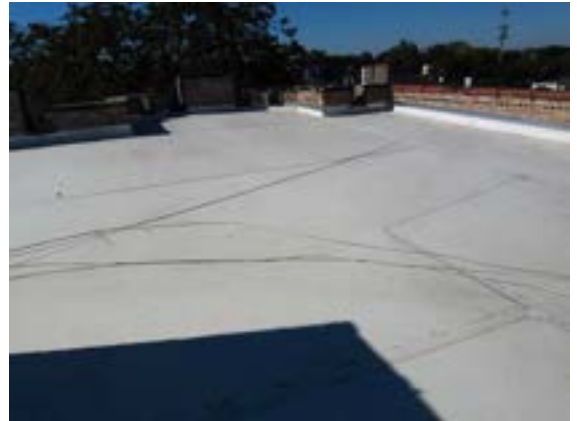
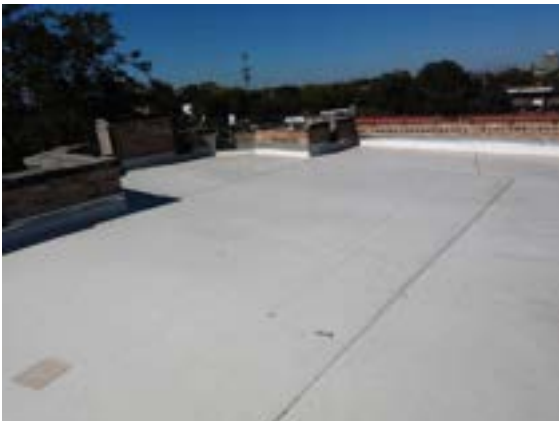
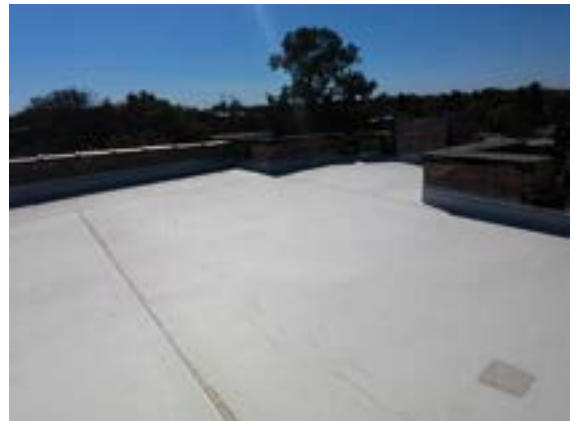
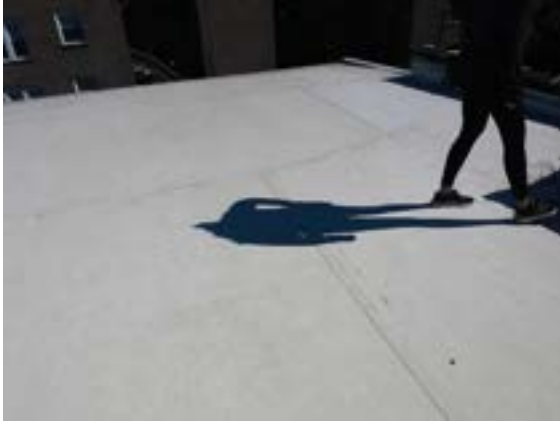
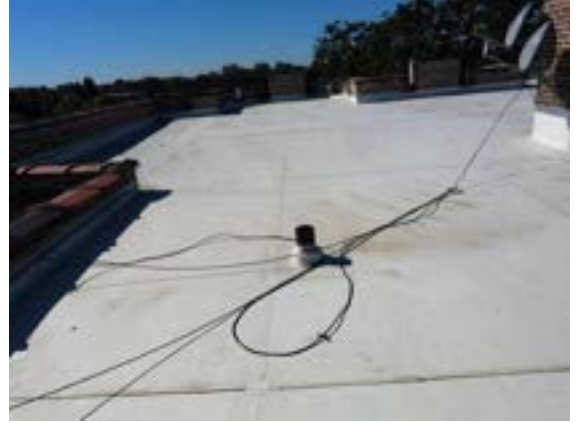
All visible roofing appeared acceptable at time of inspection.

Leaks not always detectable.

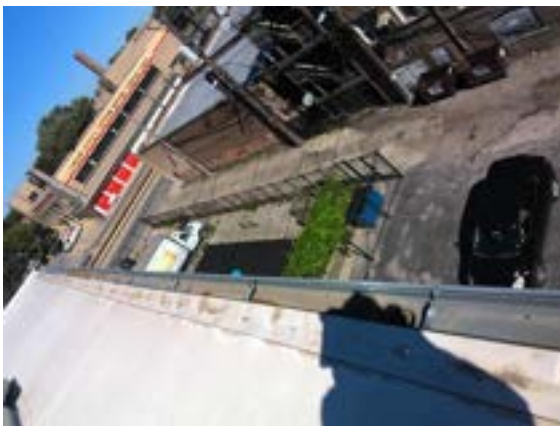
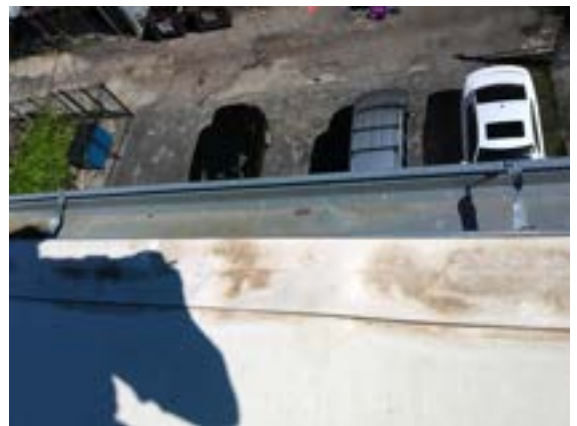
All visible gutters were in acceptable condition.

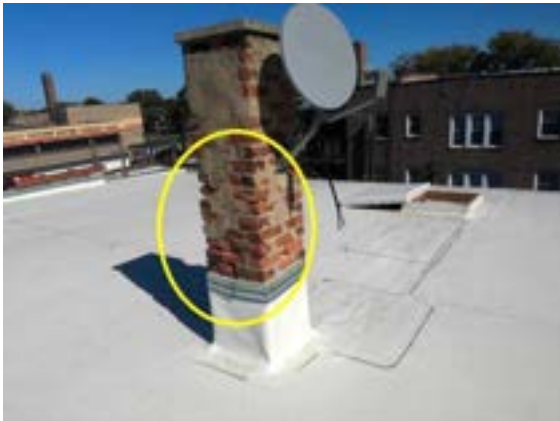
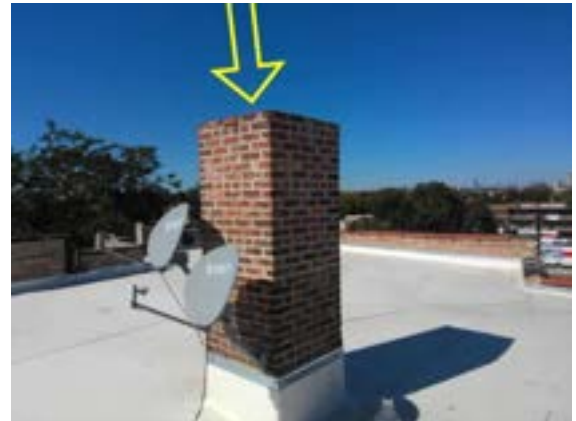
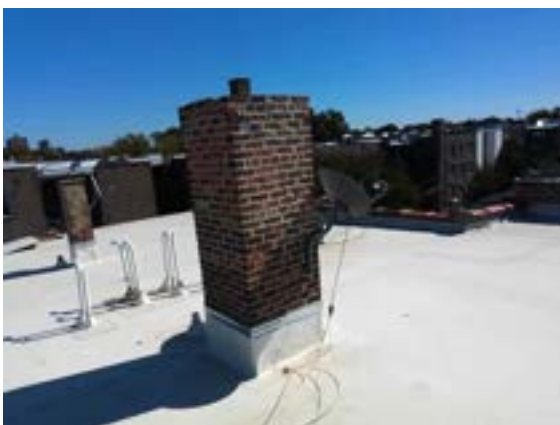
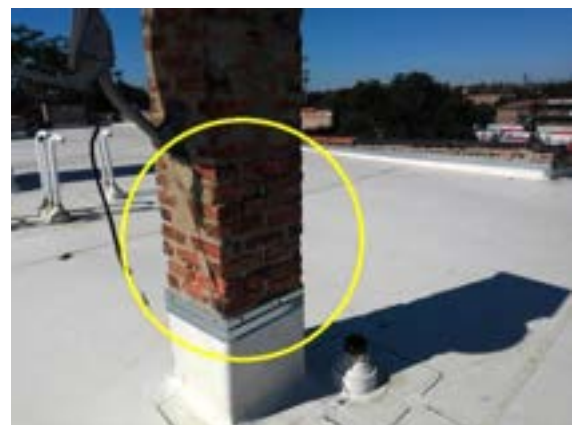
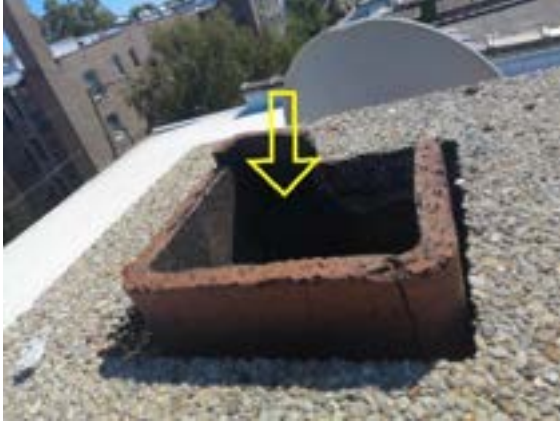
Chimneys (2) had no cap/spark arrestor to prevent water from entering chimney and spark retention if chimney was used for a wood burning.

Deteriorated brick/mortar noted on chimney.

Flue not inspected. Annual cleaning is recommended.

Recommend further evaluation/repair by qualified contractor(s).

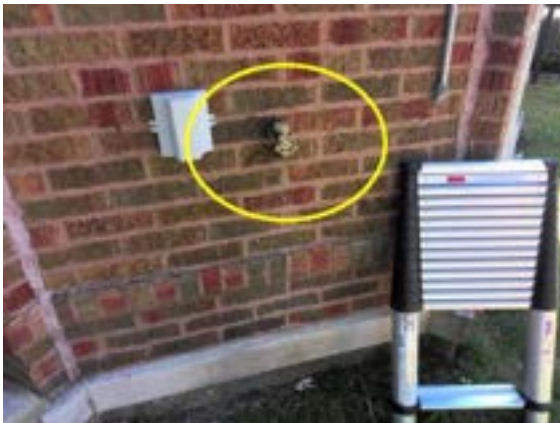
Exterior Surface:

Faucet inoperative front.

Recommend further evaluation/repair by qualified contractor(s).

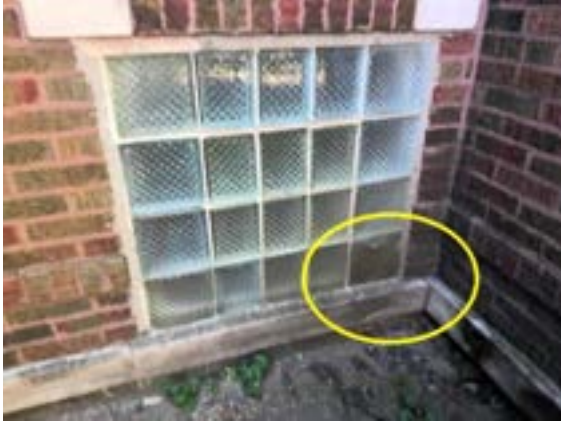
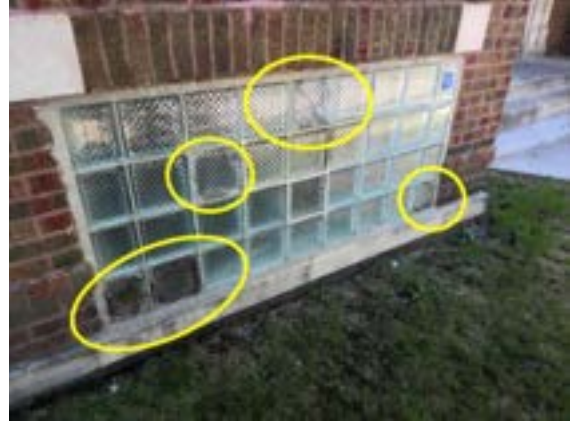
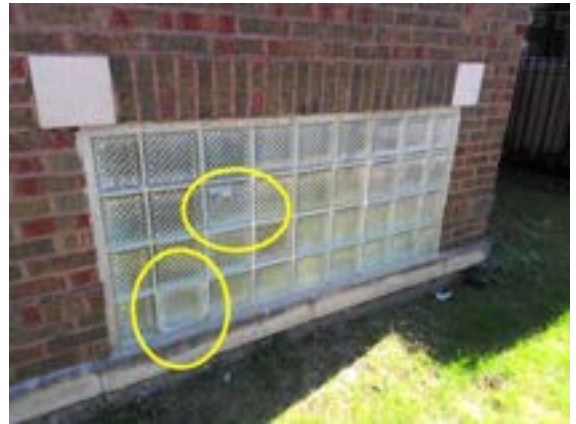
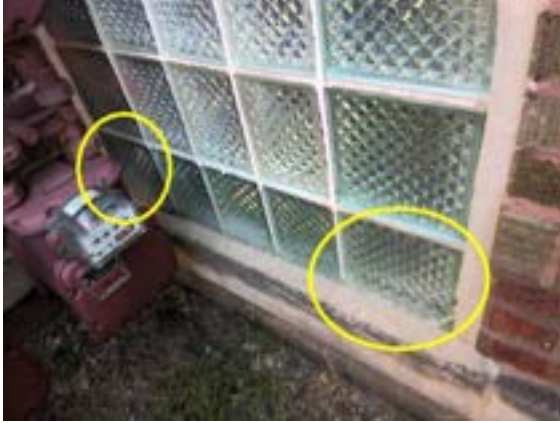
Cracked block windows noted.

Fenestration Systems: cracked front

Recommend further evaluation/repair by qualified contractor(s).

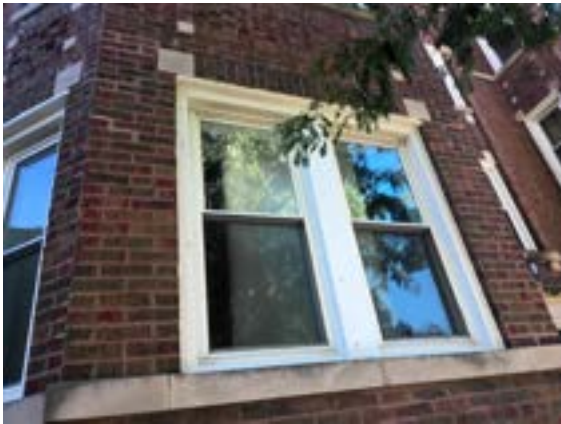
Fenestration Systems:

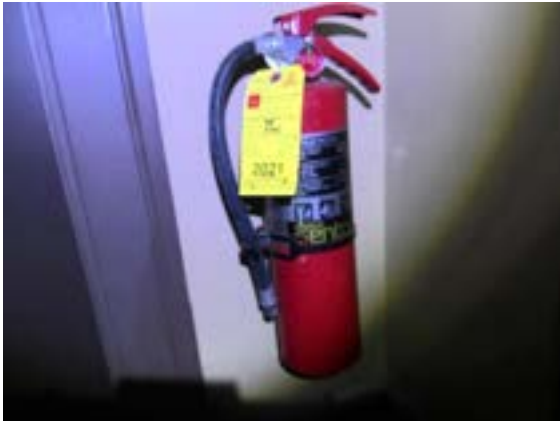
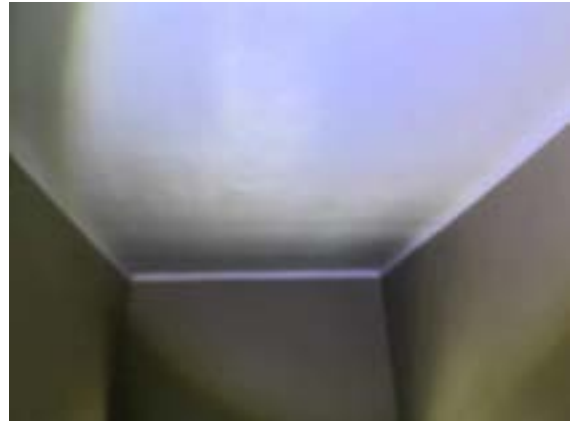
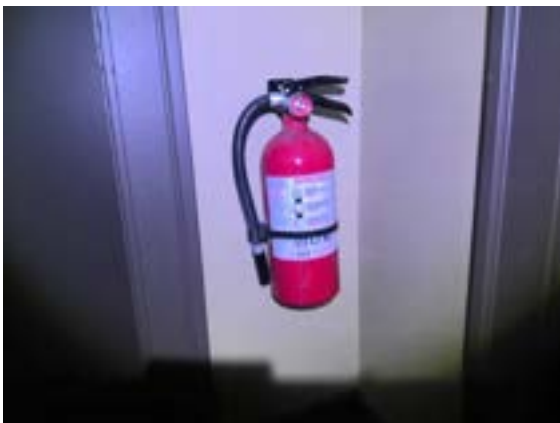
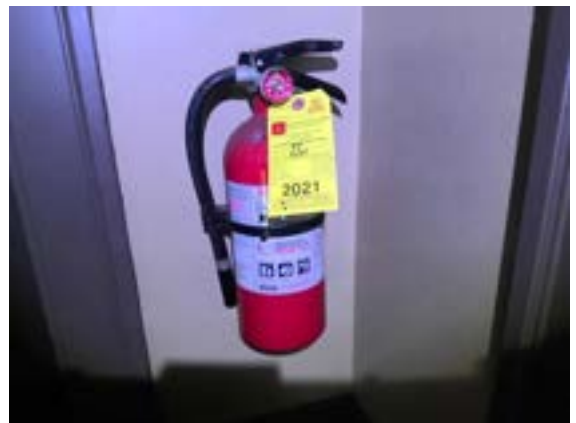
Leaks not always detectable.

Recommend further evaluation/repair by qualified contractor(s).

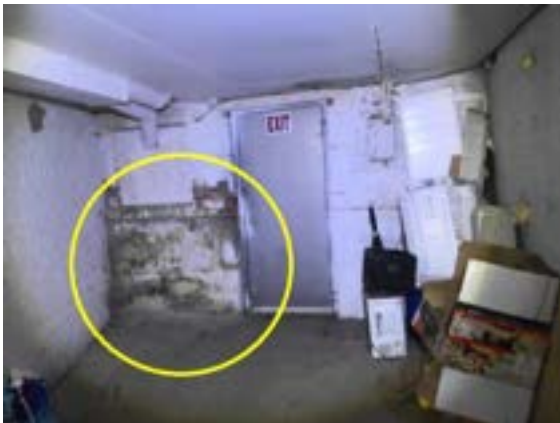
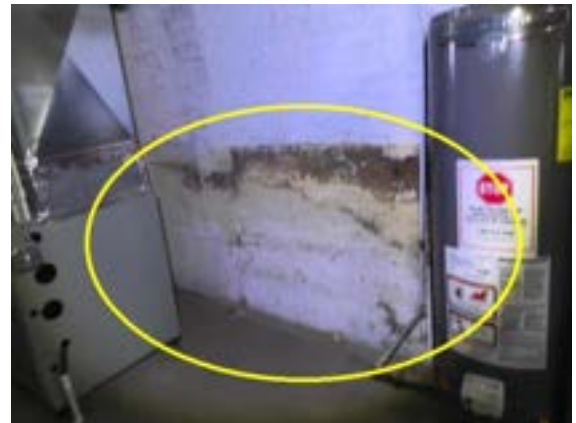
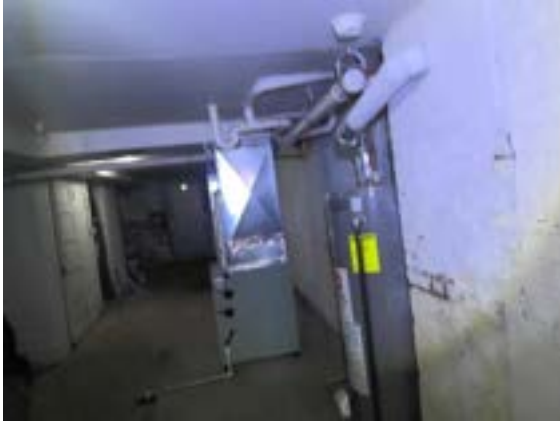
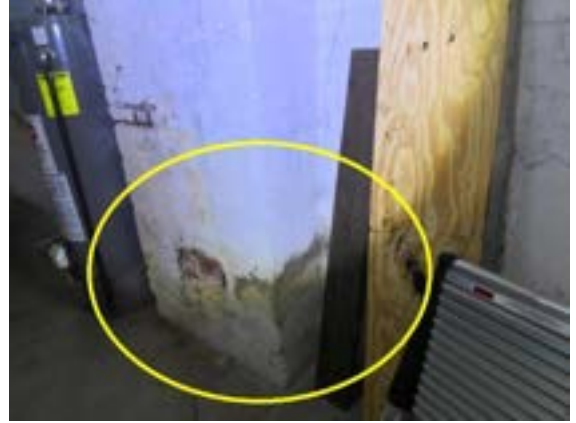
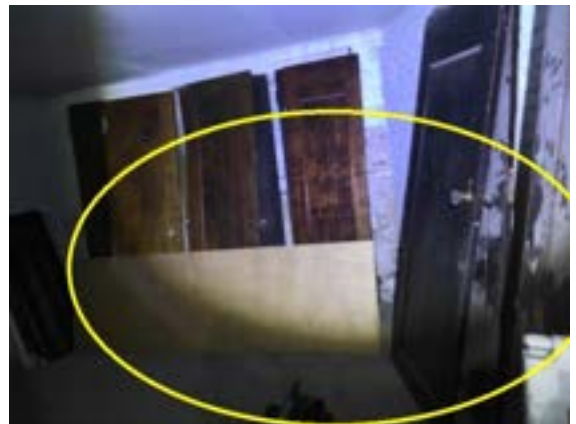
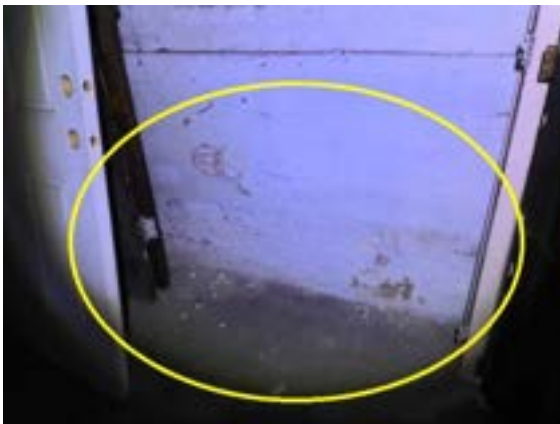
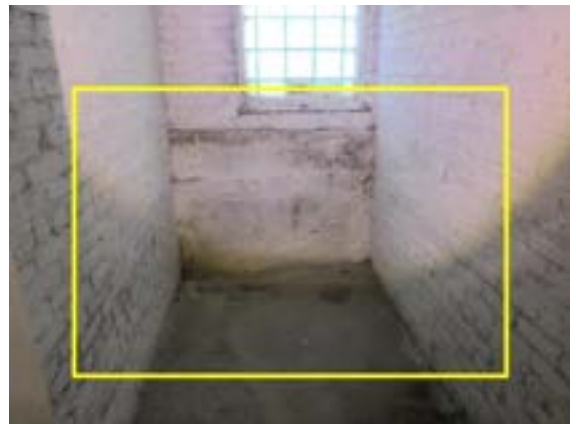
Efflorescence along foundation wall(s). Efflorescence is a powdery deposit of salts which forms on the surface of bricks and mortar. It is usually caused by water intrusion.

Possible "mold like" growth noted.

Open junction boxes noted.

Recommend further evaluation/repair by qualified contractor(s).

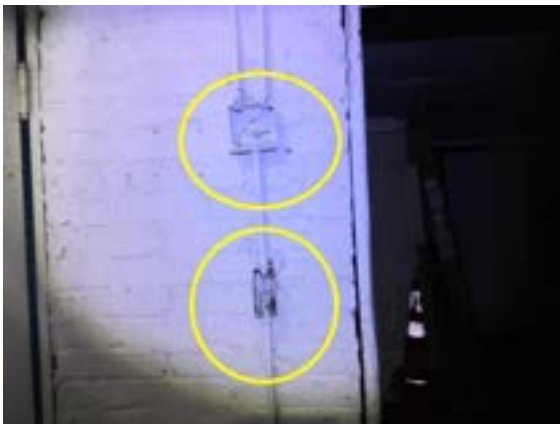
Interior Foundation Left: open junction boxes

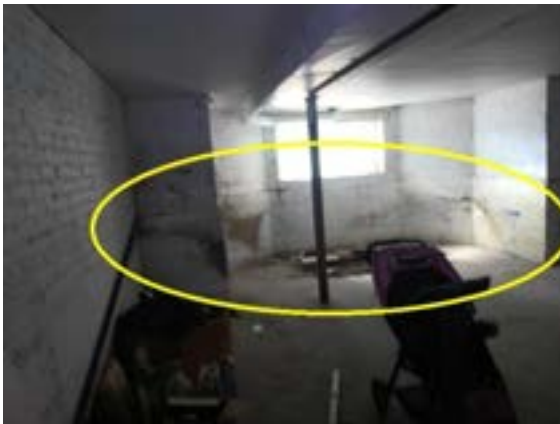
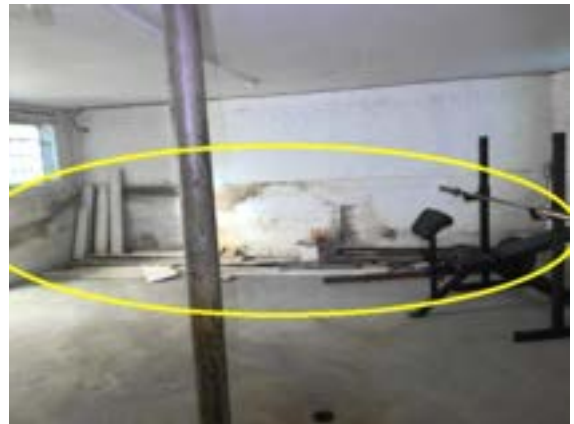
Efflorescence along foundation wall(s). Efflorescence is a powdery deposit of salts which forms on the surface of bricks and mortar. It is usually caused by water intrusion.

Possible "mold like" growth noted.

Open junction box noted.

Recommend further evaluation/repair by qualified contractor(s).

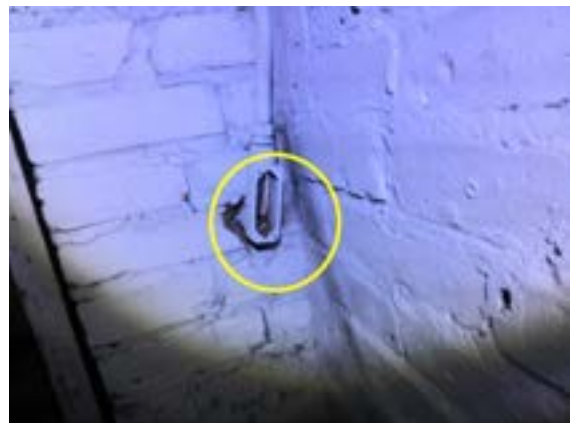
Interior Foundation Left: exposed wires

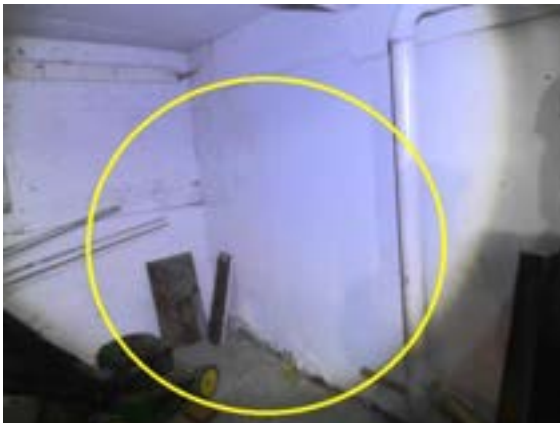
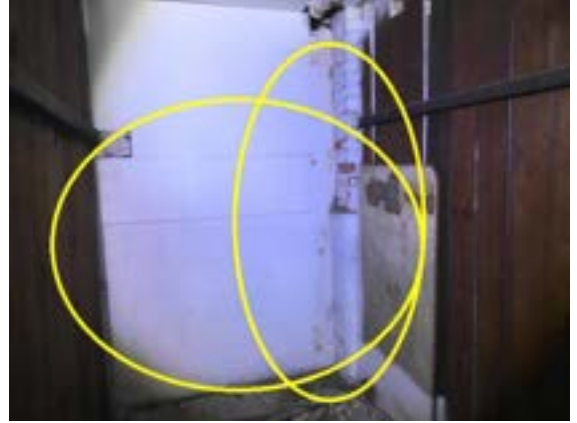
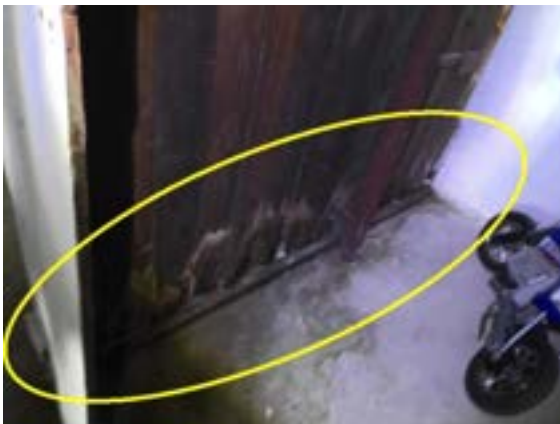
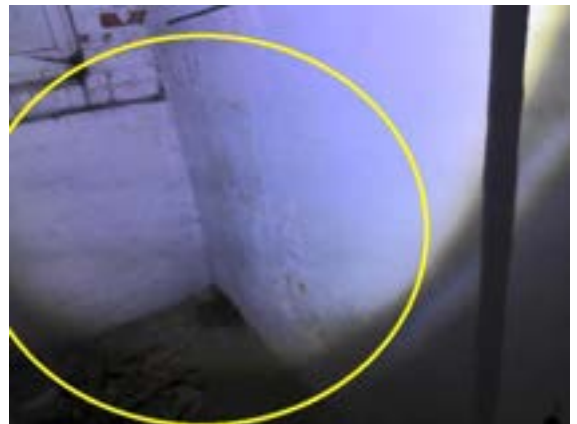
Efflorescence (E) along foundation wall(s). Efflorescence is a powdery deposit of salts which forms on the surface of bricks and mortar. It is usually caused by water intrusion.

Possible "mold like" growth noted.

Interior Foundation Right: mold/moisture

Recommend further evaluation/repair by qualified contractor(s).

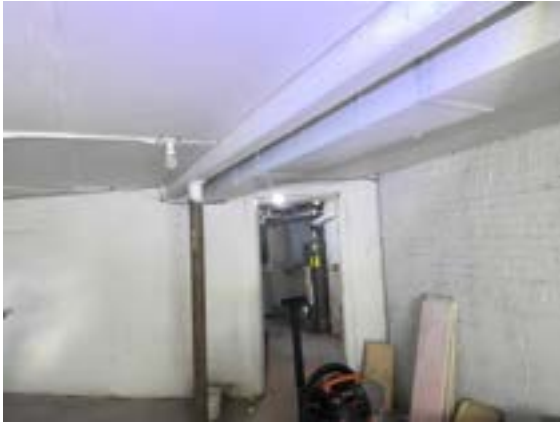
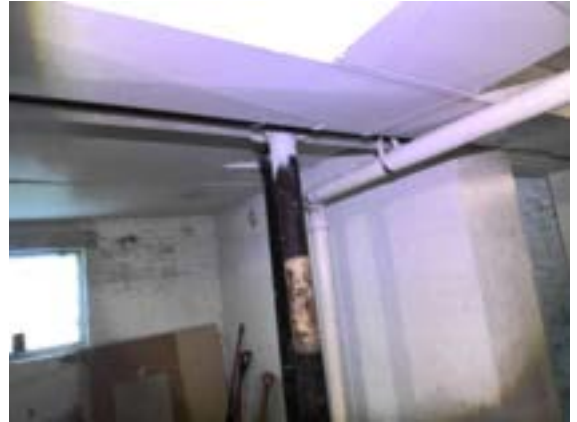
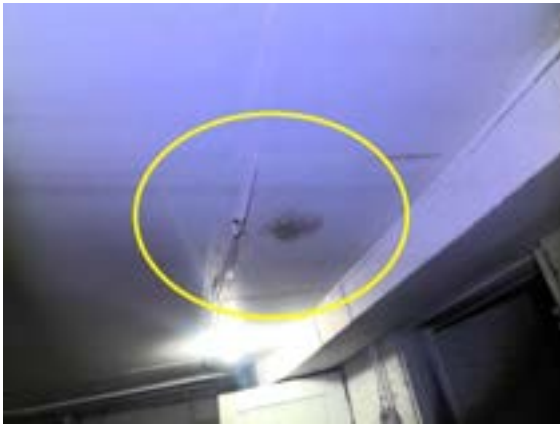
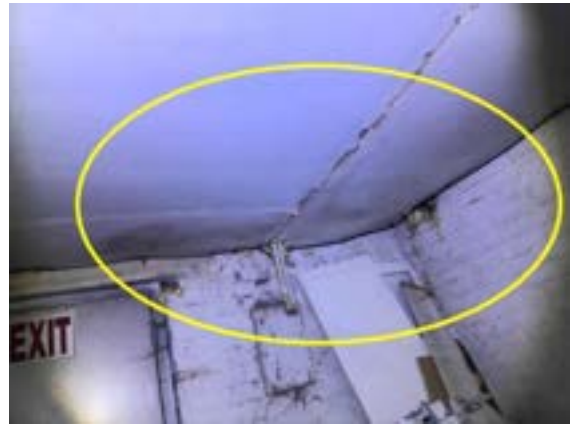
Possible "mold type" growth noted.

Recommend further evaluation/repair by qualified contractor(s).

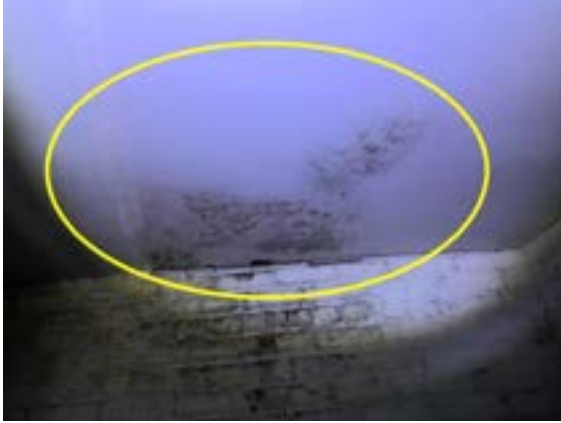
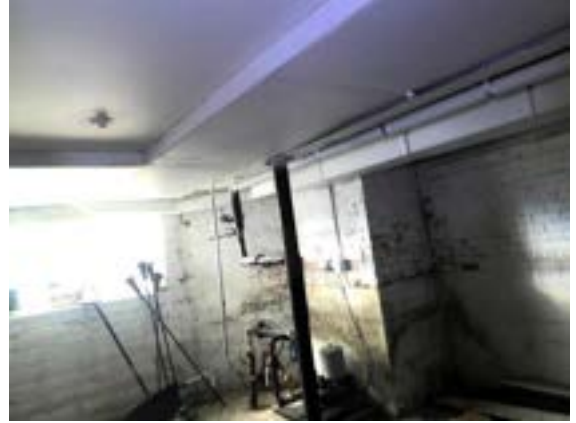
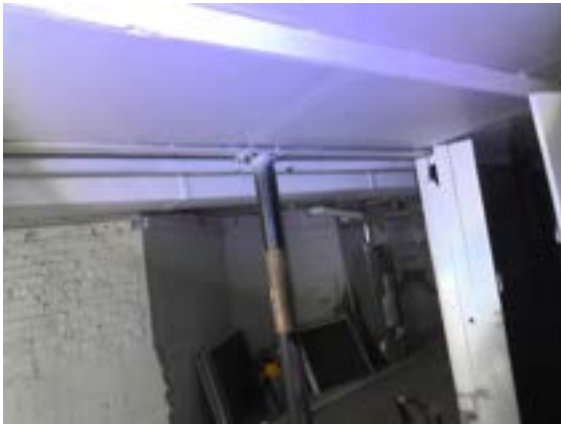
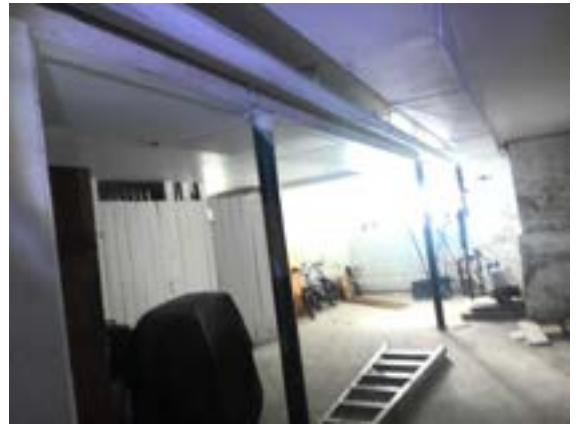
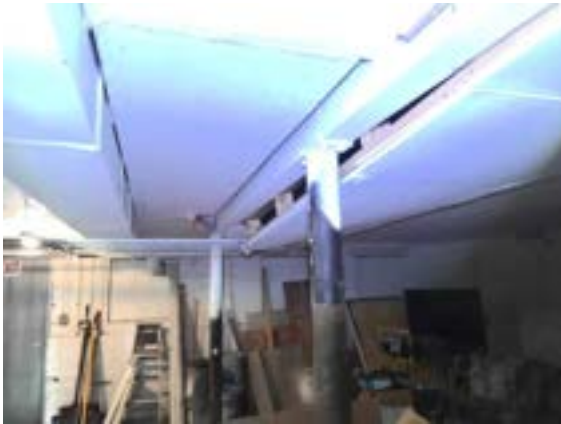
Possible "mold type" growth noted.

Recommend further evaluation/repair by qualified contractor(s).

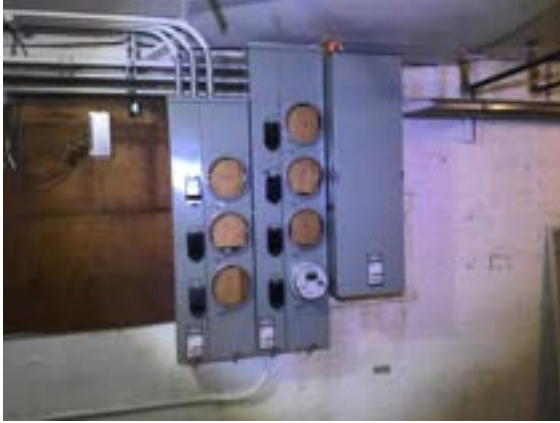
Electrical Building: not completed

Recommend further evaluation/repair by qualified electrical contractor(s).

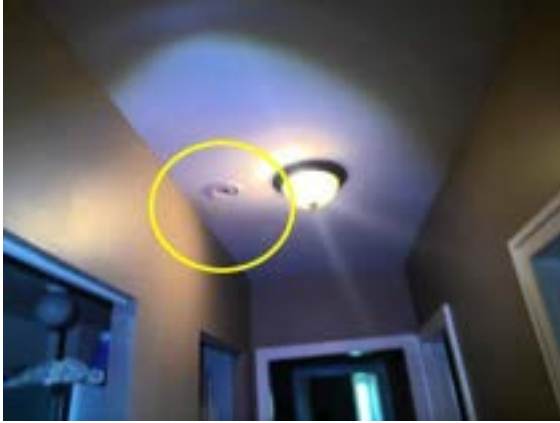
Electrical Unit 3:

Smoke/CO detector missing.

Recommend further evaluation/repair by qualified electrical contractor(s).

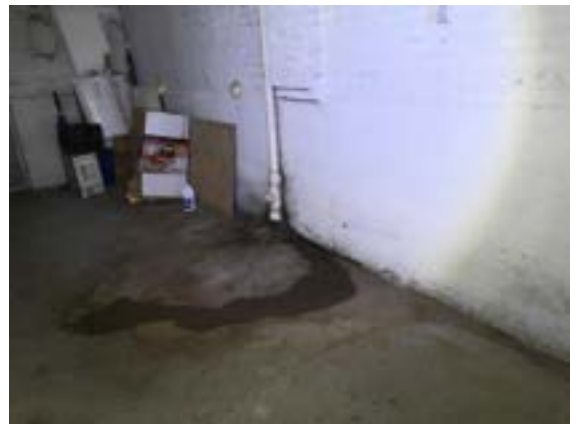
Active leak noted left.

Plumbing Building Left: active leak

Recommend further evaluation/repair by qualified contractor(s).

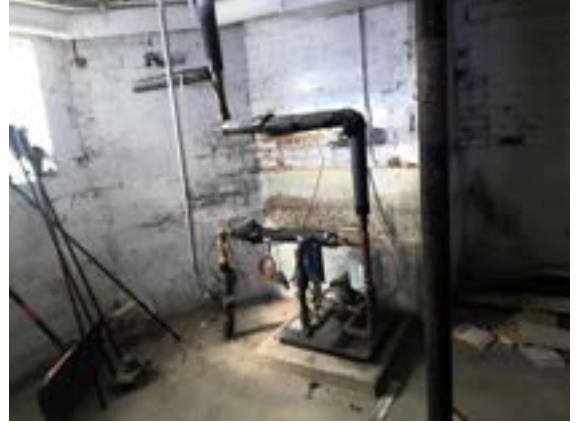
Plumbing Building Left: pump, not turned on or used

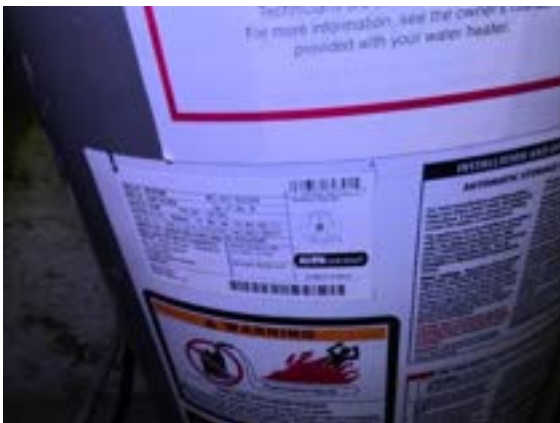
Water Heater Unit 1:

The operation and installation of the water heater appeared to be satisfactory at time of inspection. Routine maintenance such as draining the water heater could prolong its lifespan. Always refer to manufactures' specifications before doing any maintenance on your water heater.

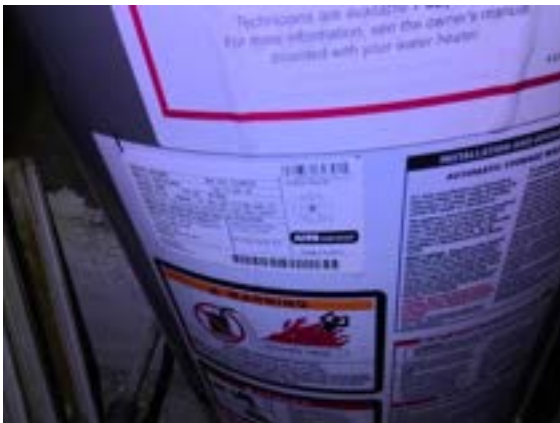
Water Heater Unit 2:

The operation and installation of the water heater appeared to be satisfactory at time of inspection. Routine maintenance such as draining the water heater could prolong its lifespan. Always refer to manufactures' specifications before doing any maintenance on your water heater.

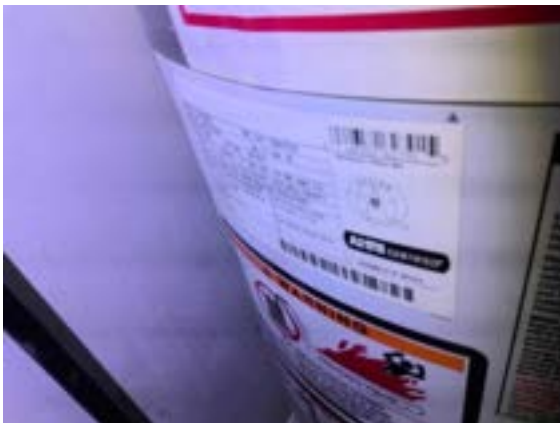
Water Heater Unit 3:

The operation and installation of the water heater appeared to be satisfactory at time of inspection. Routine maintenance such as draining the water heater could prolong its lifespan. Always refer to manufactures' specifications before doing any maintenance on your water heater.

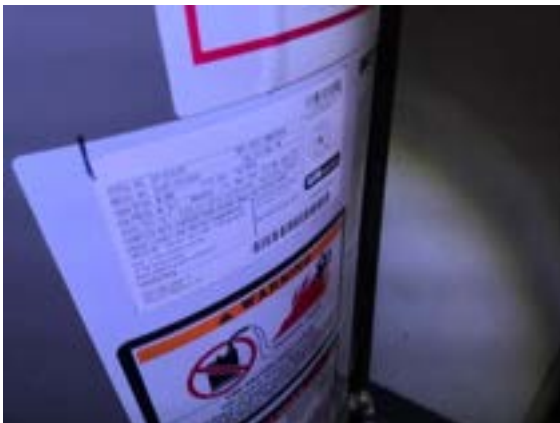
Water Heater Unit 4:

The operation and installation of the water heater appeared to be satisfactory at time of inspection. Routine maintenance such as draining the water heater could prolong its lifespan. Always refer to manufactures' specifications before doing any maintenance on your water heater.

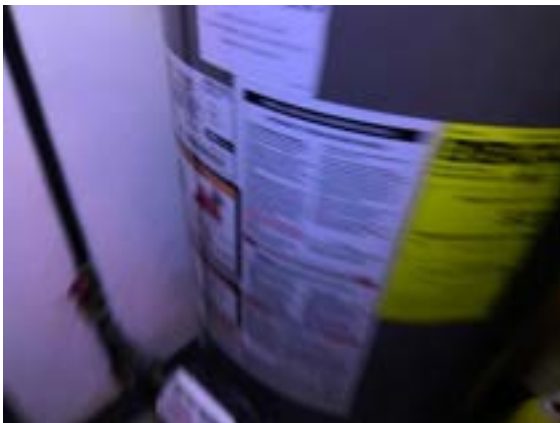
Water Heater Unit 5:

The operation and installation of the water heater appeared to be satisfactory at time of inspection. Routine maintenance such as draining the water heater could prolong its lifespan. Always refer to manufactures' specifications before doing any maintenance on your water heater.

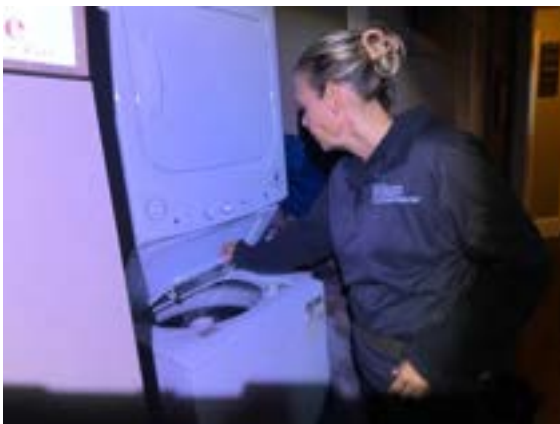
Laundry Facilities 1:

Washer and dryer were a stacked unit which makes the plumbing and electrical connection(s) inaccessible.

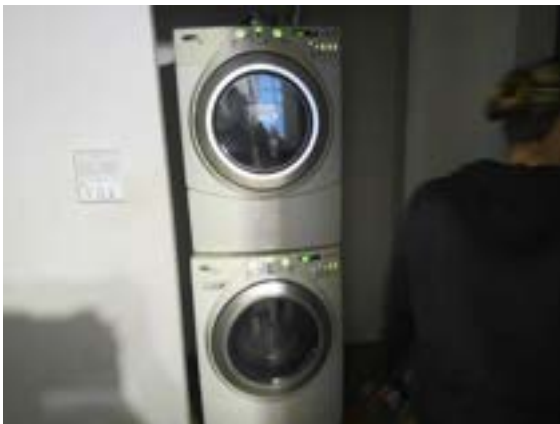
Laundry Facilities 2:

Washer and dryer were a stacked unit which makes the plumbing and electrical connection(s) inaccessible.

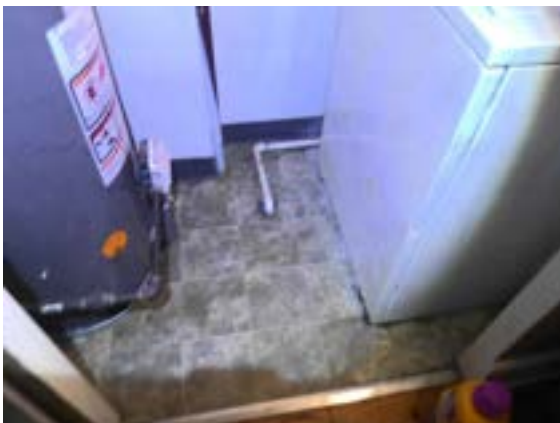
Laundry Facilities 4:

Washer and dryer were a stacked unit which makes the plumbing and electrical connection(s) inaccessible.

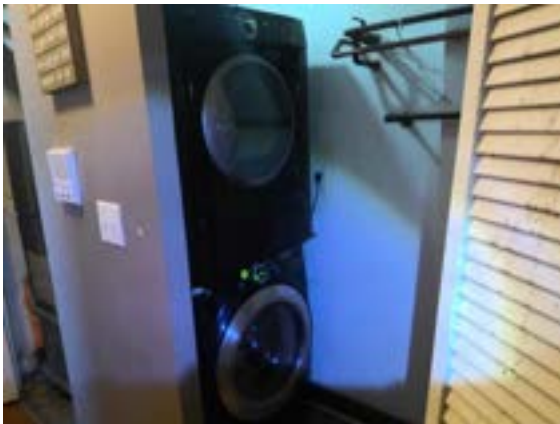
Laundry Facilities 5:

Washer and dryer were a stacked unit which makes the plumbing and electrical connection(s) inaccessible.

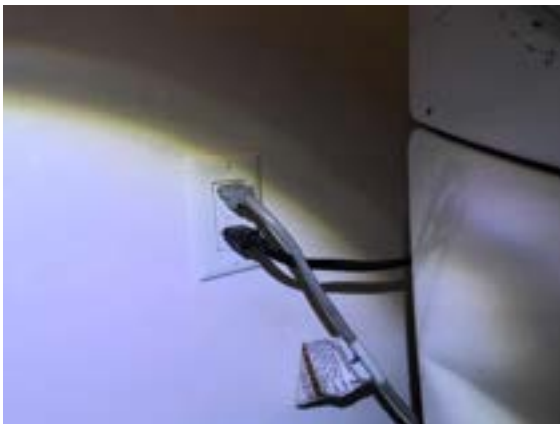
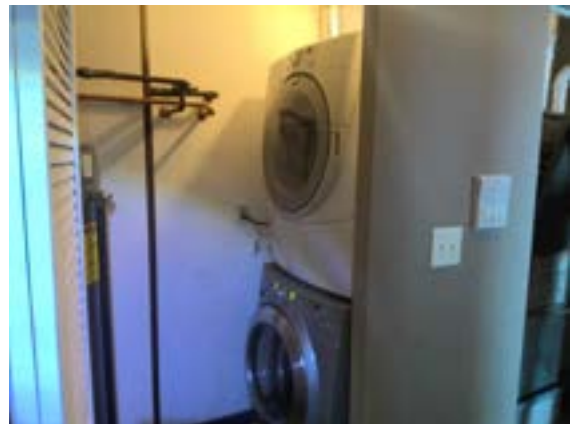
Laundry Facilities 6:

Washer and dryer were a stacked unit which makes the plumbing and electrical connection(s) inaccessible.

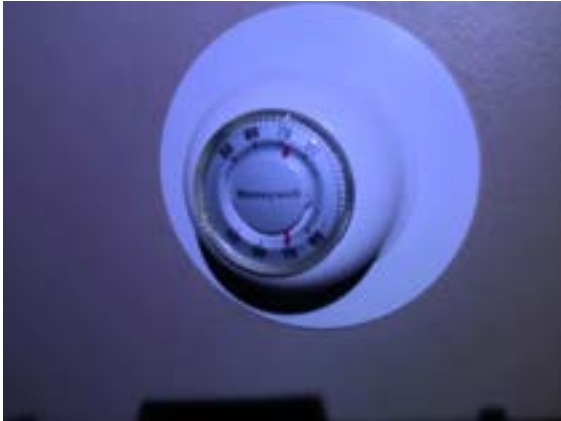
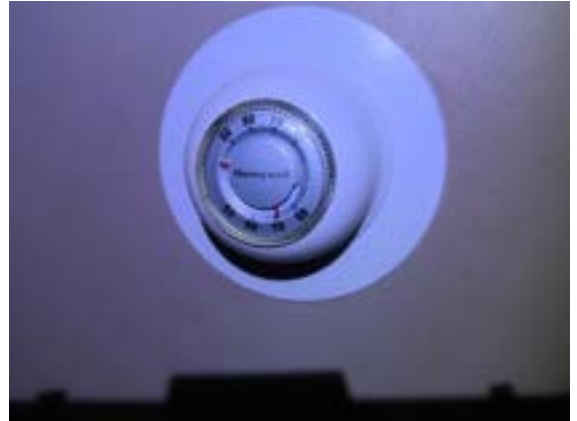
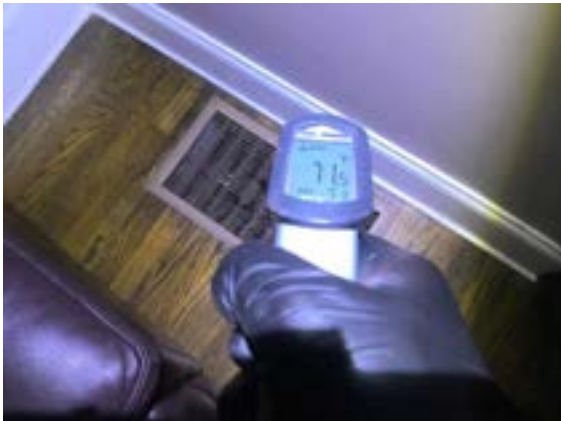
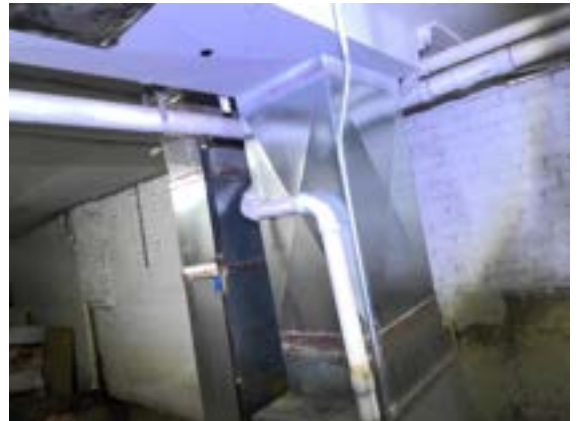
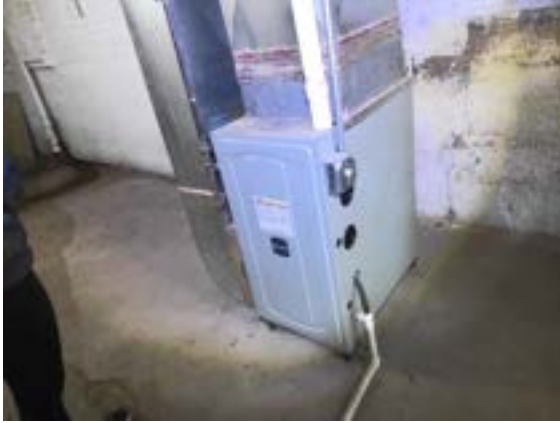
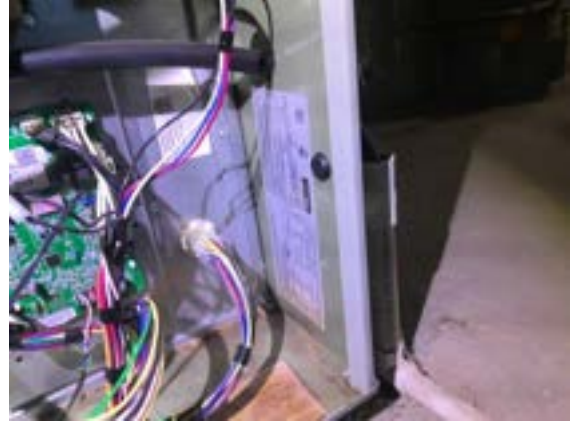
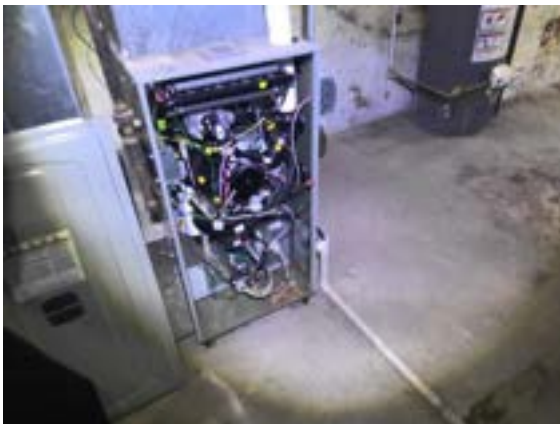
Heating Unit 1:

Furnace was running properly at time of inspection. Heat distribution was acceptable with no problems to report. It is important that the furnace be properly maintained for efficiency and greater life span. Recommend a yearly maintenance program be set up with a local heating company to service and clean the furnace. This could greatly improve the life span of unit.

Heat Exchanger - Unable to detect cracks/holes without dismantling unit.
