**Property Inspections Plus, Inc. DBA
National Property Inspections**

Commercial Multi Family

Inspection Date:
10/02/2024

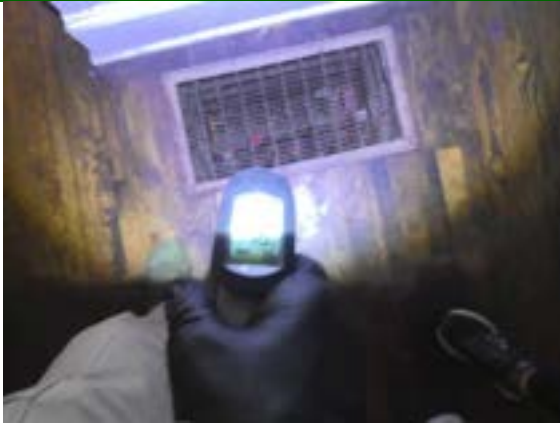
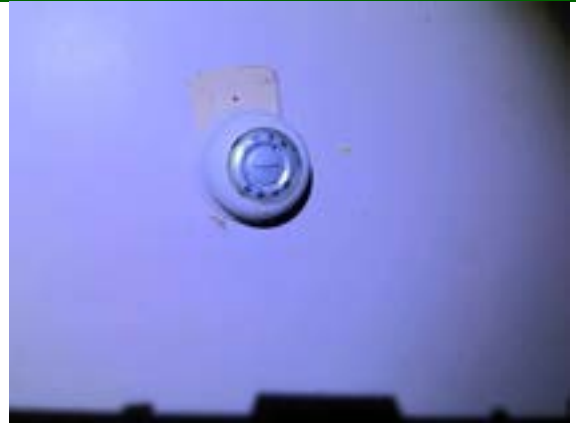
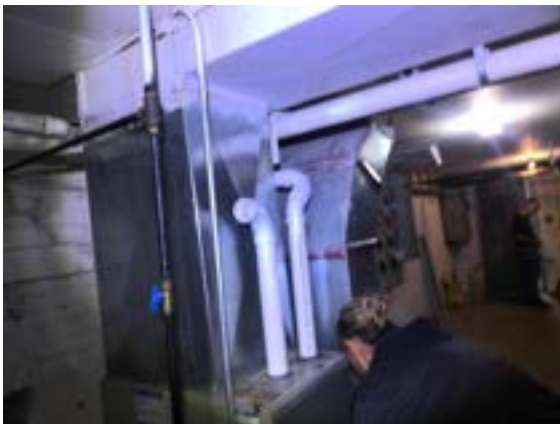
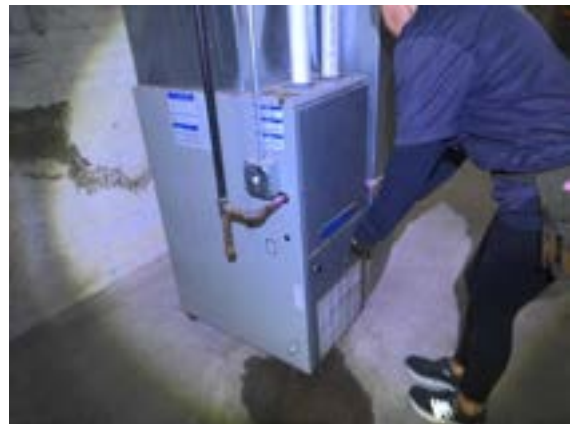
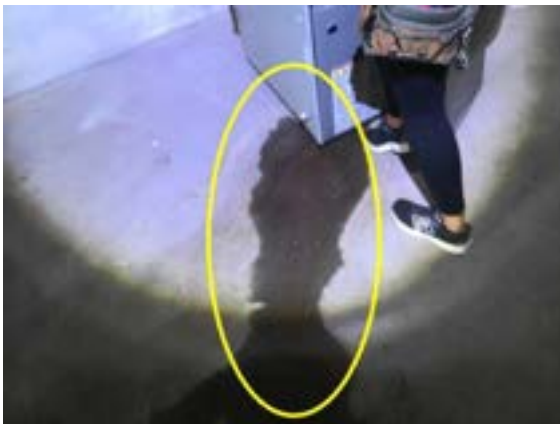
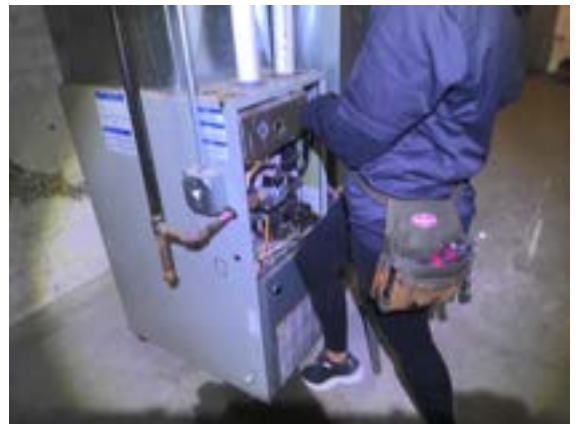
Heating Unit 2:

Condensation line missing.

Recommend further evaluation/repair by qualified contractor(s).

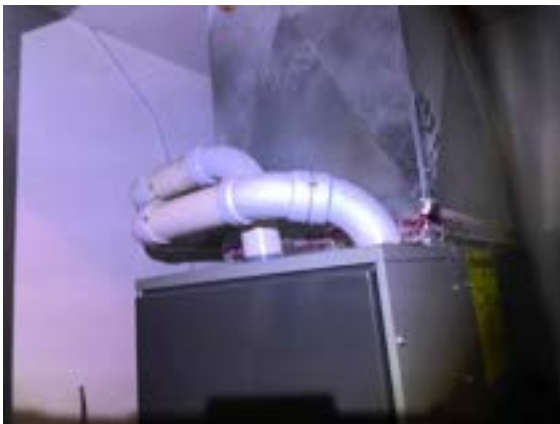
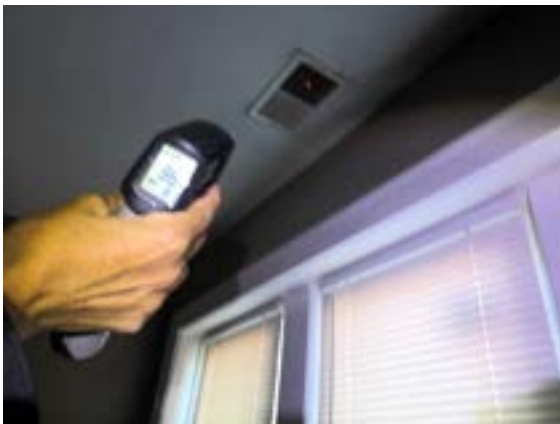
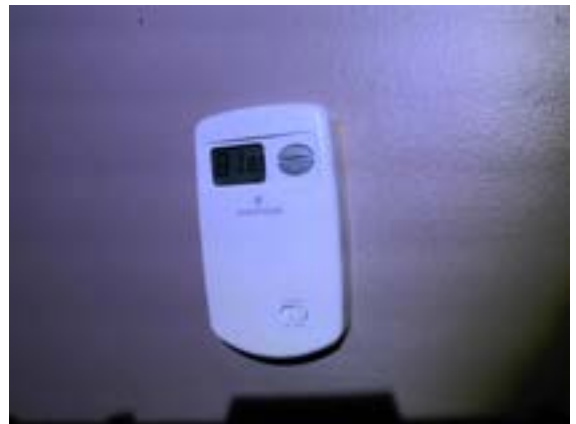
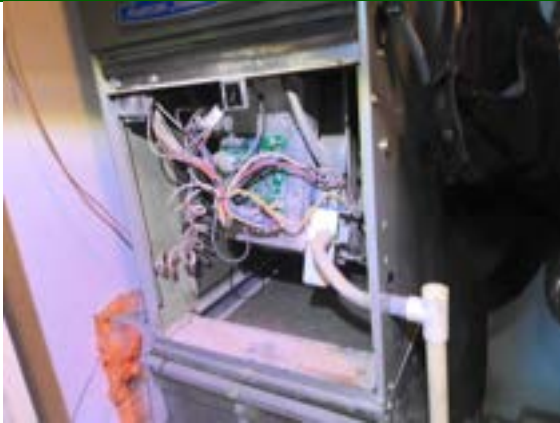
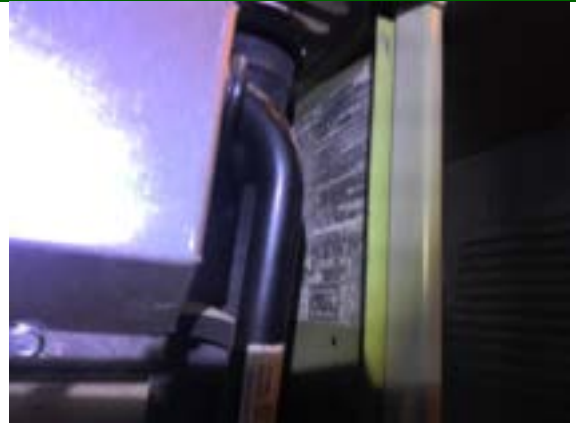
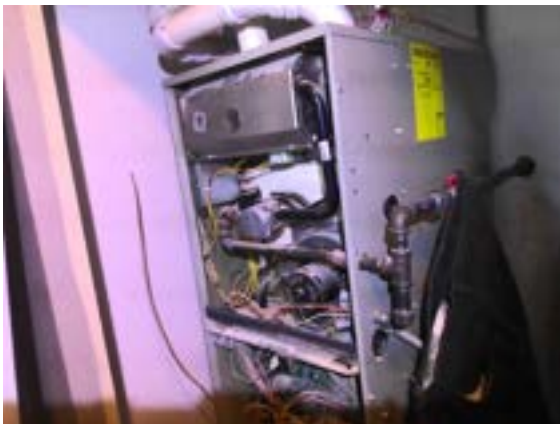
Heating Unit 3:

Furnace was running properly at time of inspection. Heat distribution was acceptable with no problems to report. It is important that the furnace be properly maintained for efficiency and greater life span. Recommend a yearly maintenance program be set up with a local heating company to service and clean the furnace. This could greatly improve the life span of unit.

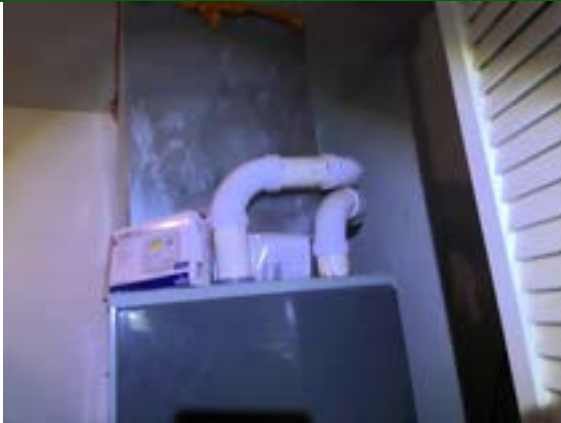
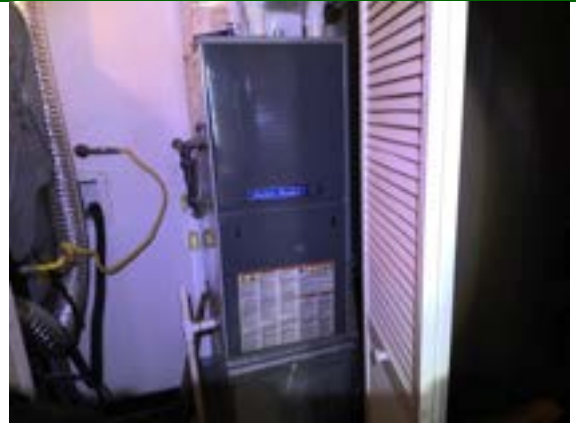
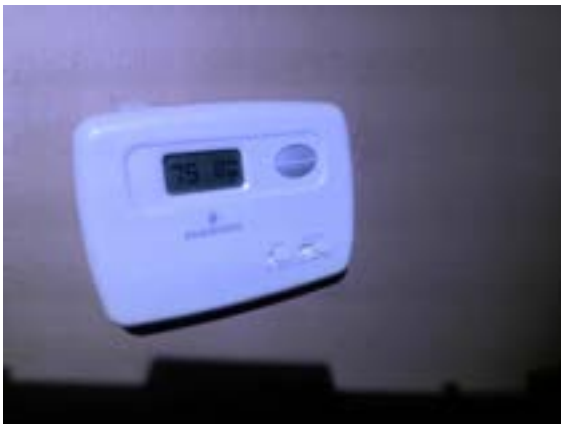
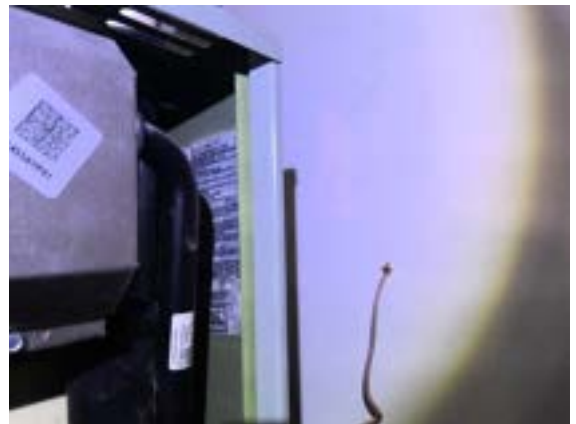
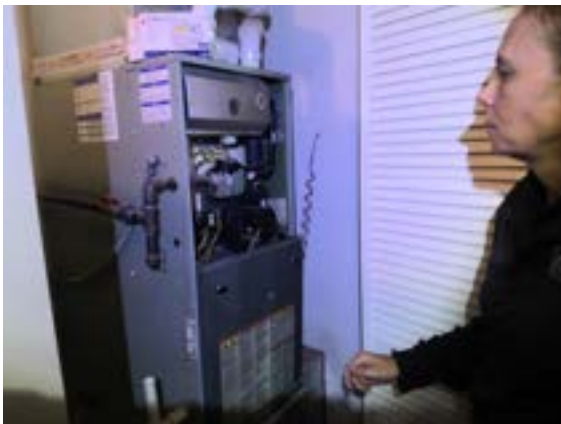
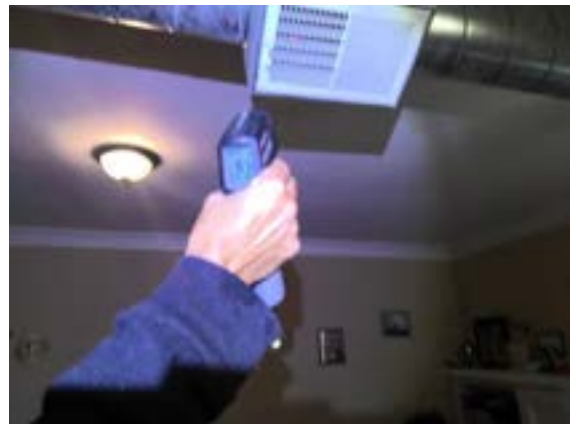
Heating Unit 4:

Furnace was running properly at time of inspection. Heat distribution was acceptable with no problems to report. It is important that the furnace be properly maintained for efficiency and greater life span. Recommend a yearly maintenance program be set up with a local heating company to service and clean the furnace. This could greatly improve the life span of unit.

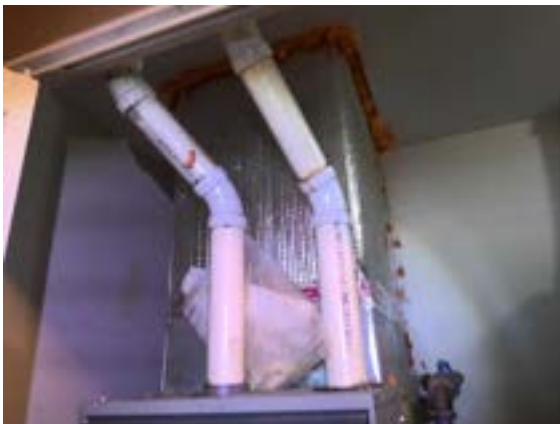
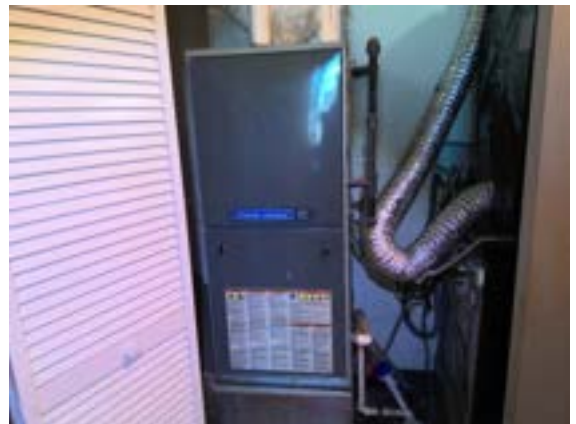
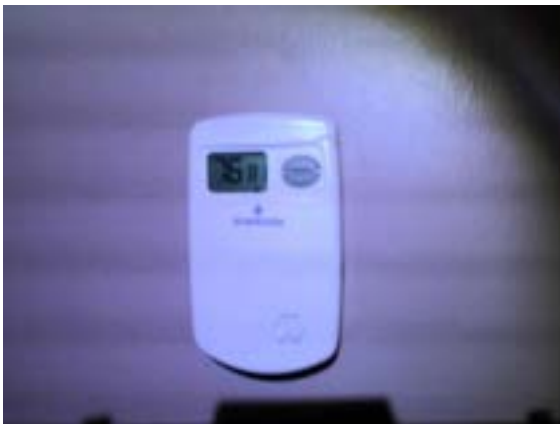
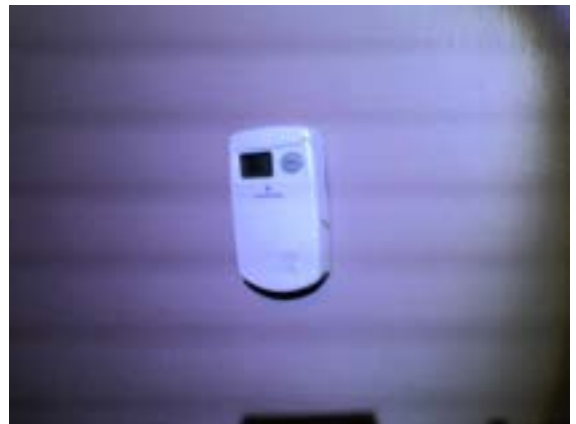
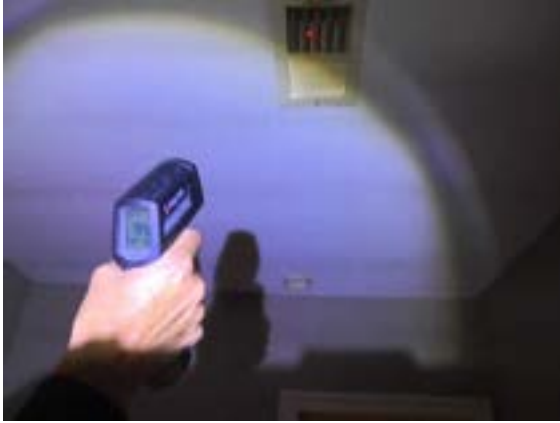
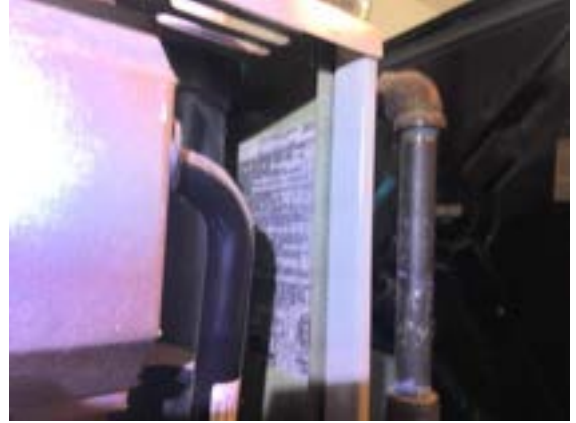
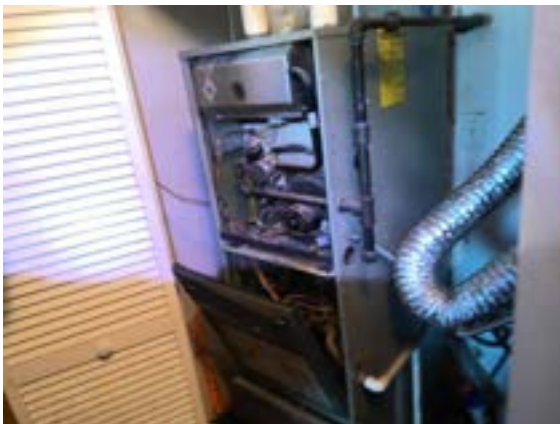
Heating Unit 5:

Furnace was running properly at time of inspection. Heat distribution was acceptable with no problems to report. It is important that the furnace be properly maintained for efficiency and greater life span. Recommend a yearly maintenance program be set up with a local heating company to service and clean the furnace. This could greatly improve the life span of unit.

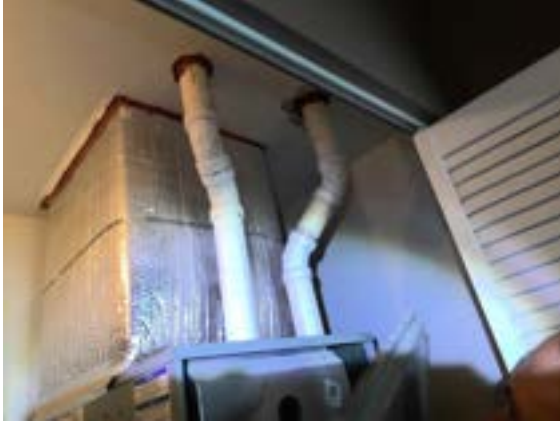
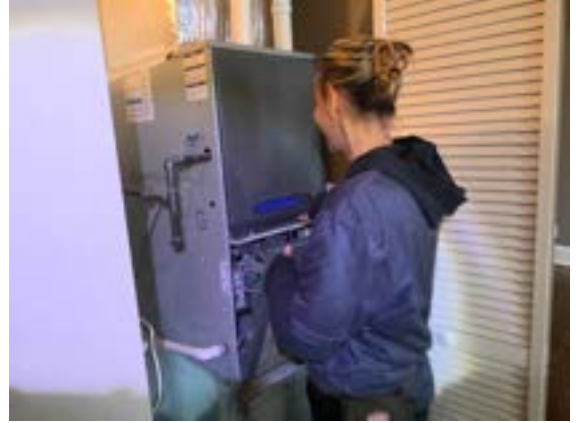
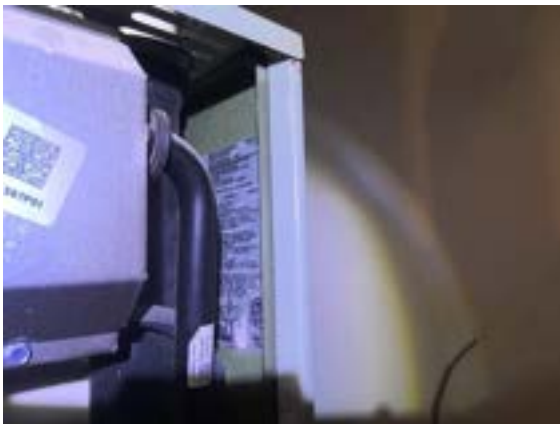
Heating Unit 6:

Furnace was running properly at time of inspection. Heat distribution was acceptable with no problems to report. It is important that the furnace be properly maintained for efficiency and greater life span. Recommend a yearly maintenance program be set up with a local heating company to service and clean the furnace. This could greatly improve the life span of unit.

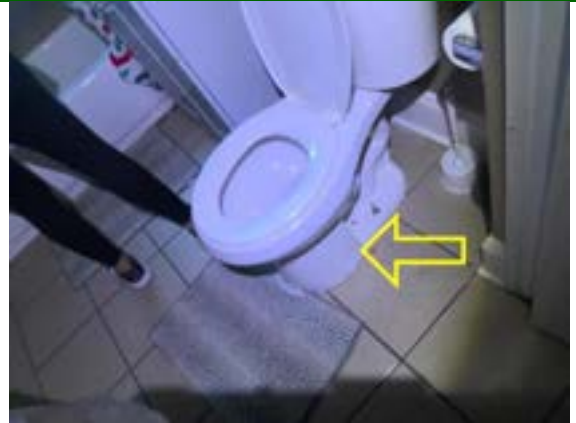
Toilet loose.

Unit 3 Bathroom 2N: loose

Recommend further evaluation/repair by qualified contractor(s).

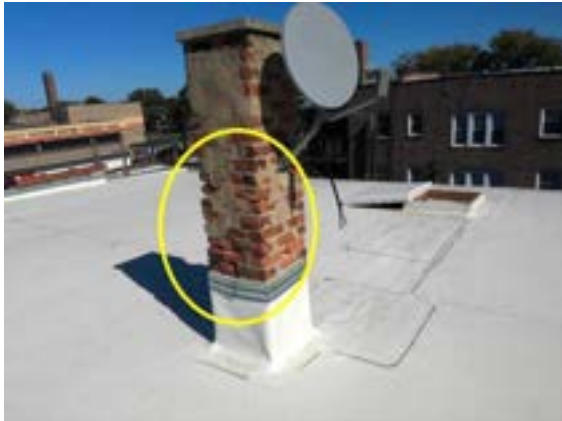
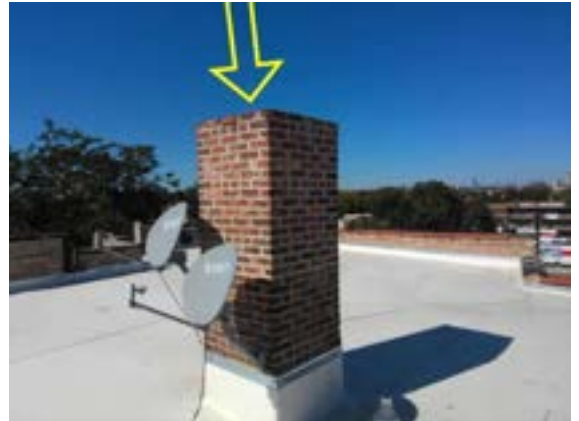
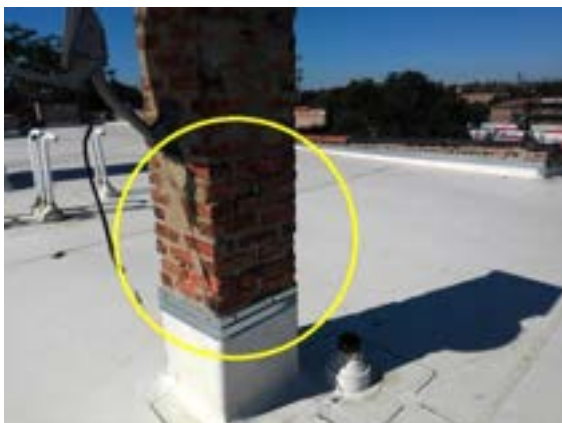
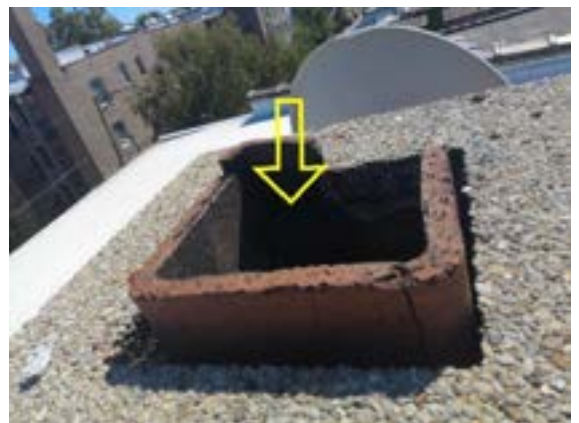
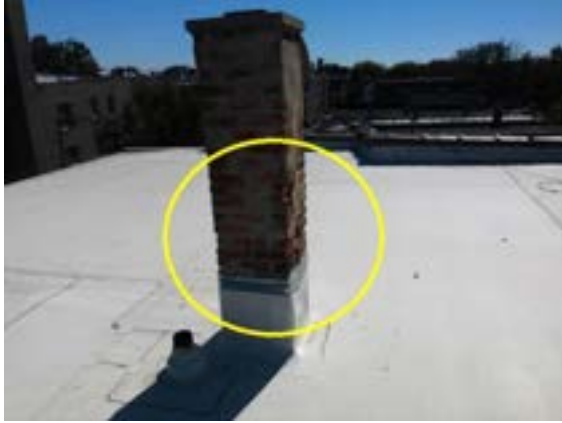
CHIMNEY(S):

Chimneys (2) had no cap/spark arrestor to prevent water from entering chimney and spark retention if chimney was used for a wood burning.

Deteriorated brick/mortar noted on chimney.

Recommend further evaluation/repair by qualified contractor(s).

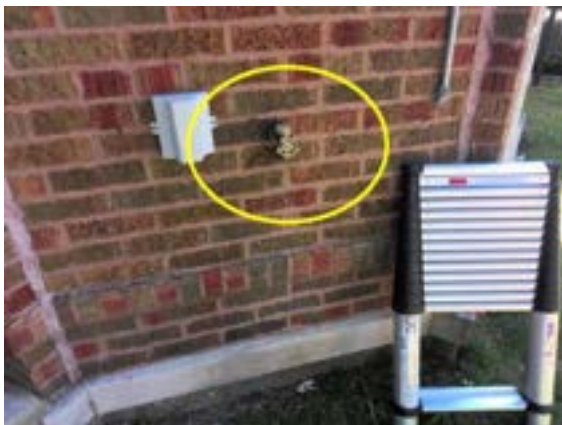
EXTERIOR SURFACE:

Faucet inoperative front.

Recommend further evaluation/repair by qualified contractor(s).

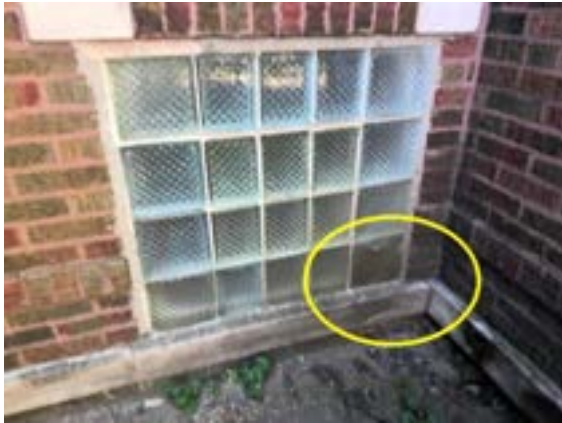
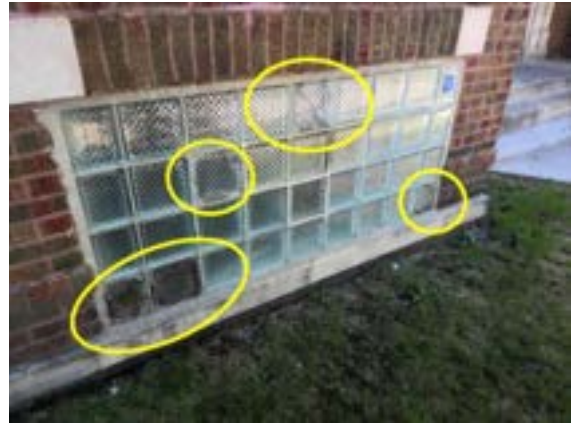
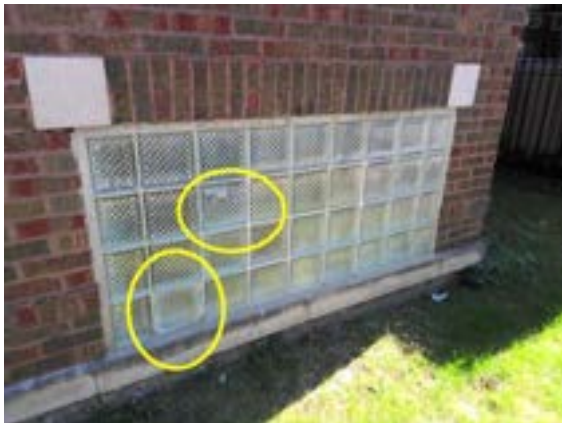
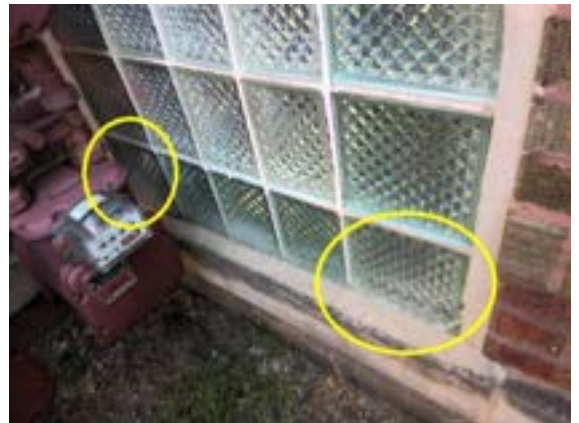
Cracked block windows noted.

FENESTRATION SYSTEMS: cracked front

Recommend further evaluation/repair by qualified contractor(s).

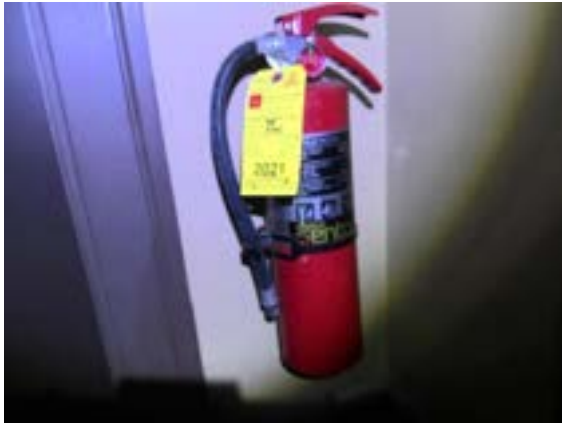
ATTIC/FIRE EXTINGUISHER :

Fire extinguisher tags expired.

Recommend further evaluation/repair by qualified contractor(s).

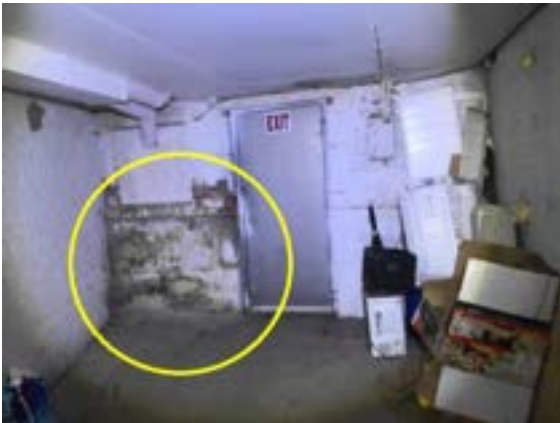
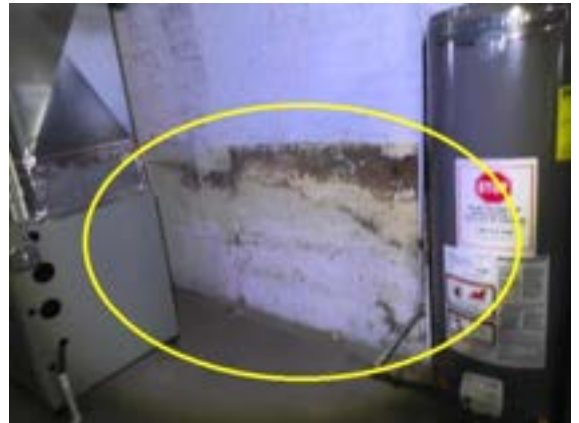
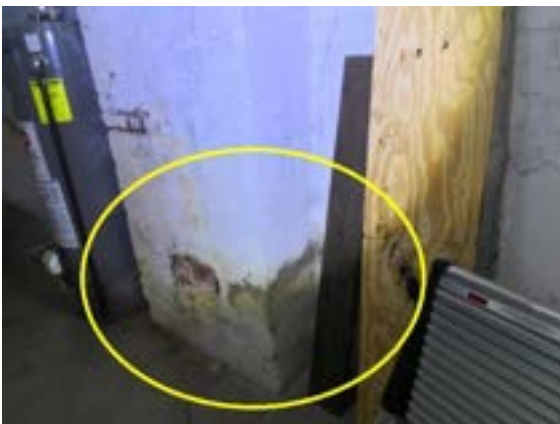
INTERIOR FOUNDATION LEFT:

Efflorescence along foundation wall(s). Efflorescence is a powdery deposit of salts which forms on the surface of bricks and mortar. It is usually caused by water intrusion.

Possible "mold like" growth noted.

Open junction boxes noted.

Recommend further evaluation/repair by qualified contractor(s).

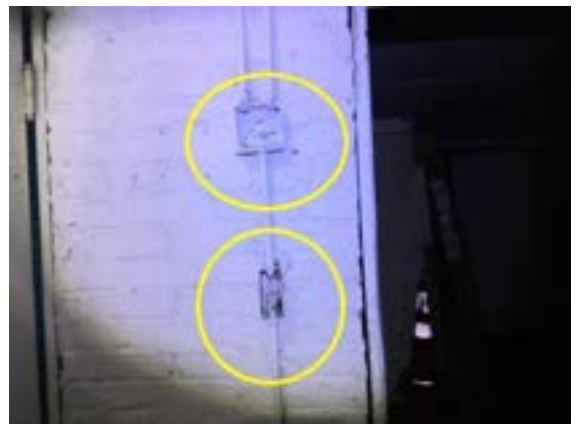
INTERIOR FOUNDATION LEFT: open junction boxes

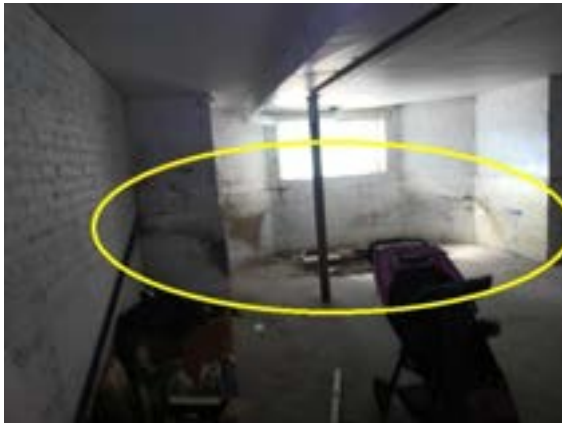
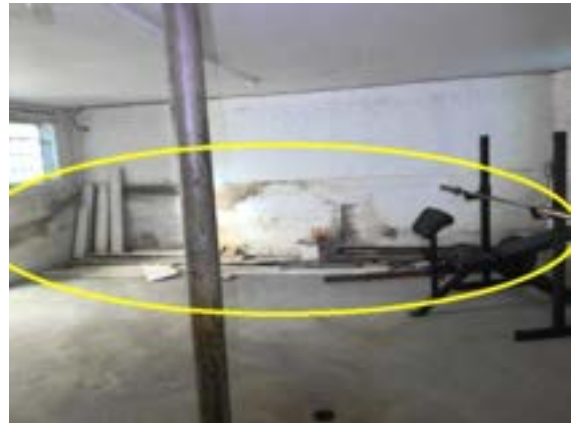
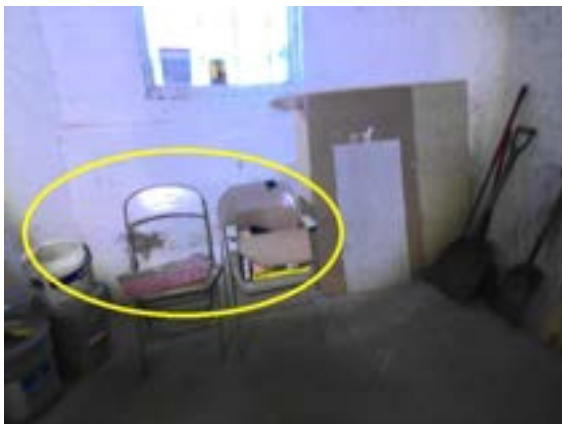
INTERIOR FOUNDATION LEFT:

Efflorescence along foundation wall(s). Efflorescence is a powdery deposit of salts which forms on the surface of bricks and mortar. It is usually caused by water intrusion.

Possible "mold like" growth noted.

Open junction box noted.

Recommend further evaluation/repair by qualified contractor(s).

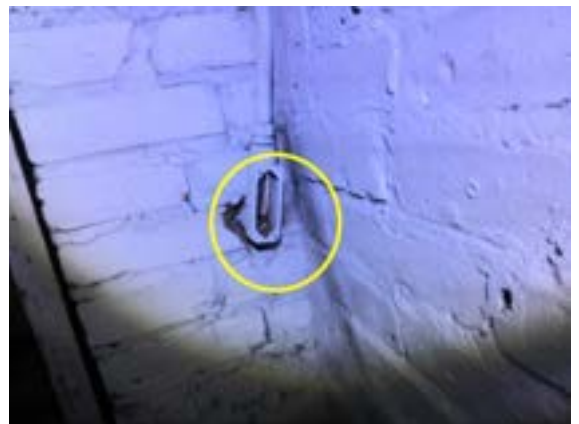
INTERIOR FOUNDATION LEFT: exposed wires

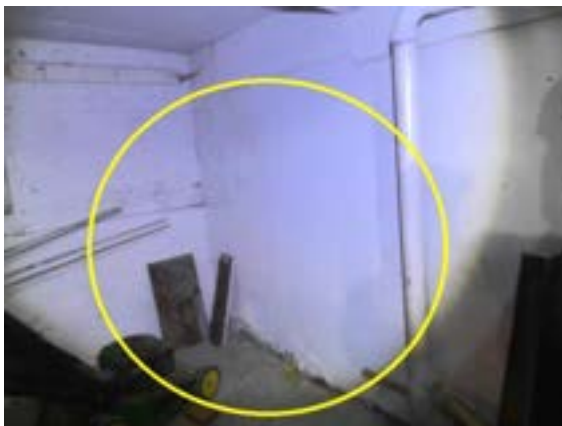
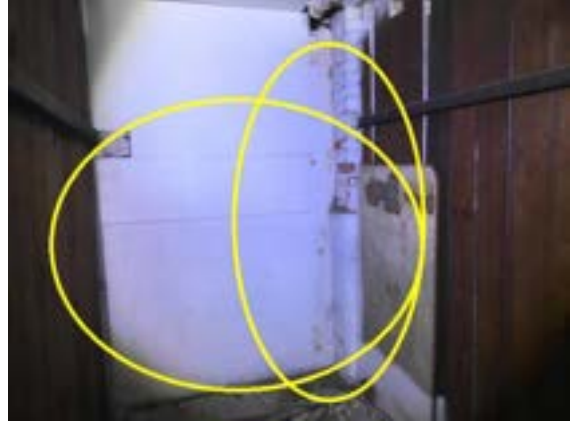
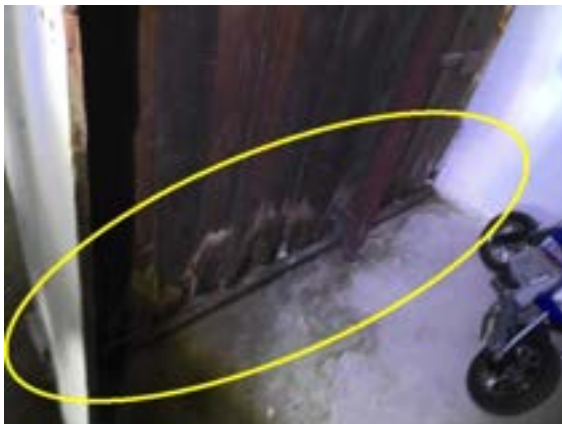
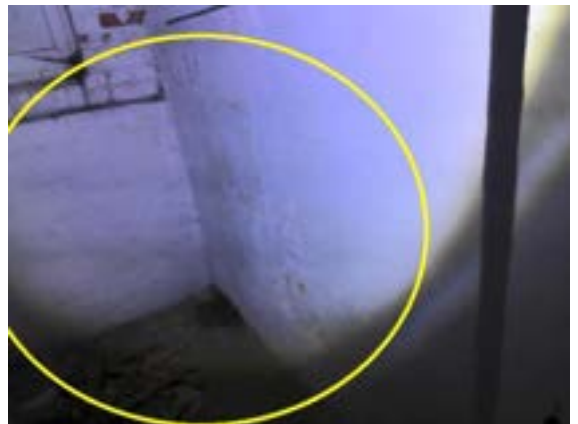
Efflorescence (E) along foundation wall(s). Efflorescence is a powdery deposit of salts which forms on the surface of bricks and mortar. It is usually caused by water intrusion.

Possible "mold like" growth noted.

INTERIOR FOUNDATION RIGHT: mold/moisrure

Recommend further evaluation/repair by qualified contractor(s).

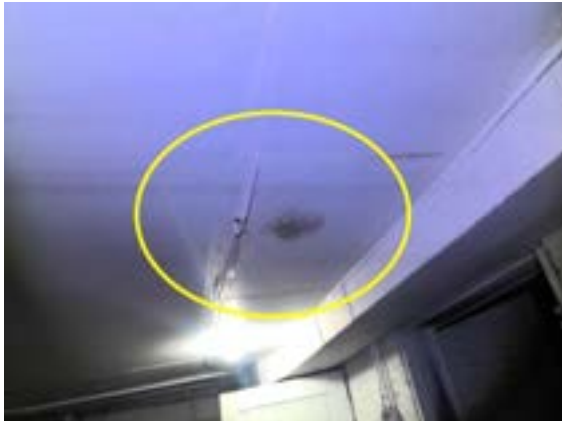
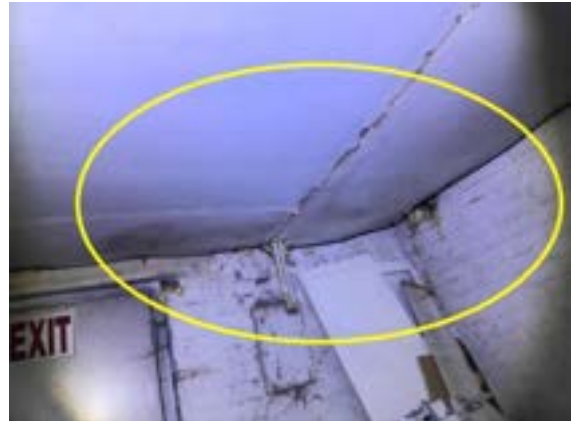
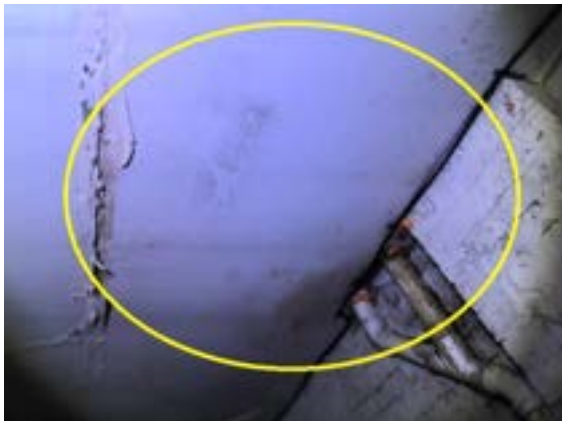
STRUCTURAL FRAME AND BUILDING ENVELOPE
LEFT:

Possible "mold type" growth noted.

Recommend further evaluation/repair by qualified contractor(s).

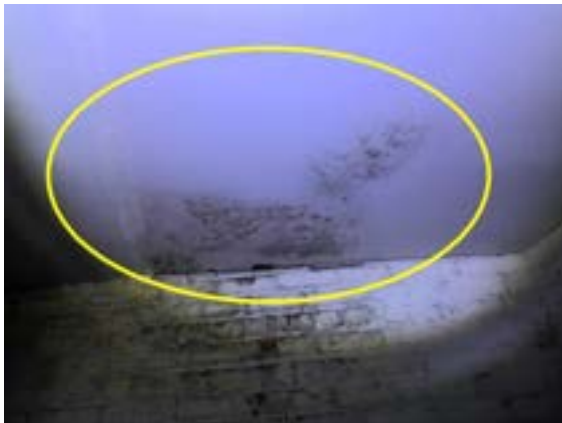
STRUCTURAL FRAME AND BUILDING ENVELOPE
RIGHT:

Possible "mold type" growth noted.

Recommend further evaluation/repair by qualified contractor(s).

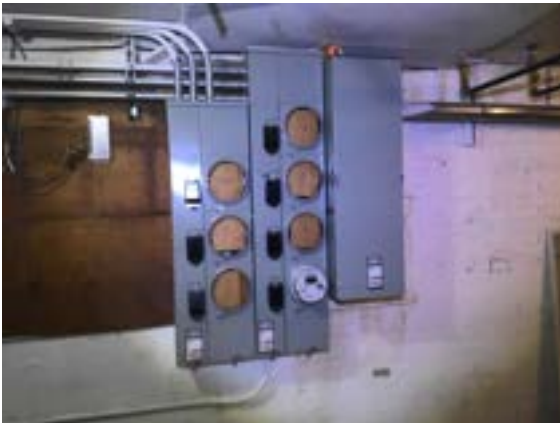
Open conduit/pipe rear.

ELECTRICAL BUILDING: not completed

Recommend further evaluation/repair by qualified electrical contractor(s).

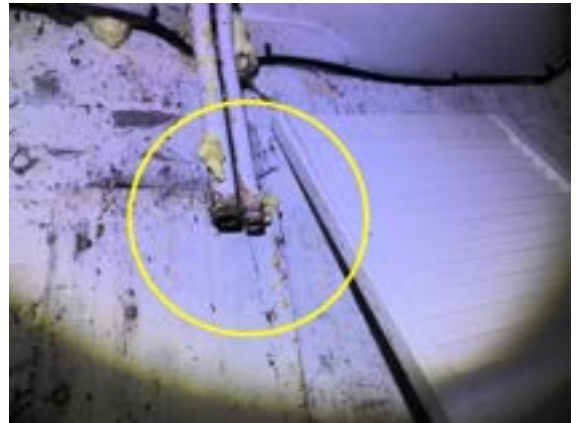
ELECTRICAL BUILDING: rear left

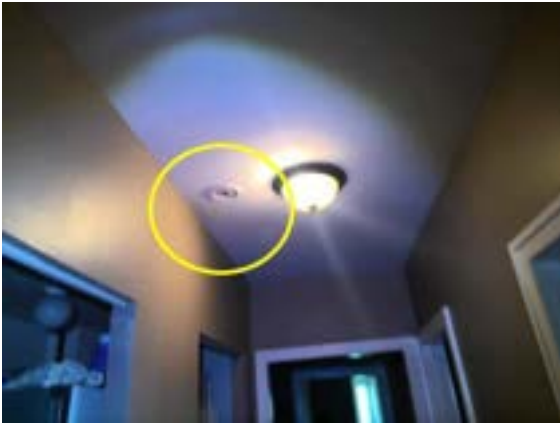
ELECTRICAL UNIT 3:

Smoke/CO detector missing.

Recommend further evaluation/repair by qualified electrical contractor(s).

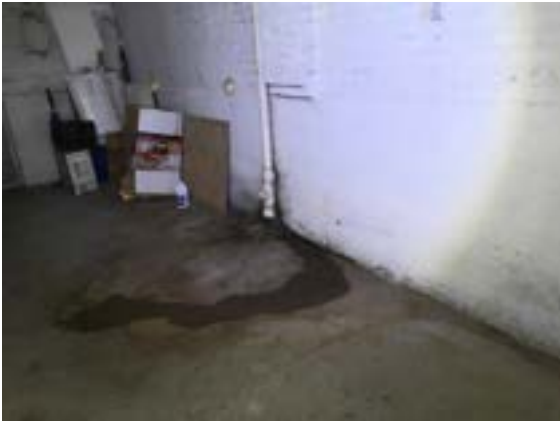
Active leak noted left.

PLUMBING BUILDING LEFT: active leak

Recommend further evaluation/repair by qualified contractor(s).

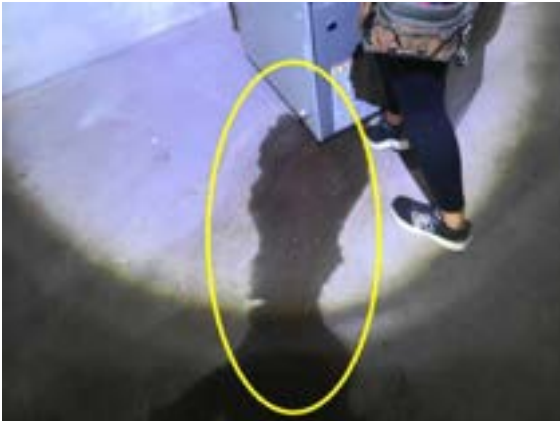
HEATING UNIT 2:

Condensation line missing.

Recommend further evaluation/repair by qualified contractor(s).

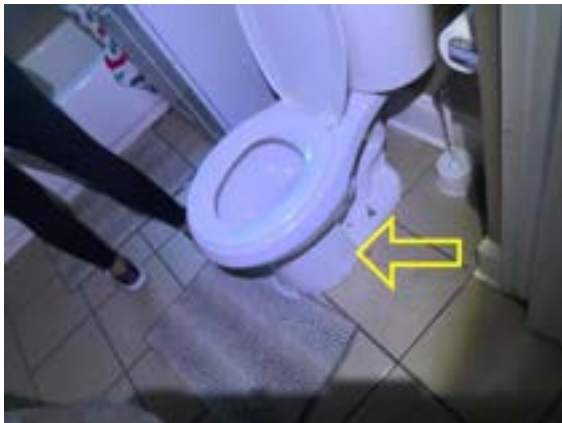
Toilet loose.

UNIT 3 BATHROOM 2N: loose

Recommend further evaluation/repair by qualified contractor(s).
