PROPERTY INSPECTION REPORT

National Property Inspections**6310 Millwood Court****Arlington, TX 76016****Office 817-492-0161****Fax 817-451-0233****Mobile 469-964-4414****www.npidfw.com****service@npidfw.com****Inspected By: Eric Evans TREC #7077****Inspection Date: 4/27/2006****Client**

Town Home Row

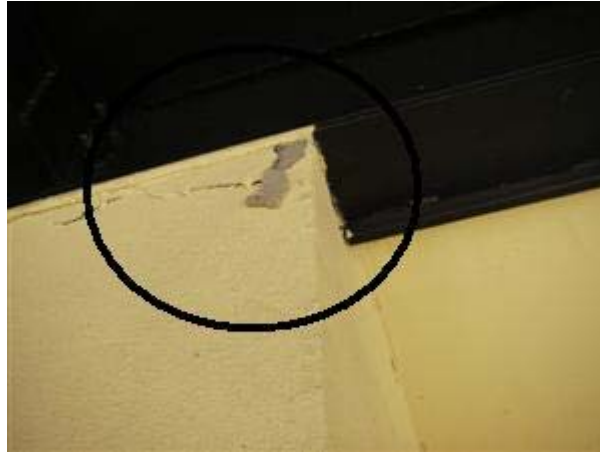
D. Picture 20

Noted paint on stucco is failing at several points around structure. Recommend qualified contractor evaluate and repair.

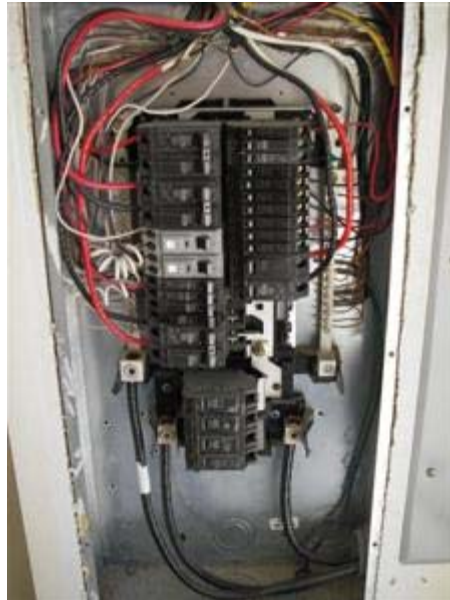
A. Picture 1

ELECTRICAL CONDUCTORS: BELOW GROUND
PANEL CAPACITY: 200 AMP
PANEL TYPE: CIRCUITS
BRANCH WIRE (15 and 20 amp): COPPER
ELEC. PANEL MANUFACTURER: GENERAL ELECTRIC
<i>Comments: Representative panel interior</i> |
