## PROPERTY INSPECTION REPORT

Prepared For: Stephen F. Austin  
(Name of Client)

Concerning: 1836 Early Days of Texas, Austin, TX 78745  
(Address or Other Identification of Inspected Property)

By: James Chris Quoyeser, Lic #TREC License #21071 08/05/2014  
(Name and License Number of Inspector) (Date)

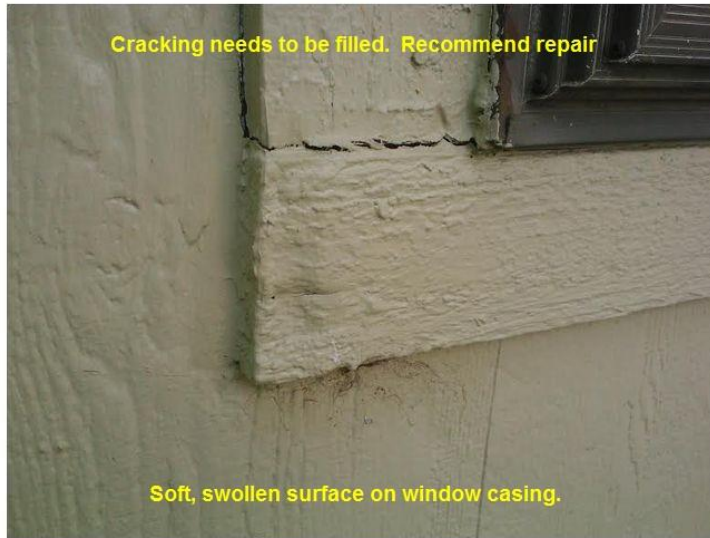
All exterior wall penetrations should be maintained with a good weather seal. Recommend sealing wall on east side of house.
