# National Property Inspections

Mr. John Doe, 20 Ocean Blvd , Holden Beach, NC, 28462

Inspection Date:  
06/30/2018

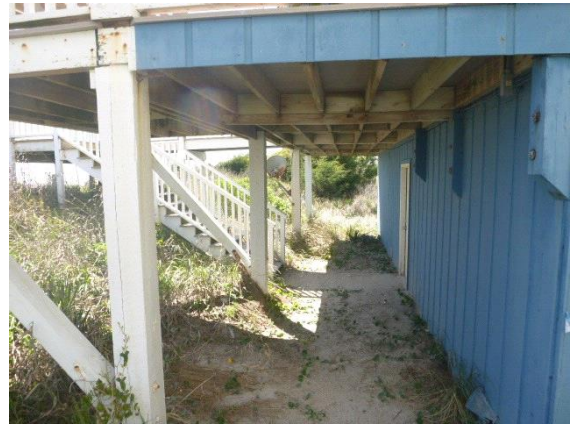
The property has positive slopes on three sides of the house with a slight negative slope at the rear of the house. See photo. Evidence suggests that during a heavy rain water may settle along the rear foundation wall. Recommend a qualified landscape contractor evaluate the grading and make any necessary repairs.

Grading / Drainage: View of rear property with negative slope present

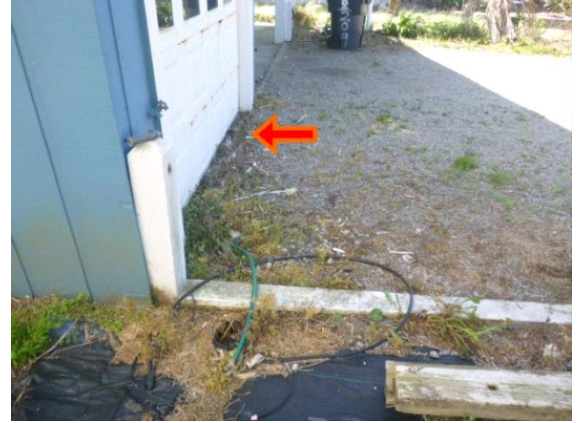
The gravel driveway has a negative slope present, located near the garage roll up door. See Photo. Evidence suggests this condition may inhibit water from draining away from the foundation. Recommend a qualified contractor evaluate and make the necessary repairs.

Driveway: View of negative slope in gravel driveway near roll up door

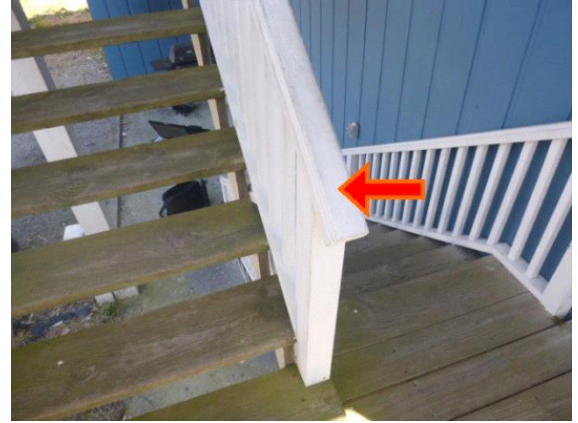
1. The wood handrails leading up to the front deck are loose. See Photos. Evidence suggests the loose handrails have created a safety hazard.
  2. The wood stairs leading up to the front and rear wood decks have multiple cracks in the stair stringers. See photos. Evidence suggests this condition creates a safety hazard.
- \*\*Recommend a licensed general contractor evaluate items 1 and 2, all exterior wood steps, determine the cause and extent of any damage, and make the necessary repairs.

Walks / Steps: View of loose handrail located on the front wood steps

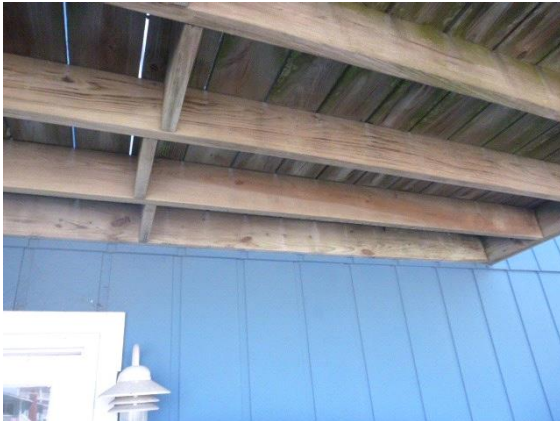
1. The front deck appears to be built before 1992 and the deck band joist is nailed to the house, and was not required to be bolted to the house at that time. However, nails may corrode and fail behind the deck band, causing the deck to collapse. Concealed damage to framing and/or siding behind the deck may also result in deck collapse. Unless it can otherwise be demonstrated that the deck attachment to the house is secure, the deck should be directly supported from below, or bolted to the house.

Decks - 1st Floor - Front : View showing the deck ledger board not bolted to the house

\*\*Recommend a licensed general contractor evaluate items 1, 2, and 3, all exterior wood decks, determine the cause and extent of any damage, and make the necessary repairs.

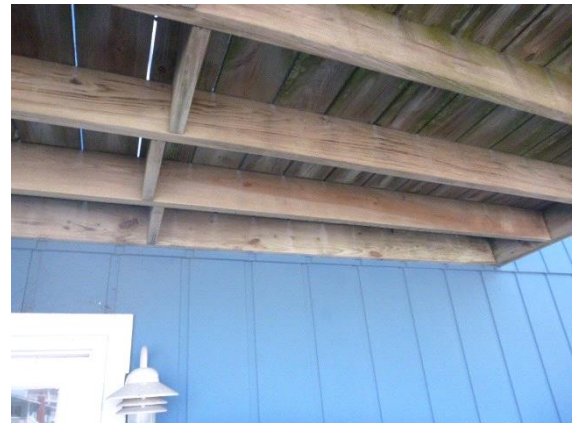
1. The front deck appears to be built before 1992 and the deck band joist is nailed to the house, and was not required to be bolted to the house at that time. However, nails may corrode and fail behind the deck band, causing the deck to collapse. Concealed damage to framing and/or siding behind the deck may also result in deck collapse. Unless it can otherwise be demonstrated that the deck attachment to the house is secure, the deck should be directly supported from below, or bolted to the house.

Decks - 2nd Floor - Front : View showing the deck ledger board not bolted to the house

\*\*Recommend a licensed general contractor evaluate items 1, 2, and 3, all exterior wood decks, determine the cause and extent of any damage, and make the necessary repairs.

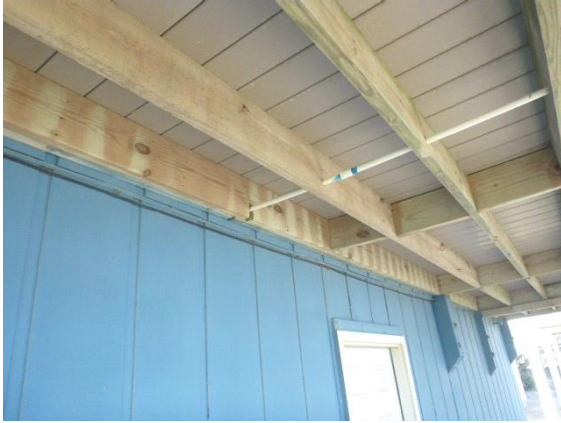
1. The rear deck appears to be built before 1992 and the deck band joist is nailed to the house, and was not required to be bolted to the house at that time. However, nails may corrode and fail behind the deck band, causing the deck to collapse. Concealed damage to framing and/or siding behind the deck may also result in deck collapse. Unless it can otherwise be demonstrated that the deck attachment to the house is secure, the deck should be directly supported from below, or bolted to the house.

2. All decks are required to have either metal joist hangers or wood ledger strips for proper end-support for all decking floor joists. The rear deck does not have either type of joist supports present, and evidence suggests this condition creates a safety hazard. See photos.

Decks - 1st Floor - Rear : View showing the deck ledger board not bolted to the house, and no joist hangers or ledger strips present

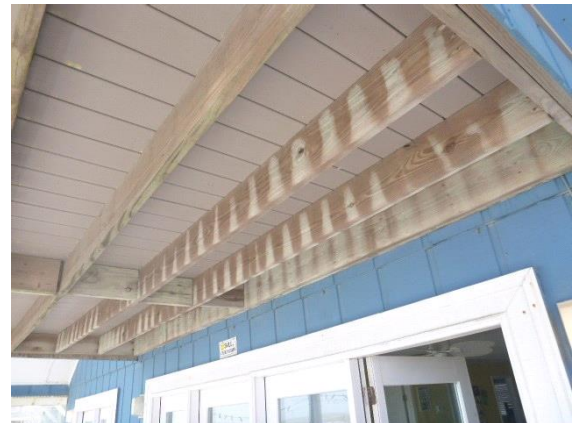
1. The rear deck appears to be built before 1992 and the deck band joist is nailed to the house, and was not required to be bolted to the house at that time. However, nails may corrode and fail behind the deck band, causing the deck to collapse. Concealed damage to framing and/or siding behind the deck may also result in deck collapse. Unless it can otherwise be demonstrated that the deck attachment to the house is secure, the deck should be directly supported from below, or bolted to the house.

Decks - 2nd Floor - Rear : View showing the deck ledger board is not bolted to the house

\*\*Recommend a licensed general contractor evaluate items 1, 2, and 3, all exterior wood decks, determine the cause and extent of any damage, and make the necessary repairs.

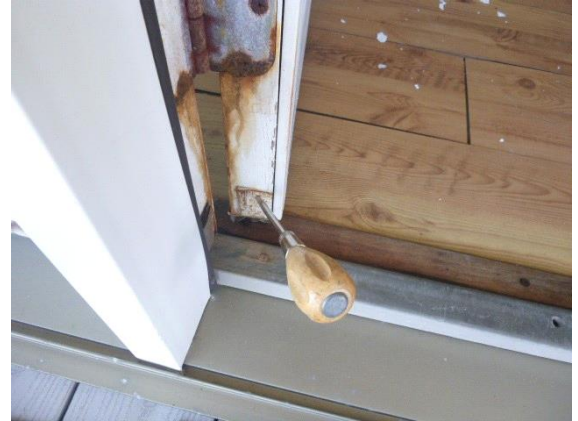
Exterior Doors: View of one location of soft wood present at rear entry door

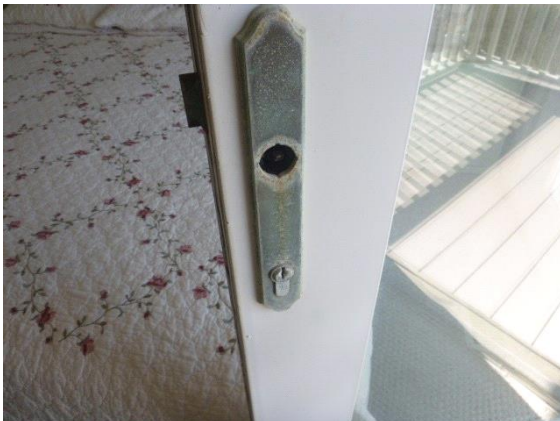
Exterior Doors: View of rear door with binding hardware and handle missing

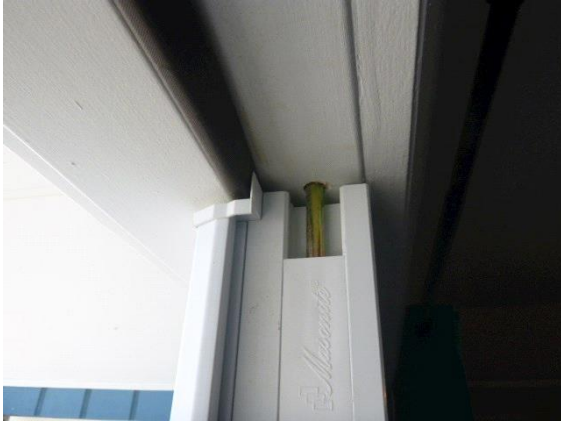
Exterior Doors: View of one location of 2nd floor rear entry door pins that do not fully latch into frame

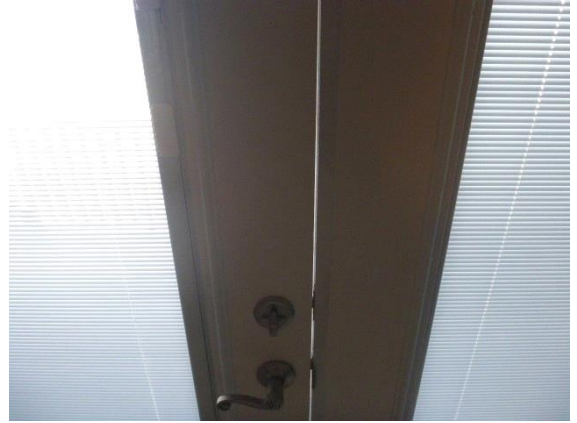
Exterior Doors: View of gap in weather stripping at rear 2nd floor entry door

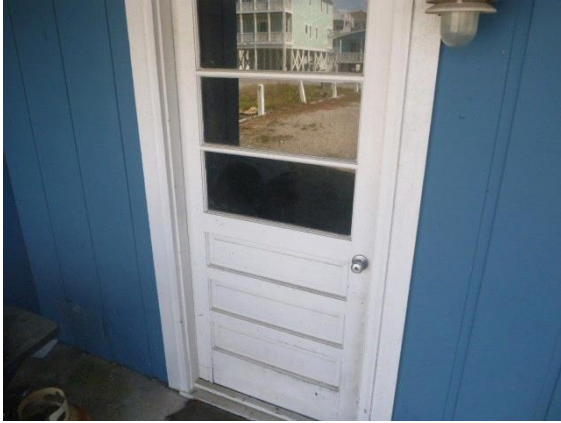
Carport/Under House: View of one location of ground floor entry doors that could not be accessed with key

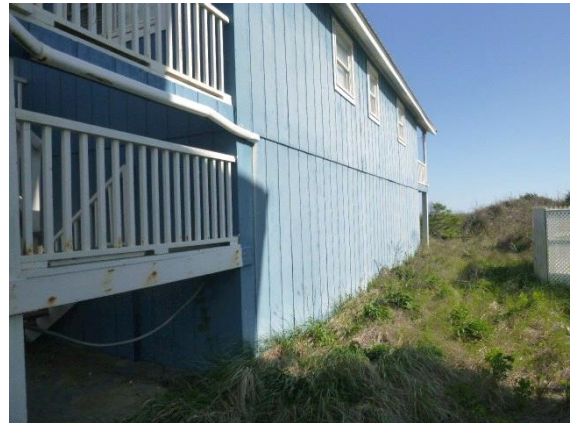
Under Floor Framing & Support: View of exterior finished walls obstructing support pilings

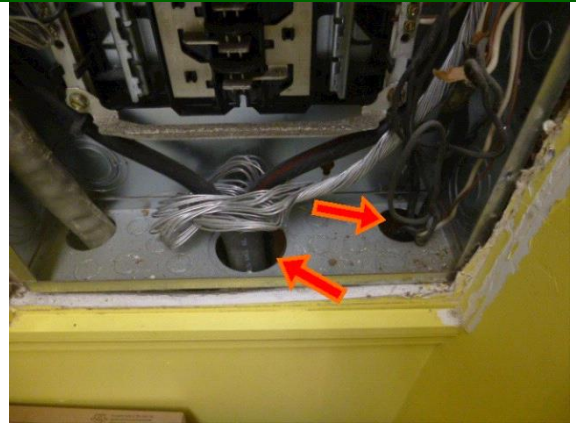
Electrical: View of one location of cables entering the electric panel that do not have the required connectors present

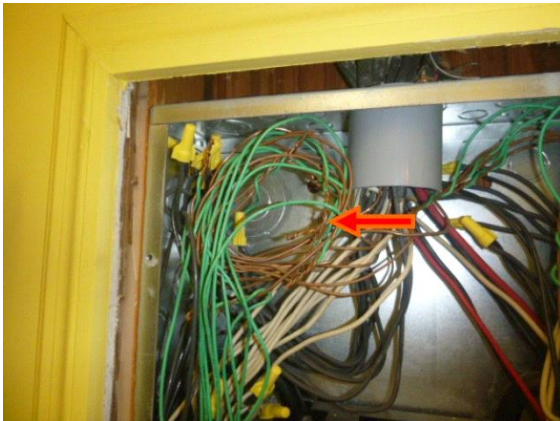
Electrical: View of ground wire connections with no caps or connectors present

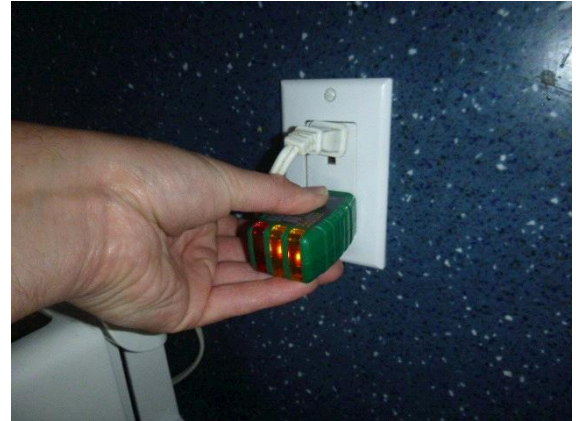
Kitchen: View of one location of kitchen wall receptacle that is not GFCI protected

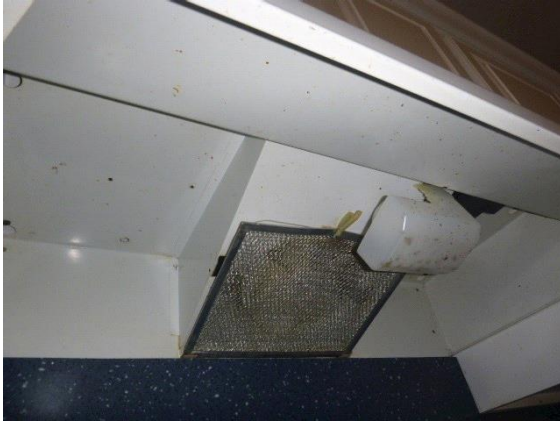
Kitchen: View of exhaust fan that made excessive noise when operating

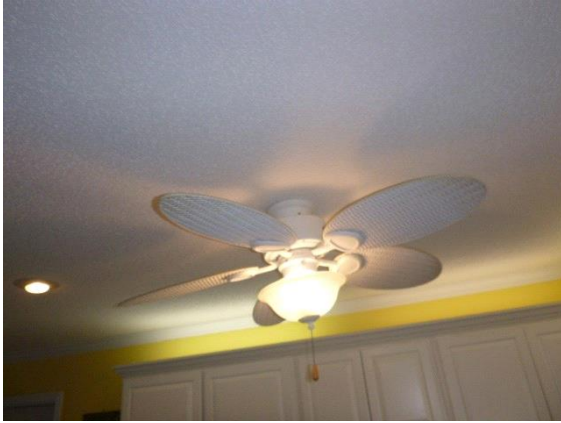
Kitchen: View of ceiling fan that did not operate

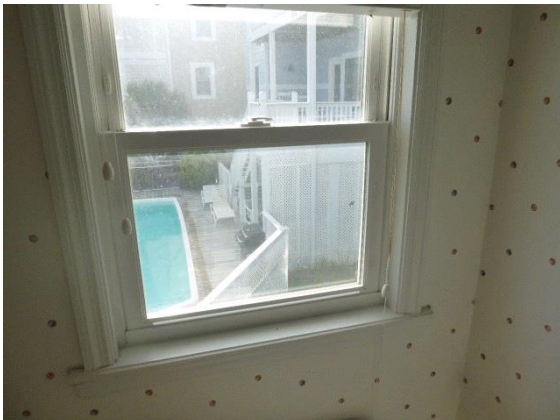
1. When opening the bathroom window, it will not stay open and slams shut. Evidence suggests that the bathroom window does not function as intended. Recommend a qualified contractor evaluate and make the necessary repairs.

Bathroom #2 - 1st Floor Right: View of window that slams shut when operating

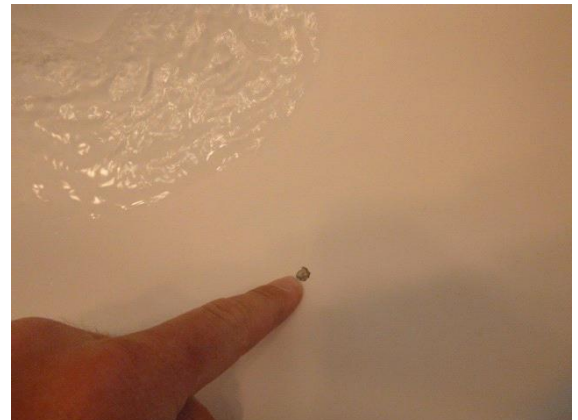
4. There is a hole present in the bathroom sink. See Photo. Evidence suggests this condition creates avenues for water intrusion. Recommend a qualified contractor evaluate and make the necessary repairs.

Bathroom #2 - 1st Floor Right: View of hole in bathroom sink

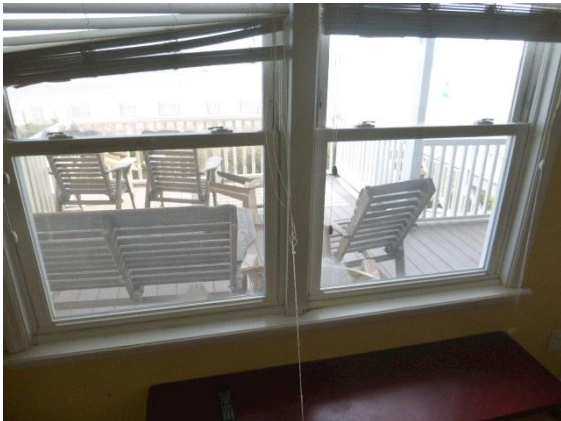
- The living room windows will not open when using a reasonable amount of upward force. Evidence suggests the windows are not operating as designed.
- There is condensation present inside the window panes of the living room double-pane glass windows. Evidence suggests this indicates the desiccant strips designed to absorb moisture from the space between the panes have become saturated, and will no longer prevent condensation from forming. In some situations repair is possible, but if irreparable damage has occurred, the window pane assemblies will need to be replaced.

Living Room: View of defective living room windows

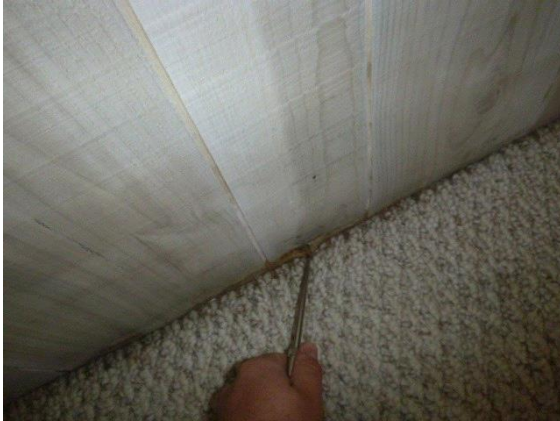
2. There are several water stains and soft wall paneling present, located on the wall of the bedroom below the windows. See photo. The stains are dry, determined by using a moisture meter, which suggests that the stains are from a previous leak. Recommend asking the owners if any repairs have been performed to stop any previous leaks. If no repair history is known, recommend a qualified contractor evaluate the cause of the stain, the extent of any damage, and make the necessary repairs.

Bedroom #1 - 1st Floor - Front Left : View of one location of soft wall paneling and water staining

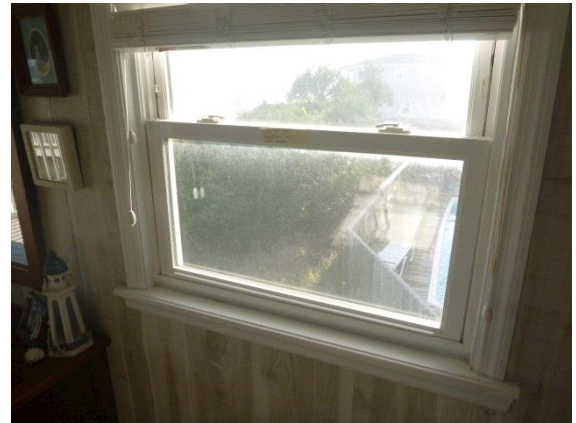
Bedroom #3 - 1st Floor - Rear Right: View of window that would not open when using a reasonable amount of force located in the bedroom

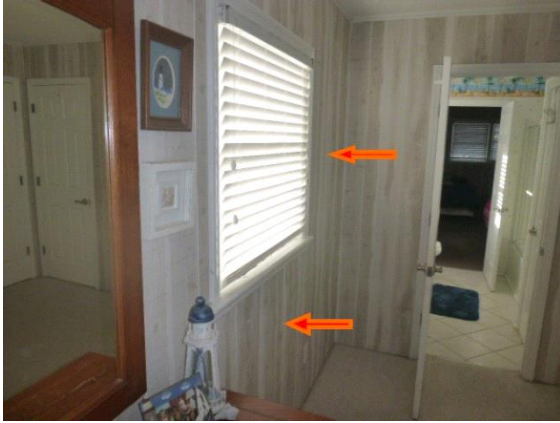
Bedroom #3 - 1st Floor - Rear Right: View of one location of buckled wall paneling

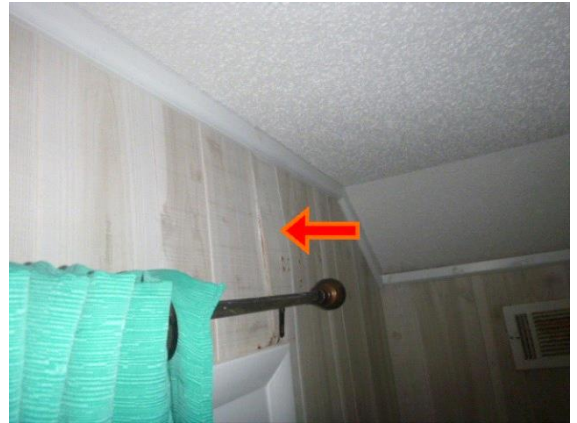
Bedroom #5 - 2nd Floor - Rear : View of one location of buckling in wall paneling
