National Property Inspections

Megan Waesche, 6210 N Ocean Blvd, Myrtle Beach, SC, 29572

Inspection Date:
04/28/2018

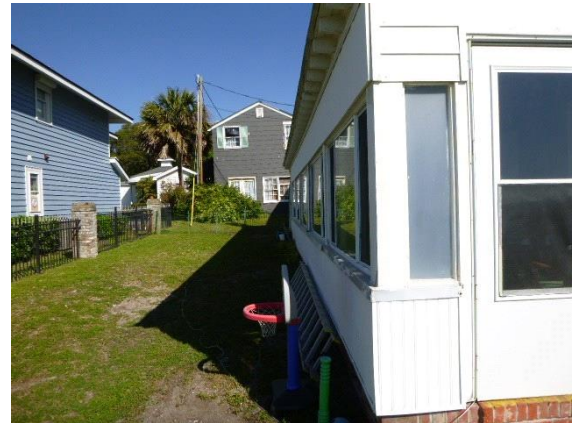
The front and right side of the property have negative slopes. See photos. This means the ground located at the front and right side of the house is pitched toward the foundation. Evidence suggests that during a heavy rain, water is likely to pool up to the foundation walls. Consider having a qualified landscape contractor install additional drainage to prevent any future water damage or water intrusion into the foundation. Recommend a qualified landscape contractor evaluate the grading and make the necessary repairs.

Grading / Drainage: View of right side property and grading

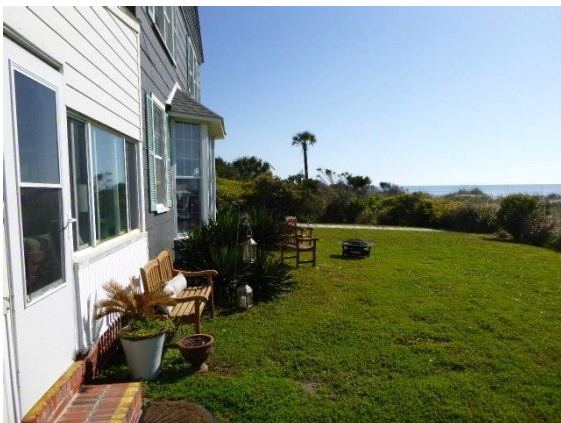
Grading / Drainage: View of rear property and grading

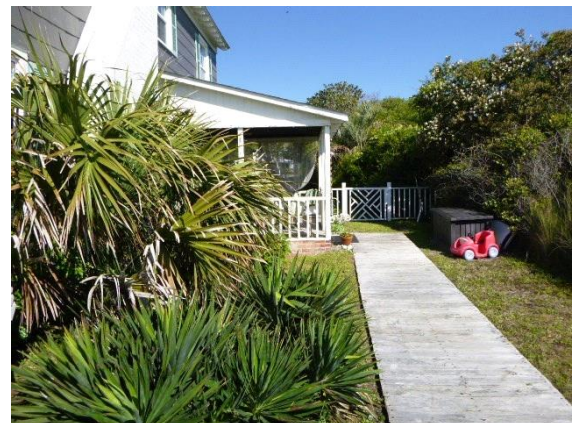
Grading / Drainage: View of left side property and grading

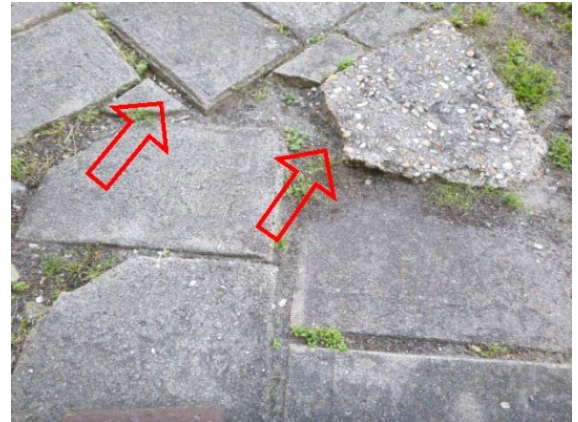
The ground beneath the front paving stone walkway is sunk down and creates an uneven surface. See photo. Recommend a qualified masonry contractor evaluate and make the necessary repairs.

Paver Walkway: View showing height differential of paver walkway

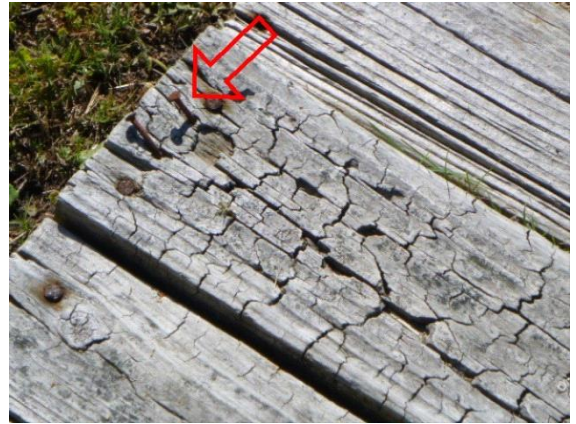
The wooden walkway, located on the left side of the house, has many weathered boards present, several with exposed nails. Several of the boards are bowed creating a trip hazard. See photos. Recommend a qualified general contractor to evaluate and make the necessary repairs.

Rear Wood Walkway: View of nails backing out of wooden walkway

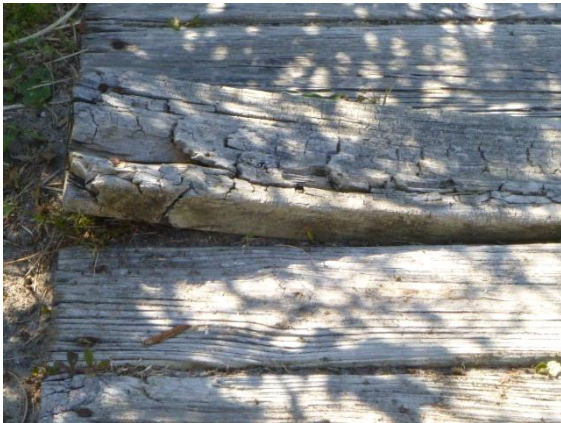
Rear Wood Walkway: View of bowed tread board on rear wood walkway

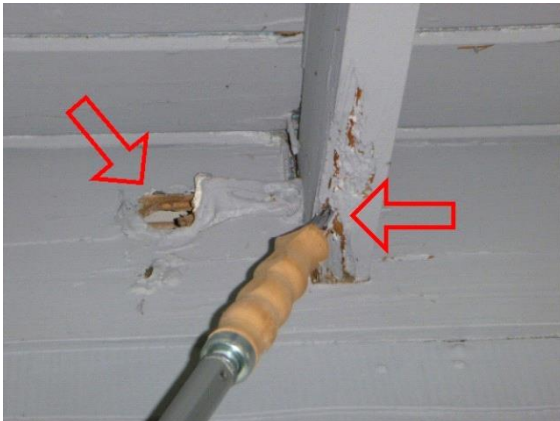
- 1.The ceiling of the enclosed porch has several areas with damaged wood present. See photos. Evidence suggests the damaged wood is a result of water intrusion.

Right Enclosed Porch: Views of soft, water damaged wood present on walls and ceiling of enclosed porch

- ***Recommend a licensed general contractor to evaluate points 1&3 and make the necessary repairs.

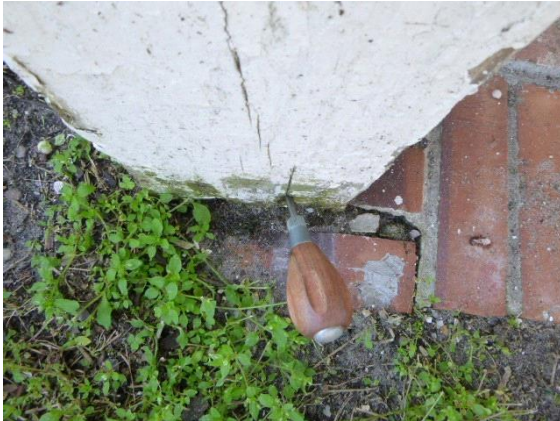
The right and left support posts, for the roof covering the patio, have wood rot present at the bases. See photos. Evidence suggests the damaged wood needs to be replaced to restore integrity of the columns.

Front Brick Patio: Views of water damaged wood at base of columns

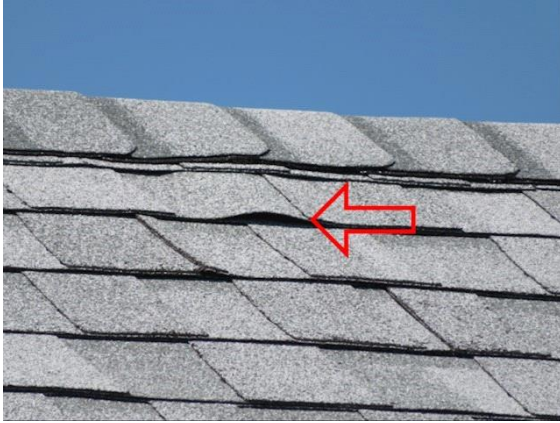
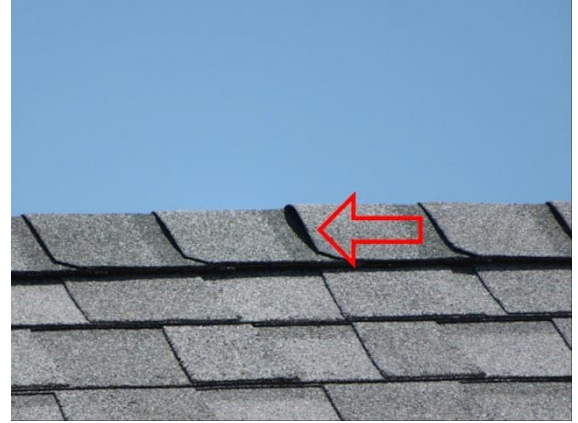
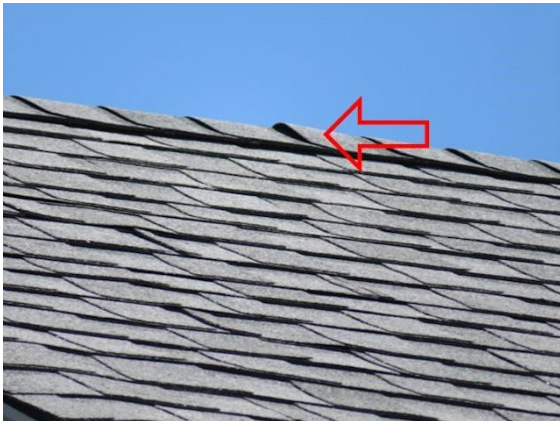
There are several roofing nails that have lifted out from the sheathing in various locations around the roof, causing the roof shingles to lift up. See photos. Evidence suggests this creates an avenue for water intrusion and needs to be repaired. Recommend a qualified roofing contractor to evaluate and make the necessary repairs to avoid future roof sheathing damage.

Roofing: View of lifted asphalt roof shingles due to roofing nails lifting out of sheathing

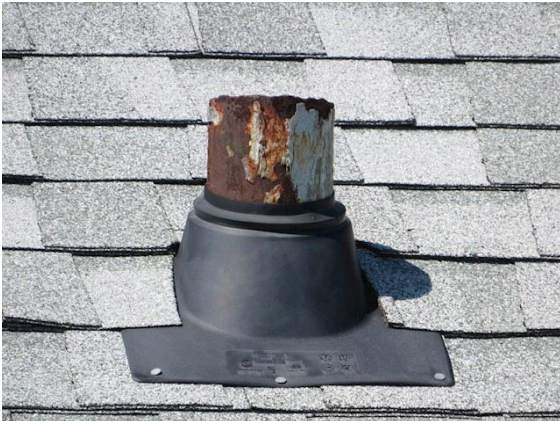
1. The plumbing vent pipes have excessive rust present. See photos. It is difficult to determine when a rusted component may fail.
2. There are exposed nails heads, located at the bottom of the neoprene vent pipe flashings. See photos. Evidence suggests the nail heads need to be sealed with an approved sealant to prevent future leaks.

Flashing/Valleys: Views of heavily corroded plumbing vents and flashing with exposed nail heads

***Recommend a qualified roofing contractor evaluate points 1&2 and make the necessary repairs.

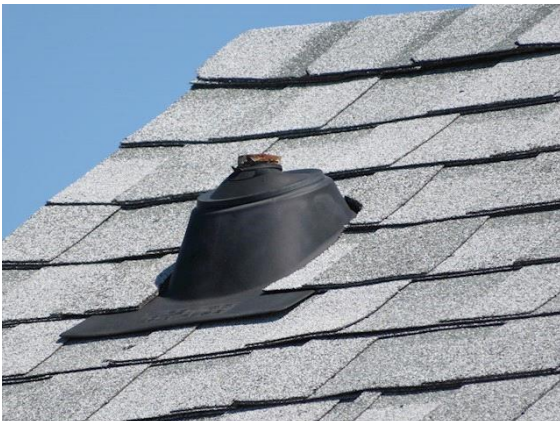
Flashing/Valleys: Views of heavily corroded plumbing vents

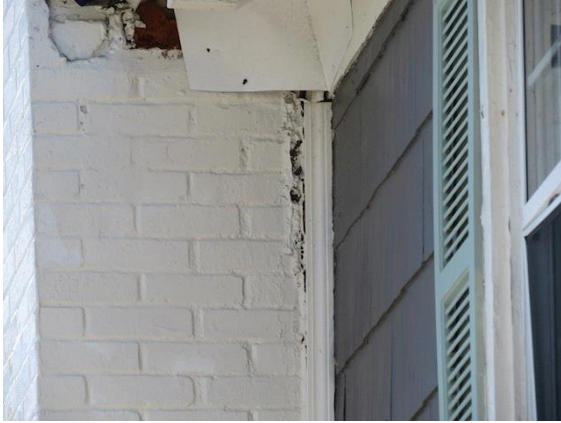
3. The external masonry chimney, located on the left side of the house, appears to be leaning and separating away from the home with cracked mortar present. See photos. This is could be due to inadequate footings or unconventional construction.

Chimney: View of left chimney pulling away from exterior wall

***Recommend further evaluation of both chimneys by a qualified masonry contractor or structural engineer to reinstate the structural integrity/stability of the chimneys.

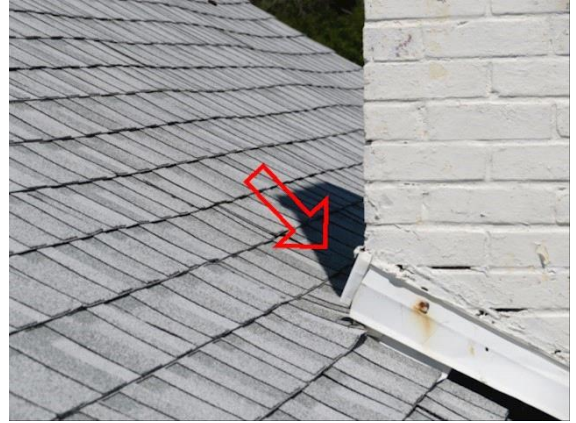
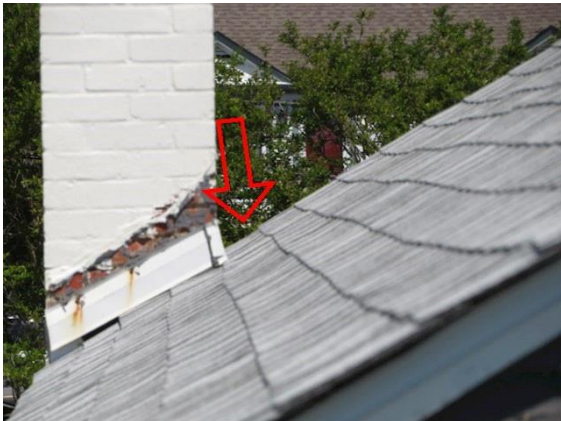
2. All chimneys that are 30 inches or wider require a "cricket" or saddle at the base of the chimney to help divert rain water away from the chimney. Both chimneys are approximately 34 inches wide and are missing the required "crickets." See photos.

Chimney: View showing where a roof cricket needs to be installed when a chimney is wider than 30 inches wide

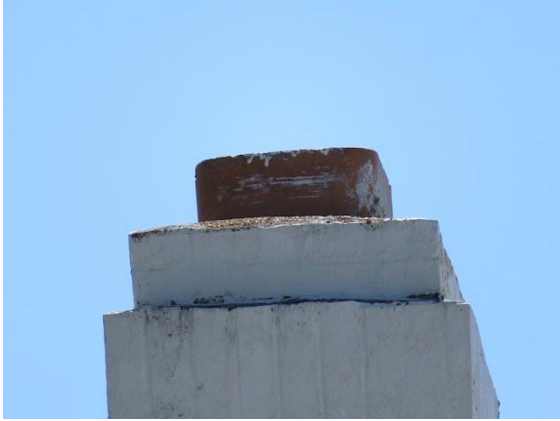
Chimney: View of missing rain cap

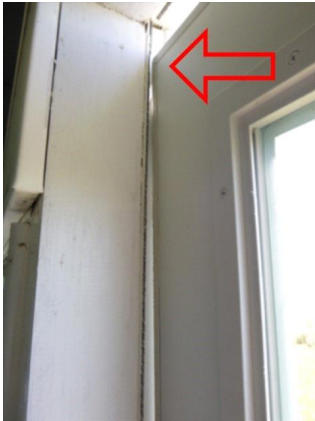
Exterior Doors: View of rear storm door hitting frame when closing

***Recommend a qualified general contractor to evaluate points 1-4 and make the necessary repairs.

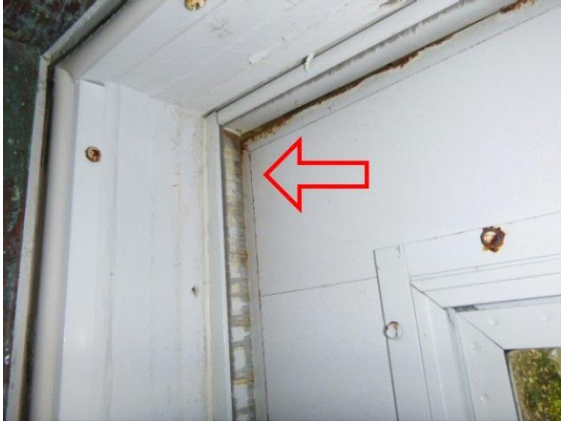
- 4.The wooden entry door located on the left side of the house is hitting the upper section of the door frame with operation which is preventing the door from closing and locking properly. See photos. Evidence suggests the door needs adjustment to function properly.

Exterior Doors: View of side entry storm door hitting frame when closing

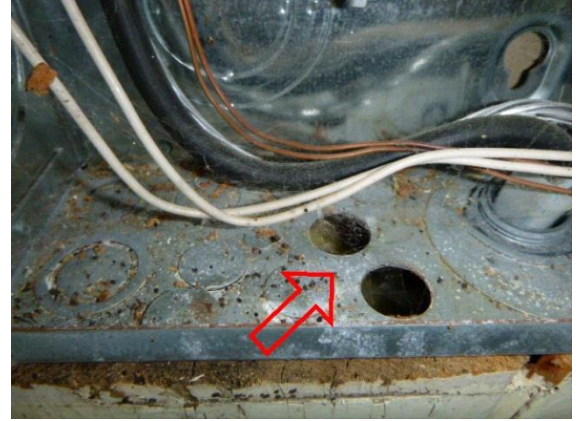
Electrical: View of open knock outs located at the bottom of the electric sub panel

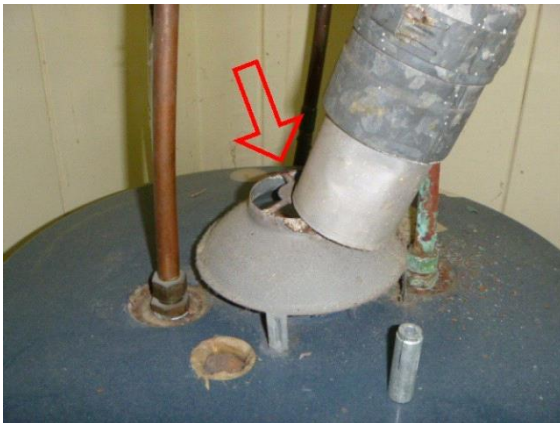
Water Heater: View of flue not properly aligned on top of water heater

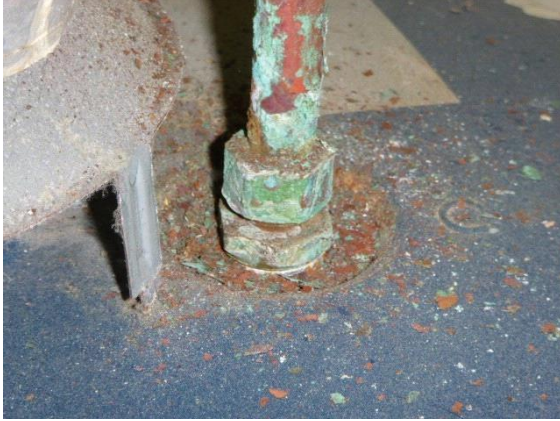
Water Heater: View of excessive corrosion present at base of the fitting located at the top of water heater

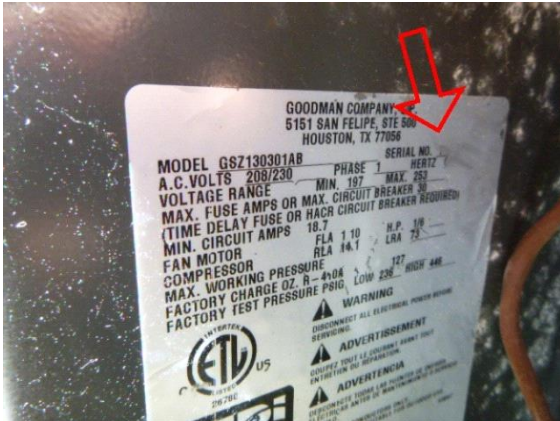
NOTE: I could not record the serial number off of the heat pump for the downstairs unit because the data plate was badly faded. See photo.

Downstairs Heating: View of faded serial number on data plate

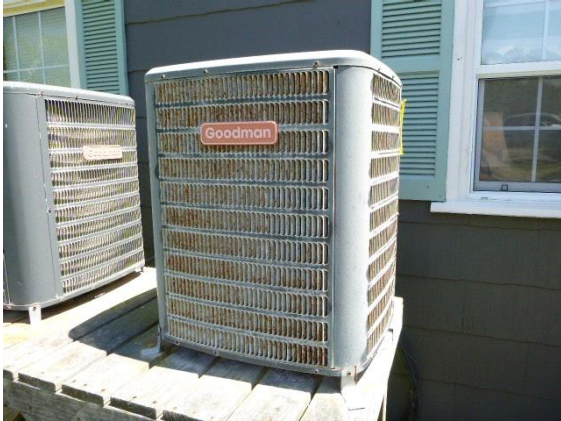
1. The condenser cover and coils, located on the outside HVAC condensing unit, have excessive corrosion present. See photos. Evidence suggests corroded condensing coils can adversely effect the efficiency of the HVAC system.
 2. The black foam insulation on the low pressure suction line on the condensing unit, located outside, is deteriorating and coming off the copper tubing. See photo.
- ***Recommend a licensed HVAC contractor evaluate points 1&2 and make the necessary repairs.

Downstairs Cooling : View of HVAC condenser located on the front side of the house

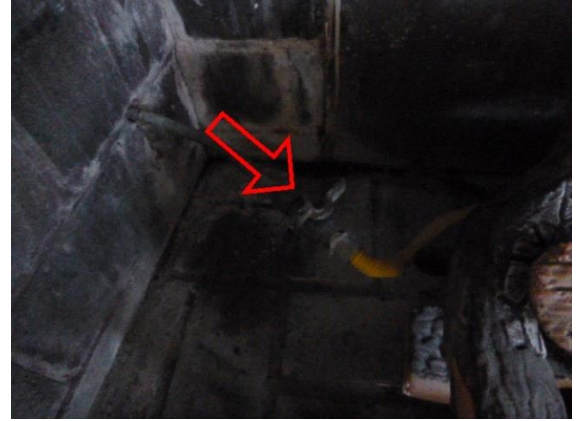
Fireplace/Stove: View showing the gas valve located inside the fireplace that is in the off position

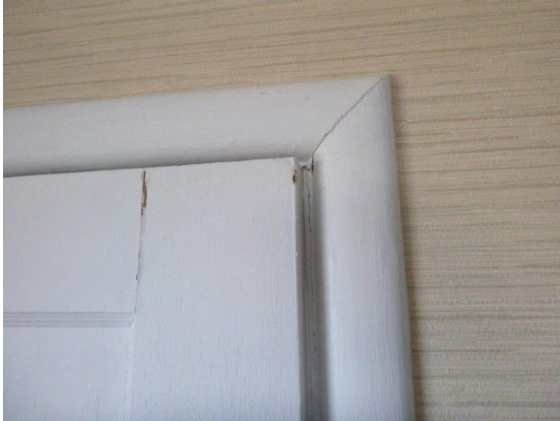
Upstairs Right Bathroom: View of bathroom entry door hitting top of door frame

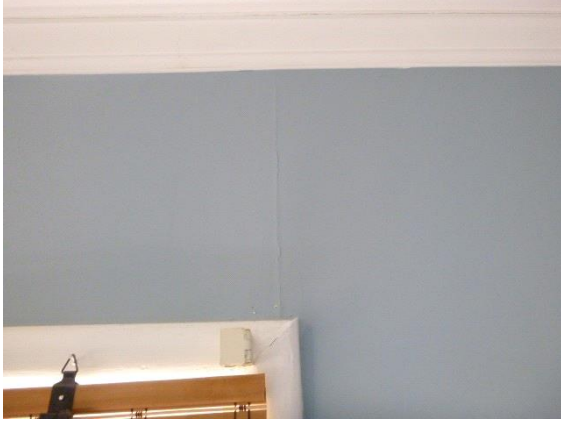
Upstairs Rear Right Bedroom: View of settlement cracks in walls above and below windows

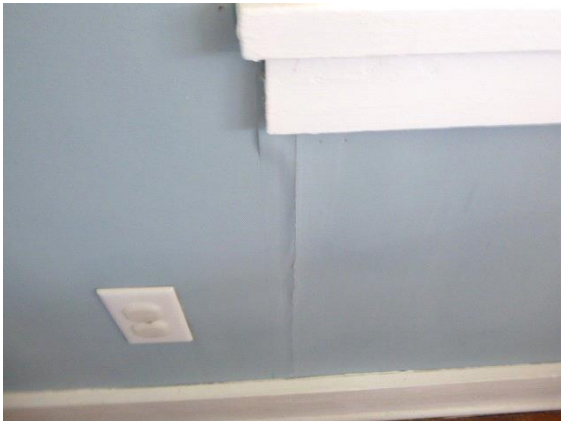
Upstairs Rear Right Bedroom: View of settlement cracks in walls above and below windows

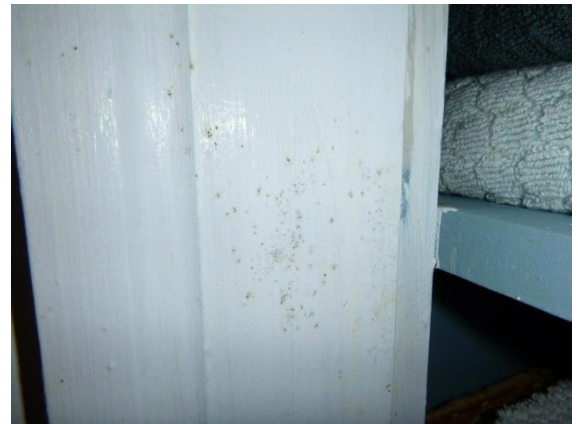
Upstairs Hall Closet: Views of microbial growth in upstairs hall closet

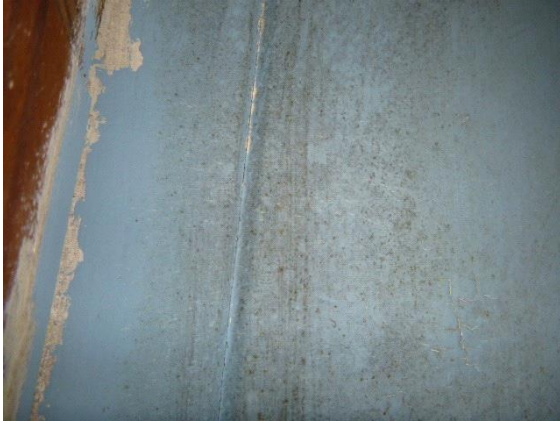
Upstairs Hall Closet: Views of microbial growth in upstairs hall closet

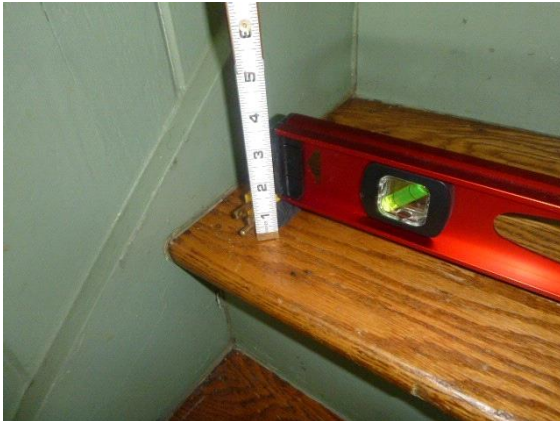
The stairs leading to the second floor are pitching towards the interior wall. When using a ruler and a level the stairs showed a negative pitch of over 1 1/2 inches. See photo. Recommend a licensed general contractor evaluate and make the necessary repairs.

Stairs / Railings: View showing negative pitch on stairs
