Sample Report Newton NH Antique Home, , Newton, NH, 03858

Inspection Date : 10/16/2010

Inspector: Steve Mangekian Inspector Phone: (603)816-1014

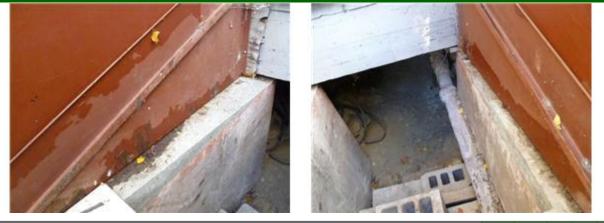
### **FOUNDATION** □ Monitor Condition ACC MAR NP DEF NI □ Recommend Repairs $\checkmark$ Concrete Block Slab Post / Pier Concrete Brick $\checkmark$ Wood Sub-Grade Entryway Stone Vertical Cracks General Deterioration Horizontal Cracks Step Cracks □ Limited Observation Needs Caulk / Seal □ Trim Vegetation

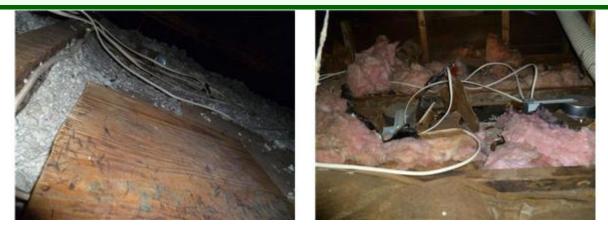
ATTIC ELECTRICAL	Monitor Condition	ACC	MAR	NI	NP	DEF
	Recommend Repairs		V

Open Splices / Junction Boxes

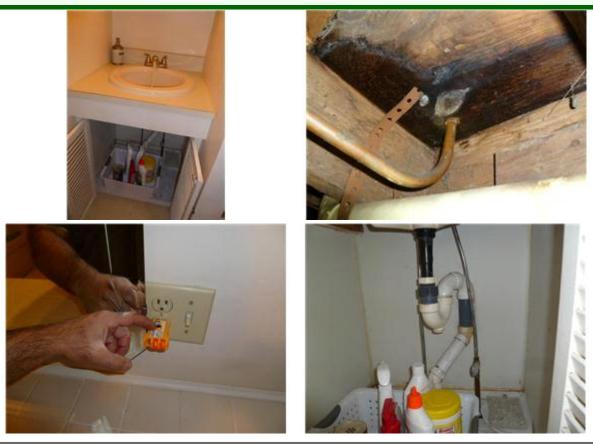
### **INTERIOR ROOM**

□ Monitor Condition ☑ Recommend Repairs
