# National Property Inspections

Mr. Buyer , 1121 Congleton Rd, Wilmington, NC, 28409

Inspection Date:  
06/30/2018

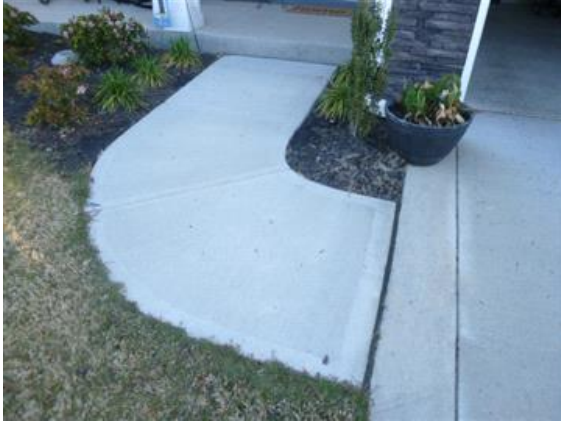
The front porch has minor cracking present in the concrete floor, to the left of the front door and on the left side extension of the porch. See photo. This type of cracking is common due to typical ground settlement and/or curing of the concrete and can create an avenue for water intrusion. Recommend a qualified contractor to evaluate and make the necessary sealing repairs.

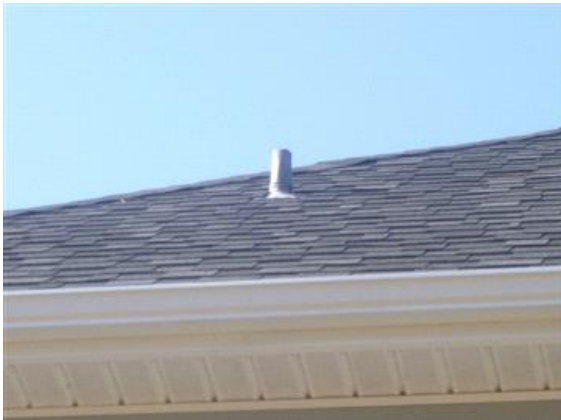
Typical Lead Plumbing Vent Flashing

The PVC plumbing vent pipes have a lead flashing covering them which will help prevent the PVC vent pipes from getting brittle and cracking from exposure to the sun.

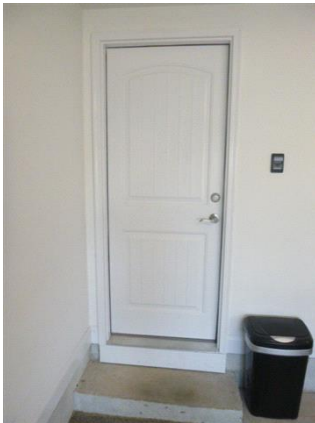
Fire Rated Door

The pedestrian door leading into the garage is a solid core, fire rated door. The door and hardware function as intended.

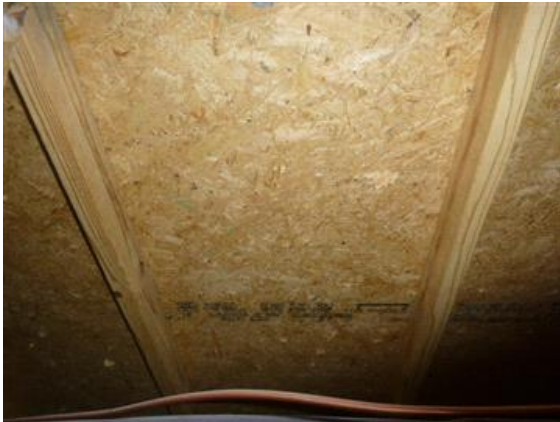
OSB Sheathing

The attic roof framing consists of engineered 2" x 4" wood trusses that are 2' on center, designed to carry the full load of the bearing roof. The sheathing type is OSB (oriented strand board). See photos. There were no visible defects or water intrusion detected at the time of inspection.

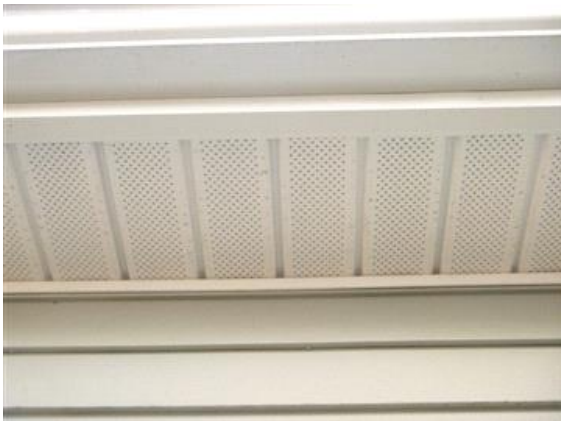
Soffit Vents

The attic ventilation consists of ridge vents running the length of the roof ridges and soffit vents along the perimeter of the roof, providing lower and upper attic ventilation.

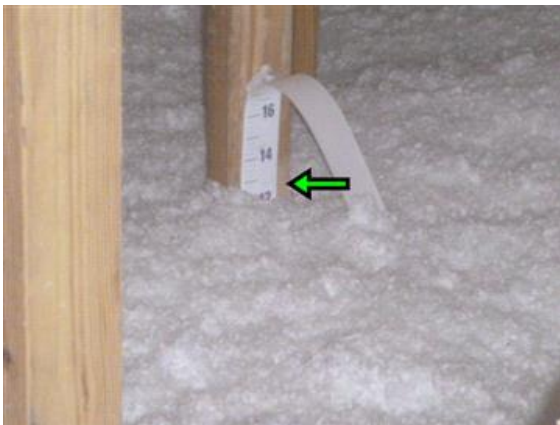
Loose Fill Insulation

There is approximately 12" of loose fill fiberglass insulation present in the attic that it is evenly distributed.

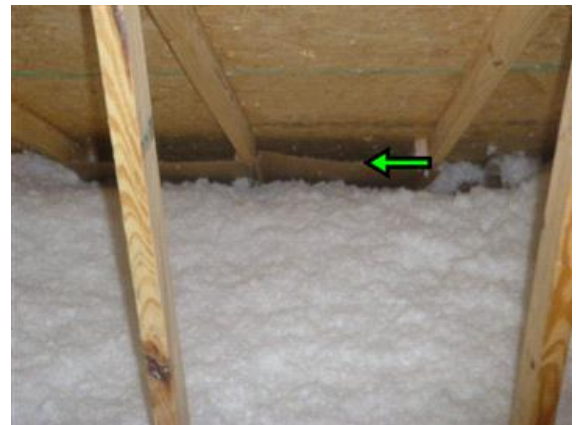
Cardboard Baffles

**NOTE:** Cardboard baffles are present at the eaves in the attic to prevent the loose insulation from blocking the soffit vents, to ensure proper ventilation.

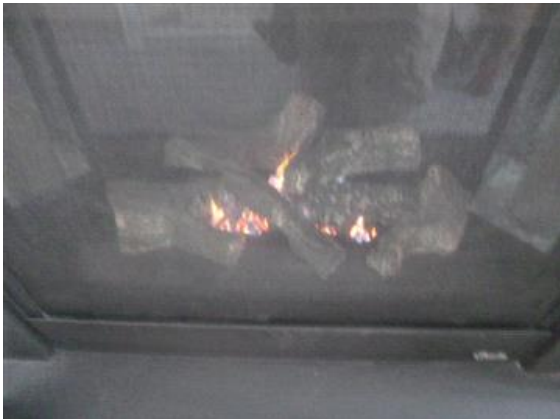
Functioning Fireplace Direct Vent

The propane gas, direct vent fireplace, located in the living room, was turned with a wall switch and functioned as intended.

Recommend annual cleaning - Fireplace design and soot / creosote buildup, in most cases, prevents view of chimney liner / cracks.
