Property Inspection Report

Residential Inspection Sample

Property Address:
123 Any Street
Any town TX 00000

By: Sean Green TREC #8266 / National Property Inspections 10/11/2018
(Name and License Number of Inspector) (Date)

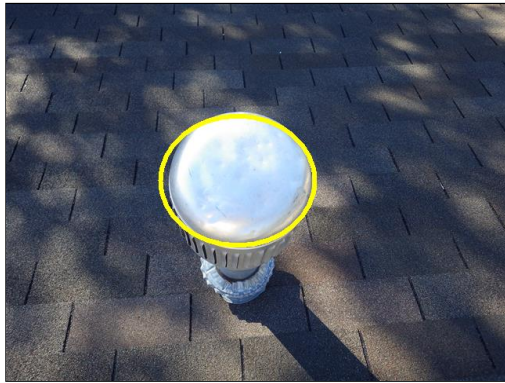
C. Photo 7 Dented spark arrester

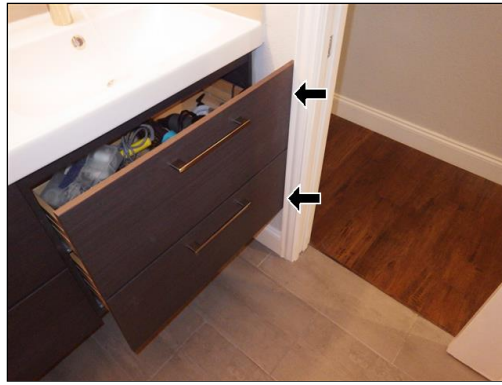
L. Photo 3

(2) In the guest bathroom, two of the cabinet drawers were not fully openable. They were hitting on the door frame trim.

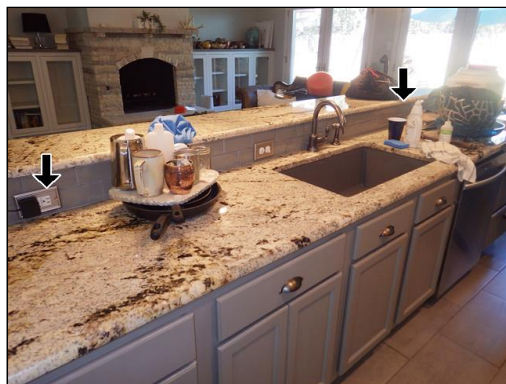
B. Photo 5

(5) Several kitchen countertop receptacles were measured to be too far away to service the adjacent countertops. Today's standards require that receptacles used to service countertops be installed so that they are no further than 24 inches from serving any point along the adjacent countertop.

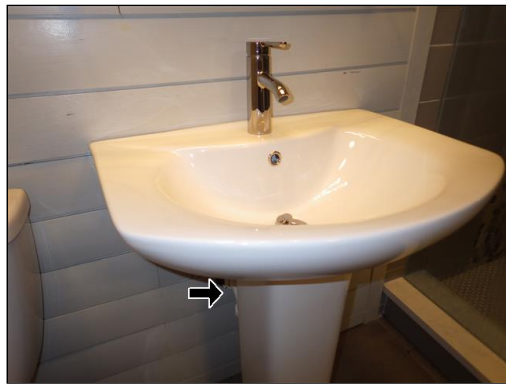
A. Photo 8

(8) There was a hole in the wall around the drain line for the sink of the right side bathroom.

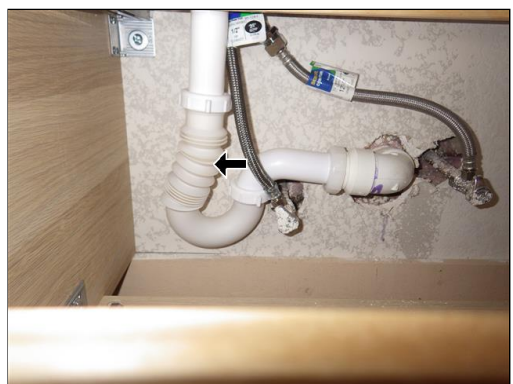
B. Photo 3

(3) The drains, wastes and vents appeared to be performing as intended at time of inspection.
