# Property Inspection Report

## New Construction w/Thermal- Sample

**Property Address:**  
123 Any Street  
Any City TX 75208

**By:** Sean Green TREC #8266, Westley Green TREC #21480 / National Property Inspections  
\_\_\_\_\_  
1/10/2017  
\_\_\_\_\_  
(Name and License Number of Inspector) (Date)

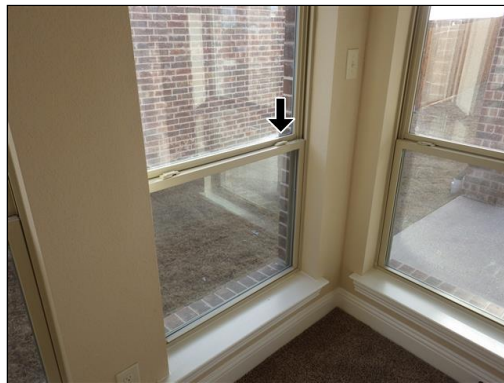
H. Photo 11

(8) Two of the windows along the left side of the living room had frames that were installed too wide. During testing, the lower sashes fell out of the frames. This is a potential safety issue. The lower sash should have very little side to side movement.

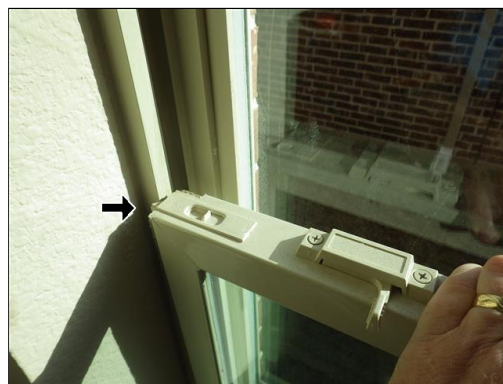
H. Photo 15

(9) At a left side breakfast nook window, the lower sash was not parallel to the frame and so it would not lock down. Also, one of the interior plastic beads was dislodged.

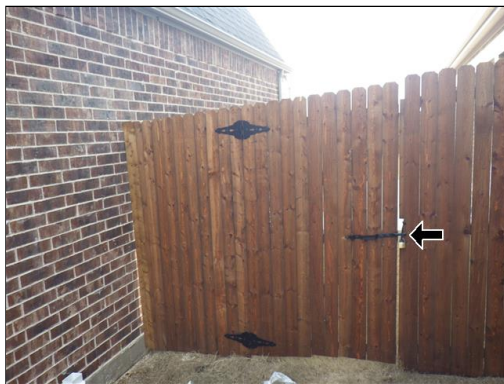
L. Photo 1

(1) The right rear corner of the structure was not accessible due to a locked gate from the adjacent residence. The wall behind the fence was not assessed.

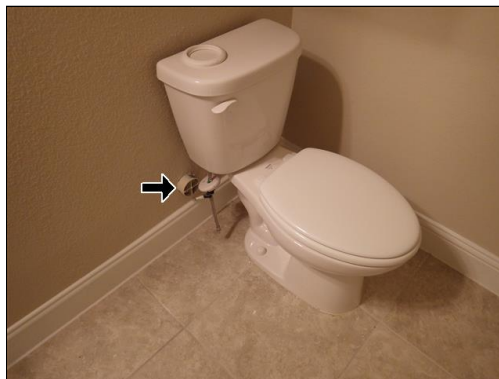
A. Photo 1

(2) The water supply for the toilet in the half bath was not yet connected.
