**PROPERTY CONDITION REPORT**

Client(s): Client Name  
 Property Address: 123 Address St  
 Mesa, AZ 85212  
 Realtor: ,  
 Date: 05/27/2024  
 Inspector: Alex Tuia  
 Report #: A052702-24RT

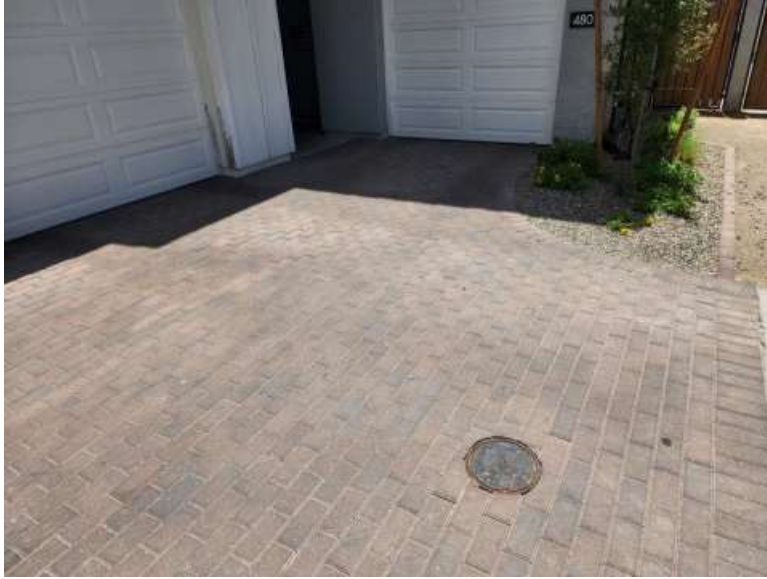
The driveway for the building is concrete and pavers, which was in generally acceptable condition with any minor cracking of flatwork a cosmetic issue only unless otherwise noted.

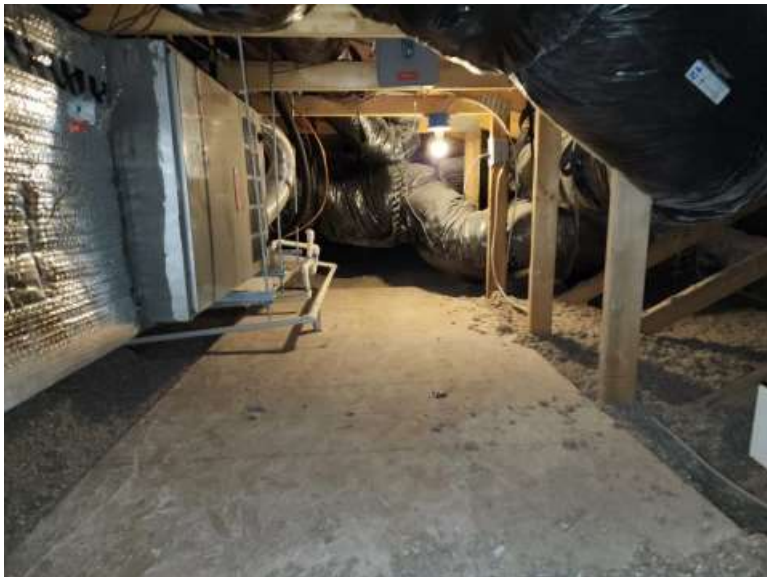
Because of limited clearance and/or the potential for damage, our inspection of the attic was performed from the air handler/furnace platform only. As such, our observations were based on a limited view of all the attic space.

**Repair:** The service platform in the attic does not extend all the way to the access. Recommend it be extended so the furnace is easily accessible to anyone servicing the unit.

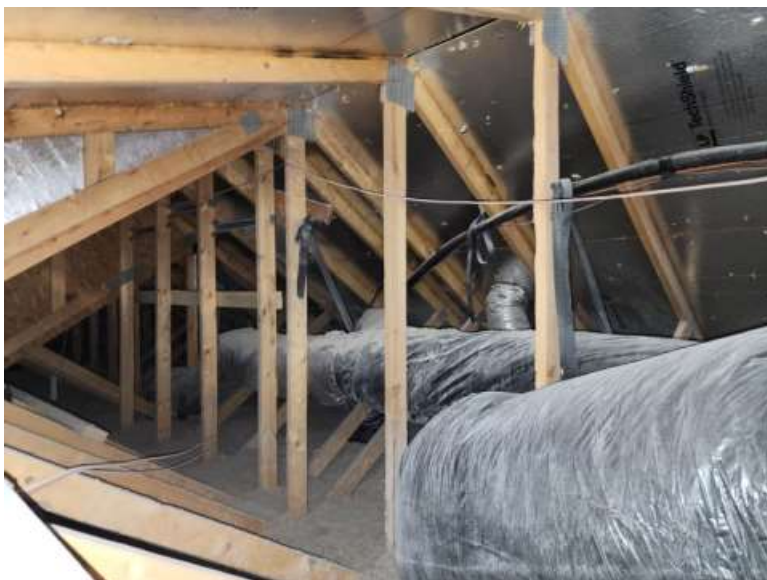
The roof structure (conventional framing and/or trusses) appeared serviceable with no noted problems.

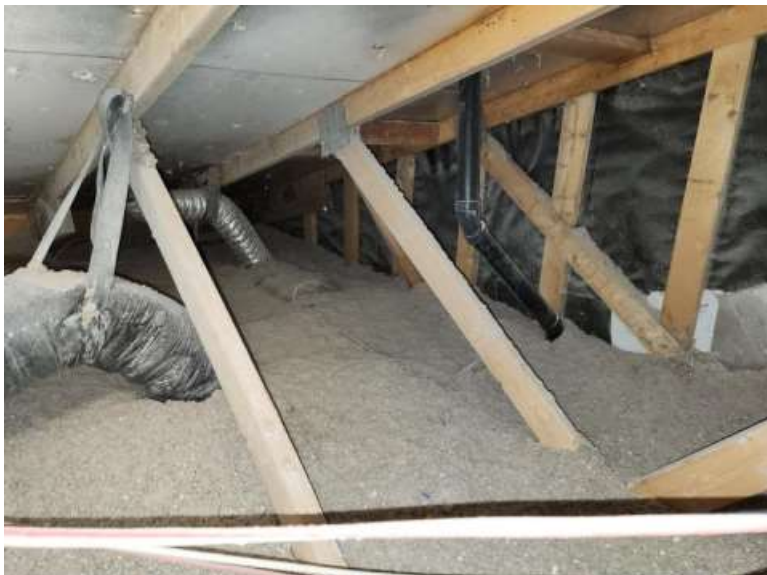
The type of insulation used to insulate the home was wood cellulose.

The estimated average depth of the attic insulation was 7 to 9 inches. The insulation visible to inspect was adequate

and properly installed. Any exceptions are noted below.

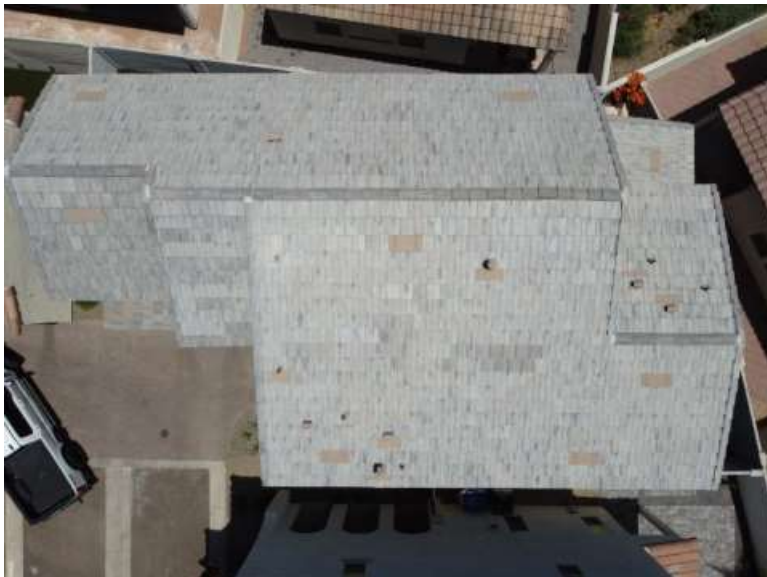
The main roof covering for this structure was a flat concrete tile.
