National Property Inspections

Joe Smith, 123 Main Street, Pensacola, FL, 32501

Saturday, September 21, 2019

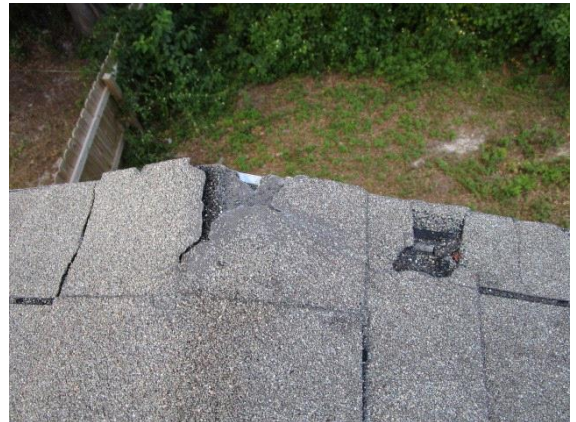
Shingles displayed various deficiencies including cracks, holes, granular loss, exposed fiber, and exposed nails.

Exposed nail.

Recommend a qualified roofing contractor remove both layers of shingles, make any necessary repairs to sheathing before installing new roof.
