National Property Inspections

Property Address, Montoursville, PA, 17754

Monday, May 2, 2022

Summary

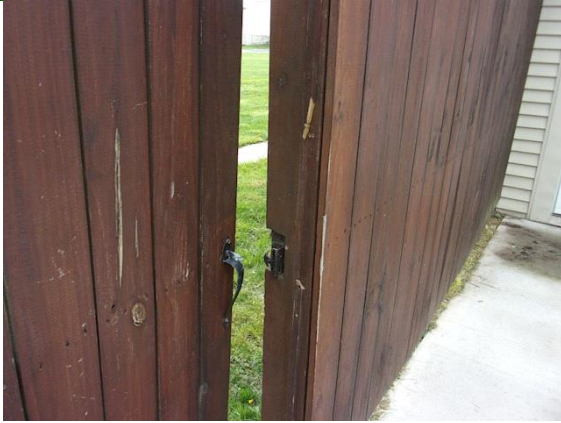
Fences / Gates:

The gate lock is inoperable from the driveway side and should be replaced.

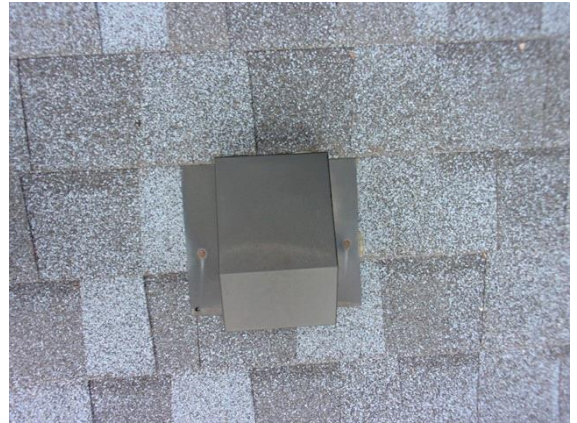
Roofing:

Shingles were in average condition for their age. The roof was inspected by walking on the lower roof surfaces and garage, while the main roof was observed from the ground.

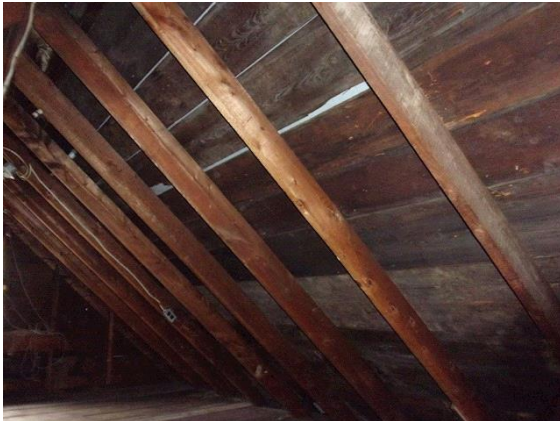
Attic Framing/Sheathing:

All the framing and sheathing that was visible from the attic was acceptable at time of inspection. Evidence of a roof leak around a chimney that has been removed and repaired was noted.

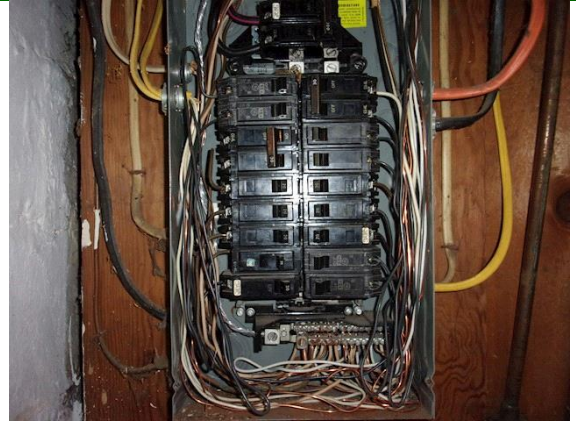
Main House Panel:

All neutral wires must be individually connected to the buss bar. Some were doubled up. Improper clearance to electric panel. Today's standards require 3 feet wide x 3 feet deep by 6 feet high for safe working clearance. Rust noted on the bottom of the electrical panel and on the screws for the neutral buss. As a result of this corrosion, hazardous conditions may be expected as the integrity of any corroded connection can become suspect.

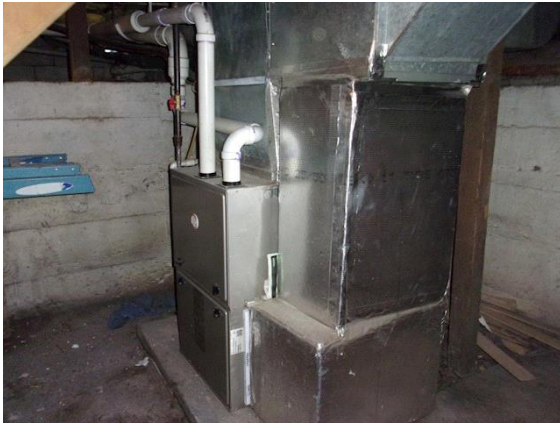
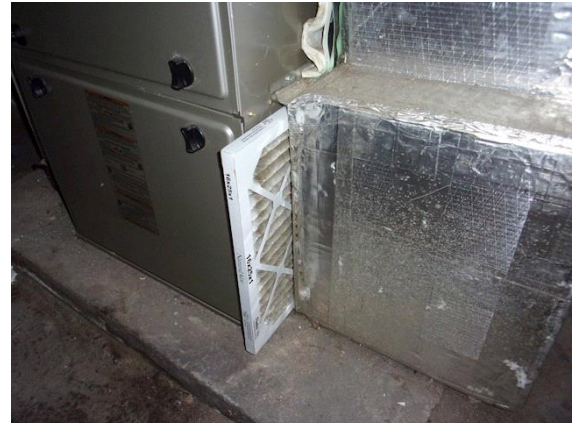
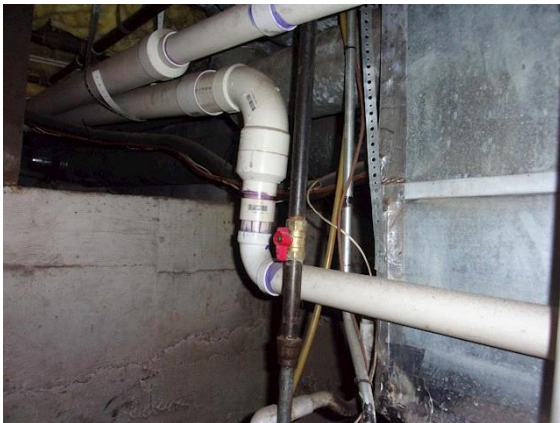
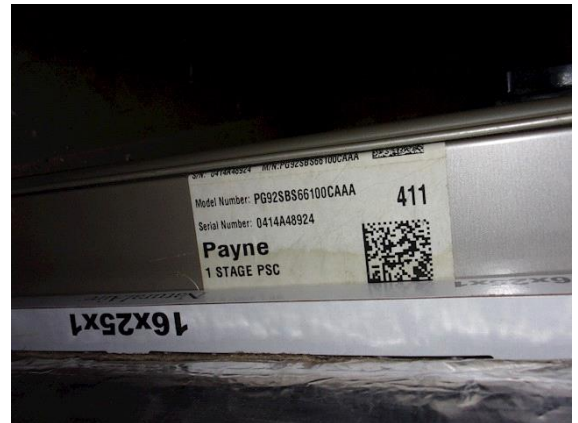
Furnace was clean and running properly at time of inspection. Heat distribution was acceptable with no problems to report. It is important that the furnace be properly maintained for efficiency and greater life span. Recommend a yearly maintenance program be set up with a local heating company to service and clean the furnace. This could greatly improve the life span of unit.

The return duct in the basement is disconnected under the living room near the front door.

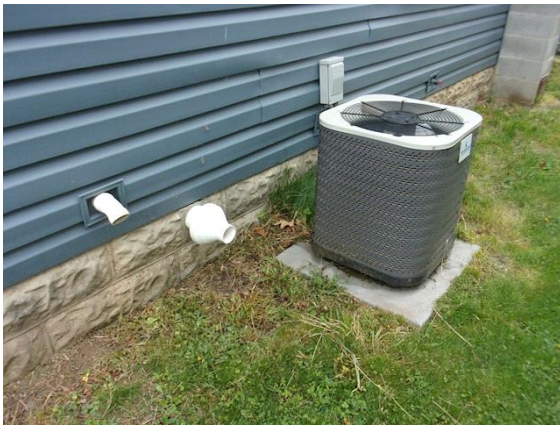
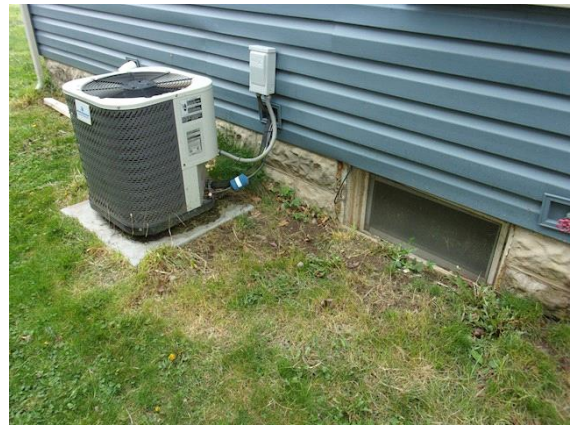
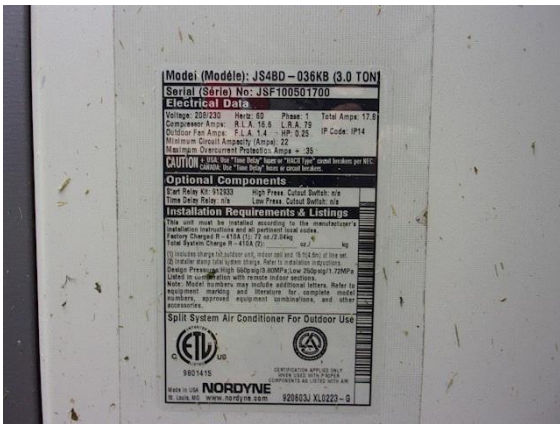
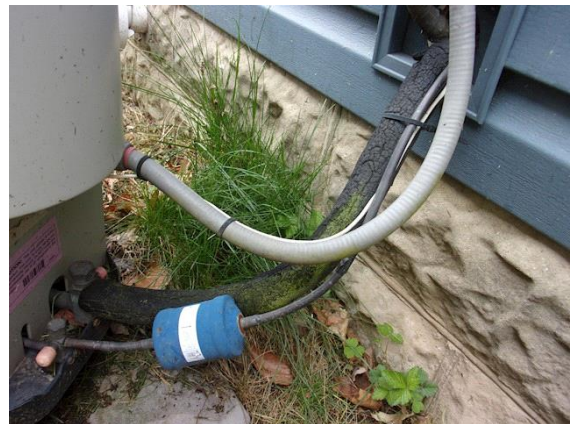
A properly maintained A/C unit should last from ten to fifteen years under normal exterior conditions. Unit was rated as marginal due to its age.
