# INSPECTION REPORT

12345 Main St  
El Paso, TX 79938

**INSPECTION DATE**  
Wednesday, January 10, 2024

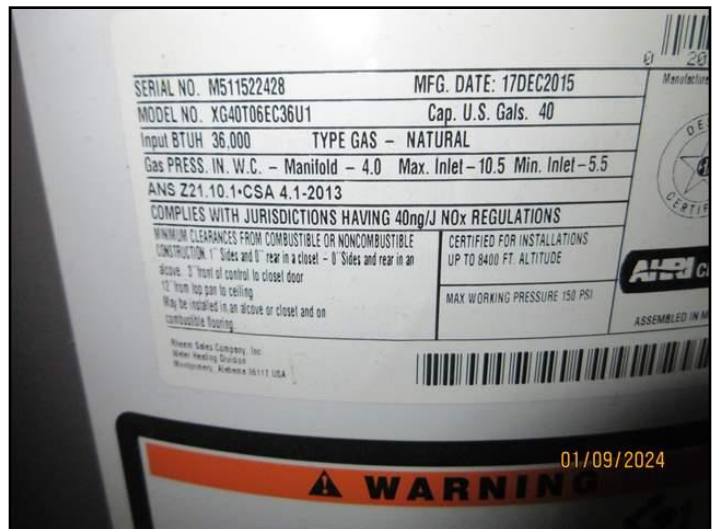
12. **Condition:** • No plumbing recommendations are offered as a result of this inspection.

14. No plumbing recommendations are offered as...
