NATIONAL PROPERTY INSPECTIONS®

Inspection Report

1234 Street
Montgomery TX

Date: 2/18/2022	Time:	Report ID: NPINHO21822
Property: Street Address Montgomery TX	Customer: Client Name	Real Estate Professional:

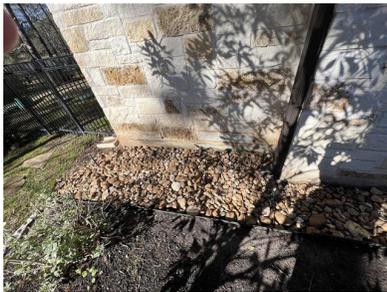
A. Item 1 (Picture)
foundation

(1) All accessible windows and doors were opened and closed to evaluate for the presence of racking/settlement. The accessible attic structure was inspected for possible separation, bowing, buckling, and signs of foundation or structural movement of the framing. At the time of inspection the foundation appeared to be supporting the structure as intended. There were no visible signs of significant cracking or other irregularities in the foundation at the time of inspection.

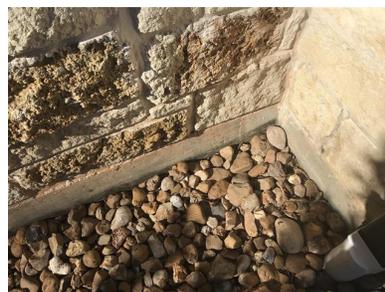
A. Item 5 (Picture)
foundation

(2) Typical corner pops were observed. It was noted that the house had corner pops on one or more corners of the foundation. Corner pops are not structural in most cases and should be patched as needed. Corner pops generally occur in areas of the foundation where it is difficult to add reinforcements into the concrete foundation forms and the lack of reinforcement allow corners to crack and sometimes pop loose. I recommend patching the concrete to prevent further deterioration

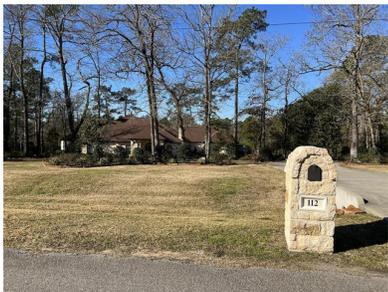
B. Item 1 (Picture)
street view

(1) Property slopes significantly from road to lake, with House located in the middle of the property. A properly designed drainage system is required to move and keep water from pooling near the foundation. Grading of the property was found to be generally acceptable with a positive slope away from the foundation. The drainage incorporates the natural flow of water through the property and assists with gutters, downspouts, french drains and swales successfully. It had rained for consecutive days before inspection and there was no pooling of water observed. There were no noticeable defects at the time of inspection

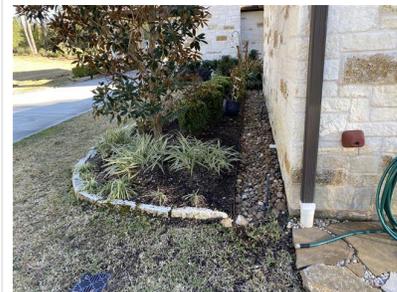
B. Item 6 (Picture)
gutter into drainage system and french drain

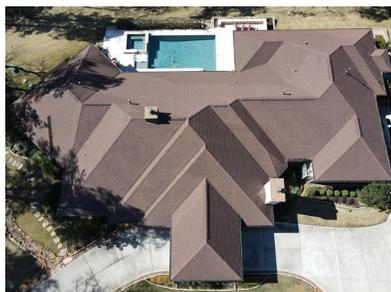
D. Item 1 (Picture)
gen roof

(1) Overall the roof was in acceptable condition, and no signs of damaged shingles or active leaks noted on day of inspection. The roof covering is estimated to be between 5-10 years old and show signs typical of similarly aged architectural shingled roofs.

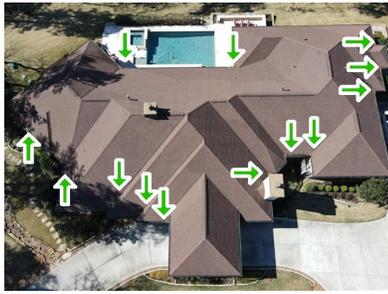
D. Item 8 (Picture)

(2) Piles of pine needles and debris were observed sitting in several locations on the roof. I recommend clearing these areas to prevent moisture being trapped on shingles and causing shingles to deteriorate at a quicker rate than the surrounding roof covering. All debris should be cleared from roof covering and gutter system to make sure runoff is directed off and away from the home.
