Inspection Report

Property Address:
1313 Mockinbird Ln
Anytown, TX 77433

PROPERTY INSPECTION REPORT

2-15-2018

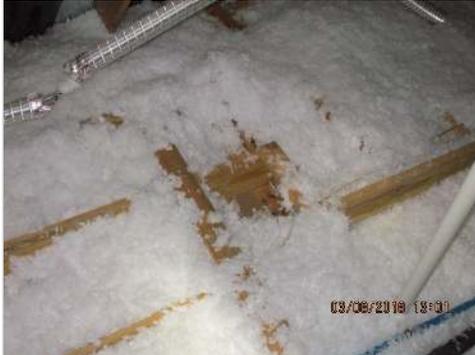
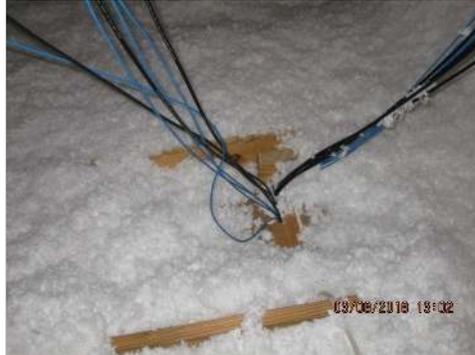
There were a few areas in the attic where the insulation appears to have been pushed aside or removed where the low voltage / communication cables are penetrating wall caps. The insulation should be replaced back in these areas to ensure the intended function is maintained.

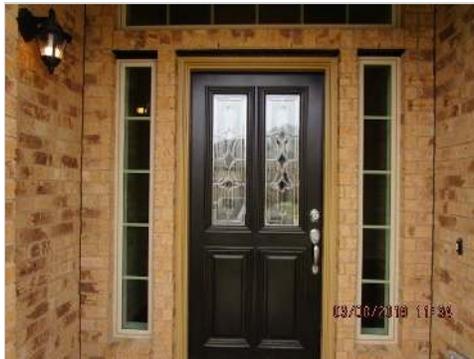
Photo of repair

Doors appear to be functioning properly and seal properly when closed, but the rear door knob was not properly installed and fell off when attempting to open the door.

3.20.2018 Reinspection comment: Door knob was repaired.

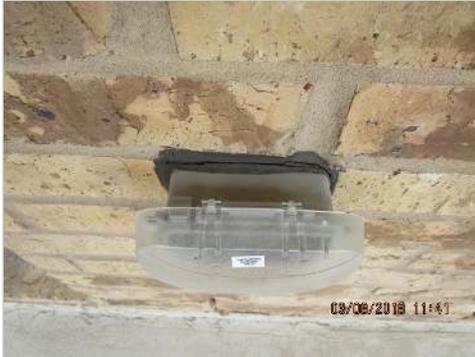
Exterior GFCI receptacle box at rear of house has caulk that appears to be weathered and requires caulking.

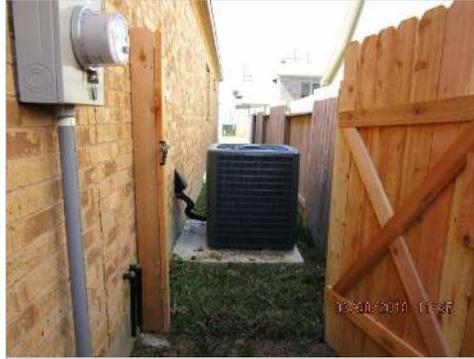
Photo of repair

Outside A/C unit is noisy due to vibration. Recommend shim or soft spacers be applied at footings.

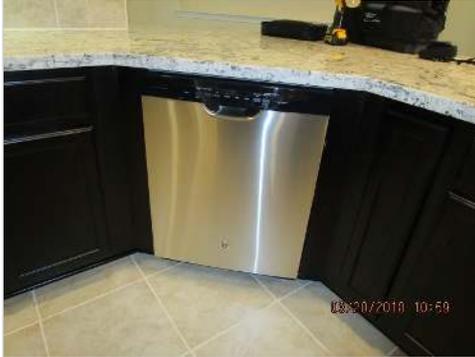
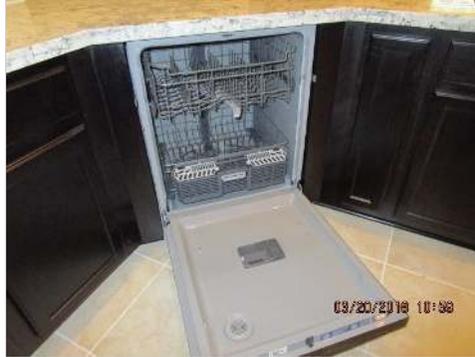
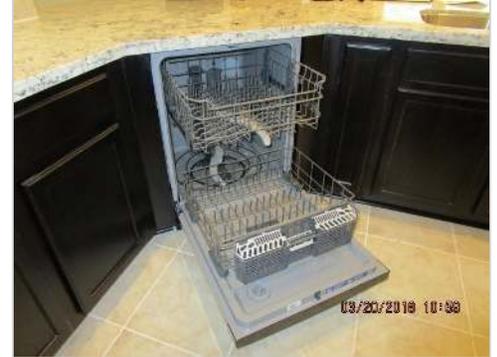
3.20.2018 Reinspection comment: All mechanical components of the dishwasher were checked for proper operation. The unit was run through the normal operation cycle and no leaks or deficiencies were noted.

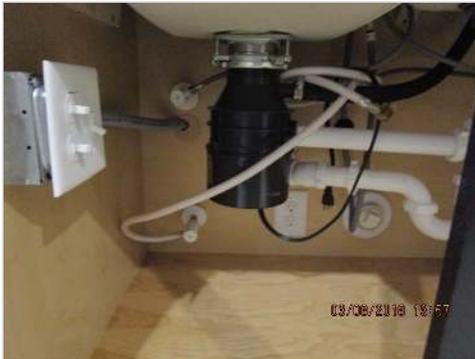
3.20.2018 Reinspection comment: Food Waste Disposal was inspected for leaks and operation with water running. No deficiencies were noted at the time of inspection.

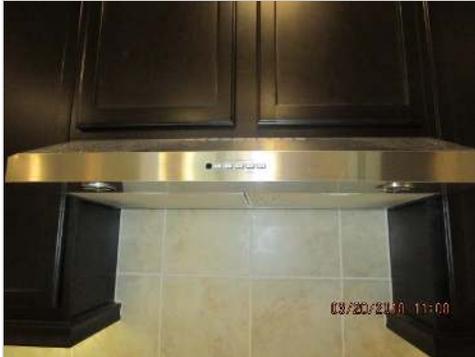
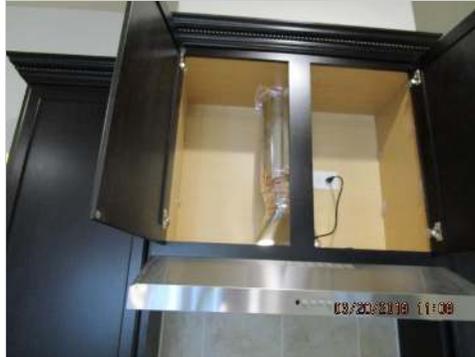
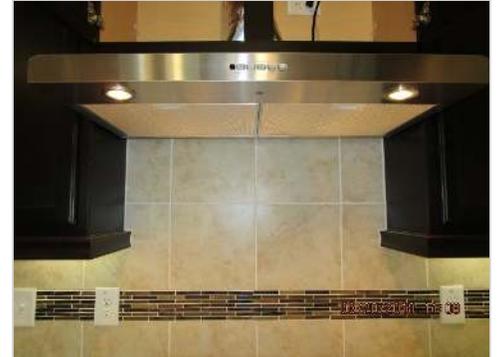
3.20.2018 Reinspection comment: Vent Hood was in New Condition at time of inspection. Vent Hood was operated all all fan speeds and light settings. Screens were removed and checked for cleanliness

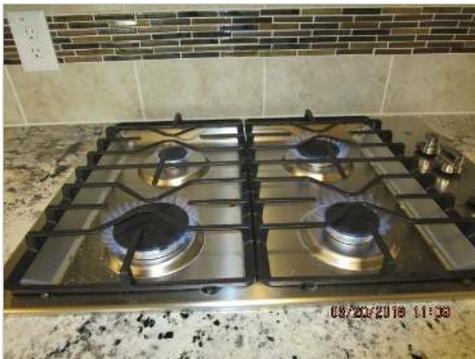
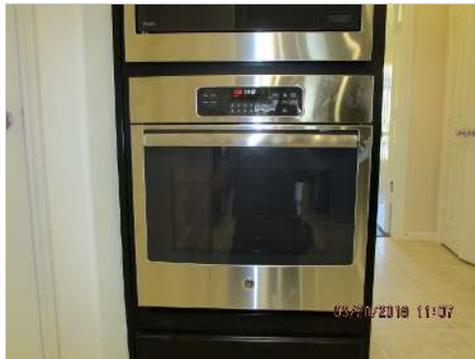
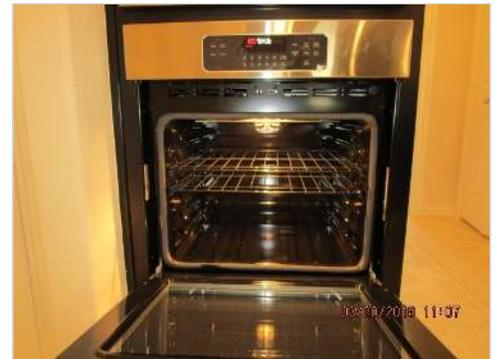
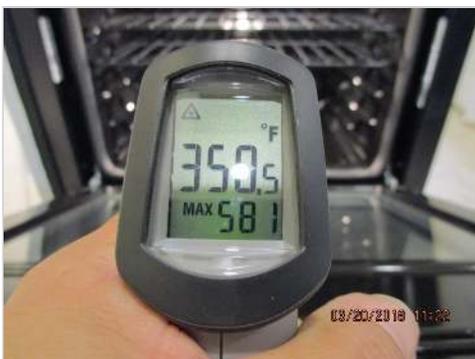
3.20.2018 Reinspection comment: All burners on the cooktop were found to function as intended.

Oven was preheated to 350°F. Oven actual temperature was 351°F

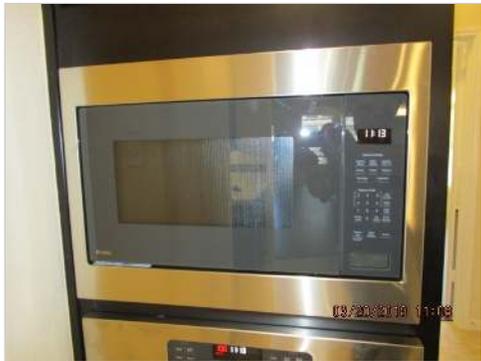
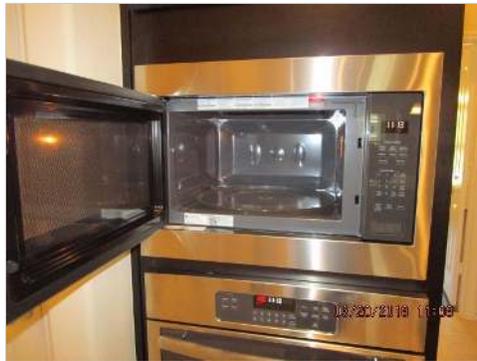
Microwave was found to function as intended at time of inspection

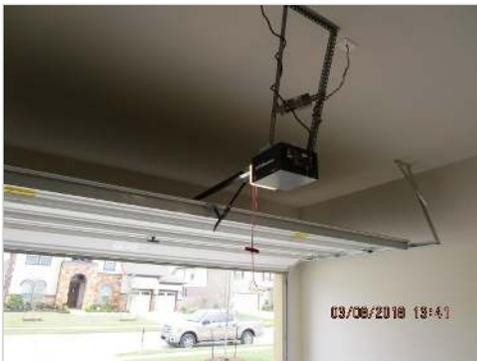
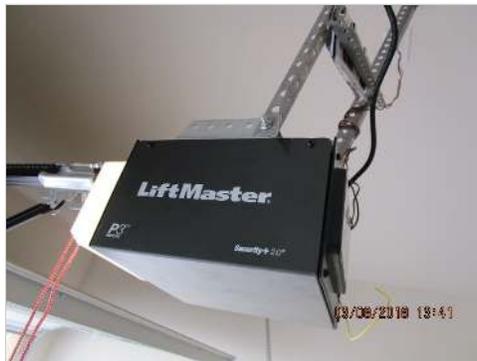
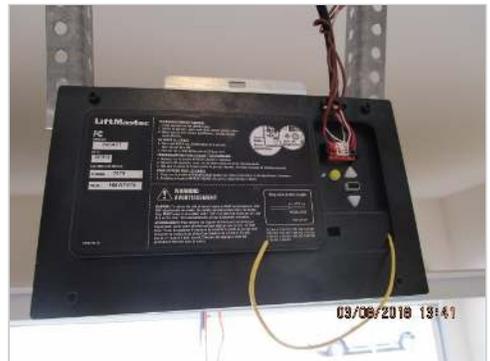
Garage Door Auto Reverse function did not operate correctly when upward pressure is used against door while closing. This can likely be fixed by adjusting the upward / downward force settings at the motor
