Thoreyon Enterprises LLC DBA
National Property Inspections

Inspection Date:
03/11/2025

GENERAL INFORMATION

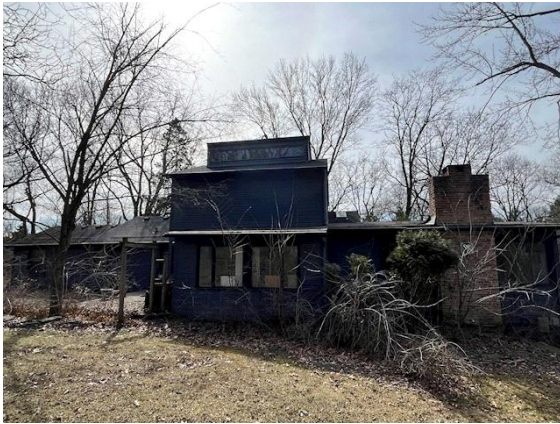
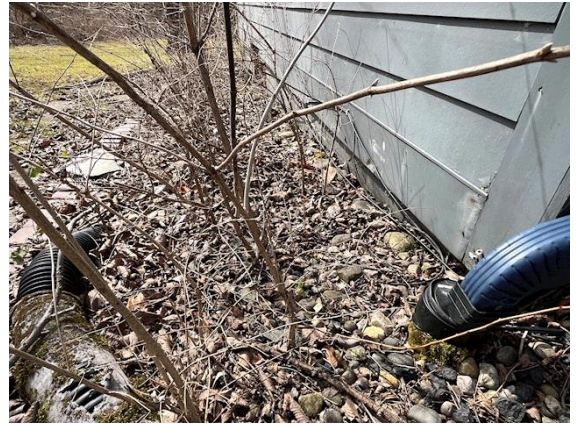
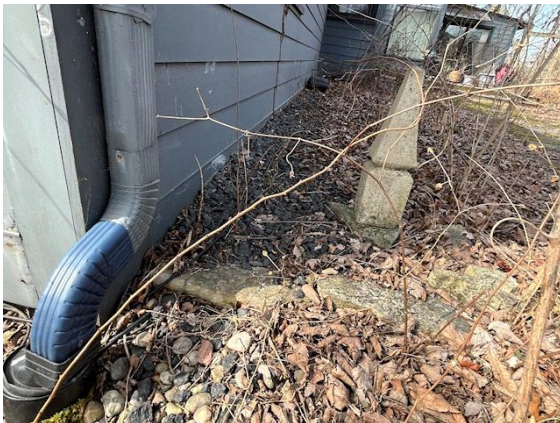
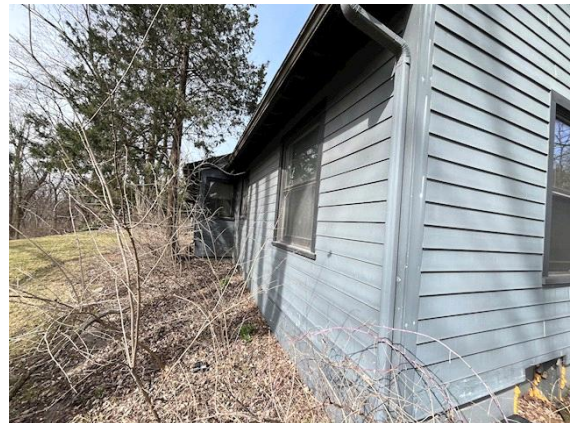
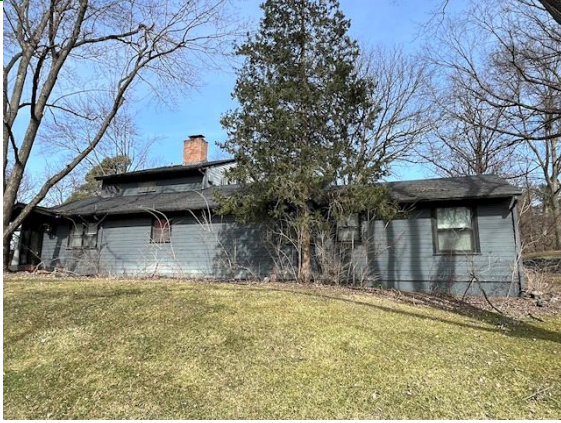
Appeared to be a positive slope around all sides of the home.

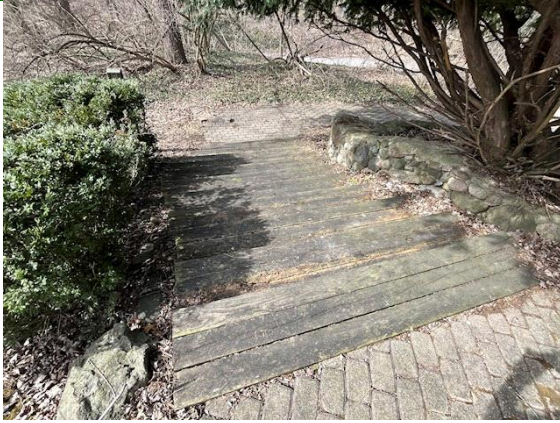
Walks / Steps:

Wood steps leading from the driveway to the front and rear of the property were deteriorating and overgrown with vegetation recommend clearing out the vegetation and re laying the steps

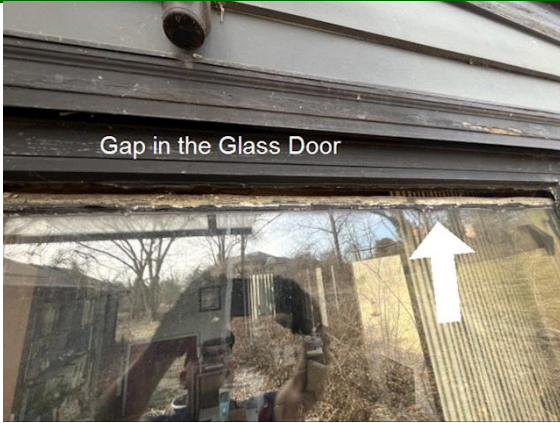
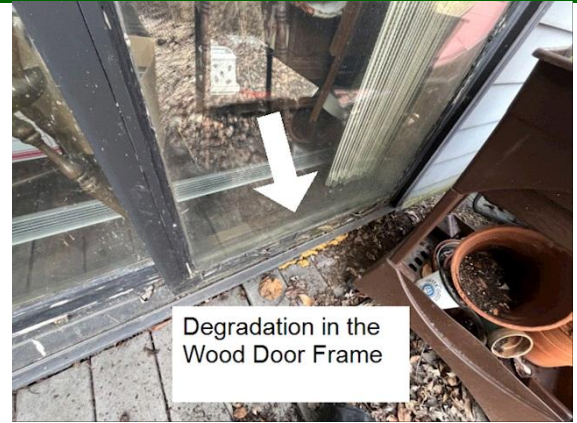
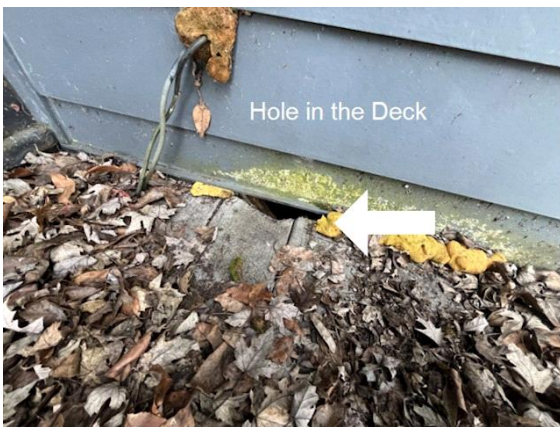
Rear deck showed some deterioration of the wood. There were holes present and deck was covered in vegetation recommend repairing the wood and clearing the deck and resealing. Sliding doors to sun room were deteriorated and glass has slipped down due to degradation of the wood frame leaving a gap in the top of the door.

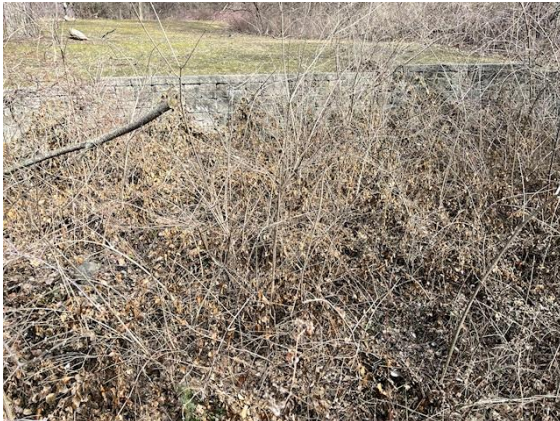
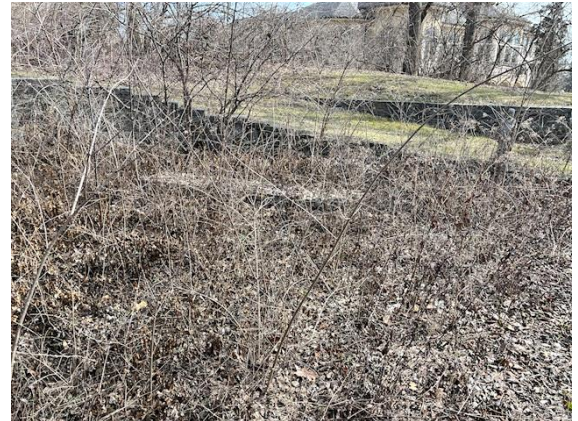
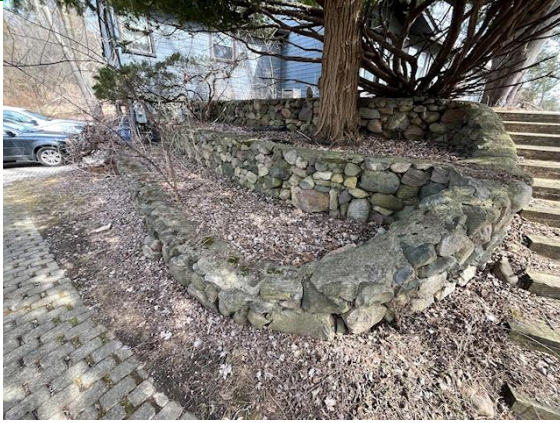
Retaining wall appeared to be functioning as designed and is in good shape at time of inspection.

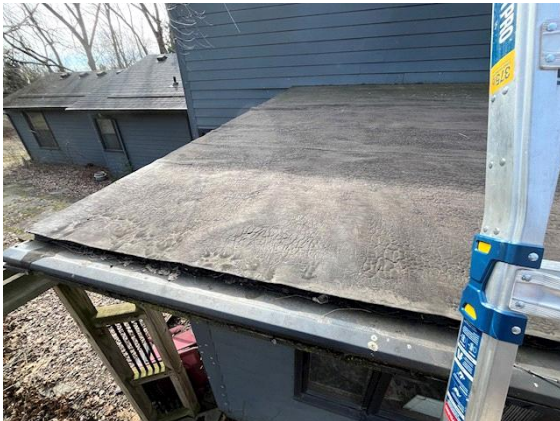
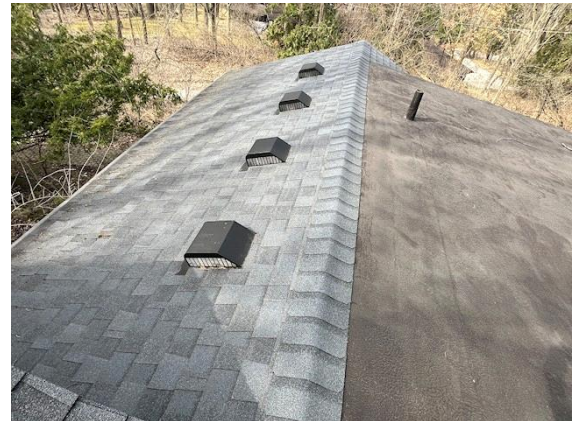
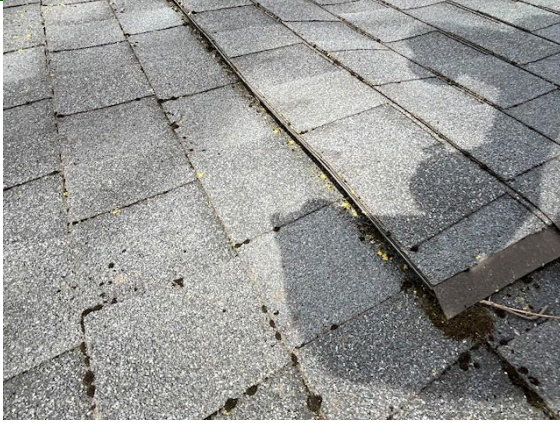
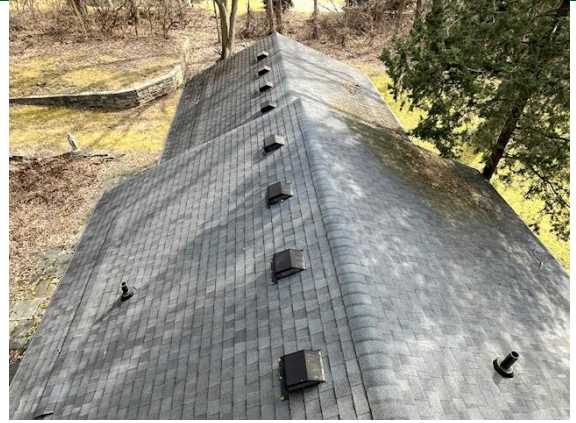
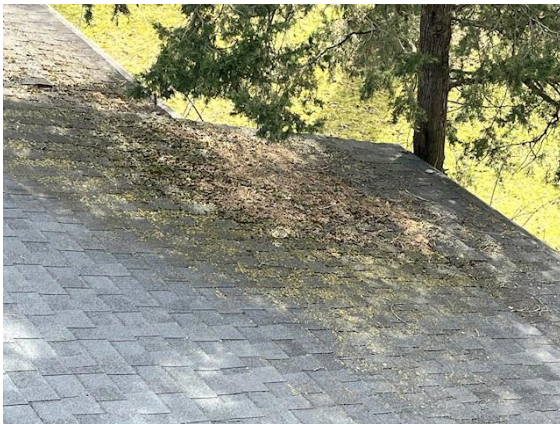
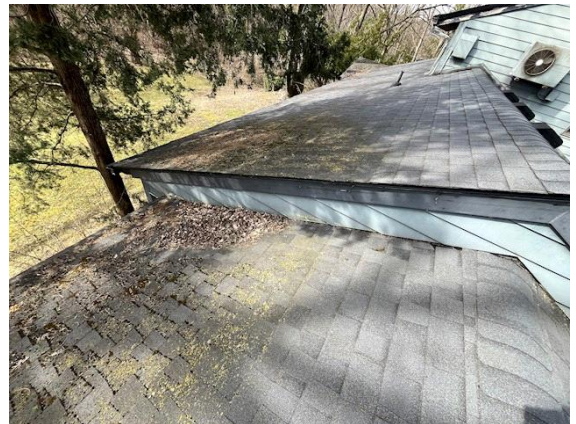
Architectural asphalt shingles were in acceptable condition at the time of the inspection. Rear membrane roofing was starting to show signs of deterioration. There was Moss growth visible on the north side of the roof and tree overhang and debris on the roof. Recommend trimming the trees to prevent further damage to the shingles

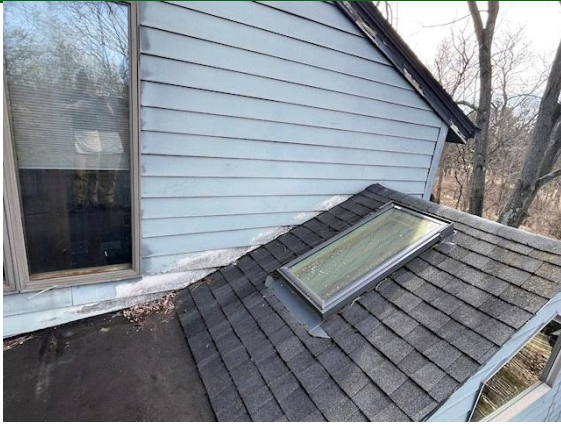
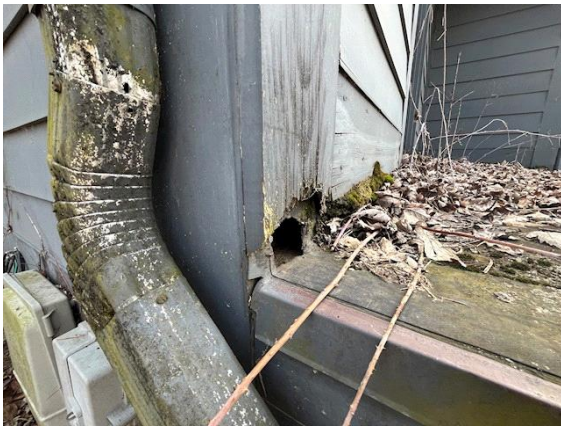
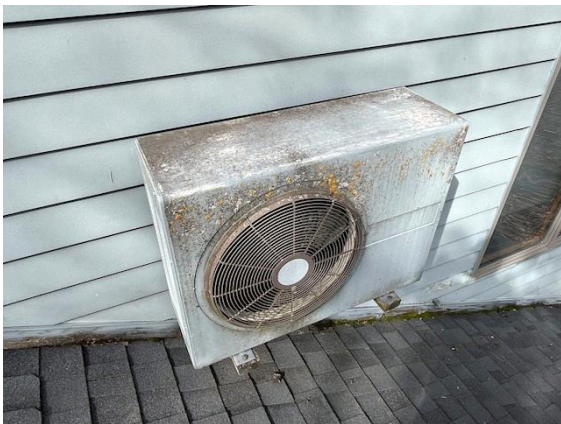
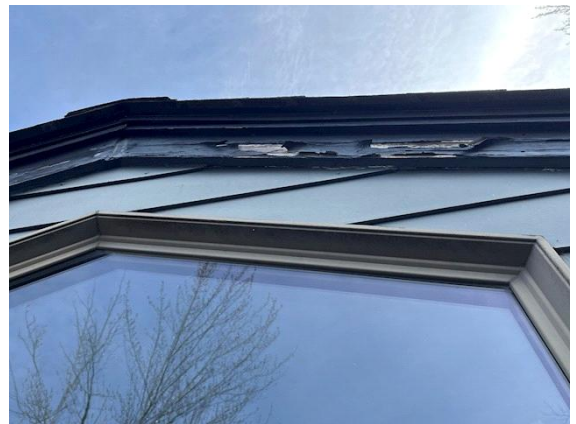
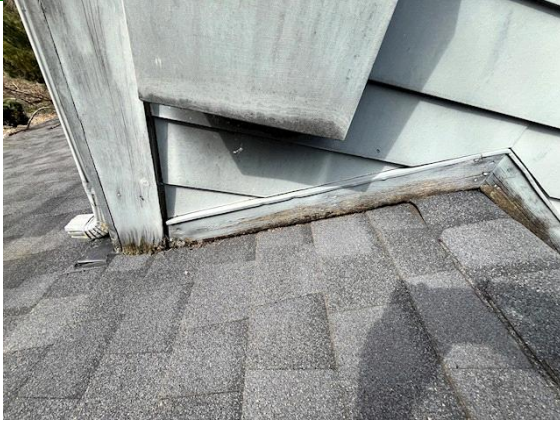
There were many areas where the flashing had deteriorated and there were holes present that could be a conducive condition for water intrusion and rodent and pest entry. There were areas where the wood Ridge board and fascia had deteriorated. Recommend repair to prevent further damage and intrusion

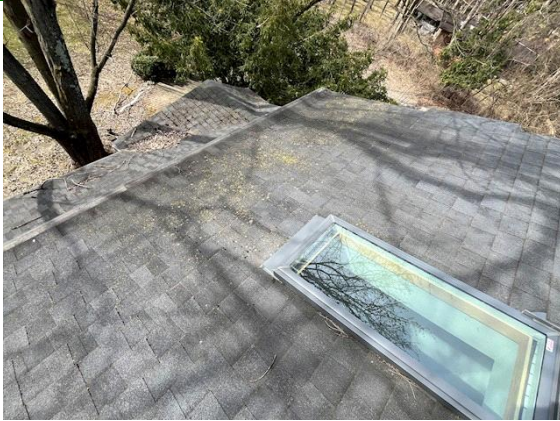
Skylights:

Flashing around the skylights could be causing some water intrusion. Recommend resealing and caulking to prevent further intrusion. Thermal Imaging shows possible moisture intrusion. This could be due to loose flashing or leak in the skylight.

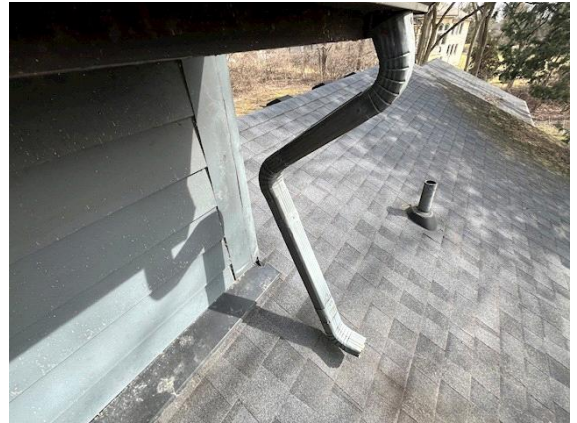
Gutters were in acceptable condition at the time of the inspection. Leaf covers were present. Downspout coming off the 2nd floor roof in the front has become detached. Some of the downspout we're missing extensions or had crushed extensions. Recommend repairing to prevent water intrusion into the foundation.

Gutters/Down Spouts: Gutter downspout has become detached.

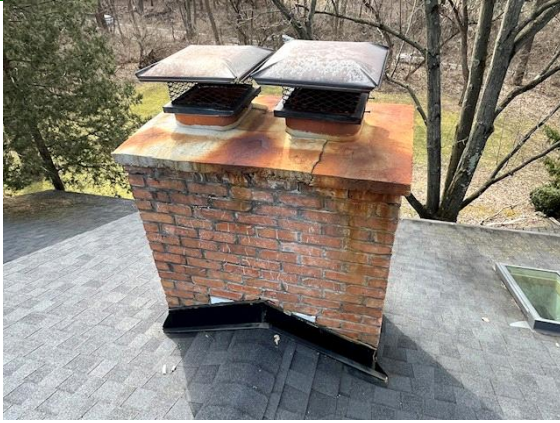
Chimney:

There are two chimneys. The chimney off the dining room appears to have been sealed off and was in acceptable condition at the time of the inspection. The chimney connected to the living room showed some signs of deterioration. Recommend repointing and tucking the mortar in the chimney

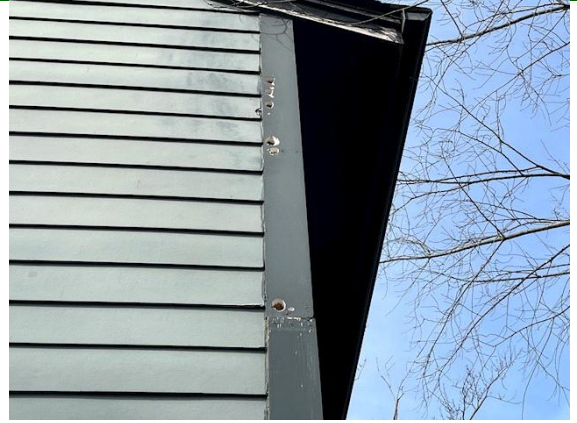
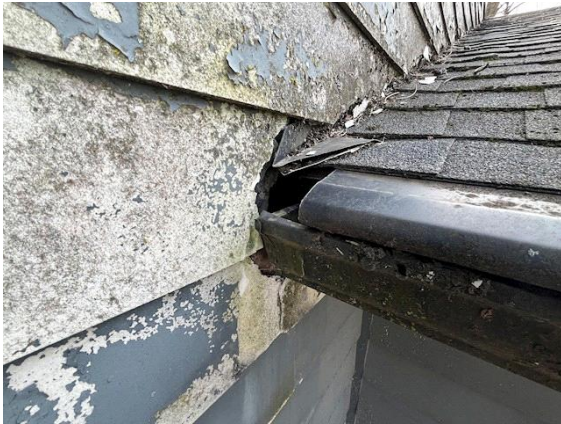
There were areas of the siding that had become deteriorated and degraded. This condition could lead to water intrusion and pest intrusion. Recommend repairing damaged siding to prevent further degradation.

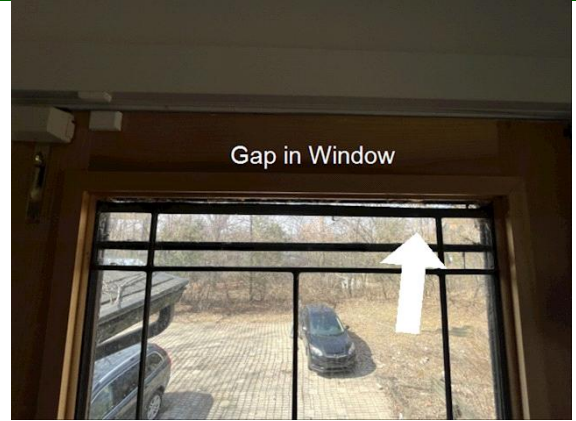
Sliding doors off the rear deck in the sunroom word degraded and deteriorated glass had slid down allowing for a gap in the top of the door. Balcony door off the dining room also had a deteriorated frame which has caused the glass to slide down as well allowing for a gap in the top of the window. Front door and rear laundry room door were in acceptable condition at the time of the inspection.

Exterior Doors: Balcony Door off Dining Room. Wood Frame is deteriorated and there is a Gap in the door between the Glass and the top of the frame.

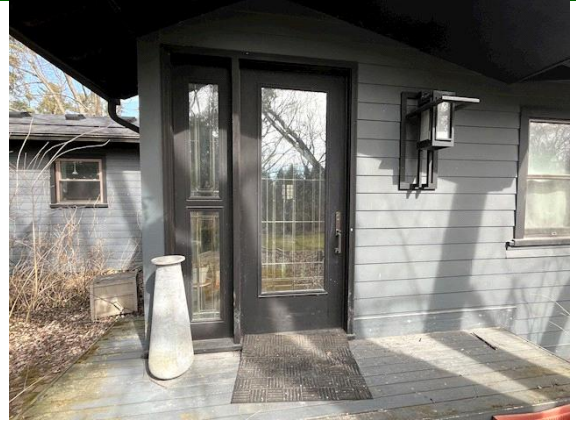
Exterior Doors: Balcony Door off Dining Room. Wood Frame is deteriorated and there is a Gap in the door between the Glass and the top of the frame.

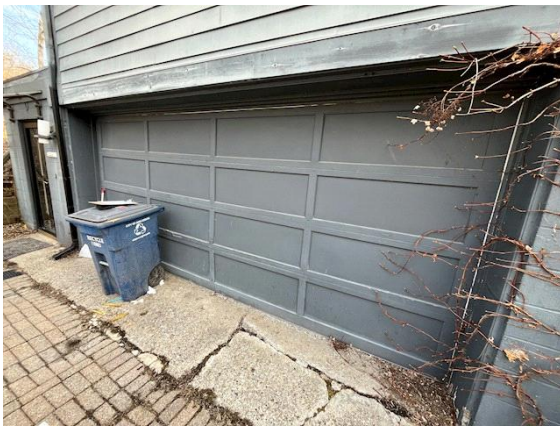
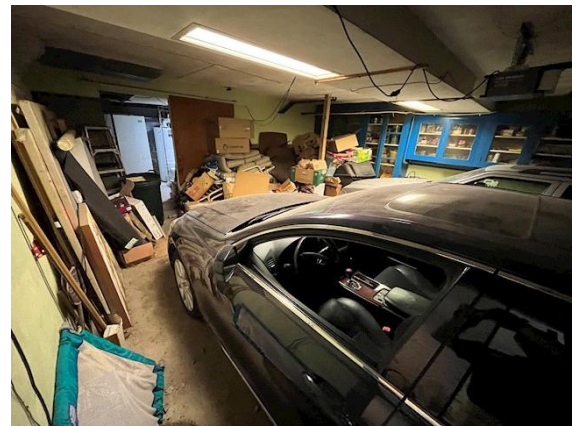
Flooring walls and ceiling of the garage were in acceptable condition at the time of the inspection. One of the electrical outlets in the garage showed an open ground.

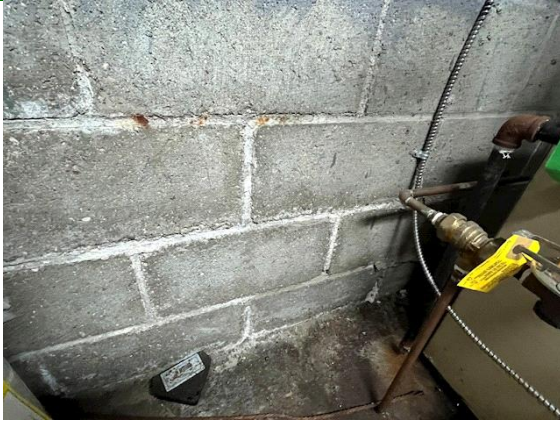
Interior Foundation:

Limited observation due to crawl space and owners' belongings. Some evidence of efflorescence and spalling observed. Recommend monitoring for further evidence.

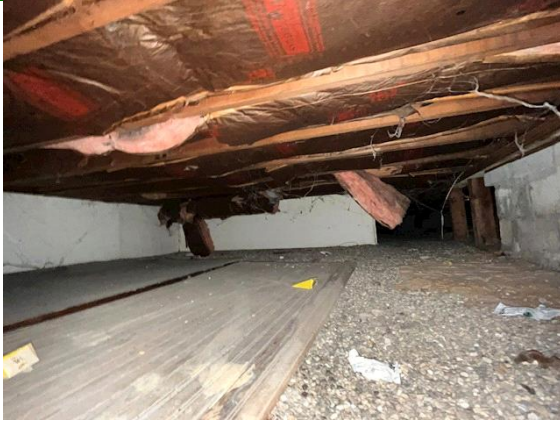
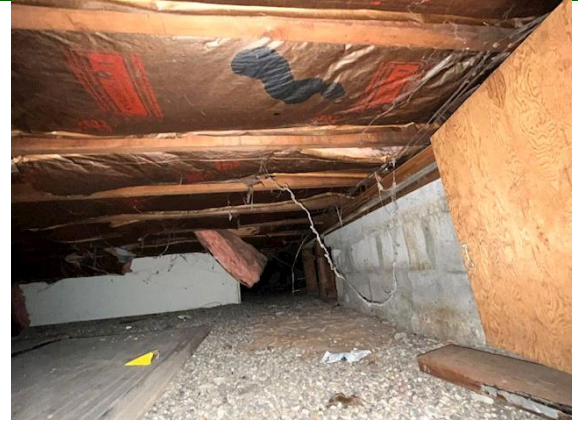
Limited observation due to crawl space and rodent activity. Framing appears to be an acceptable condition but there were many areas where the insulation was missing or had fallen from the under flooring.

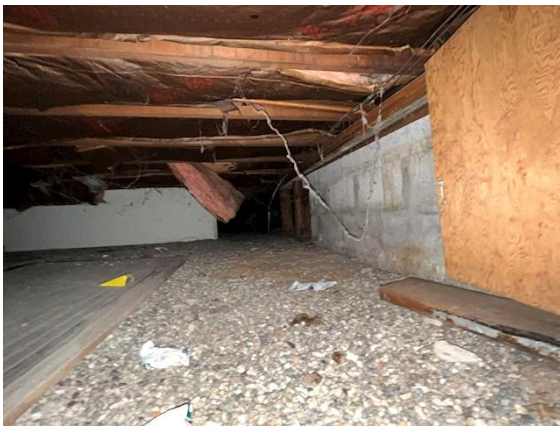
Crawl Space:

Crawl space was not entered due to rodent activity. Space was observed from the opening. Recommend continued treatment to prevent further activity.

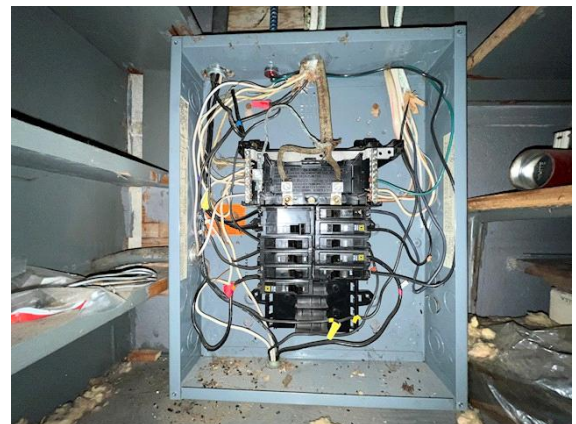
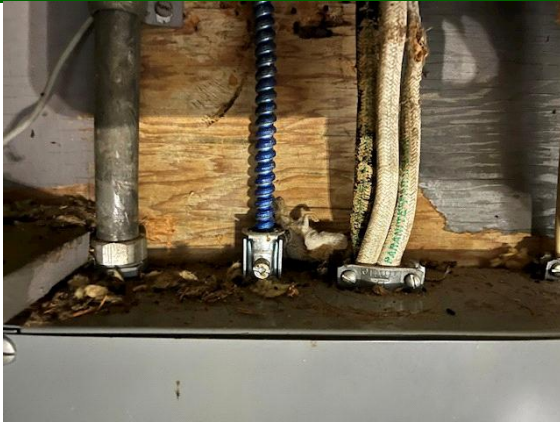
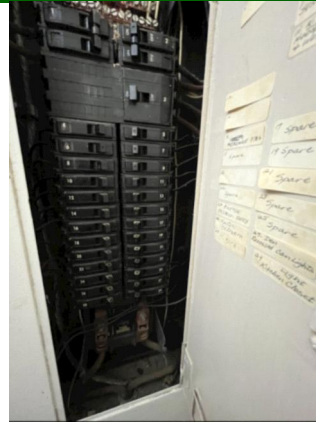
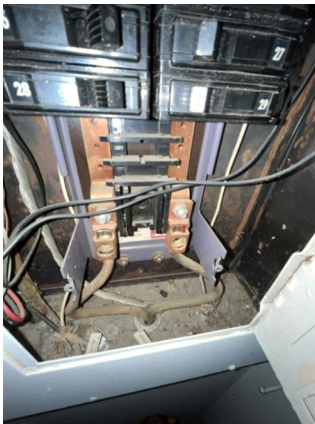
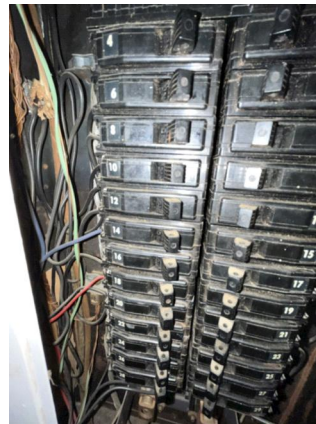
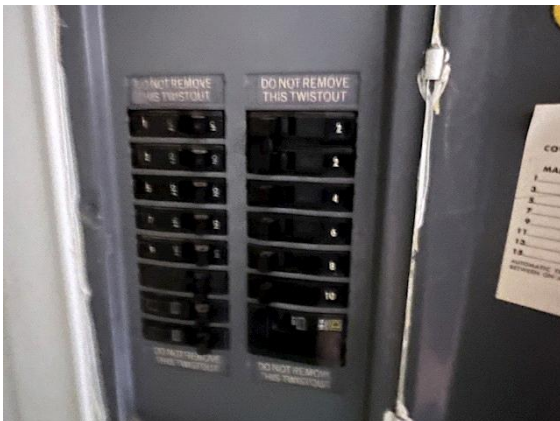
There were three electrical panels observed during the inspection. Electrical panel in the garage showed signs of rodent activity in the panel and a dead mouse on top of the panel. This is a potential fire hazard. Electrical panel in the kitchen was in acceptable condition at the time of the inspection. Electrical panel in the laundry room was painted shut and unable to be inspected for the wiring. There were no GFI protected outlets in the home. GFI outlets were not standard at the time of construction but recommend adding GFI protected outlets in kitchen and bathrooms. Smoke detectors were present in the home but not tested due to the homeowner being present and sleeping.

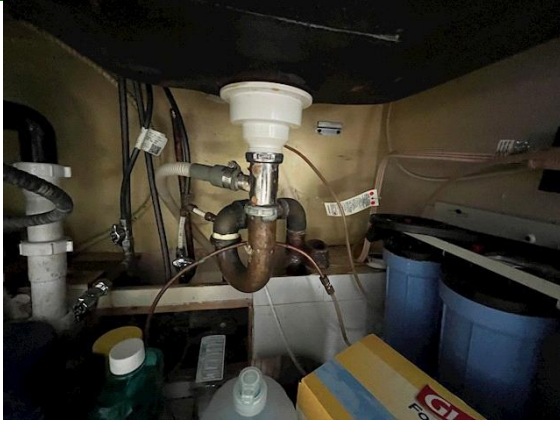
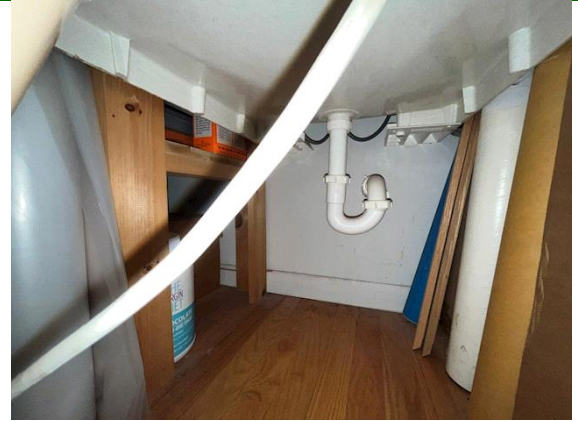
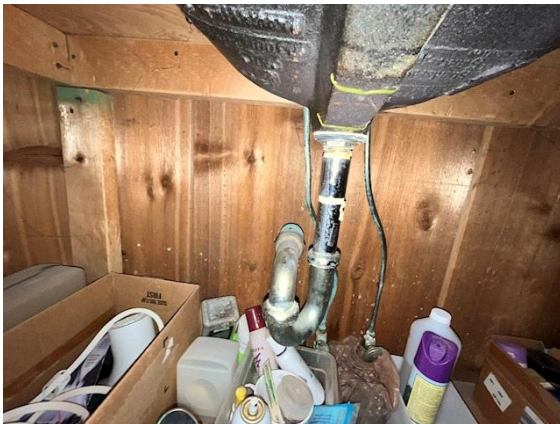
Plumbing appeared to be an acceptable condition at the time of the inspection. Some galvanized piping was observed which is known to degrade and cause leaks. Recommend replacing with PVC pipe as needed.

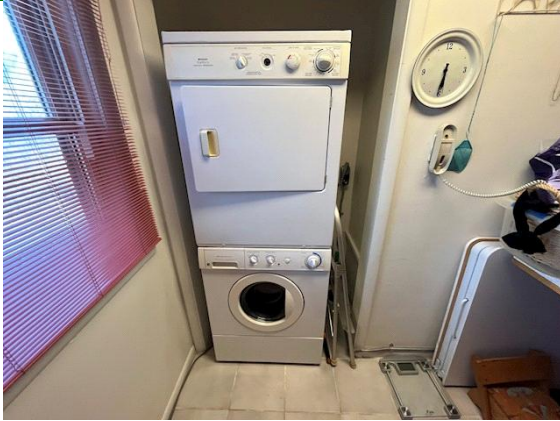
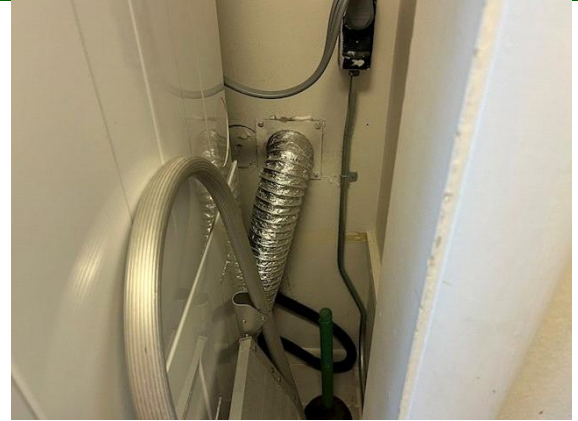
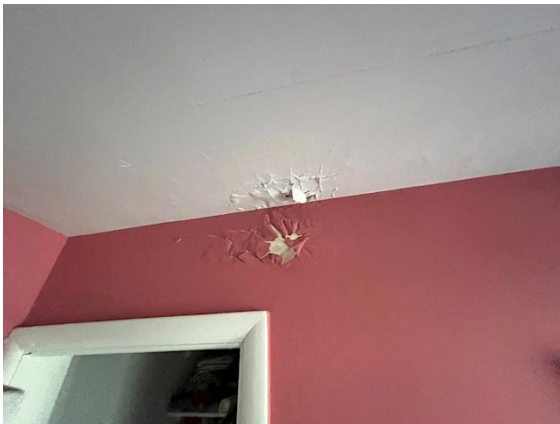
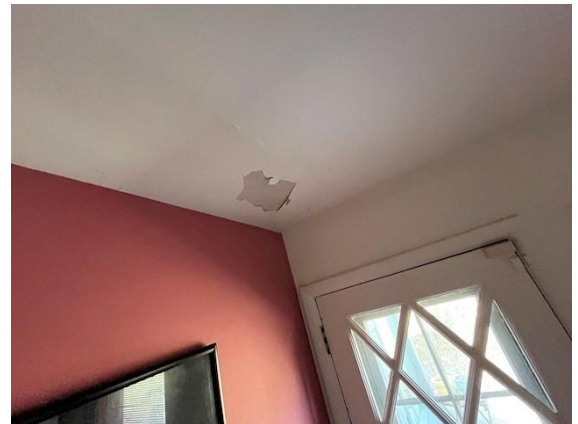
There was damage/peeling paint on wall and ceiling near the door of the Laundry Room. All components in laundry room were acceptable at time of inspection.

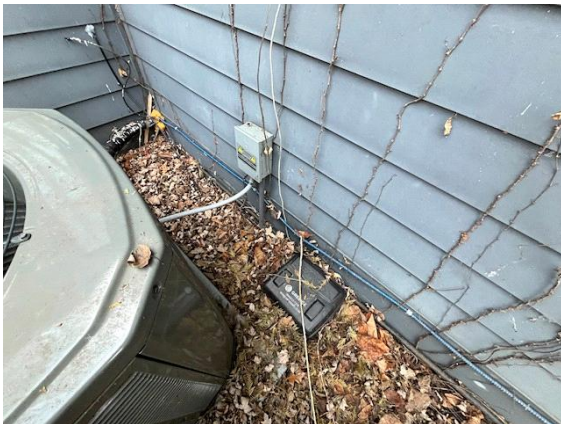
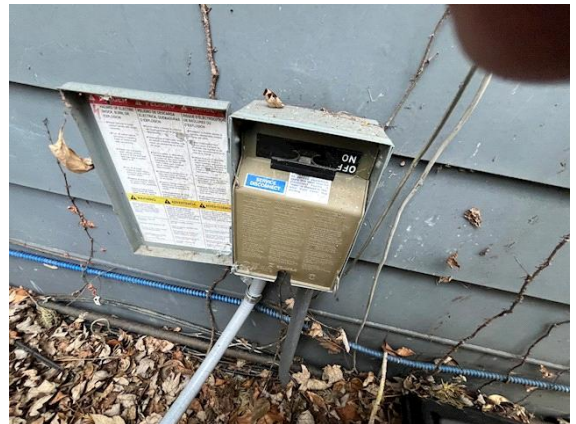
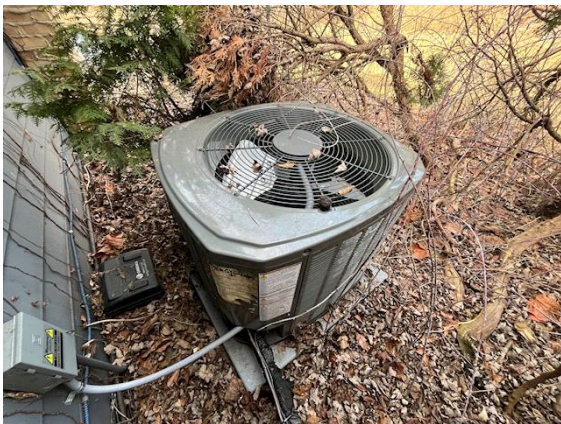
A/C Condenser is within design life but was not tested due to the outdoor temperature being below 60°F. Recommend keeping the condenser unit free of vegetation.

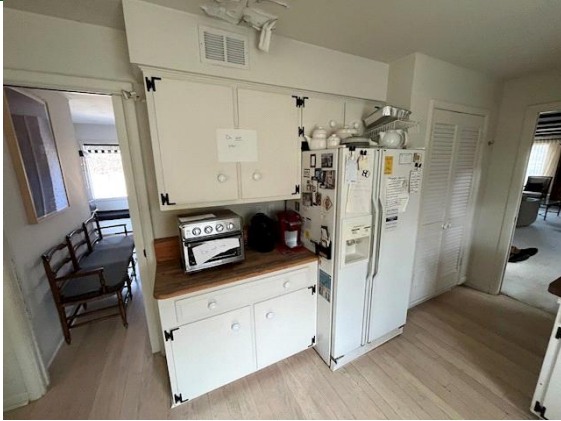
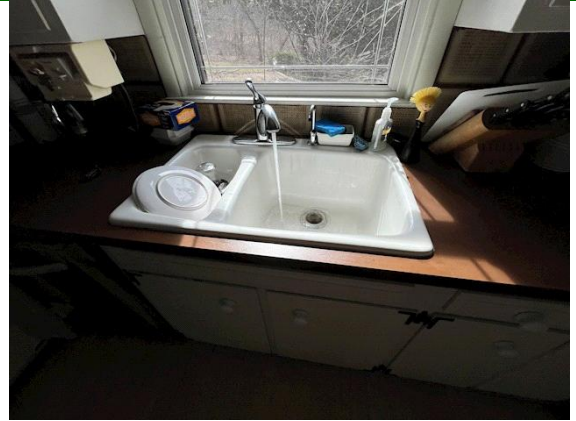
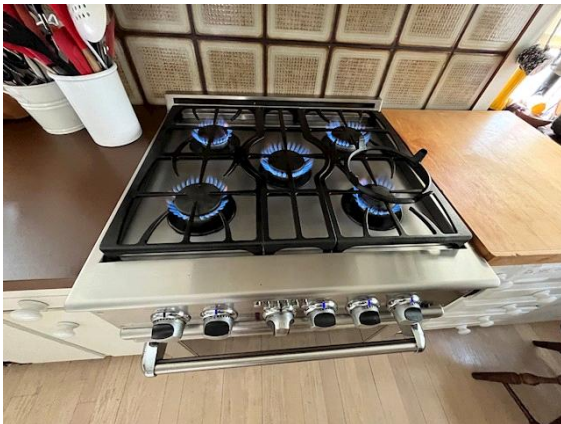
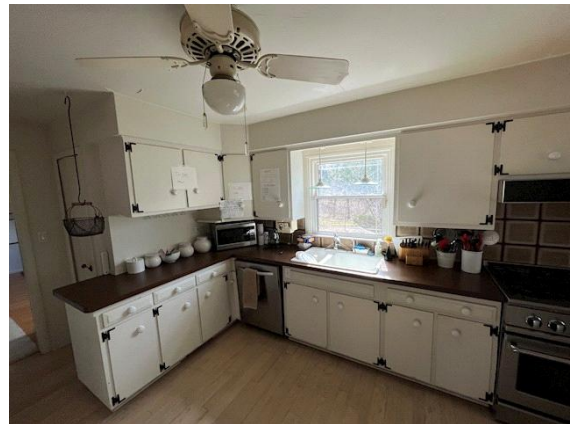
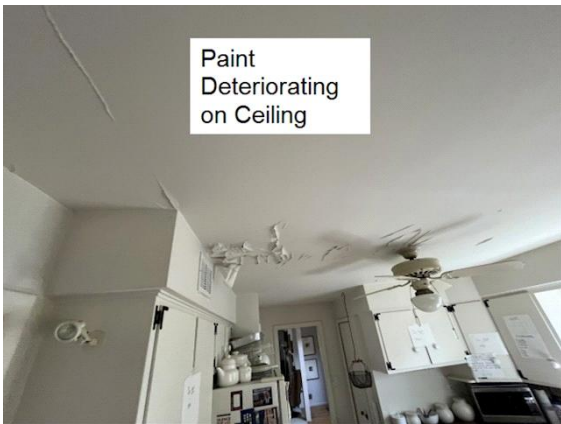
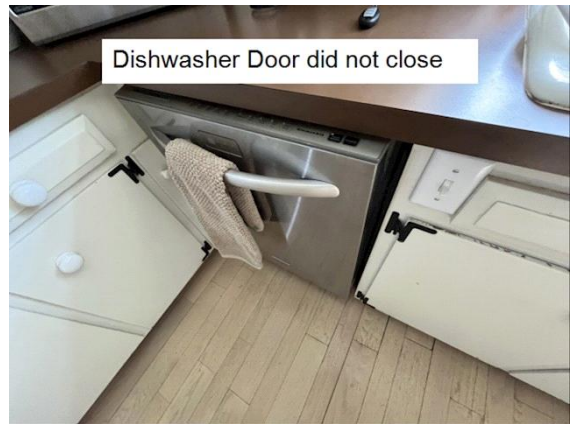
Kitchen ceiling showed peeling paint in several areas. There was no evidence of leak or damage at the time of the inspection. Recommend Repainting as needed. Plumbing under the kitchen sink appeared to be galvanized steel. Recommend replacing with PVC pipe. Dishwasher door did not close properly power completely dishwasher was not tested. All other components in the kitchen appeared acceptable at the time of the inspection. Recommend adding GFI protected outlets in the kitchen.

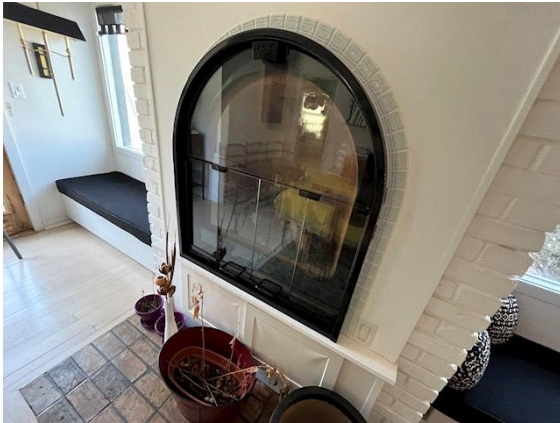
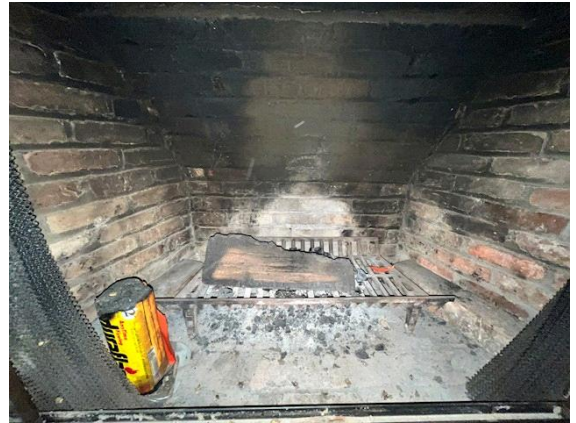
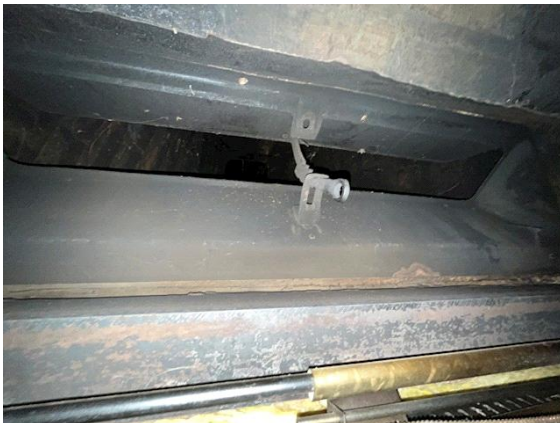
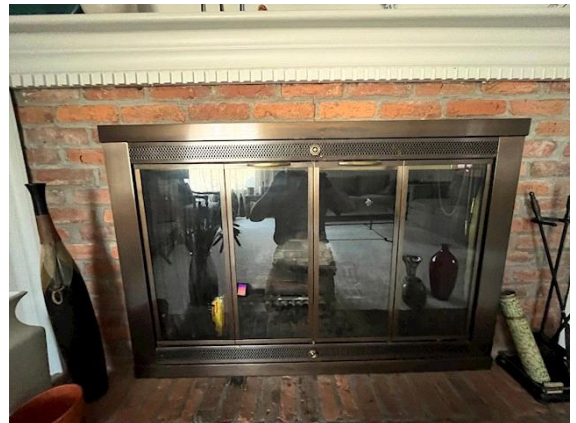
There are two fireplaces one in the dining room and one in the living room. The dining room fireplace appears to be a gas operated unit but was not tested due to the pilot not being lit. The living room fireplace is a wood burning fireplace and appeared to be in an acceptable condition at the time of the inspection.

Recommend annual cleaning - Fireplace design and soot / creosote buildup, in most cases, prevents view of chimney liner / cracks.

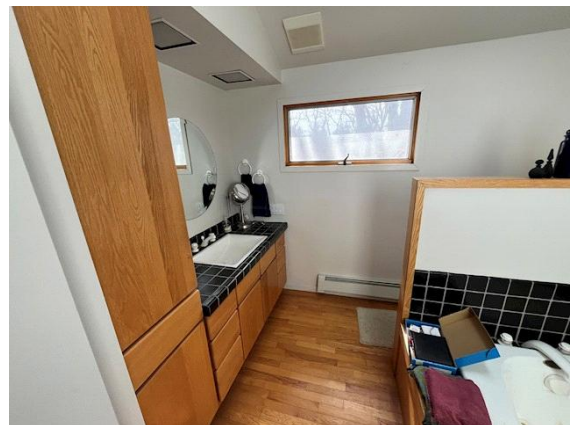
Toilet flush handle was not connected. Water to bathtub was not turned on. Sink was functional. Door handle was loose.

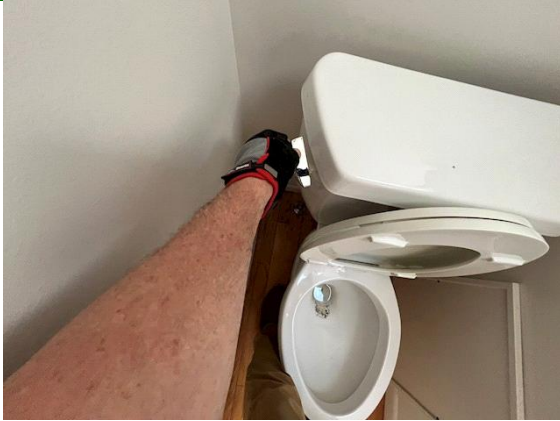
Bathroom - 2nd Floor: Flush handle disconnected

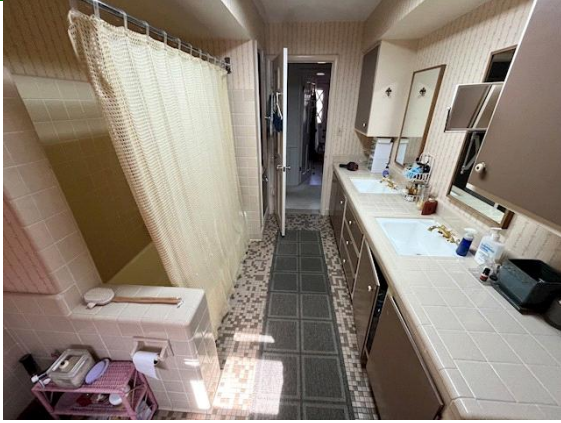
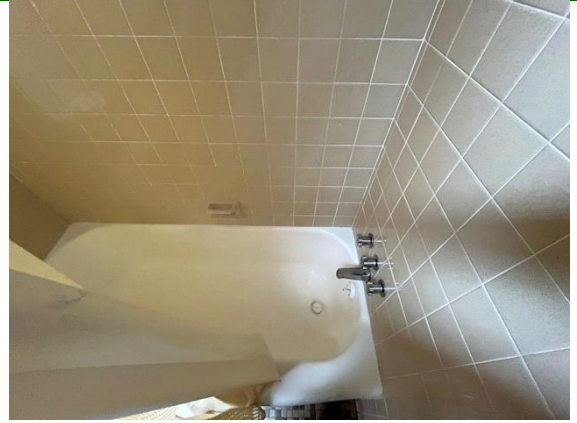
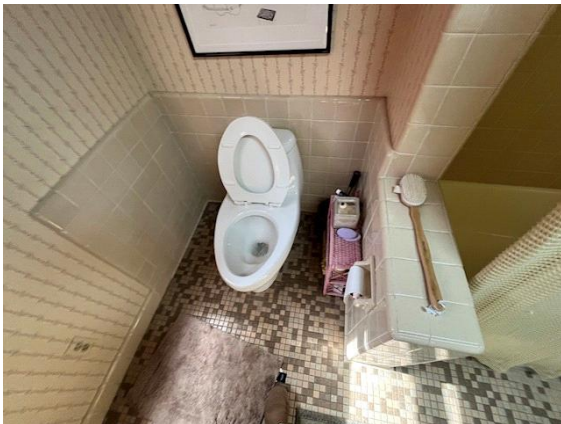
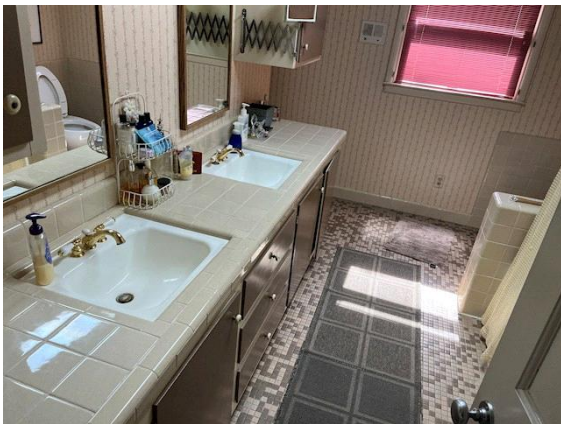
Faucets on the right hand sink were leaking when turned on. All other components were acceptable at the time of the inspection

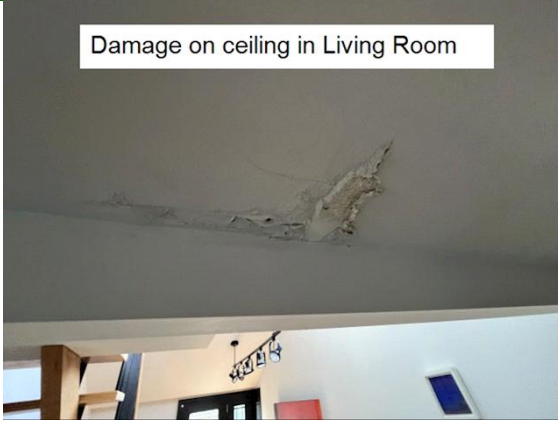
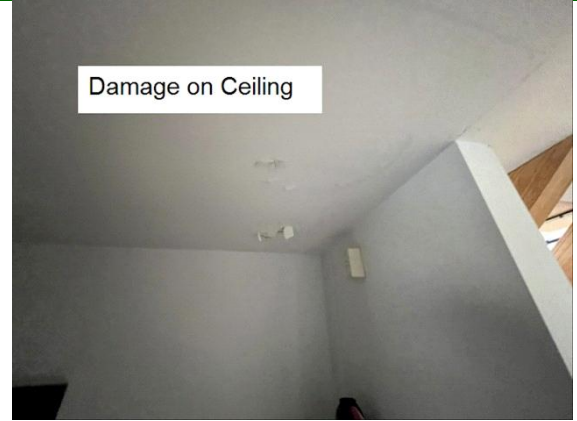
There was evidence of previous damage/leak to the ceiling of the Living Room. Walls were free of cracks. Window(s) functioned properly and seals were acceptable. Receptacles and lights appeared to be wired correctly.
