INSPECTION REPORT

1234 Sample Rd
Sometown, AR

INSPECTION DATE
Tuesday, March 25, 2025

INSPECTED BY
Micah Talley, AR License #2568 OK License #70002960

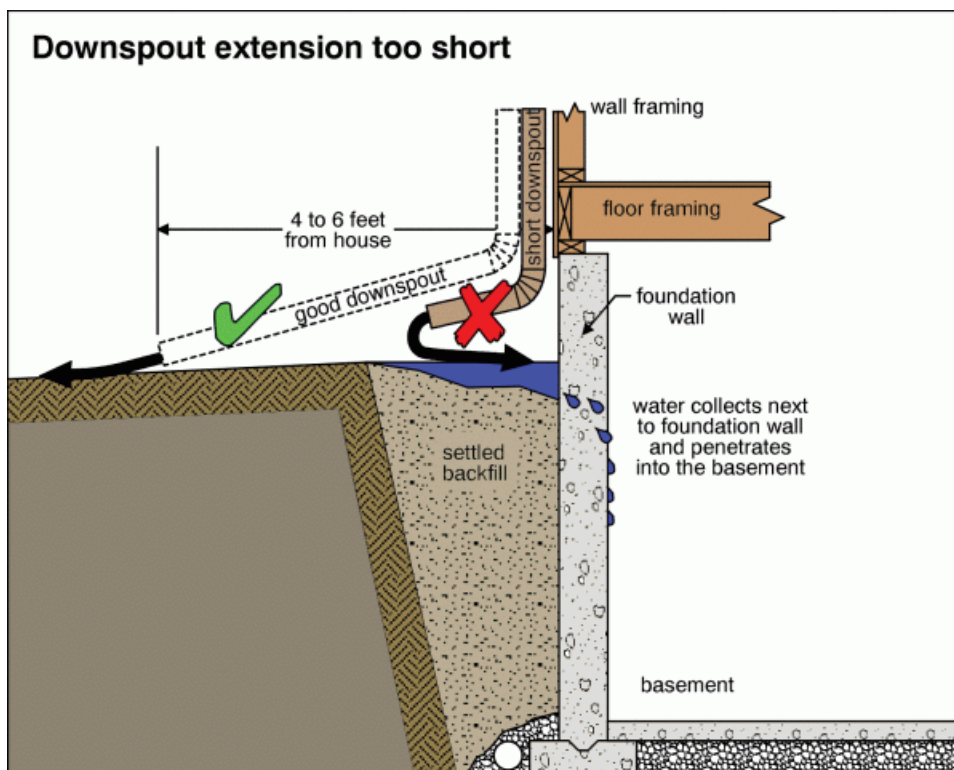
10. Discharge too close to building

3. Condition: • Discharge too close to building

Downspout discharges too close to the building. This can lead to soil erosion and water damage. Recommend downspout extension or splash blocks be installed.

Location: Throughout

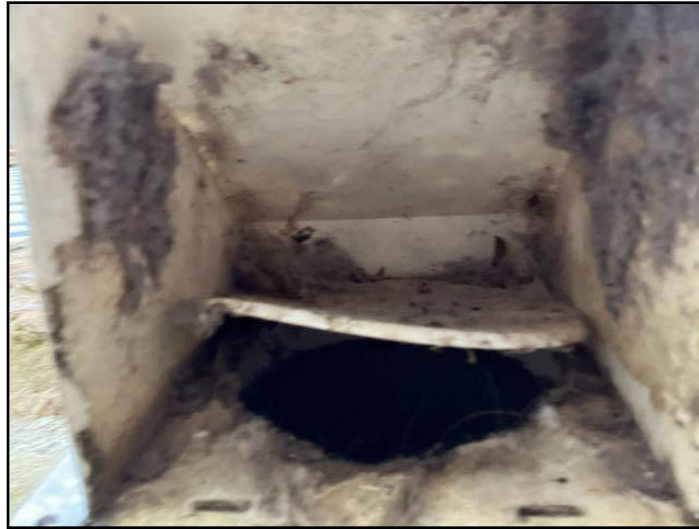
16. Cover does not close properly

6. Condition: • Cover does not close properly

The dryer vent cover did not close properly and the vent was missing the grate. This can allow pest intrusion and lint buildup can be a fire hazard. Recommend having the vent cleaned and replaced if it does not close properly after

cleaning.

Location: Front

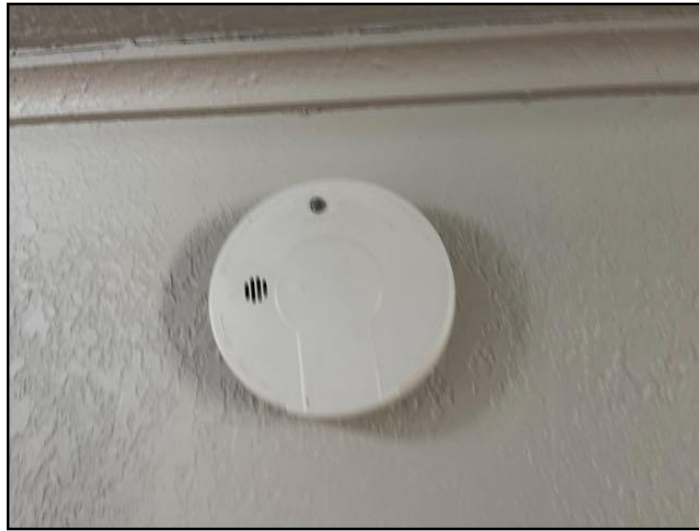
Smoke alarm present.. NFPA recommends interconnected smoke alarms in every sleeping room and outside each sleeping area (hallways leading to bedrooms). They also recommend smoke alarms be replaced every 10 years and tested monthly. The smoke detectors were chirping at the time of inspection, indicating they need new batteries.

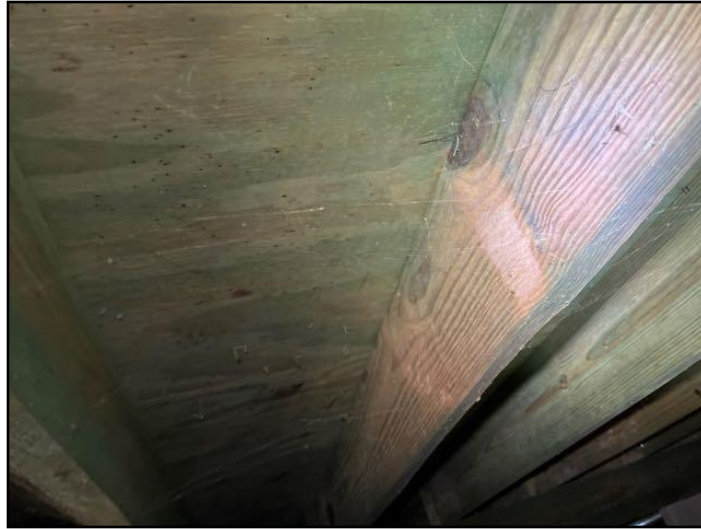
66. None found

Floor above basement/crawlspace insulation amount/value: • None found

• None found

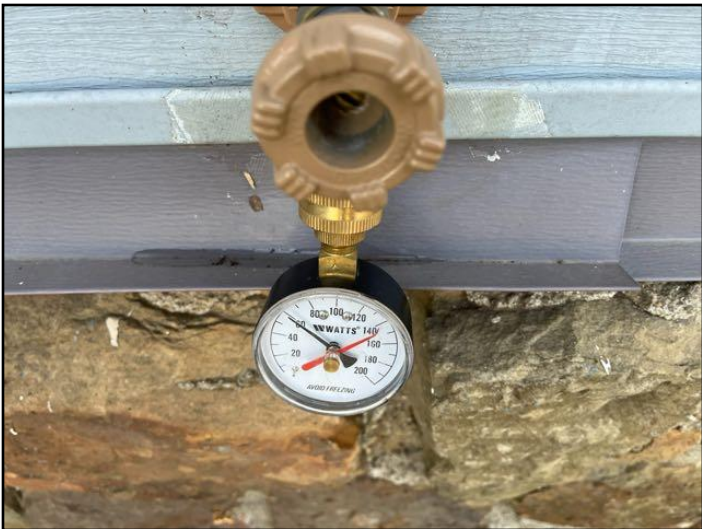
71. Functional

- Functional
- 60 PSI. Recommended range 40-80 PSI.

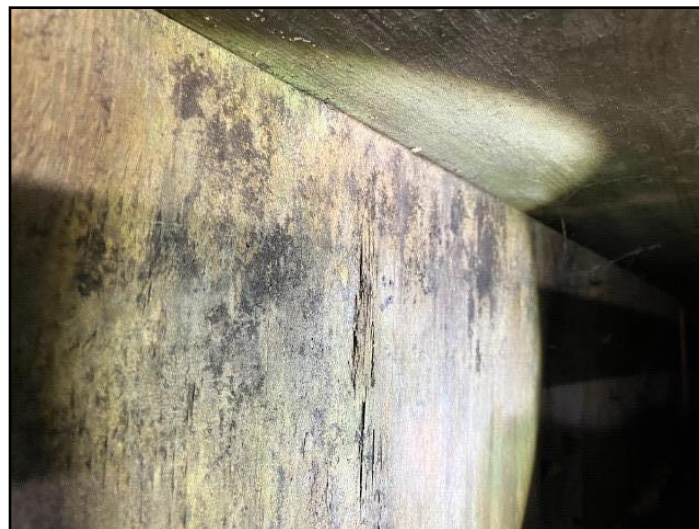
83. Crawlspace sample

Potential sources: Moist environment created by the lack of a vapor barrier in the crawlspace. This assessment is non-invasive and does not include latent or hidden sources. More testing and evaluation may be required.

1. NPI recommends that the client engage a company that specializes in mold remediation services to develop a mold remediation plan and conduct professional mold remediation services on the property.

2. NPI recommends that any source of water/moisture intrusion be remedied.

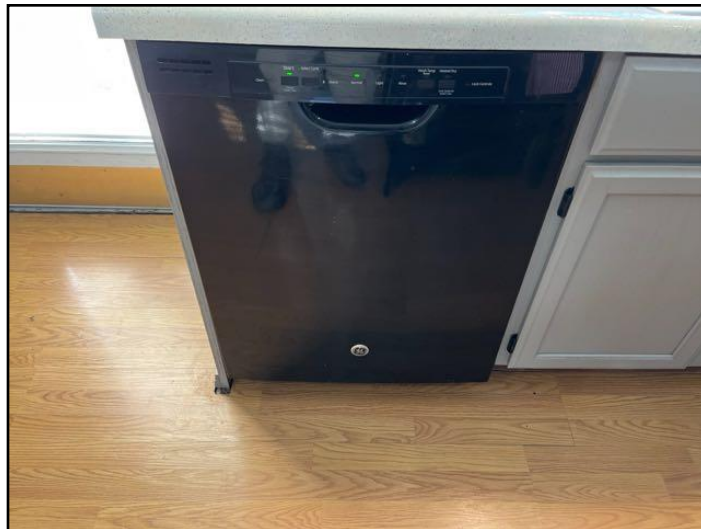
96. GE

The dishwasher's cancel feature did not work at the time of inspection.
