National Property Inspections of Middle Tennessee DBA
National Property Inspections

Your Street, Middle, TN

Sunday, July 1, 2018
Inspector
Jason Lee
(931) 398-8477
jason.lee@npiinspect.com

Summary

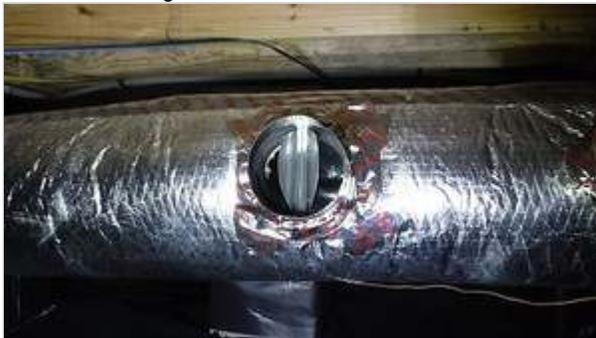
Crawl space positive ventilation system
