National Property Inspections of Middle Tennessee DBA  
**National Property Inspections**

Thursday, July 17, 2025  
**Inspector**  
Jason Lee  
(931) 398-8477  
jason.lee@npiinspect.com

<b>Type of Property:</b> Office Building <b>Primary Construction:</b> ISO - I Wood Frame <b>Property Occupied:</b> No <b>Property Faces:</b> Southeast	<b>Temperature:</b> 90's, 80's F <b>Weather:</b> Sunny <b>Soil Conditions:</b> Dry
---	--

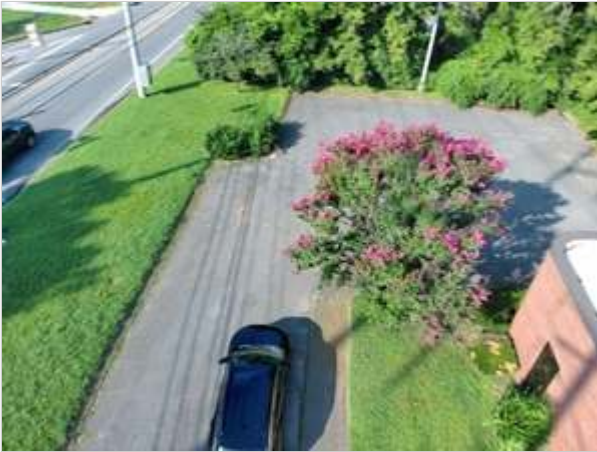
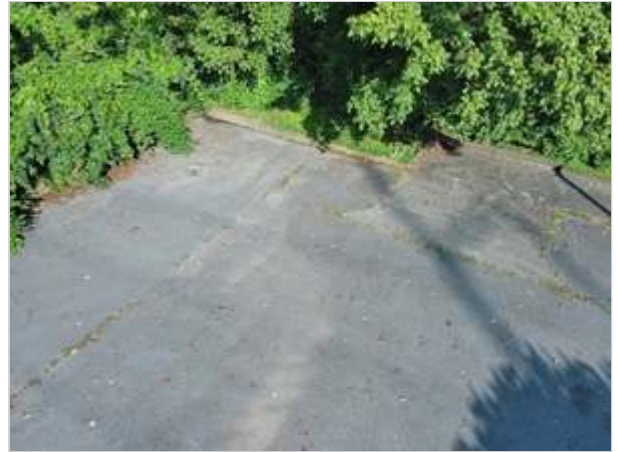
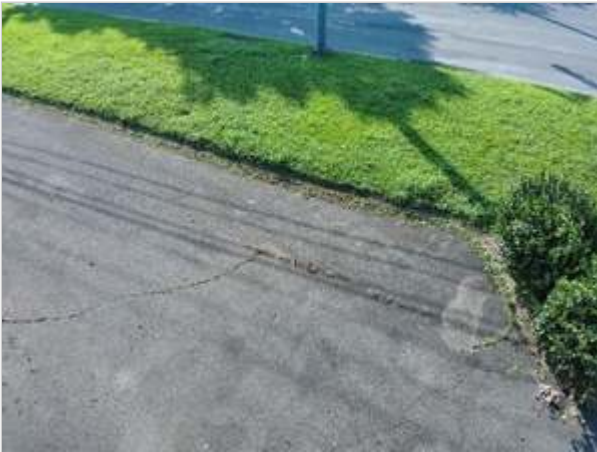
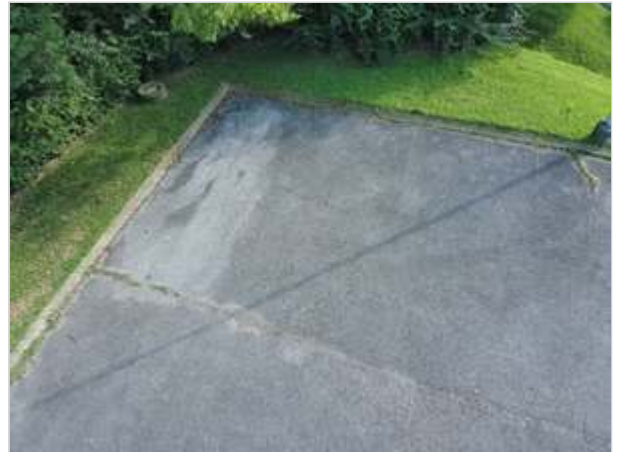
1. Surface deterioration of the paved surface was present at various locations. The areas should be repaired to prevent further damage.
2. The paved surface was cracked at various locations and vegetation was growing between the cracks. Vegetation should be removed, and the cracks sealed.
3. The surface sealant and striping were worn at many locations. The surface should be sealed to prevent further deterioration and the lot striping and decals repainted.
4. Evidence of ponding was present at the north parking lot.

Recommend repair/replace by a qualified contractor for the following:

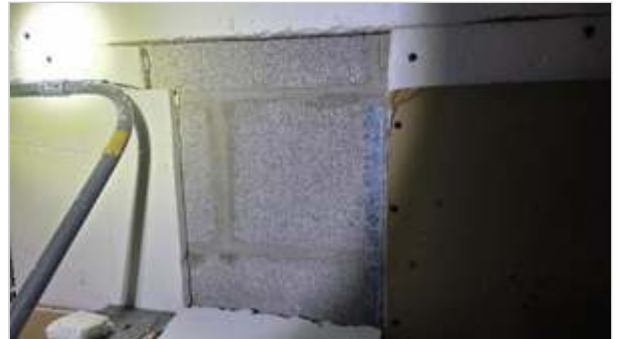
Concrete block exterior walls

Recommend further evaluation by a qualified contractor to assess the stability of the exterior walls as signs of water intrusion and deterioration was present along the exterior walls.

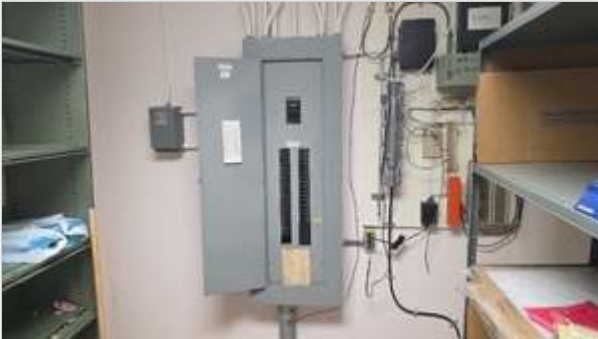
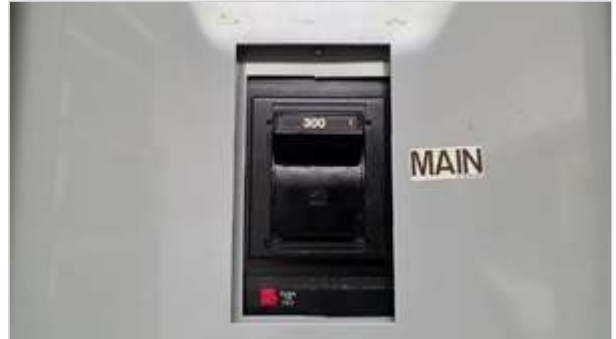
- Recommend further evaluation and repair/replace by a licensed electrician for the following:
  1. Further evaluation as a bonding clamp was not observed at the main gas service. Current standards of practice call for bonding clamps to be installed on the customer side of the gas meter.
  2. Installation of GFCI protection for all bathroom and exterior outlets.
  3. An outlet was testing as being incorrectly wired within the north prep room.
  4. Wire nut terminations were exposed within the attic and should be enclosed into electrical junction boxes.
  5. Some outlets were loose at the wall.
  6. The interior cover was missing at the HVAC disconnect panel.

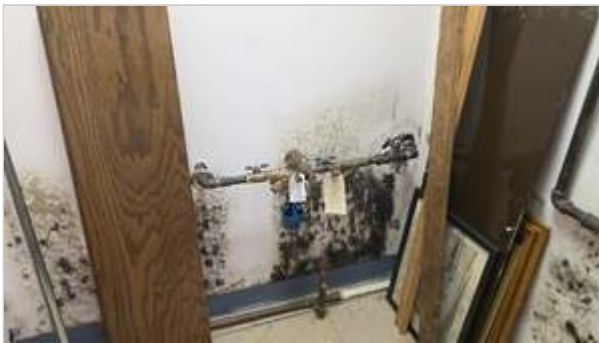
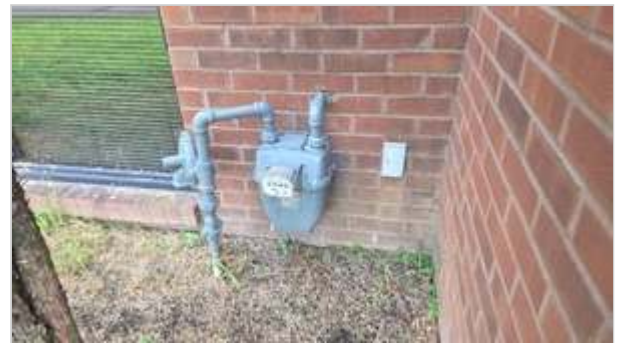
Water Supply Shut-Off, Backflow Prevention & Gas Meter

1. Evidence of possible water leak(s) were observed at rear wall and utility room walls at time of inspection. Biological growth was likely present and visible on the walls which may be caused by a plumbing leak and/or water intrusion from roofing issues.
2. The building did not have any visible interior or exterior plumbing cleanouts. Current standards of practice call for plumbing cleanouts within five feet of the exterior foundation and located at least every 100 feet to the city sewer connection.
3. A sediment trap was missing from the gas supply at the rooftop HVAC unit. Standards of practice call for the trap to be located between the appliance and shut-off valve.
4. The plumbing and gas will need to be fully tested once service is restored.
5. All metal drainpipes beneath sinks need to be changed to PVC as signs of past leaks was evident.

Recommend repair/replace by a qualified contractor for the following:
