National Property Inspections of Middle Tennessee DBA
National Property Inspections

Tuesday, July 15, 2025
Inspector
Jason Lee
(931) 398-8477
jason.lee@npiinspect.com

GENERAL INFORMATION

Type of Property: Single-Family Home	Temperature: 80's F
Primary Construction: Crawl Space, Wood Framing	Weather: Sunny
Property Occupied: Yes	Soil Conditions: Dry
Estimated Age of Property: Two Year(s)	Persons Present: Buyer, Owner(s), Inspector
Property Faces: East

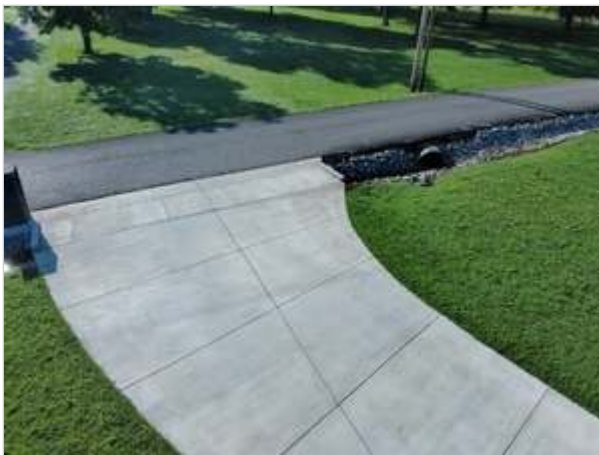
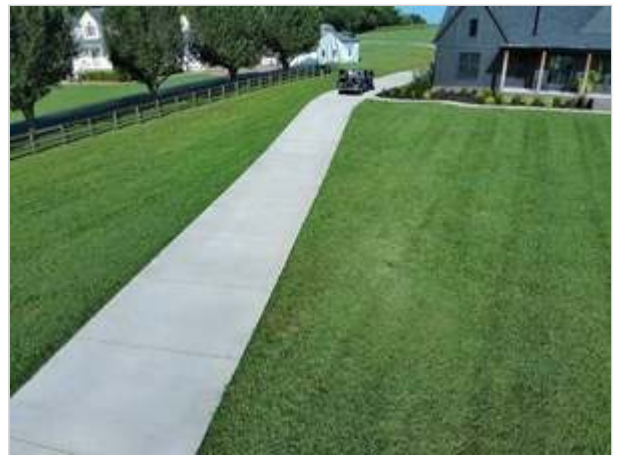
The driveway was inspected for general firmness and drivability.

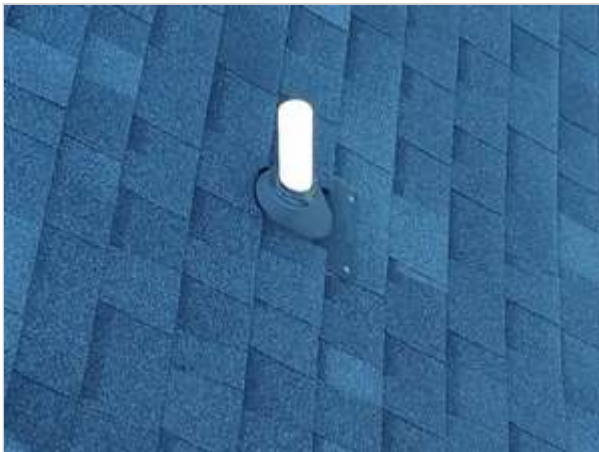
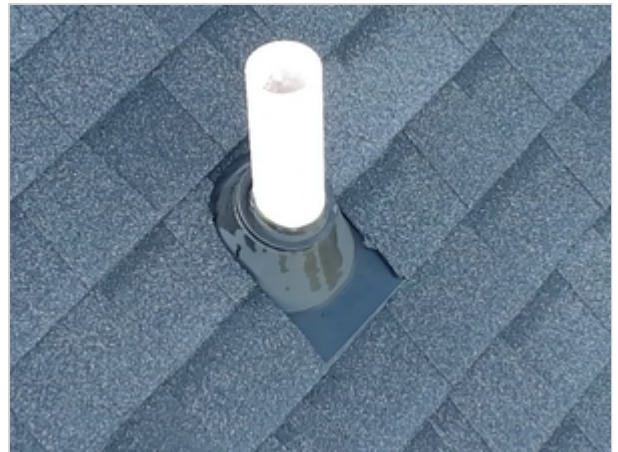
- Recommend further evaluation by a qualified contractor as the apparent underlayment of the roof was secured beneath the drip edge at the lower edge of the roof. The lower edge of the underlayment of the roof should be installed on top of the drip edge to allow for full drainage of any water which may be beneath the layer of shingles.

The roof covering was inspected for coverage, around openings, visible flashings, overall condition and thermal infrared imaging was used to identify areas of possible roof water leaks. Roof flashing is not always visible around adjacent roof surfaces and inside the home should be monitored at these areas. Roof underlayment will be noted within this report if viewable and can only be noted for presence, at accessible areas. Buyers are encouraged to consult sellers about roof surface and the presence of any current or prior leaks. This inspection and rating are on the roofing material only and not a guarantee against leaks, for a more exact estimate of life expectancy or repair/replacement cost a qualified roofing contractor should be consulted and a roof certification obtained. This inspection is made on the basis of what is visible and accessible at the time of the inspection and is not a warranty of the roof system or how long it will be watertight in the future or certify it for insurability.

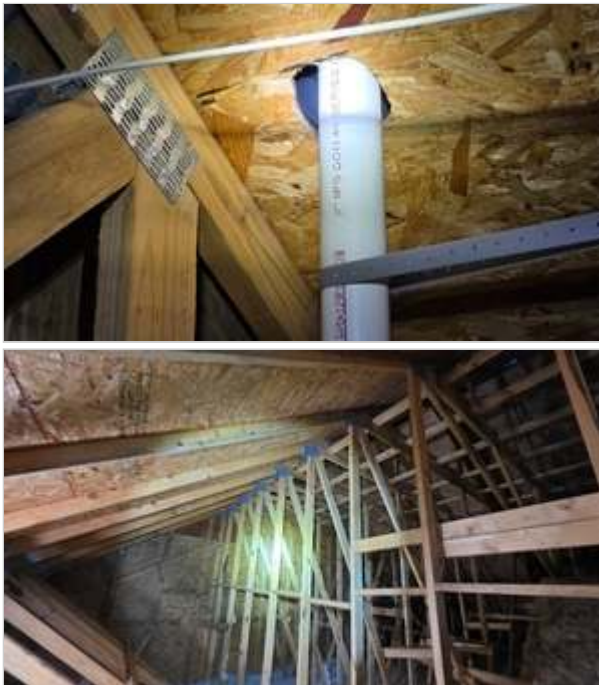
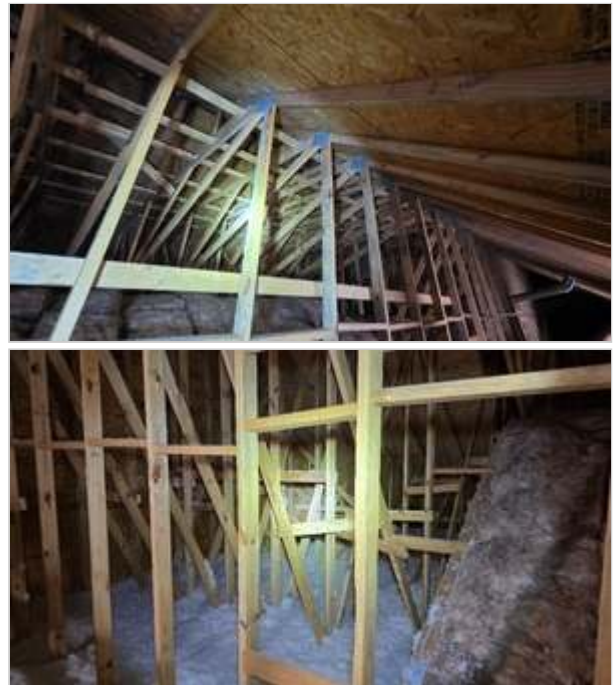
All visible framing, sheeting and fasteners were inspected for construction methods and overall attic conditions. This inspection is made based on what is visible and accessible at the time of the inspection and is not a warranty of the roof system or how long it will be watertight in the future. Buyers are encouraged to consult sellers about the presence of any current or prior leaks. This inspection and rating are on the visible framing and sheathing only and not a guarantee against leaks, for a more exact estimate of life expectancy or repair/replacement cost a qualified roofing contractor should be consulted and a roof certification obtained.

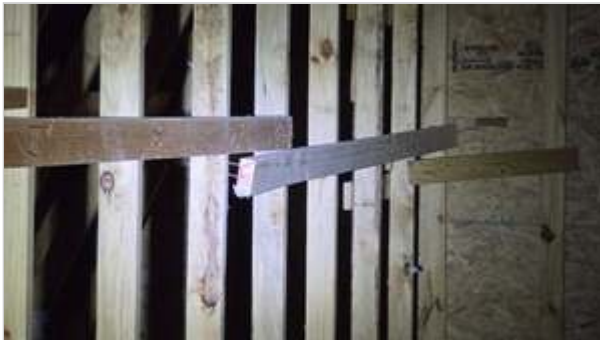
Above south bedroom

Recommend repair as a bracing member above the living room was observed as being loose at time of inspection.

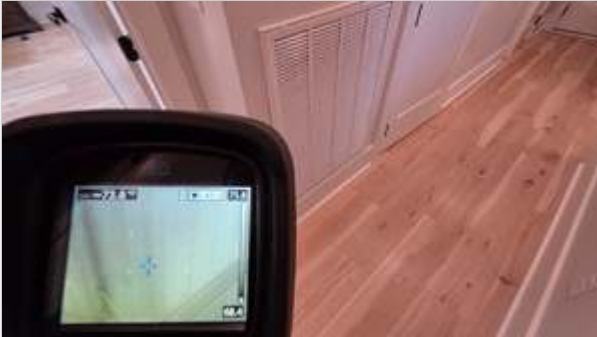
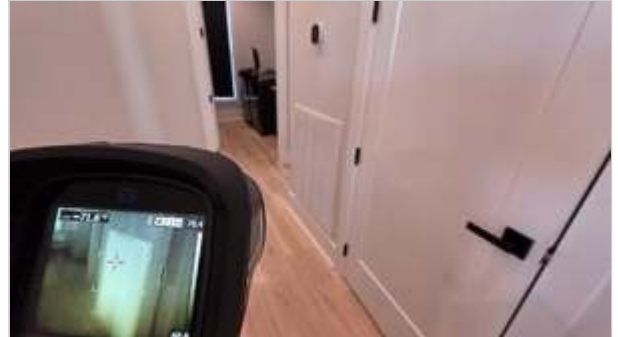
Dining room register

Recommend further evaluation and repair/replace by a qualified HVAC contractor for maintenance and service for cleaning, refrigerant pressure check and evaluation of exhaust systems.
