12345

Des Moines IA 50311

Prepared for:  
Client Name

Chris Meade  
npiguydsm@gmail.com

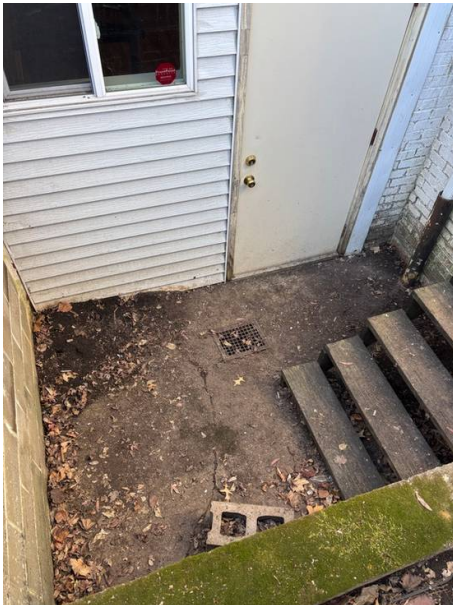
Insufficient drainage observed in the rear entrance to the east basement room stairwell, evidenced by dirt nearly level with the threshold and in contact with the siding despite the presence of a drain, as well as an interior drain on the other side of the door suggesting potential water management issues, recommend a comprehensive evaluation by a qualified contractor to ensure the drain is functioning, the grading prevents water accumulation and contact with the siding, and the threshold is protected from moisture intrusion.

Rear entrance to east basement room

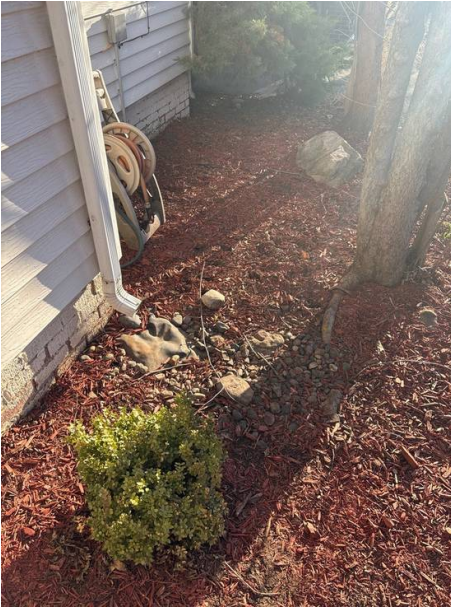
Near level grading present. Recommend monitoring during rainfall/moist conditions for possible ponding near the perimeter of the home for possible water intrusion problems that may effect the foundation system of the home and/or water intrusion problems. The final grade of the grounds should be sloped away from the foundation by 1/2 inch per foot over a minimum distance of 10 feet.

Neutral grading along the south foundation

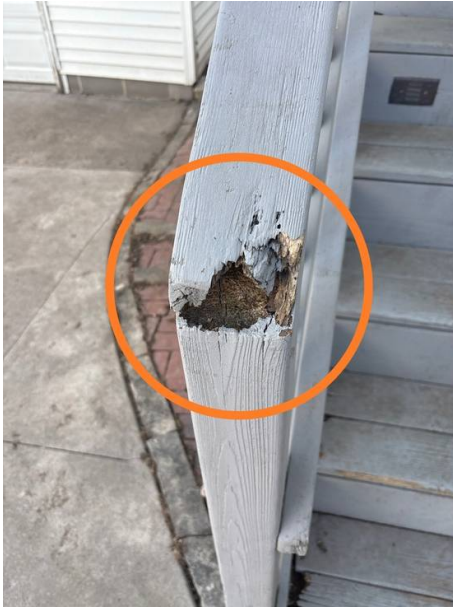
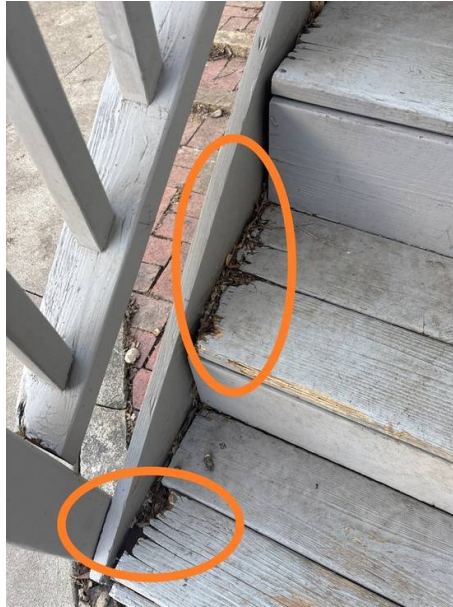
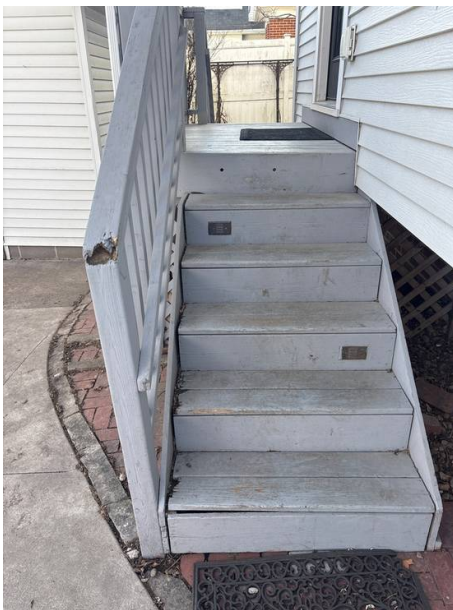
Handrails observed as loose and deteriorated, posing a safety concern, with general deterioration noted on the deck and stairs. Deck is at or near life expectancy. Recommend further evaluation by a qualified contractor for any or all repair or replacement needs.

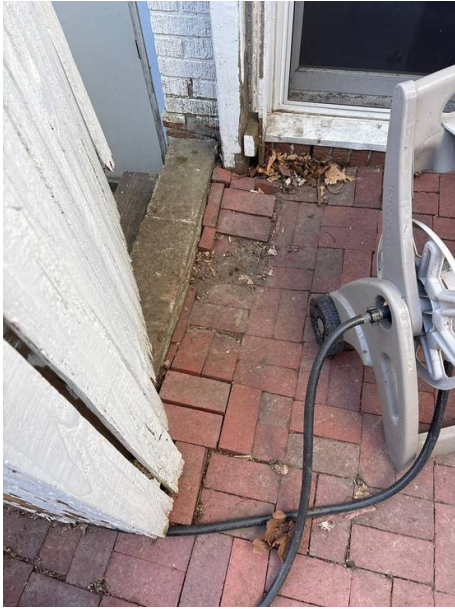
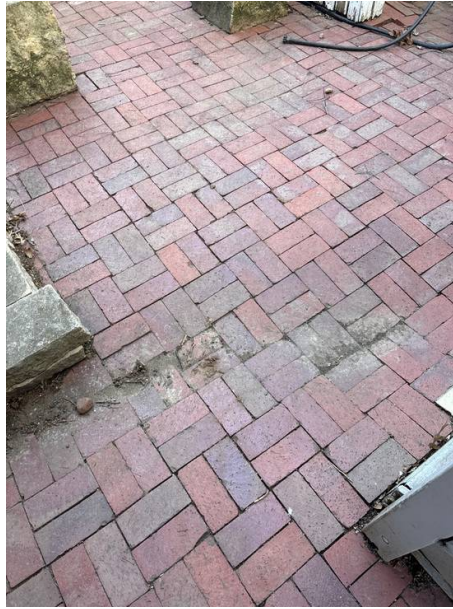
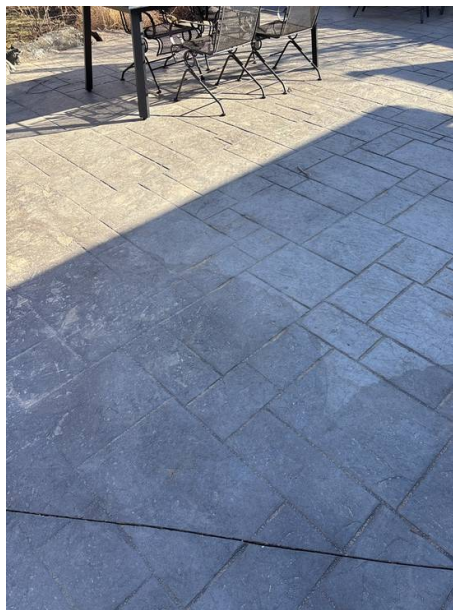
Loose bricks observed in the brick patio near the stairs leading to the northeast rear entrance, with the patio noted as wavy, recommend further evaluation by a qualified contractor to ensure stability and safety.

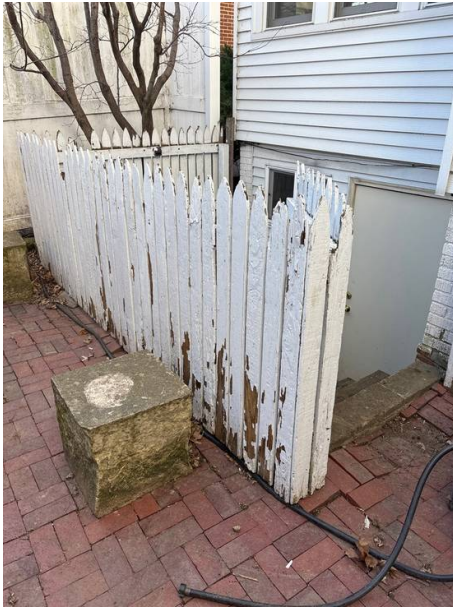
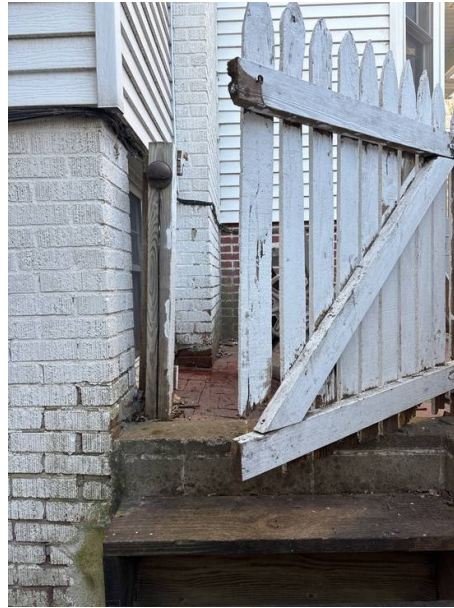
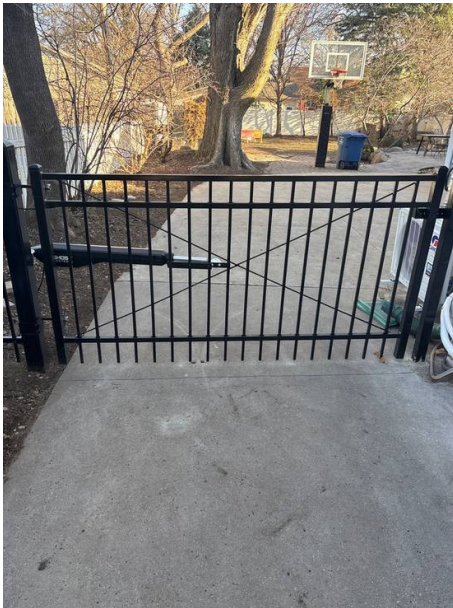
Deterioration observed on the wood fence around the rear northeast entrance, recommend replacement by a qualified contractor to ensure stability and proper function.

Vegetation is observed in contact with the fence, potentially causing structural damage and promoting rot or insect

activity. Recommend vegetation be trimmed back.

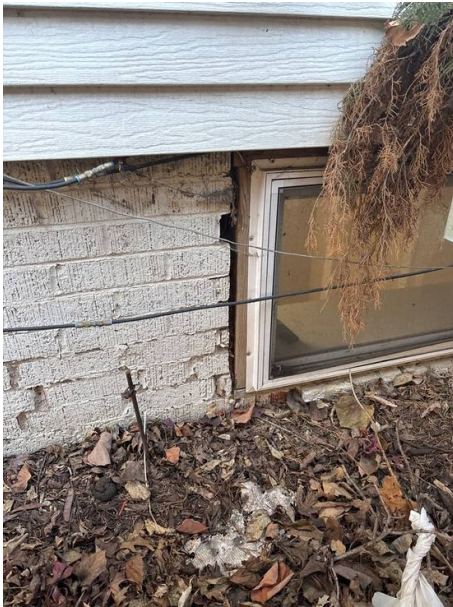
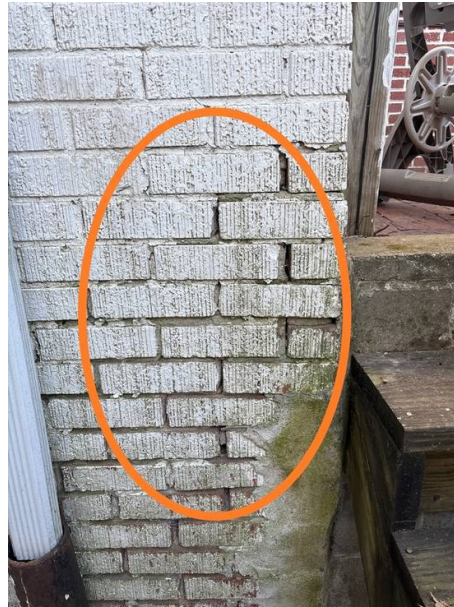
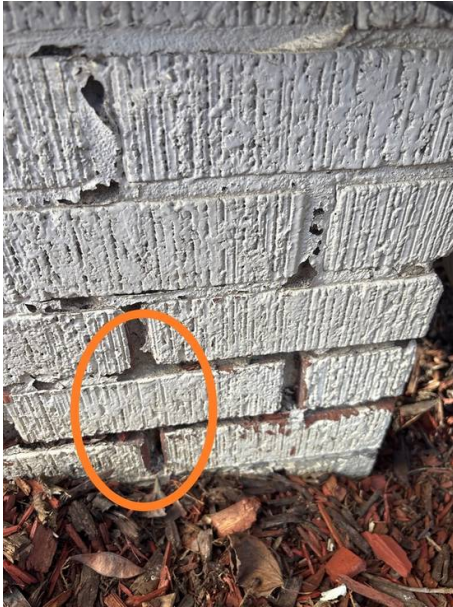
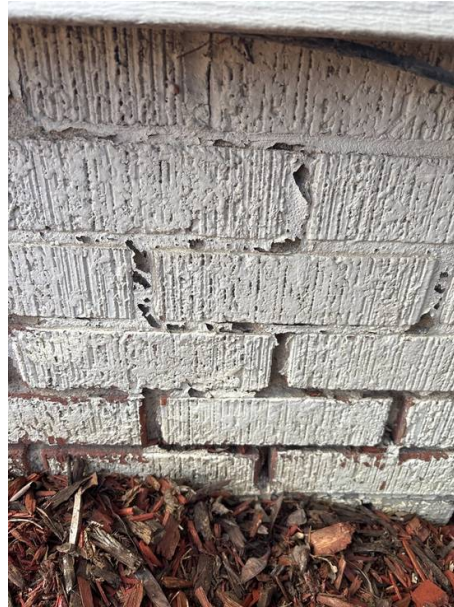
Gap observed between the foundation and the northeast basement window, with an uneven foundation noted along the gap, potentially allowing moisture infiltration and structural stress, recommend further evaluation and repair by a qualified contractor to ensure structural stability and protection from moisture damage.

Minor gaps observed throughout the rest of the painted brick foundation wall with no significant cracking or movement noted. Recommend monitoring the area for signs of moisture infiltration or further deterioration, and suggest minor repairs to the gaps in the brick foundation as needed to maintain protection against weathering. Further evaluation by a qualified contractor is advised if moisture or worsening conditions become evident.

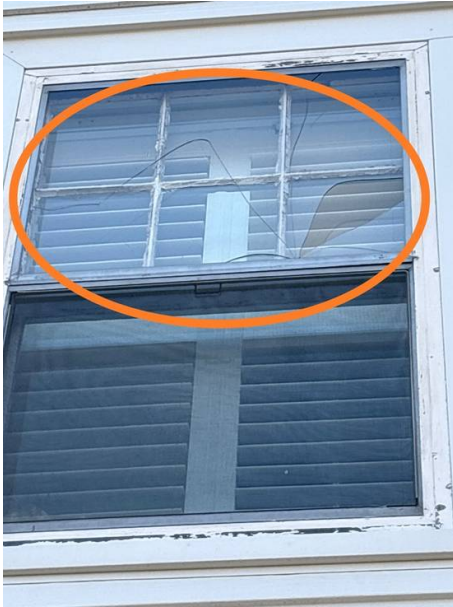
Broken window pane observed on the second-floor window, with visible cracks and damage to the glass, potentially compromising security and weatherproofing, recommend replacing the broken pane and suggest further evaluation by a qualified contractor to ensure proper sealing and protection from environmental damage.

Broken 2nd floor, west facing window

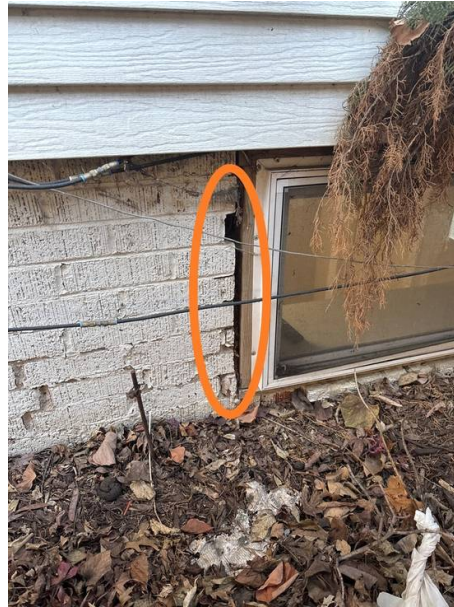
Bare wood observed on the window frame of the basement window on the northeast side of the house, potentially allowing moisture infiltration and deterioration, recommend treating or painting the bare wood to prevent rot, and suggest further evaluation by a qualified contractor to ensure proper weatherproofing and protection from moisture damage.

Northeast basement window - bare wood on window frame

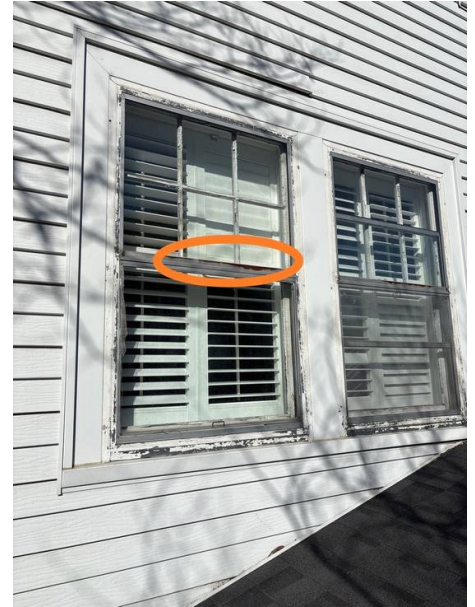
Rust observed on the metal window frame of the second-floor window, with discoloration noted in the lower right corner, wood grilles deteriorated, and the screen missing, potentially allowing further corrosion and pest entry, recommend treating the rust, repainting the frame, replacing the deteriorated wood grilles, installing a new screen, and suggest further evaluation by a qualified contractor to ensure proper weatherproofing and protection from environmental damage.

2nd floor east facing window

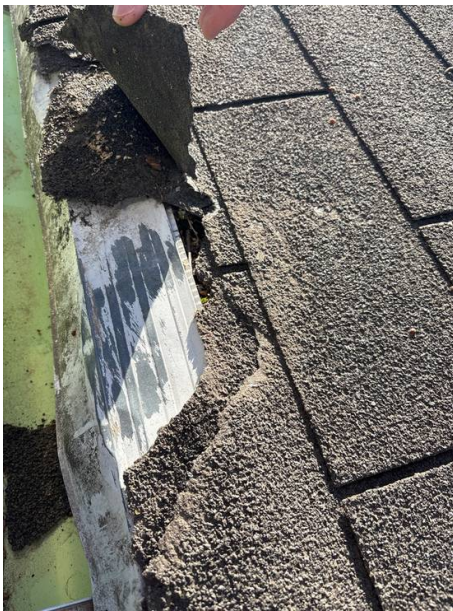
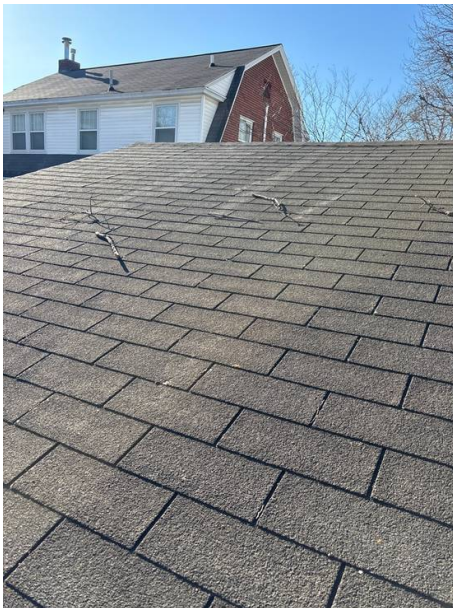
Damage observed on the rear of the garage roof, where 3-tab shingles (with an average lifespan of 20-25 years) are missing/deteriorating, exposing the underlying roof surface. Multiple layers observed, potentially allowing moisture infiltration and complicating repairs. Recommend further evaluation by a qualified roofing contractor to assess the overall roof condition and remaining lifespan.

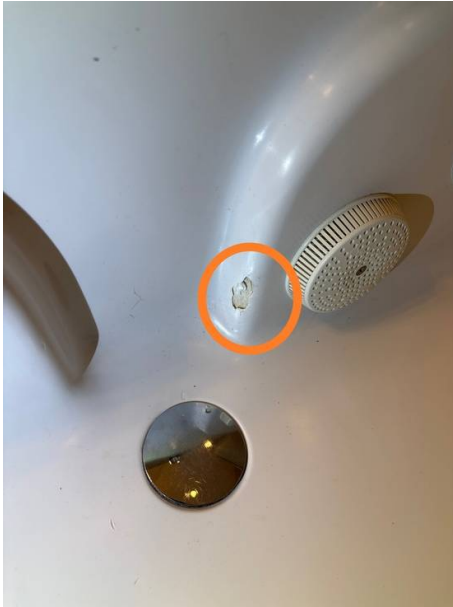
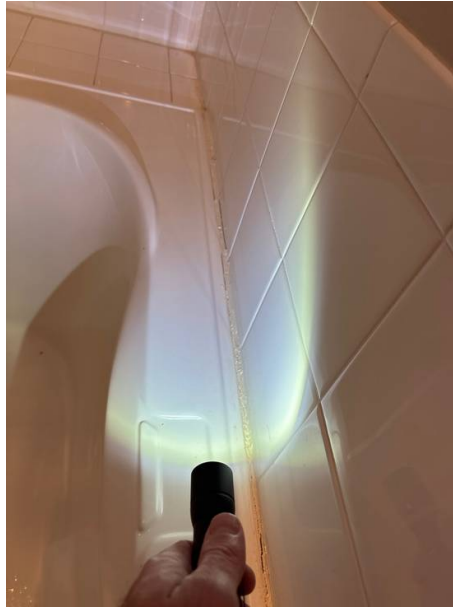
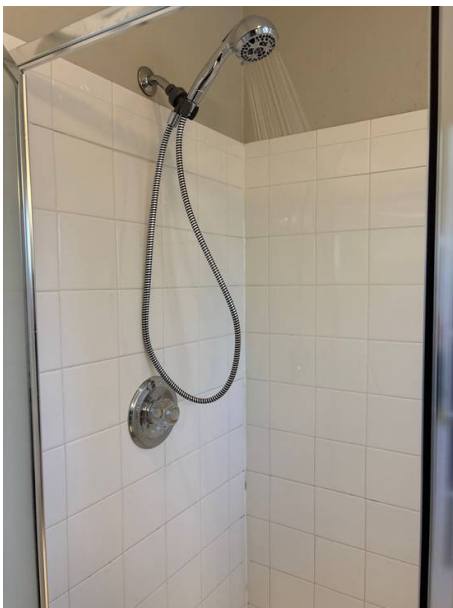
Chip observed in the jacuzzi tub, potentially allowing moisture to penetrate the underlying material. Jacuzzi tub jets appeared underpowered during operation, indicating a possible mechanical or electrical issue. No dedicated GFCI (Ground Fault Circuit Interrupter) protection observed for the unit, posing a safety hazard. Deteriorated caulk observed between the tiles in the bathroom, potentially allowing moisture infiltration behind the walls. Recommend further evaluation/repair of jacuzzi tub and surrounding area by a qualified contractor.

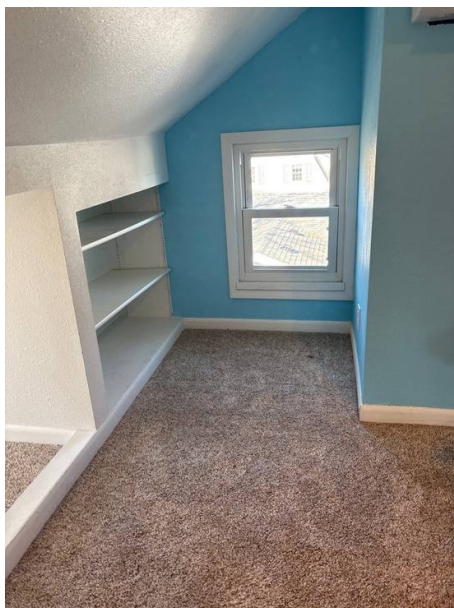
3rd floor window

Windows in the finished attic space on the third floor observed to not meet the minimum sill height requirements of 24 inches for fall protection. This poses a fall hazard for children given the significant height above the exterior grade. Recommend installing window guards and/or further evaluation by a qualified contractor to ensure compliance with safety standards and prevent potential falls.

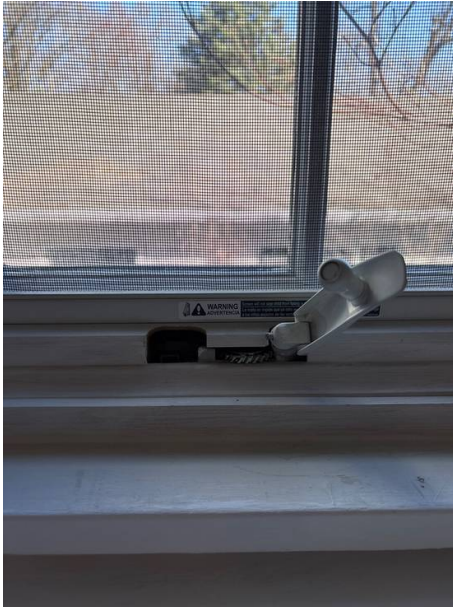
Window right of the fireplace in the living room observed with a missing sash lock, compromising the ability to secure or operate the window properly. Additionally, the primary bedroom closet window in the primary bedroom observed with a loose sash lock. Recommend replacing the missing sash lock in the living room window and tightening or replacing the loose sash lock on the closet window to restore proper function and security. Suggest further evaluation by a qualified contractor to ensure both windows operate safely and effectively.

Window right of the fireplace in the living room is missing hardware

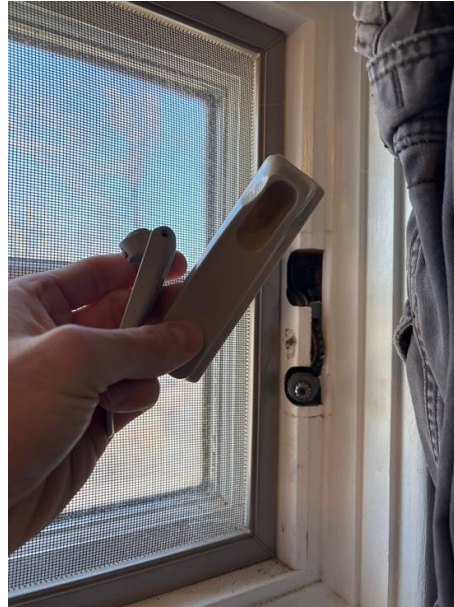
Primary bedroom closet window hardware

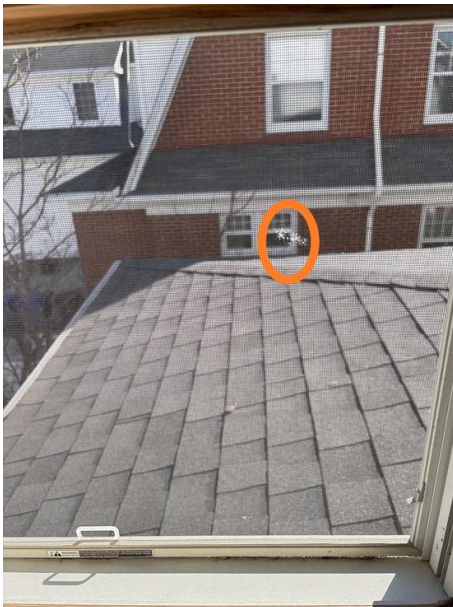
Damaged screen was observed, potentially allowing pests or debris to enter and reducing security or ventilation effectiveness.

Hole in east facing screen in northeast bedroom

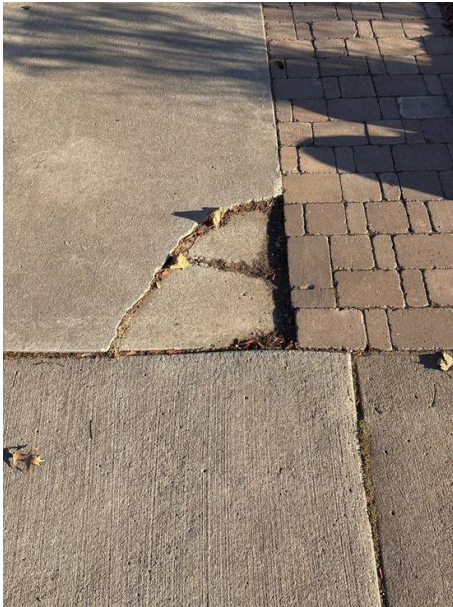
Cracks and loose concrete observed near the driveway approach, recommend sealing the cracks (per standard maintenance practices) and further evaluation by a qualified contractor to assess the loose section and ensure proper repair if sealant alone isn't sufficient.

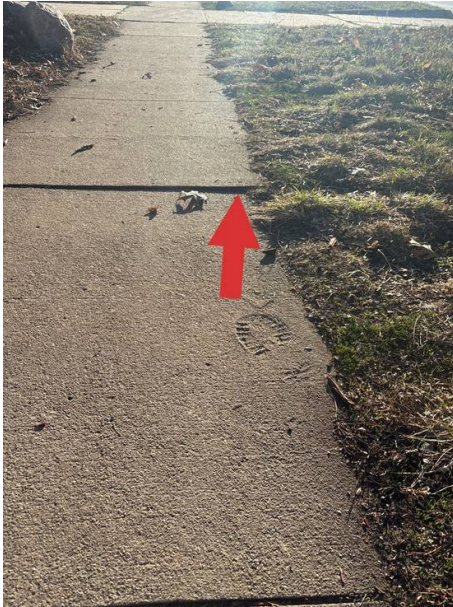
Trip hazards observed. Recommend trip hazards be addressed for a smooth transition to enhance safety and accessibility.

Trip hazard on sidewalk in front of the house

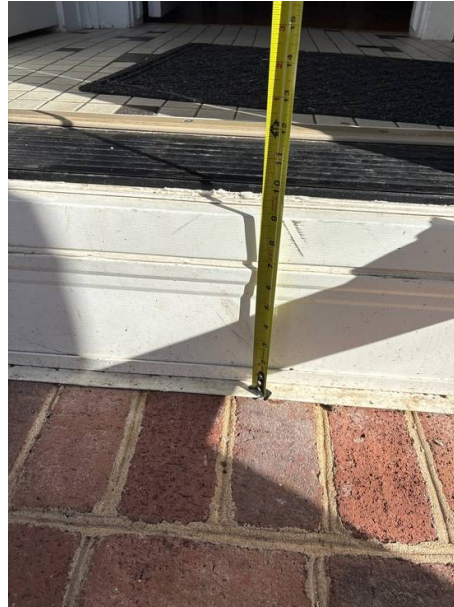
Step leading to the front porch exceeds maximum allowable height. Current standards require risers to have a maximum variance of 0.375 inches between the highest and lowest risers on the staircase and riser height to not exceed 7 3/4 inches.

Top step leading to front door exceeds maximum height requirements

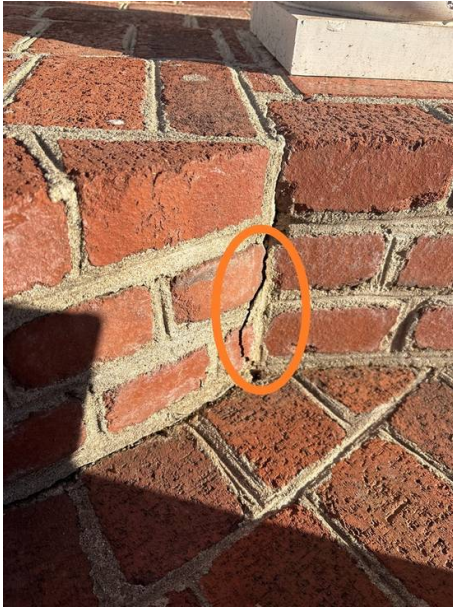
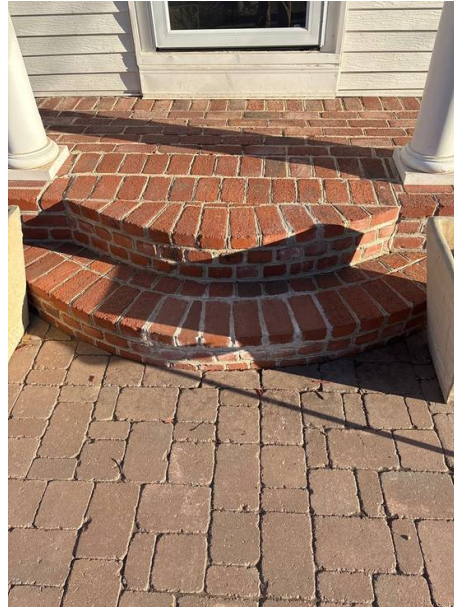
Crack observed in the brick on the front porch, recommend sealing or repointing the affected area to prevent further damage, and suggest further evaluation by a qualified contractor to ensure structural stability and proper repair.

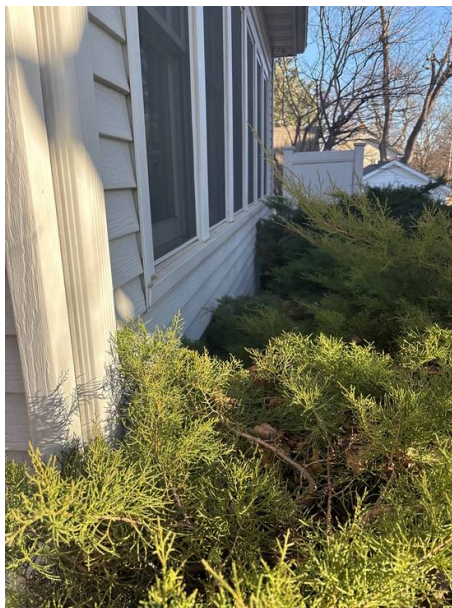
Vegetation observed to be in contact with the siding on the east side of the house, potentially trapping moisture and promoting deterioration, recommend trimming back the vegetation to maintain a clear gap between the siding and plants.

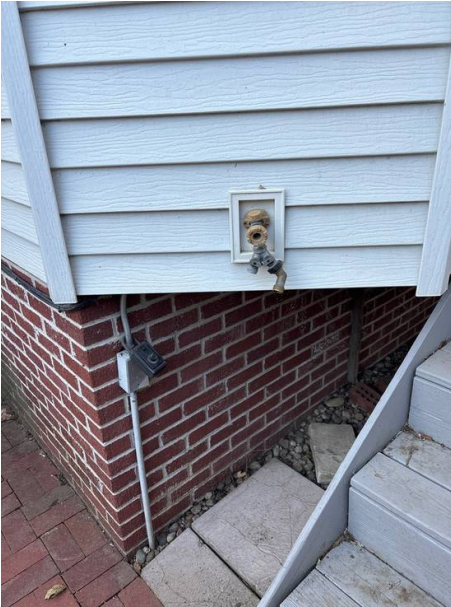
The hose bibs failed to produce water flow when tested during the inspection. Recommend assessment and repair by a qualified contractor to restore proper function and ensure reliable outdoor water access.

Hose bib at the bottom of the east deck stairs did not dispense water

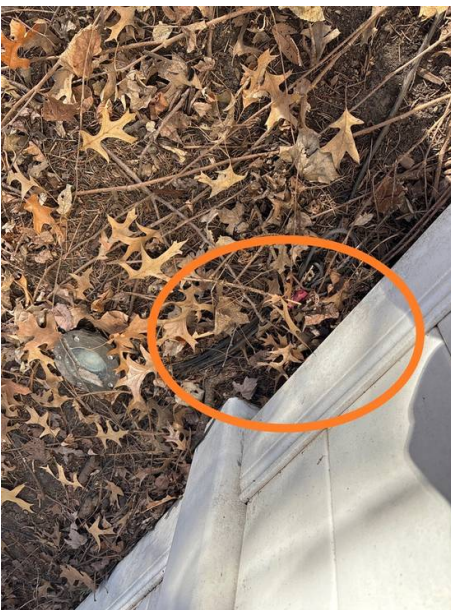
Wires for the yard light observed lying on top of the ground along the fence with visible wire nuts, posing a potential electrical hazard and exposure to moisture.

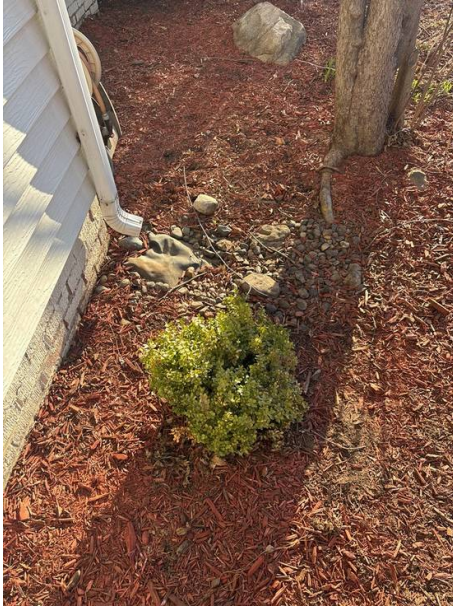
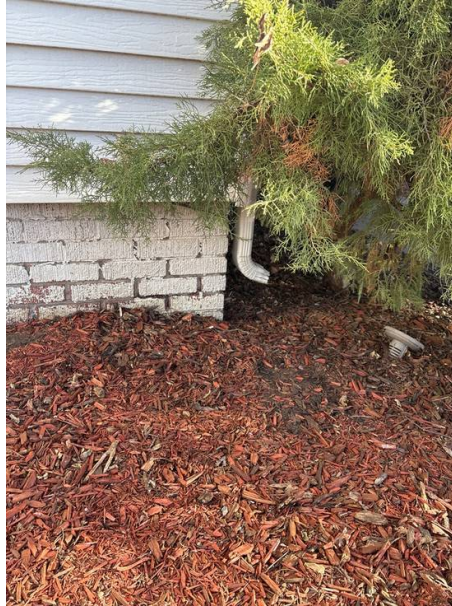
Multiple gutter downspout extensions observed to be missing, potentially allowing water to pool near the foundation and cause damage or erosion. Recommend replacing missing downspout extension.

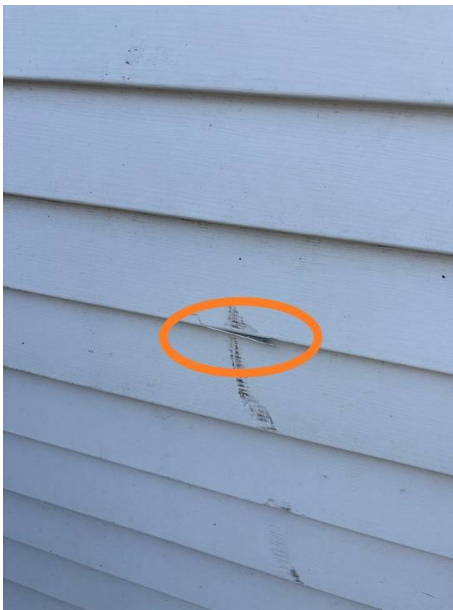
Small cracks observed in the vinyl siding at the rear of the garage. Recommend sealing the cracks to prevent water damage.

Crack in siding

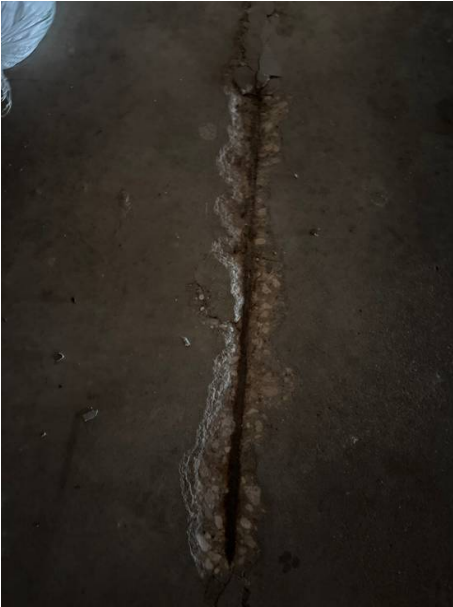
Cracks were observed in the garage floor during the inspection. These appear to be standard and typical; however, they should be monitored for excessive movement or worsening over time.

Deteriorated section of garage slab

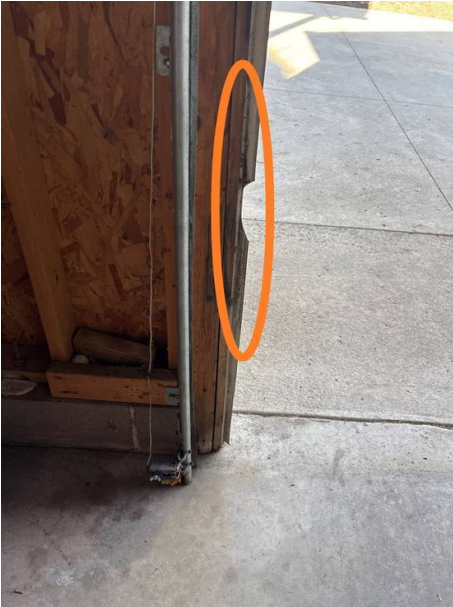
Weather stripping is missing or damaged, recommend replacement to improve energy efficiency and weather resistance.

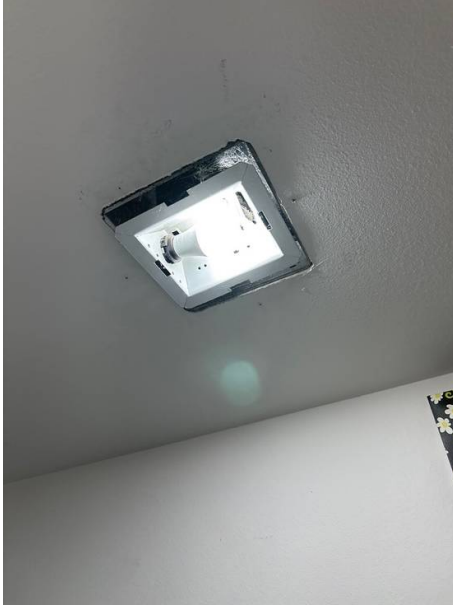
Exhaust fan is missing its cover. Recommend replacing missing cover.

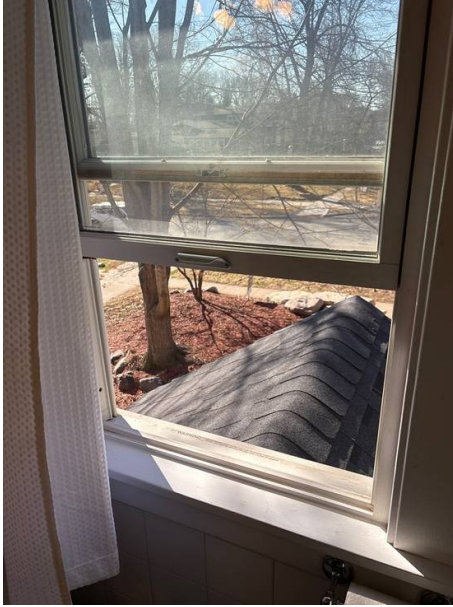
Missing window screen which may result in a deficiency allowing insects to enter and reducing ventilation control. Recommend installing a window screen to correct the deficiency and restore proper window functionality.

Upstairs hall bathroom window is missing its screen

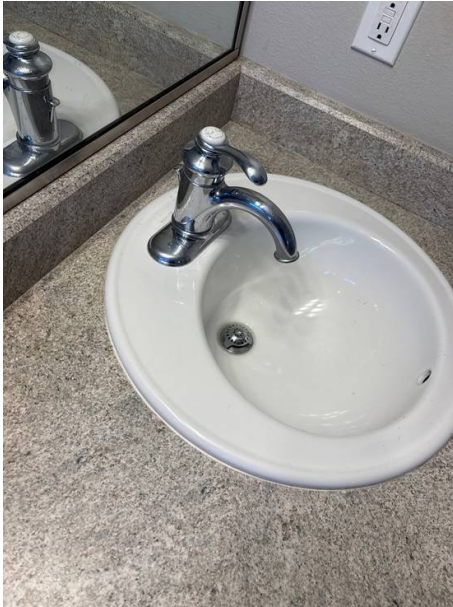
The bathroom sink drain stopper was observed to be non-functional during the inspection. Recommend evaluation and repair or replacement by a qualified contractor to restore proper operation and ensure effective use of the sink.

Primary bedroom bathroom, right sink

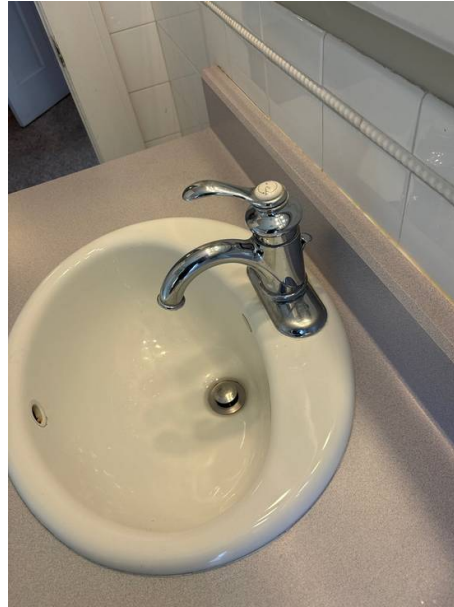
Upstairs hall bath, drain stopper

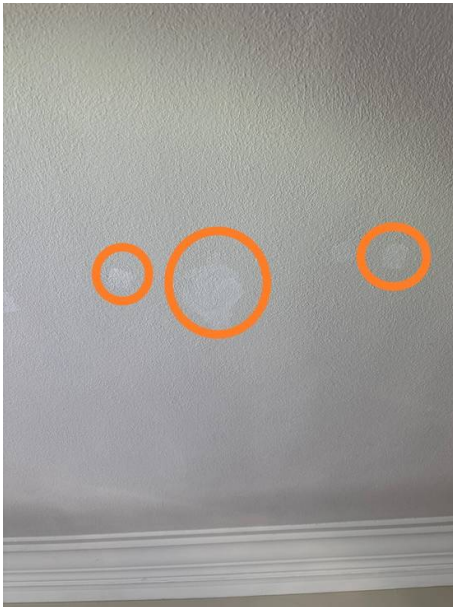
Living room ceiling

Multiple areas of the living room ceiling observed to have been recently painted. Some areas show slight texture or color variation. All areas were dry at the time of inspection. Recommend monitoring for signs of moisture or staining that may indicate underlying issues. Requesting seller disclosure regarding any previous water damage or repairs in these areas. Suggest further evaluation by a qualified contractor if discoloration or moisture reappears.

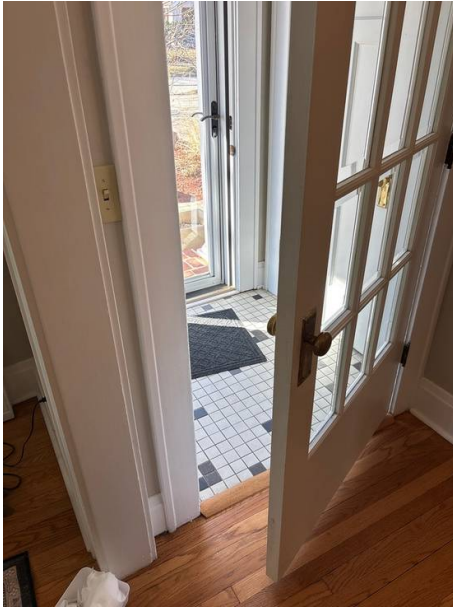
Door from entryway to living room observed with no hardware and does not lock or latch

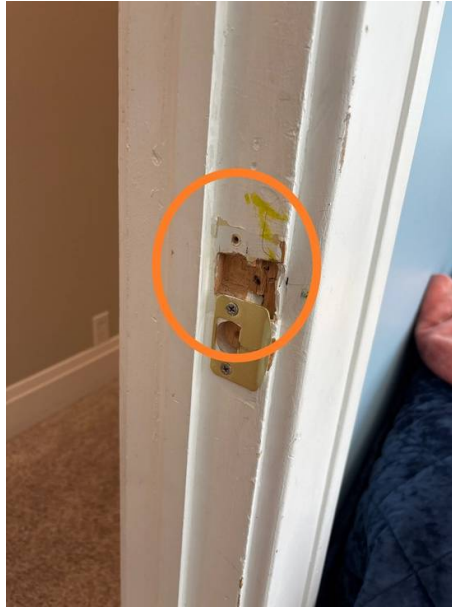
Northeast bedroom

Door frame in the northeast bedroom observed with damaged wood and exposed areas around the latch plate, indicating wear or impact damage.

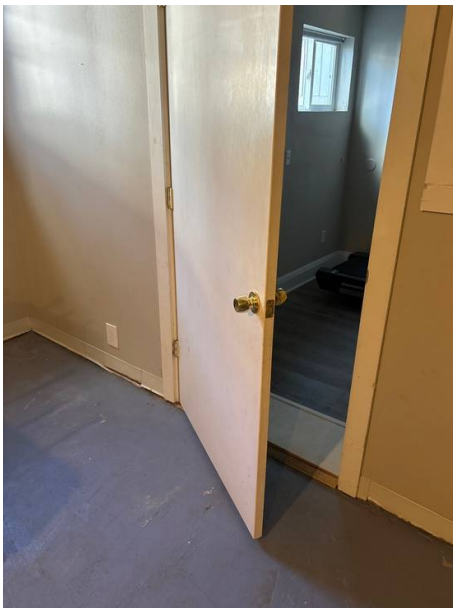
Door to east basement room rubs on floor and ceiling

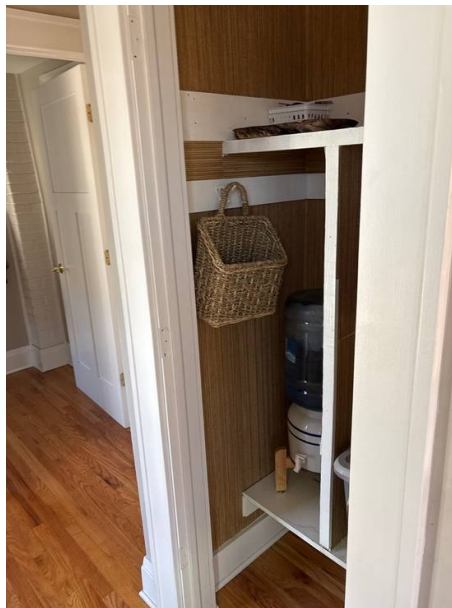
Missing closet door. Recommend missing closet door be replaced.

Missing closet door

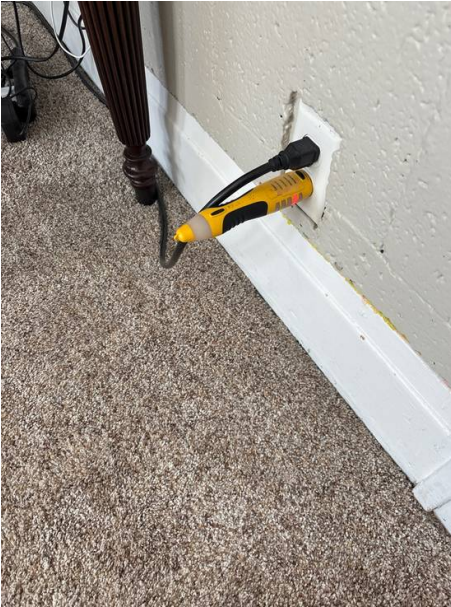
Southeast bedroom

Location: Bedroom, Southeast.  
Ungrounded outlet observed. Recommend all outlets be grounded.

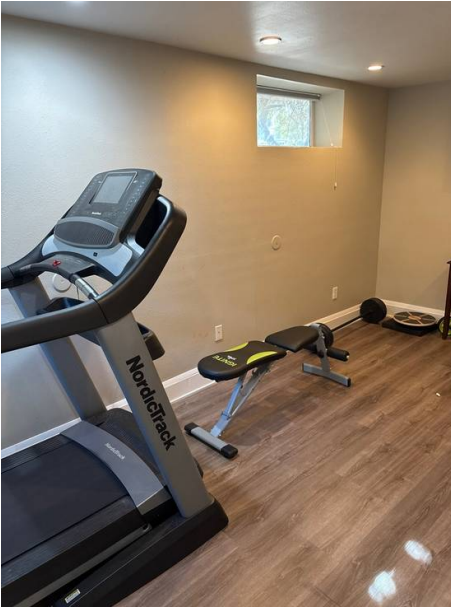
East basement room

No vents observed in the east basement room, a finished area within a larger unfinished basement, currently used as a gym, potentially leading to poor air circulation and increased risk of moisture or air quality issues in this section. Recommend installing proper ventilation, such as a supply and return vent, to improve air circulation in the finished area. Suggest further evaluation by a qualified HVAC contractor to ensure adequate ventilation and air quality for the space.

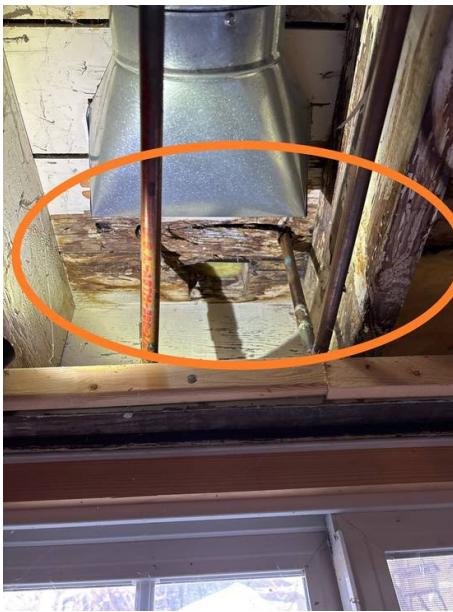
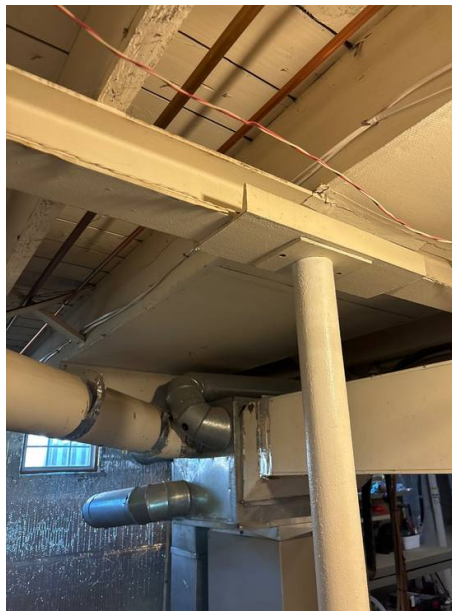
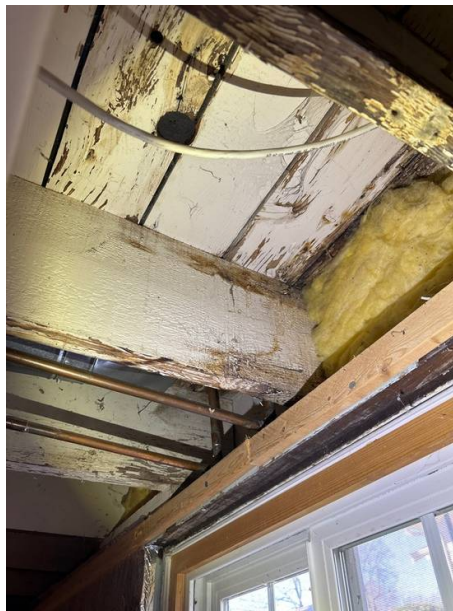
Staining and deterioration noted on the basement ceiling near the electrical panel, with the area dry at the time of inspection, and the painted ceiling limiting a full assessment of the extent of damage or potential moisture issues. This may indicate past or ongoing water infiltration.

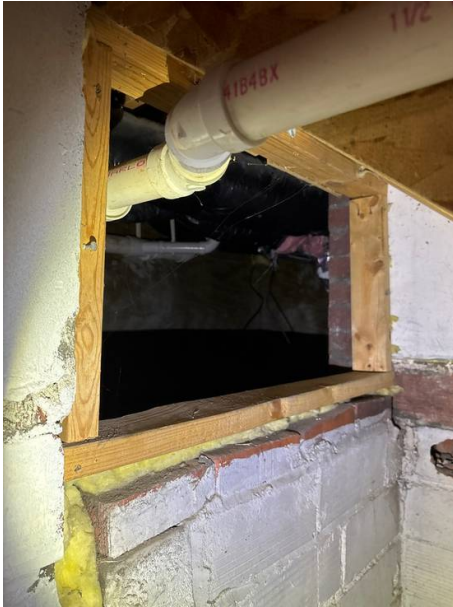
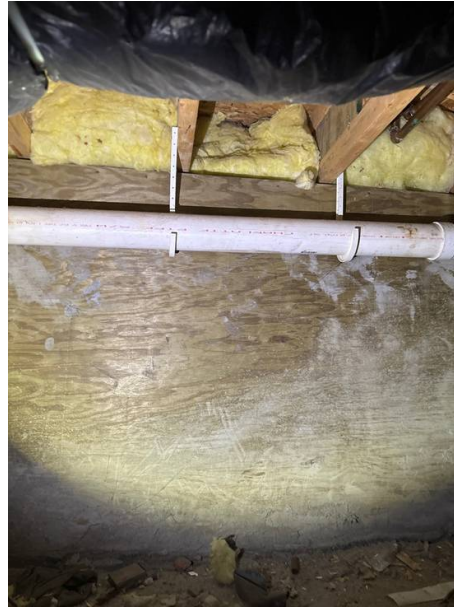
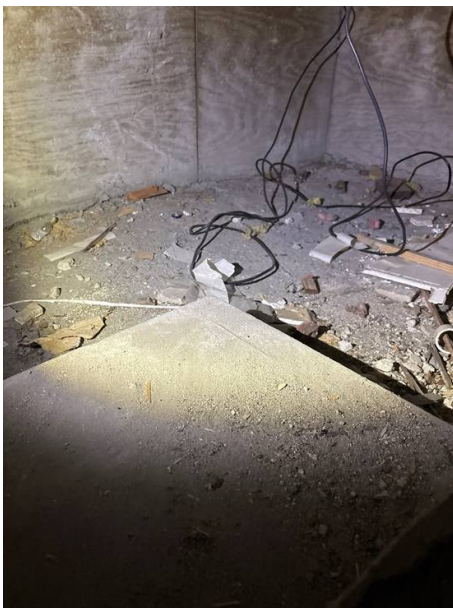
Small crawlspace area observed with a missing access panel, resulting in an exposed opening, and no vapor barrier on the floor or insulation on the ceiling, potentially allowing moisture infiltration, pest entry, and energy loss. Recommend installing an access panel to cover the opening, adding a vapor barrier to the floor, and installing insulation on the ceiling to improve moisture control and energy efficiency.

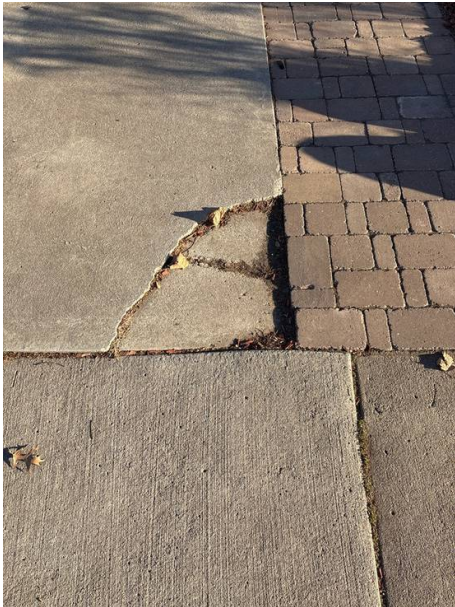
Cracks and loose concrete observed near the driveway approach, recommend sealing the cracks (per standard maintenance practices) and further evaluation by a qualified contractor to assess the loose section and ensure proper repair if sealant alone isn't sufficient.

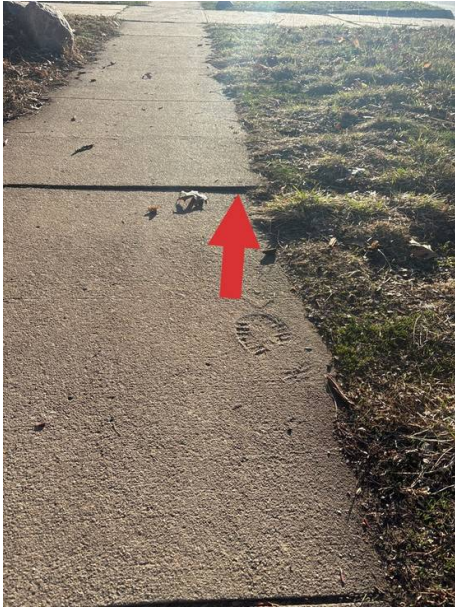
Trip hazards observed. Recommend trip hazards be addressed for a smooth transition to enhance safety and accessibility.

Trip hazard on sidewalk in front of the house

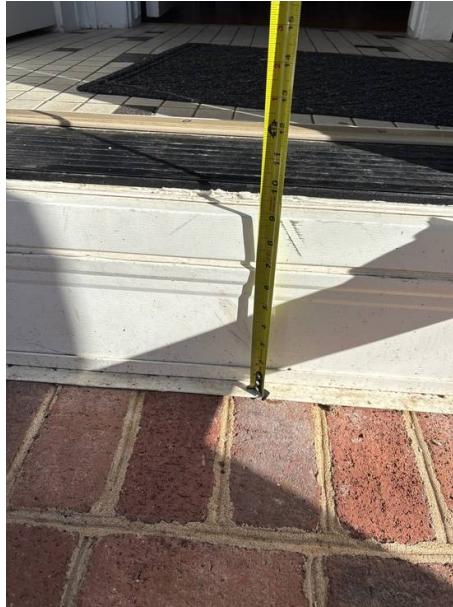
Step leading to the front porch exceeds maximum allowable height. Current standards require risers to have a maximum variance of 0.375 inches between the highest and lowest risers on the staircase and riser height to not exceed 7 3/4 inches.

Top step leading to front door exceeds maximum height requirements

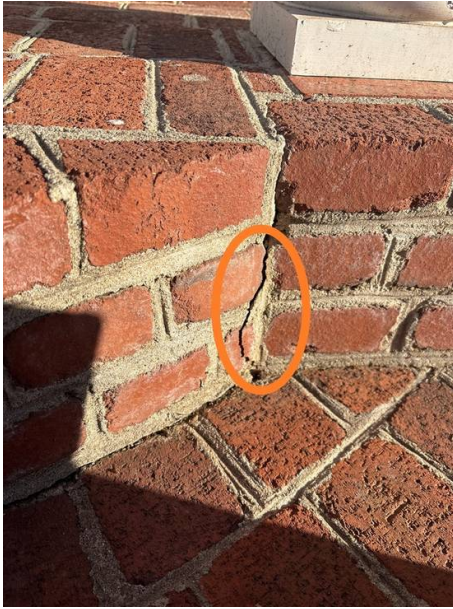
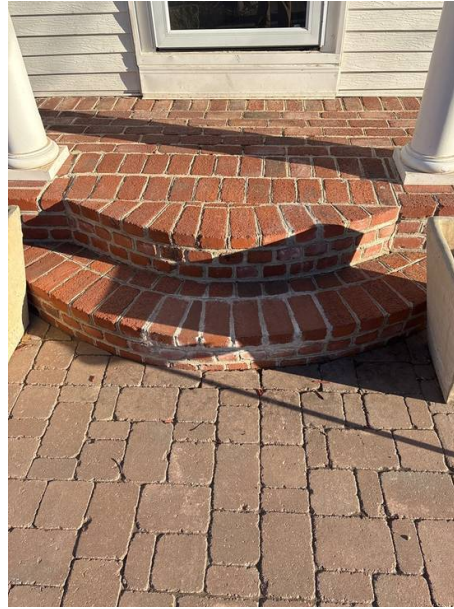
Crack observed in the brick on the front porch, recommend sealing or repointing the affected area to prevent further damage, and suggest further evaluation by a qualified contractor to ensure structural stability and proper repair.

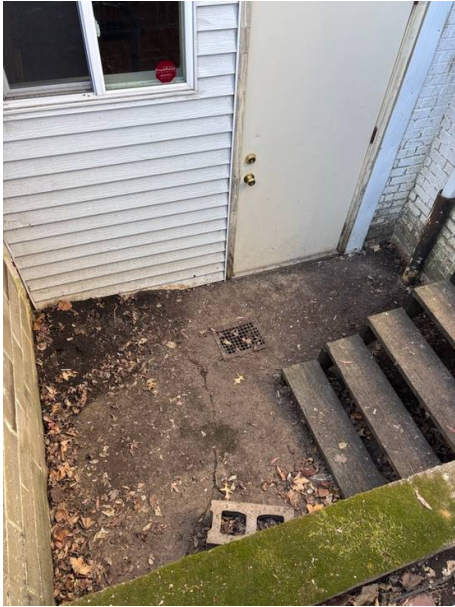
Location: Northeast.  
Insufficient drainage observed in the rear entrance to the east basement room stairwell, evidenced by dirt nearly level with the threshold and in contact with the siding despite the presence of a drain, as well as an interior drain on the other side of the door suggesting potential water management issues, recommend a comprehensive evaluation by a qualified contractor to ensure the drain is functioning, the grading prevents water accumulation and contact with the siding, and the threshold is protected from moisture intrusion.

Rear entrance to east basement room

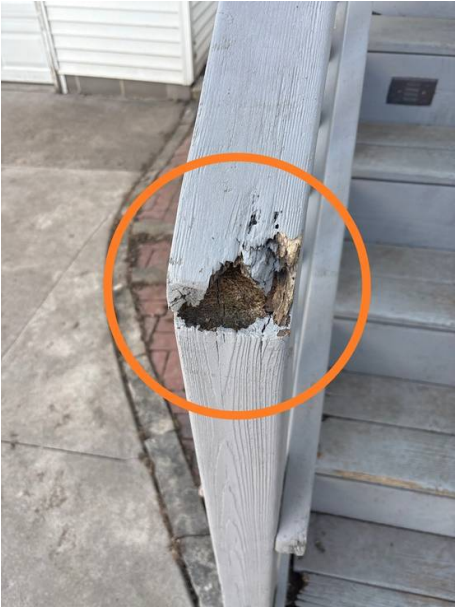
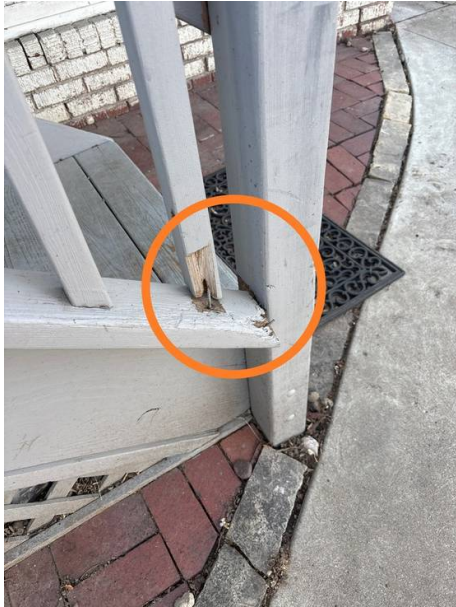
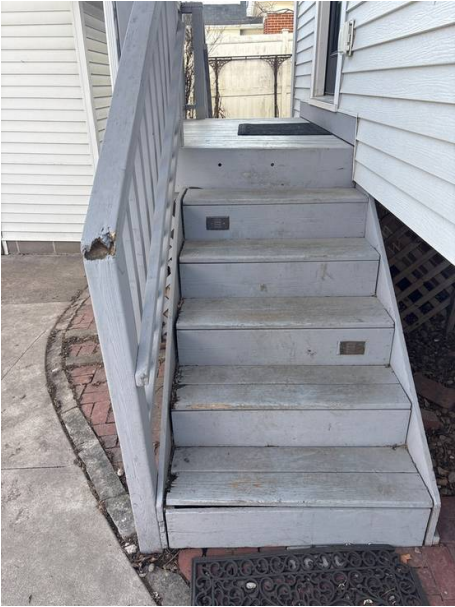
Handrails observed as loose and deteriorated, posing a safety concern, with general deterioration noted on the deck and stairs. Deck is at or near life expectancy. Recommend further evaluation by a qualified contractor for any or all

repair or replacement needs.

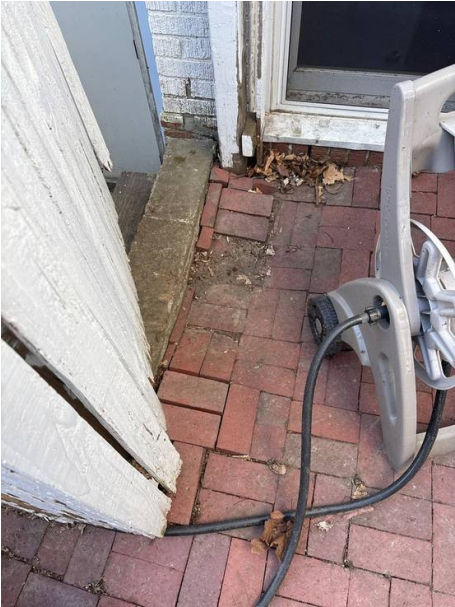
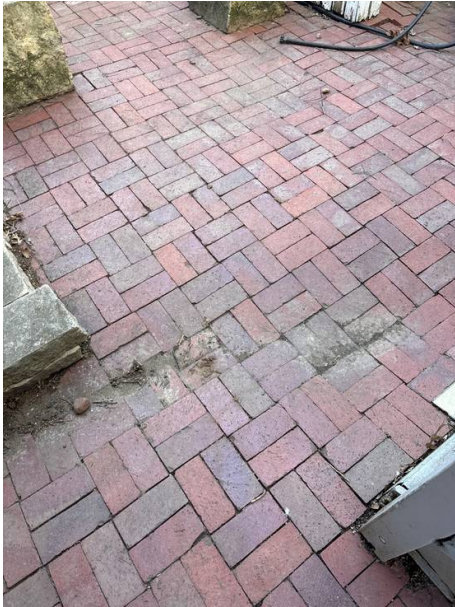
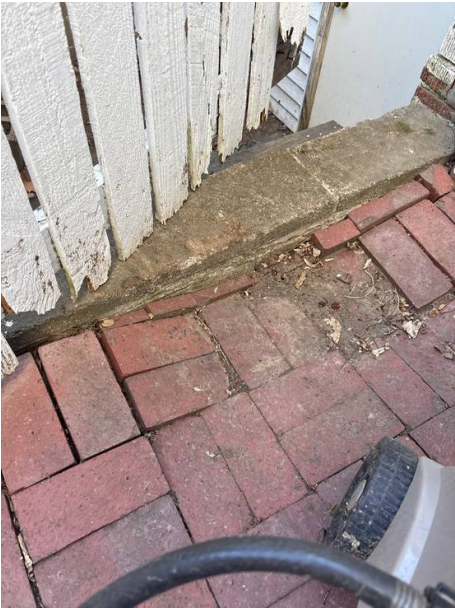
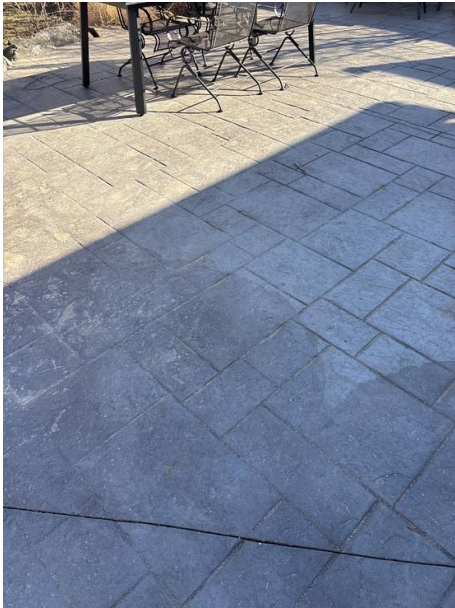
Loose bricks observed in the brick patio near the stairs leading to the northeast rear entrance, with the patio noted as wavy, recommend further evaluation by a qualified contractor to ensure stability and safety.
