12345

Des Moines IA 50311

Prepared for:  
Client Name

Chris Meade  
npiguydsm@gmail.com

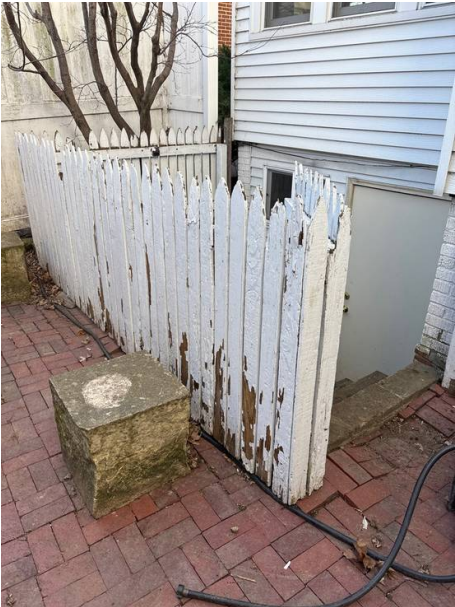
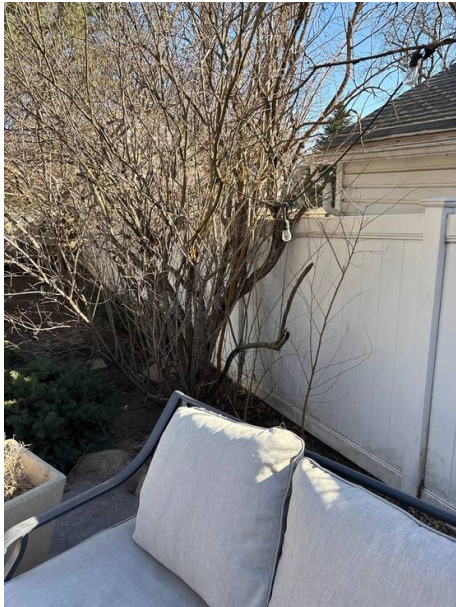
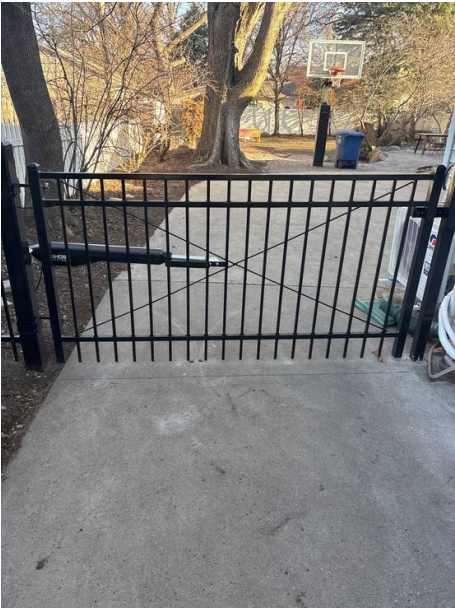
Deterioration observed on the wood fence around the rear northeast entrance, recommend replacement by a qualified contractor to ensure stability and proper function.

Location: East.  
Vegetation is observed in contact with the fence, potentially causing structural damage and promoting rot or insect activity. Recommend vegetation be trimmed back.

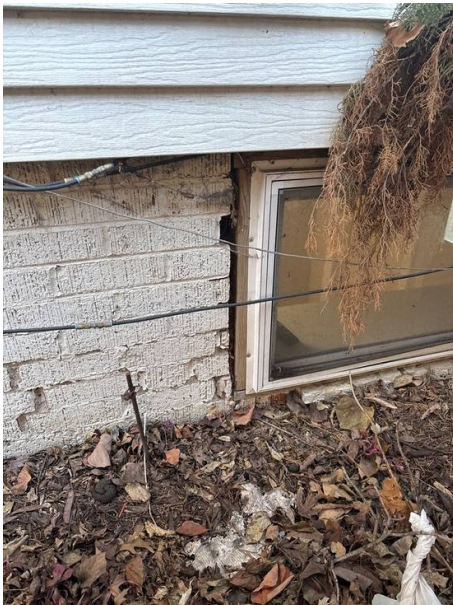
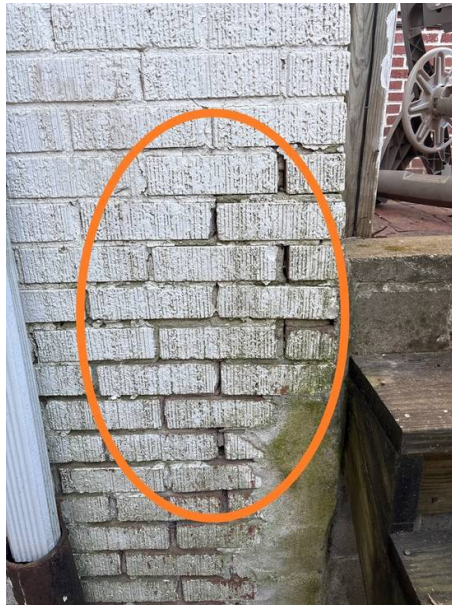
Gap observed between the foundation and the northeast basement window, with an uneven foundation noted along the gap, potentially allowing moisture infiltration and structural stress, recommend further evaluation and repair by a qualified contractor to ensure structural stability and protection from moisture damage.

Minor gaps observed throughout the rest of the painted brick foundation wall with no significant cracking or movement noted. Recommend monitoring the area for signs of moisture infiltration or further deterioration, and suggest minor repairs to the gaps in the brick foundation as needed to maintain protection against weathering. Further evaluation by a qualified contractor is advised if moisture or worsening conditions become evident.

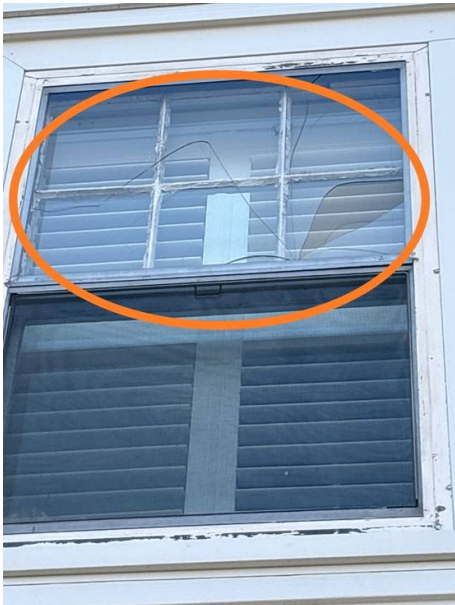
Broken window pane observed on the second-floor window, with visible cracks and damage to the glass, potentially compromising security and weatherproofing, recommend replacing the broken pane and suggest further evaluation by a qualified contractor to ensure proper sealing and protection from environmental damage.

Broken 2nd floor, west facing window

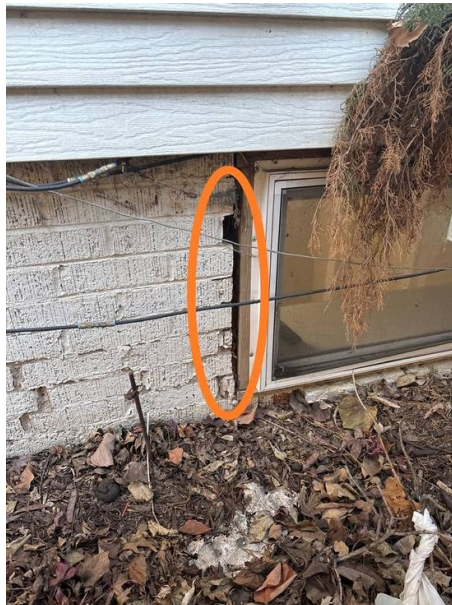
Bare wood observed on the window frame of the basement window on the northeast side of the house, potentially allowing moisture infiltration and deterioration, recommend treating or painting the bare wood to prevent rot, and suggest further evaluation by a qualified contractor to ensure proper weatherproofing and protection from moisture damage.

Northeast basement window - bare wood on window frame

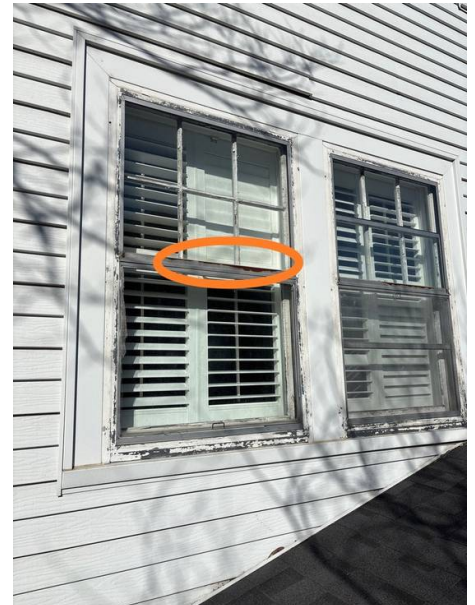
Rust observed on the metal window frame of the second-floor window, with discoloration noted in the lower right corner, wood grilles deteriorated, and the screen missing, potentially allowing further corrosion and pest entry, recommend treating the rust, repainting the frame, replacing the deteriorated wood grilles, installing a new screen, and suggest further evaluation by a qualified contractor to ensure proper weatherproofing and protection from environmental damage.

2nd floor east facing window

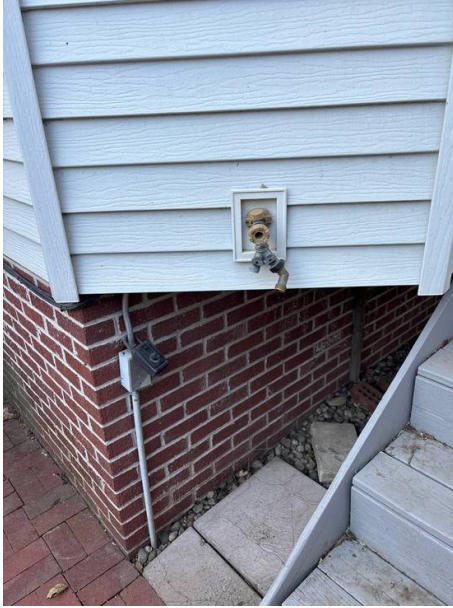
The hose bibs failed to produce water flow when tested during the inspection. Recommend assessment and repair by a qualified contractor to restore proper function and ensure reliable outdoor water access.

Hose bib at the bottom of the east deck stairs did not dispense water

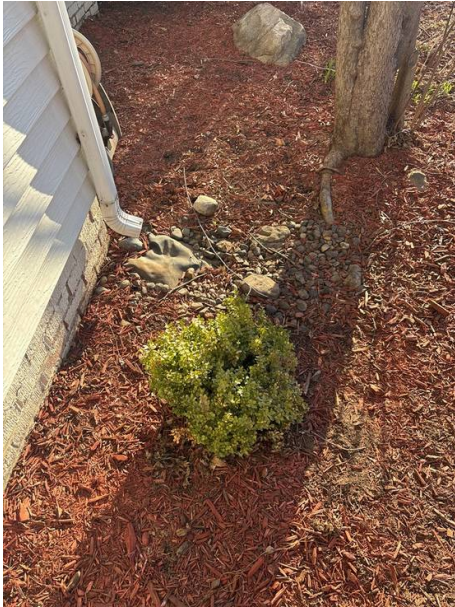
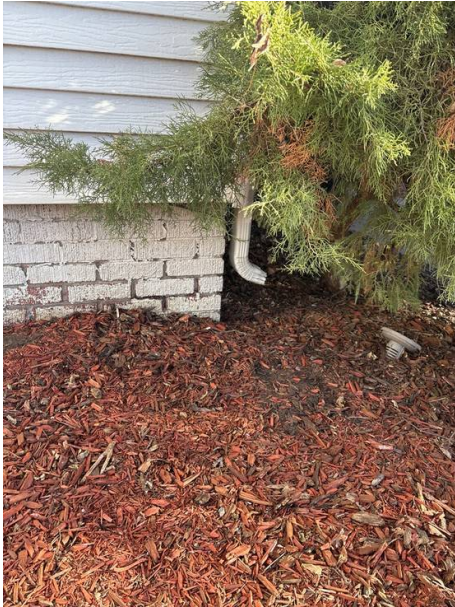
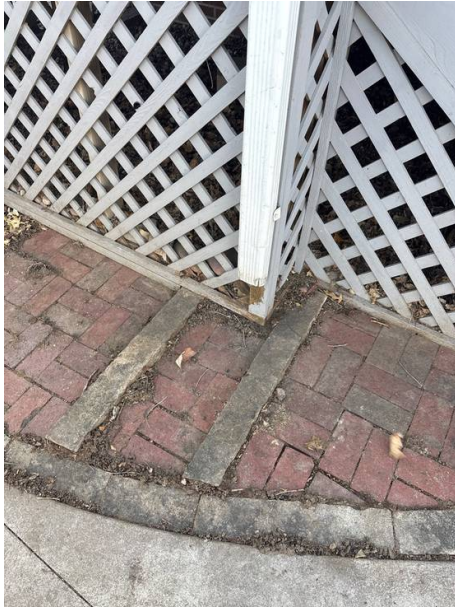
Multiple gutter downspout extensions observed to be missing, potentially allowing water to pool near the foundation and cause damage or erosion. Recommend replacing missing downspout extension.

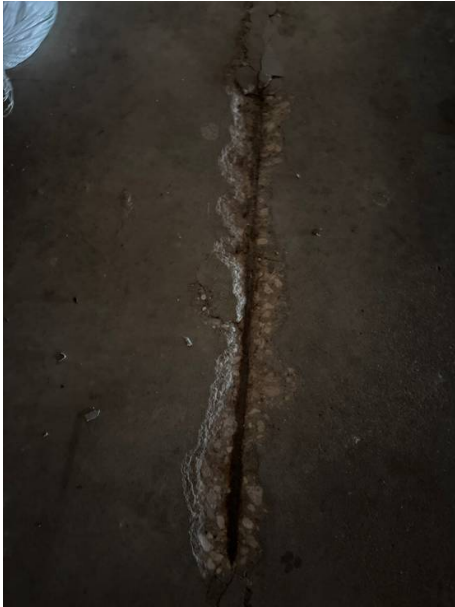
Cracks were observed in the garage floor during the inspection. These appear to be standard and typical; however, they should be monitored for excessive movement or worsening over time.

Deteriorated section of garage slab

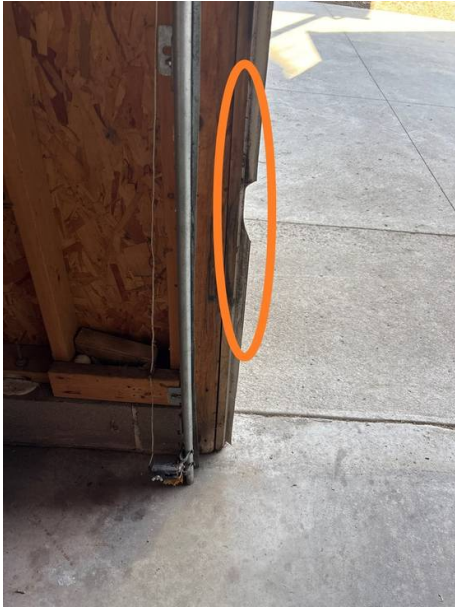
Weather stripping is missing or damaged, recommend replacement to improve energy efficiency and weather resistance.

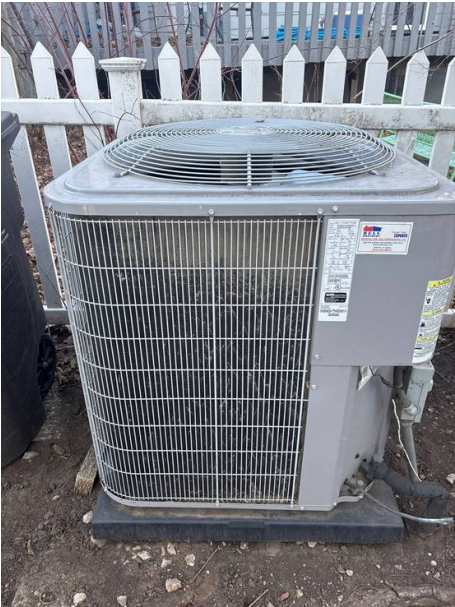
The air conditioning unit's fins were found to be dirty. Recommend cleaning.

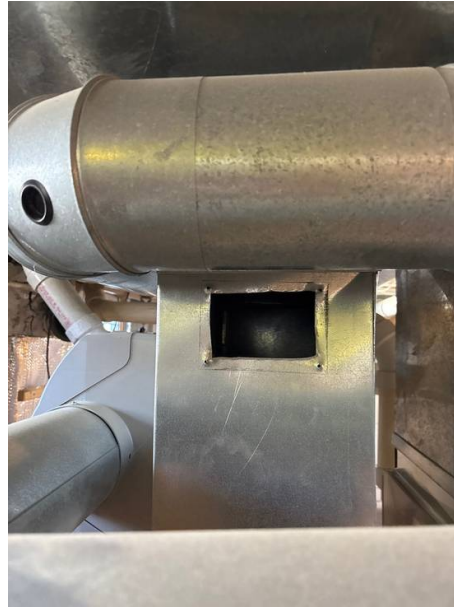
Tapped off vent observed in utility room

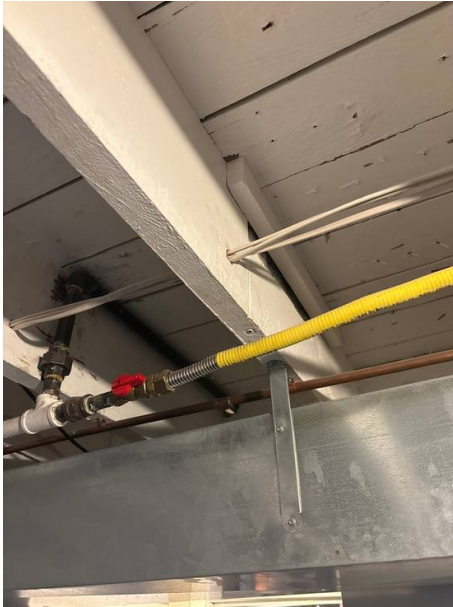
Corrugated Stainless Steel Tubing (CSST) was observed and does not appear to be properly bonded, posing a potential safety risk. Recommend further evaluation/repair by a qualified contractor.

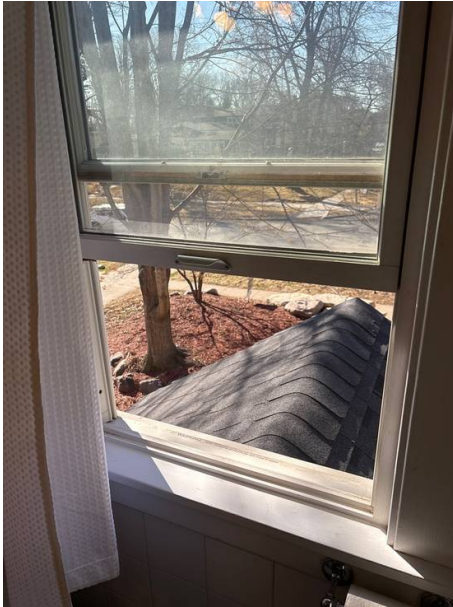
Missing window screen which may result in a deficiency allowing insects to enter and reducing ventilation control. Recommend installing a window screen to correct the deficiency and restore proper window functionality.

Upstairs hall bathroom window is missing its screen

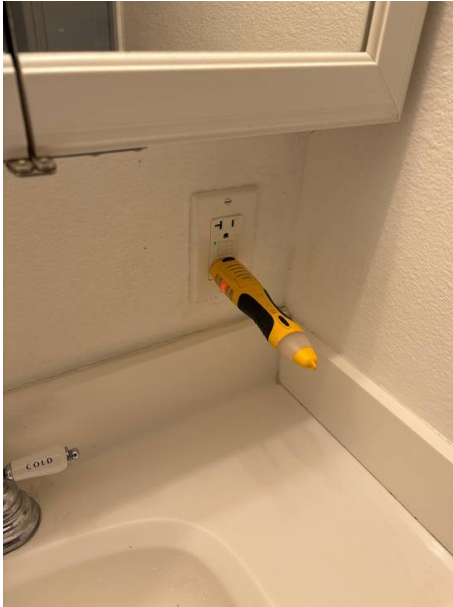
Outlet in the basement bathroom next to the sink observed to be wired incorrectly with a hot/neutral reverse as indicated by tester readings, posing a potential electrical hazard. Recommend further evaluation by a qualified contractor to ensure safety and proper function.

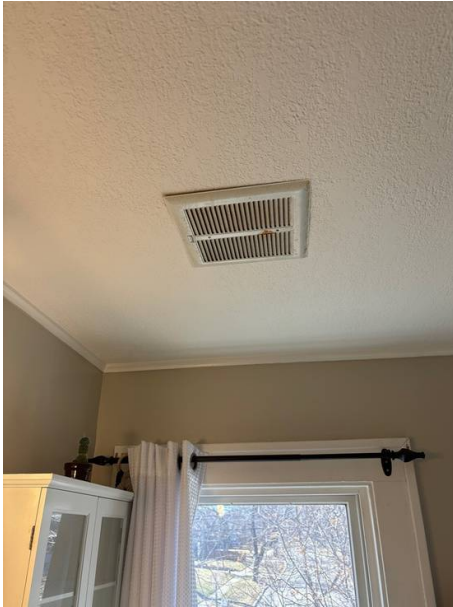
Location: 2nd Floor, Bathroom.  
The exhaust fan is loud, which may result in a deficiency indicating potential mechanical wear or imbalance affecting performance. Recommend further evaluation/repair by a qualified contractor to correct the deficiency and ensure proper fan operation.

Upstairs exhaust fan is loud

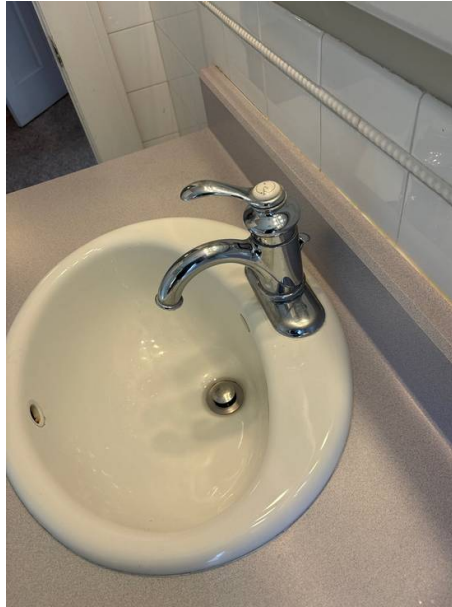
The bathroom sink drain stopper was observed to be non-functional during the inspection. Recommend evaluation and repair or replacement by a qualified contractor to restore proper operation and ensure effective use of the sink.

Upstairs hall bath, drain stopper

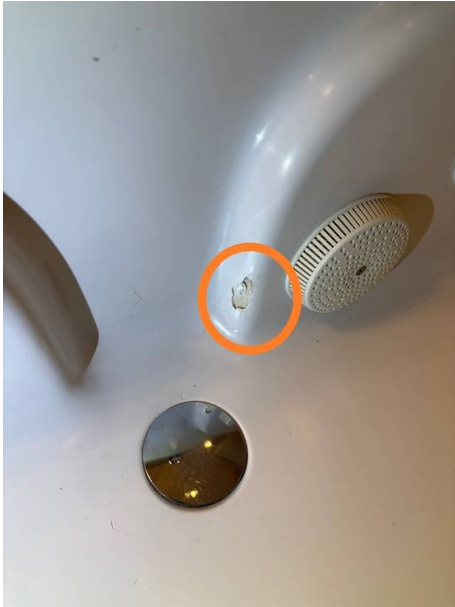
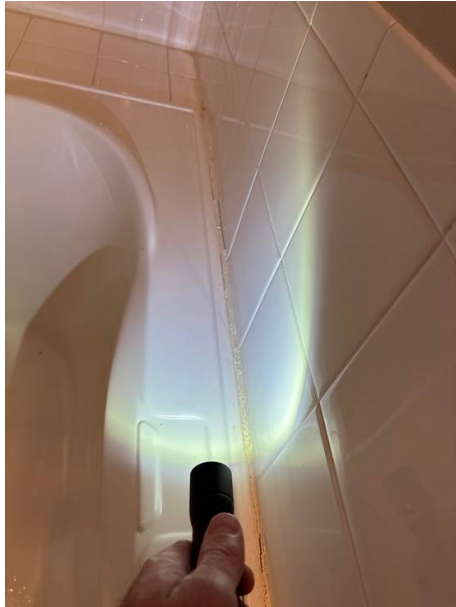
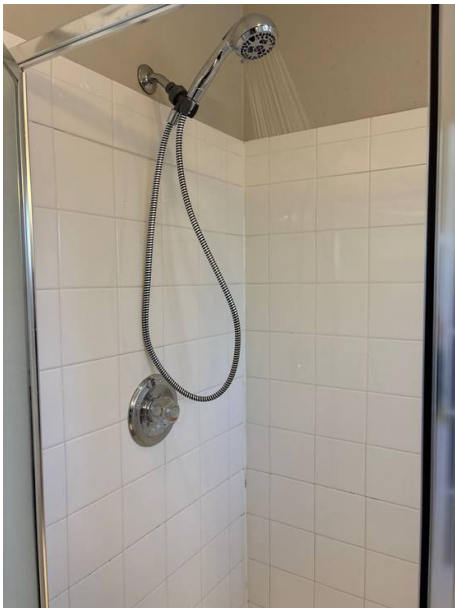
Chip observed in the jacuzzi tub, potentially allowing moisture to penetrate the underlying material. Jacuzzi tub jets appeared underpowered during operation, indicating a possible mechanical or electrical issue. No dedicated GFCI (Ground Fault Circuit Interrupter) protection observed for the unit, posing a safety hazard. Deteriorated caulk observed between the tiles in the bathroom, potentially allowing moisture infiltration behind the walls. Recommend further evaluation/repair of jacuzzi tub and surrounding area by a qualified contractor.

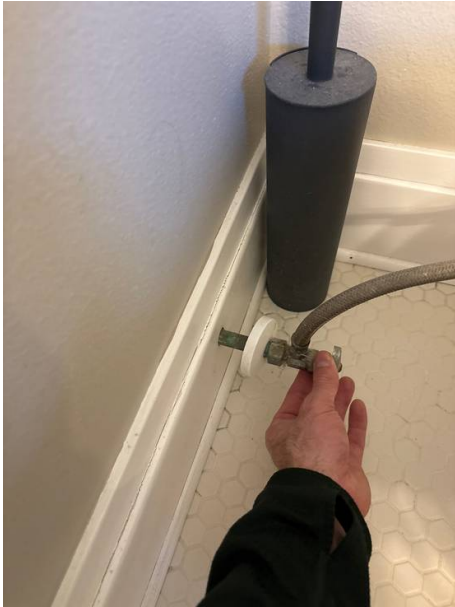
Location: 2nd Floor, Primary , Bathroom.  
White trim ring cover found loose, potentially allowing movement or minor leaks, recommend tightening the connection and securing the trim ring cover

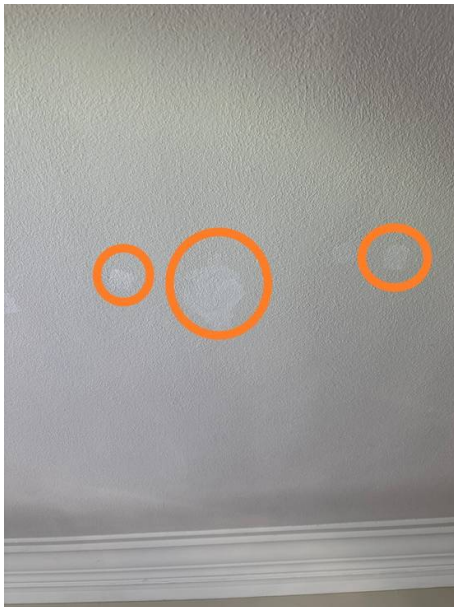
Living room ceiling

Multiple areas of the living room ceiling observed to have been recently painted. Some areas show slight texture or color variation. All areas were dry at the time of inspection. Recommend monitoring for signs of moisture or staining that may indicate underlying issues. Requesting seller disclosure regarding any previous water damage or repairs in these areas. Suggest further evaluation by a qualified contractor if discoloration or moisture reappears.

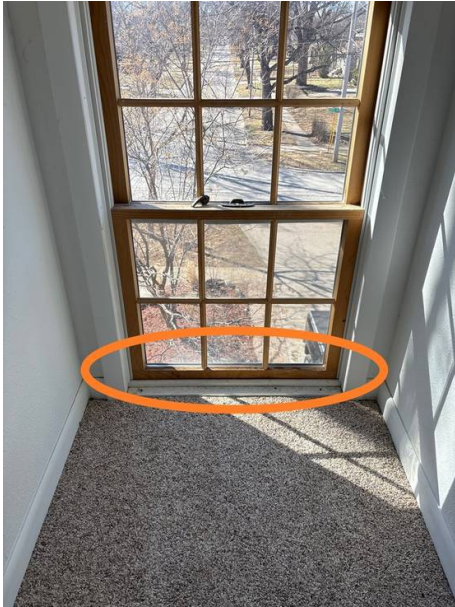
Windows in the finished attic space on the third floor observed to not meet the minimum sill height requirements of 24 inches for fall protection. This poses a fall hazard for children given the significant height above the exterior grade. Recommend installing window guards and/or further evaluation by a qualified contractor to ensure compliance with safety standards and prevent potential falls.

3rd floor window does not meet minimum height requirements and has broken locking hardware

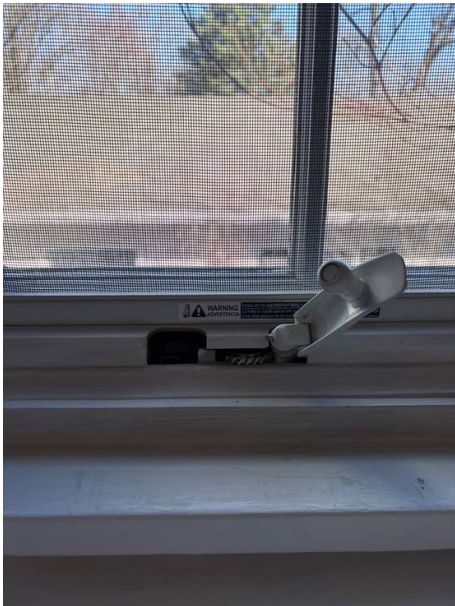
Window right of the fireplace in the living room observed with a missing sash lock, compromising the ability to secure or operate the window properly. Additionally, the primary bedroom closet window in the primary bedroom observed with a loose sash lock. Recommend replacing the missing sash lock in the living room window and tightening or replacing the loose sash lock on the closet window to restore proper function and security. Suggest further evaluation by a qualified contractor to ensure both windows operate safely and effectively.

Window right of the fireplace in the living room is missing hardware

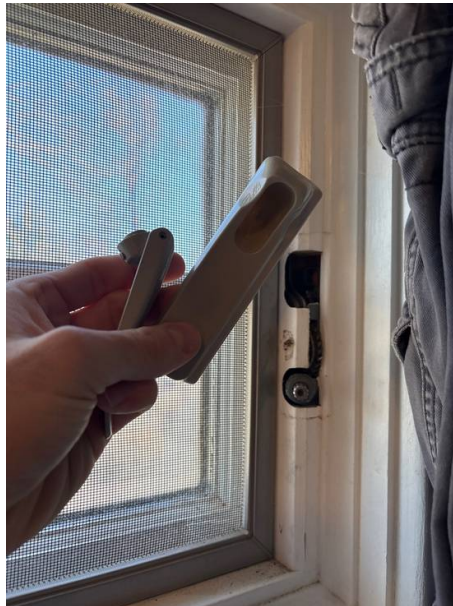
Primary bedroom closet window hardware

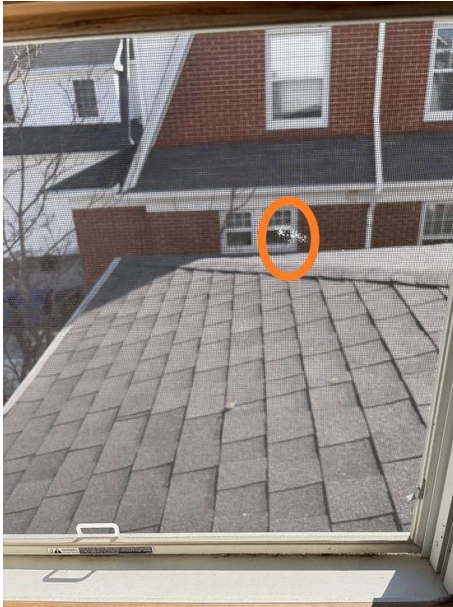
Damaged screen was observed, potentially allowing pests or debris to enter and reducing security or ventilation effectiveness.

Hole in east facing screen in northeast bedroom

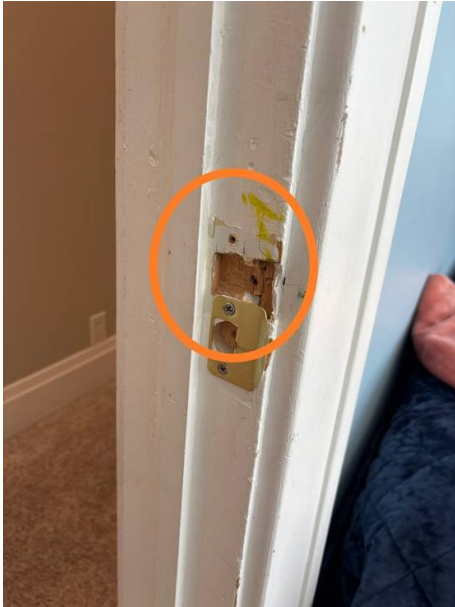
Northeast bedroom

Door frame in the northeast bedroom observed with damaged wood and exposed areas around the latch plate, indicating wear or impact damage.

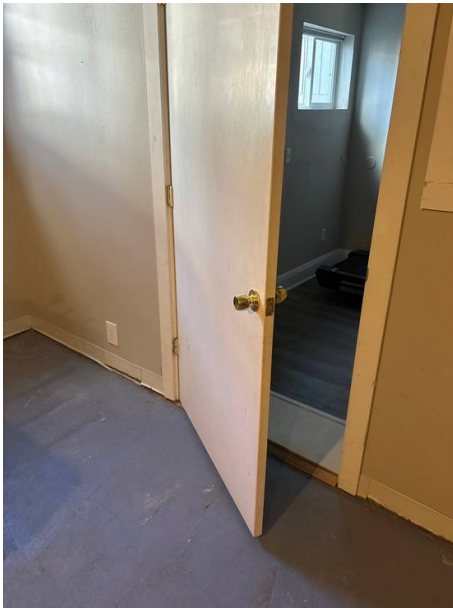
Door to the east basement room observed to rub on the floor and ceiling, indicating improper alignment or settling issues. This may hinder proper operation and cause wear over time.

Door to east basement room rubs on floor  
and ceiling

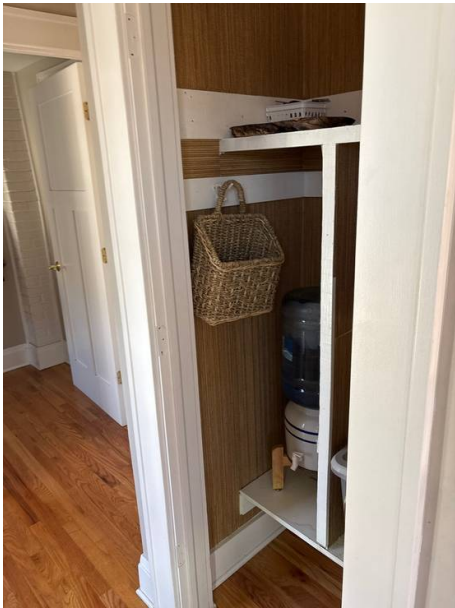
Missing closet door. Recommend missing closet door be replaced.

Missing closet door

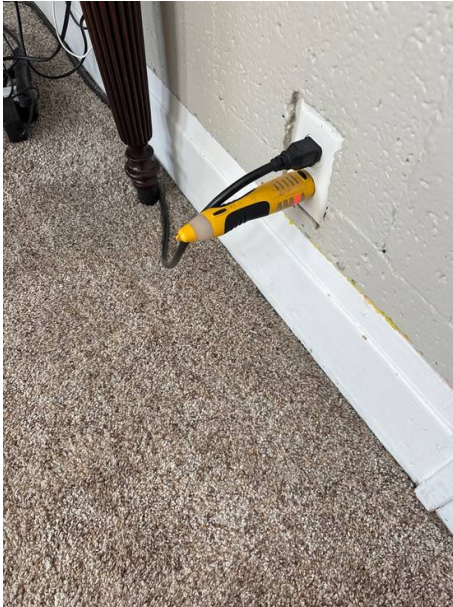
Southeast bedroom

Location: Bedroom, Southeast.  
Ungrounded outlet observed. Recommend all outlets be grounded.

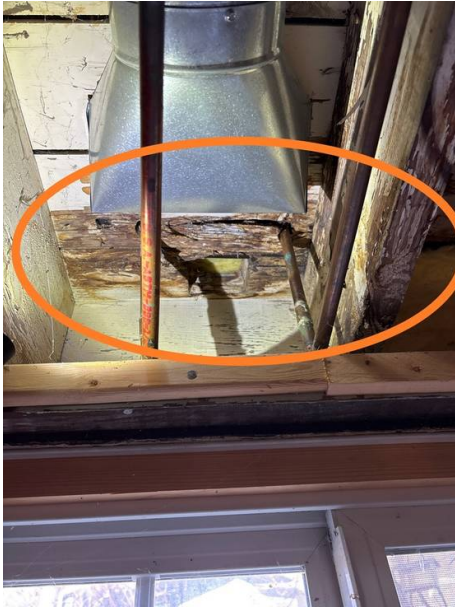
Location: Basement, Northwest.

Staining and deterioration noted on the basement ceiling near the electrical panel, with the area dry at the time of inspection, and the painted ceiling limiting a full assessment of the extent of damage or potential moisture issues. This may indicate past or ongoing water infiltration.

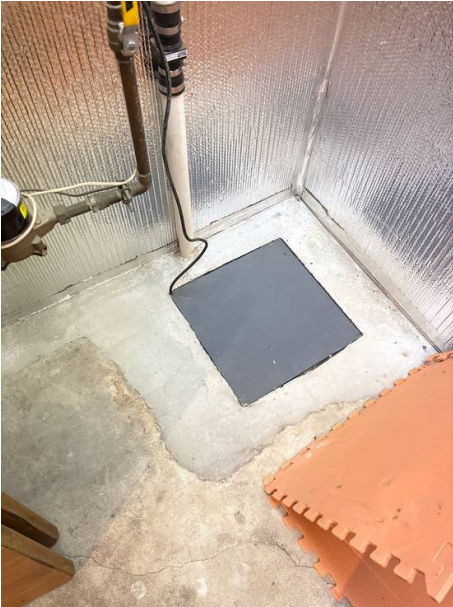
The sump pump lid was sealed shut and could not be opened for testing during the inspection. As a result, the pump's functionality, condition, and discharge system could not be evaluated.

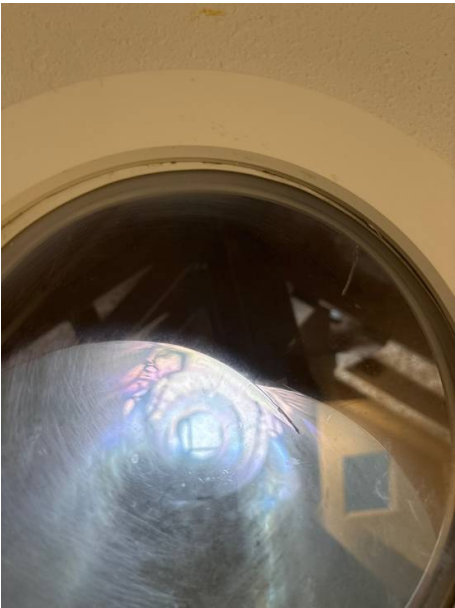
A small viewing hole with a plastic covering was present, allowing limited observation into the unfinished attic space, making a comprehensive assessment challenging. The visible structural components appeared intact but could not be fully evaluated due to restricted access
