National Property Inspections

Sample Report, 151 Sample Report, Miami Beach, Fl, 33139

Wednesday, April 9, 2025

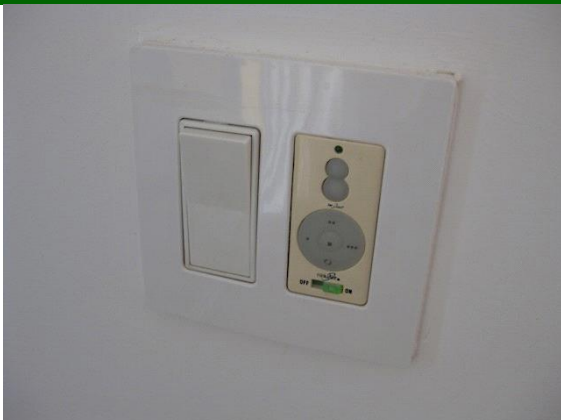
Fan controller turned on and off however the fan itself did not move at all, recommend repair

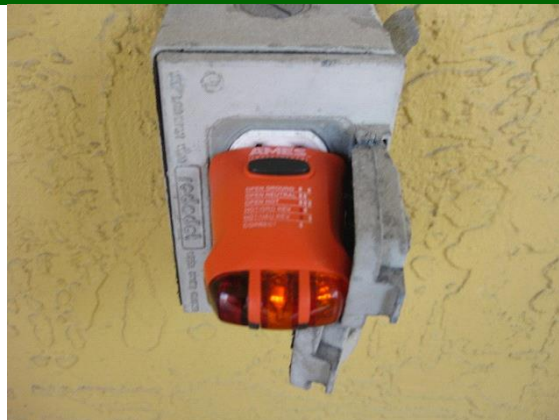
Electrical outlet on balcony was function at time of inspection and had proper outlet cover present

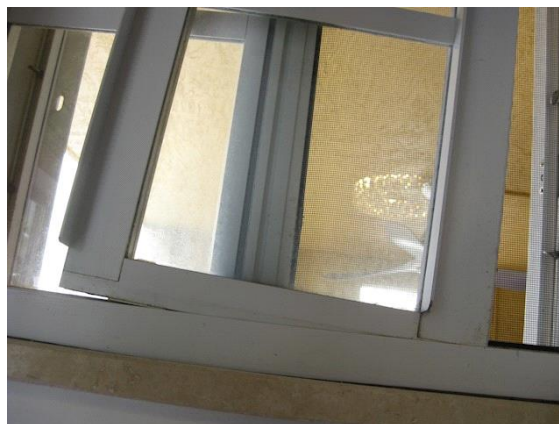
One of the small windows in bedroom 2 came off its tracks when opened, although the window opened and closed maintenance is recommend to prevent further damage

Window in bedroom 2 showed signs of deterioration, recommend repair for ease of use

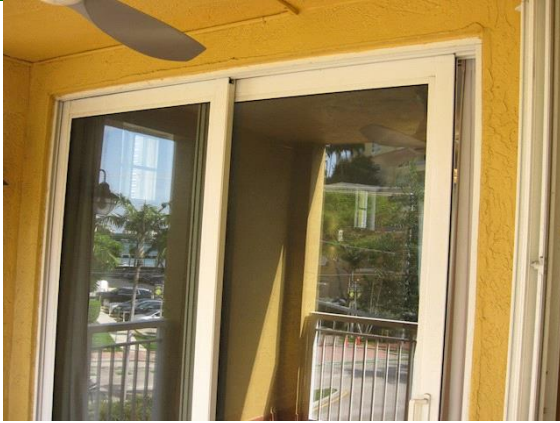
Sliding glass door in main bedroom did not have weather strip present, stagnated water was observed in sliding glass door track area, recommend repair to prevent additional moisture from entering apartment

Sliding glass door did not have weather strip present, stagnated water was observed in sliding glass door track area, recommend repair to prevent additional moisture from entering apartment

Recommend further evaluation/repair by qualified contractor(s).

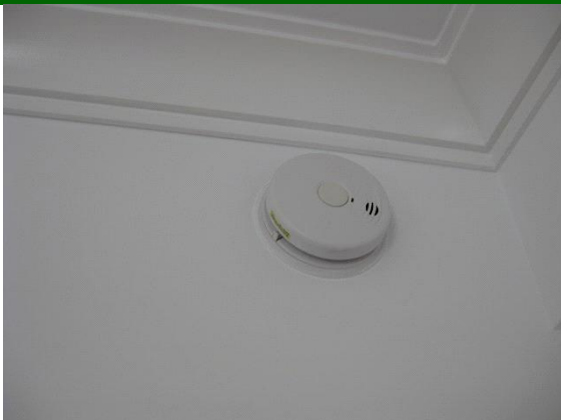
One of the smoke detectors in the unit did not turn off and had a constant beeping.
Recommend further evaluation/repair by qualified contractor(s).

Smoke detector had a constant beeping observed, recommend repair

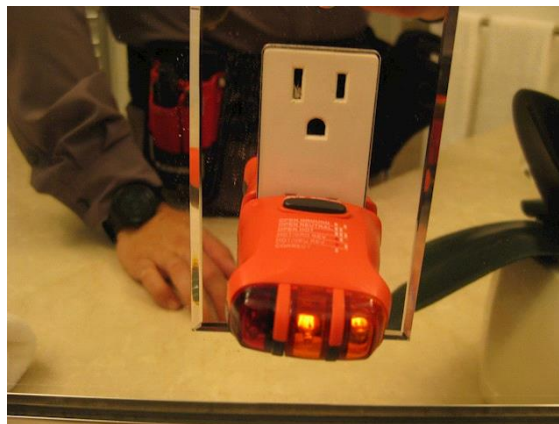
Electrical outlet in main bathroom was acceptable at time of inspection

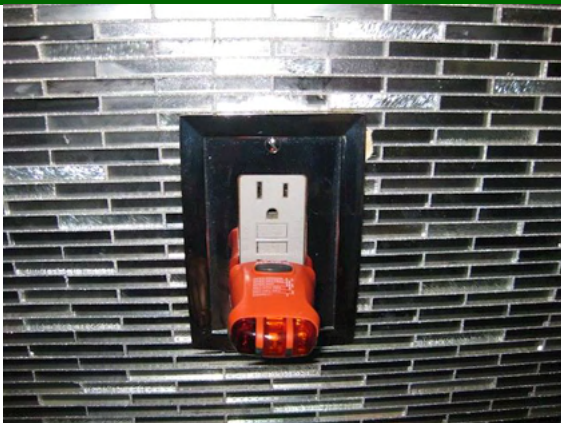
Electrical outlet in kitchen was acceptable at time of inspection

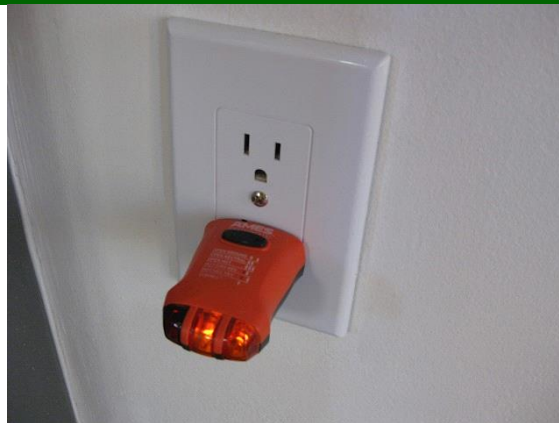
Electrical outlet in living/dining room was acceptable at time of inspection

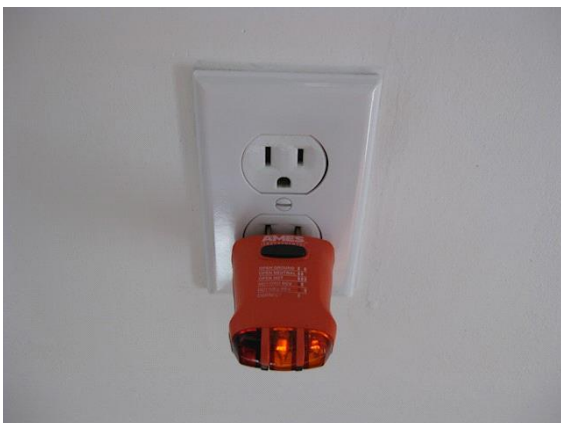
Electrical outlet in bedroom 2 was acceptable at time of inspection

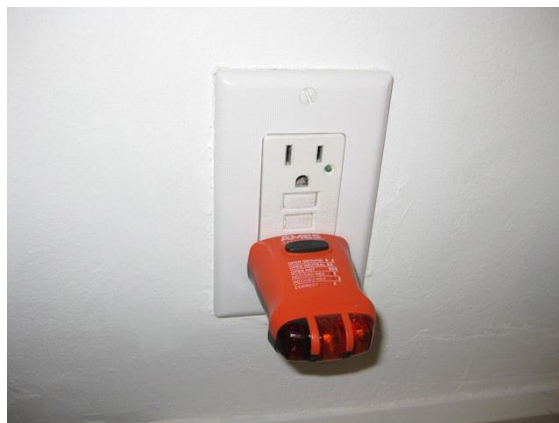
Electrical outlet in bathroom 2 was acceptable at time of inspection

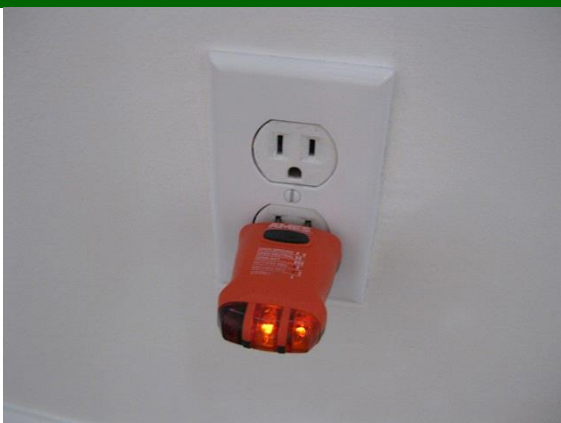
Electrical outlet in bedroom 3 was acceptable at time of inspection

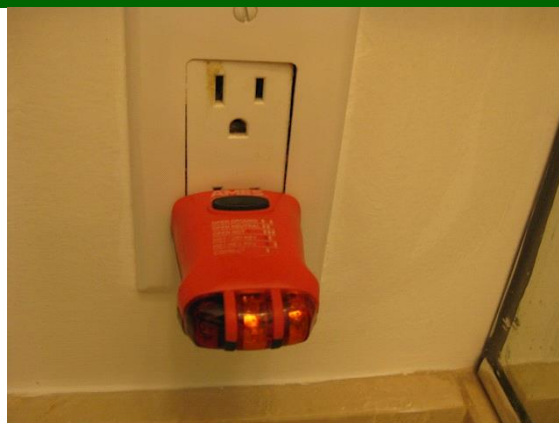
Electrical outlet in bathroom 3 was acceptable at time of inspection

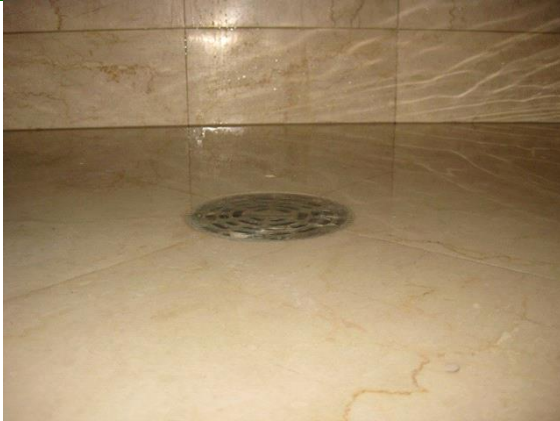
The shower in the main room bathroom did not drain at time of inspection, this is an issue that should be addressed as it may lead to more serious issues such as water intrusion
Recommend further evaluation/repair by qualified contractor(s).

Shower in main room bathroom did not drain at time of inspection, recommend repair

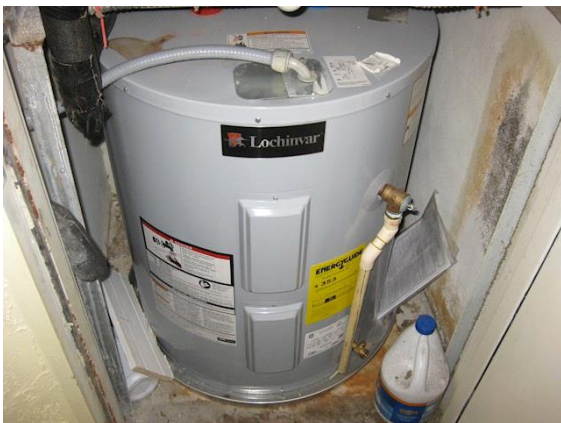
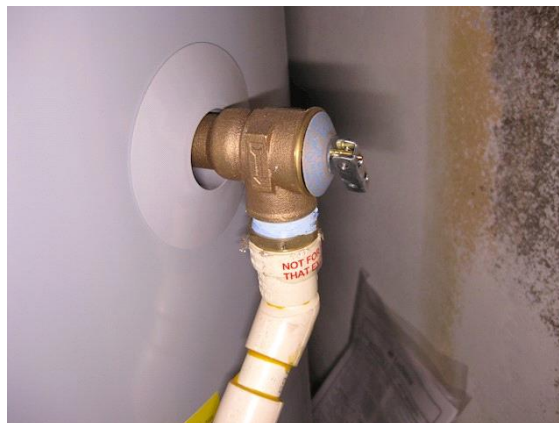
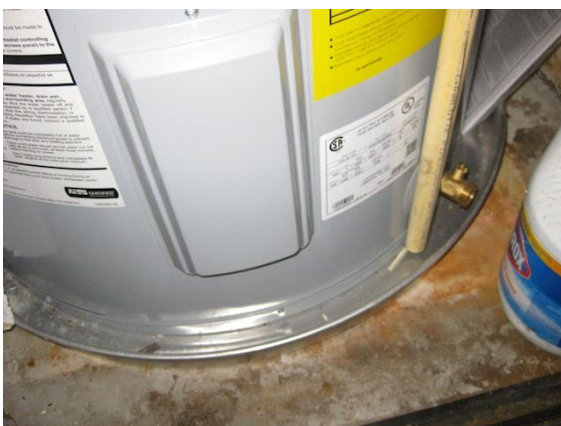
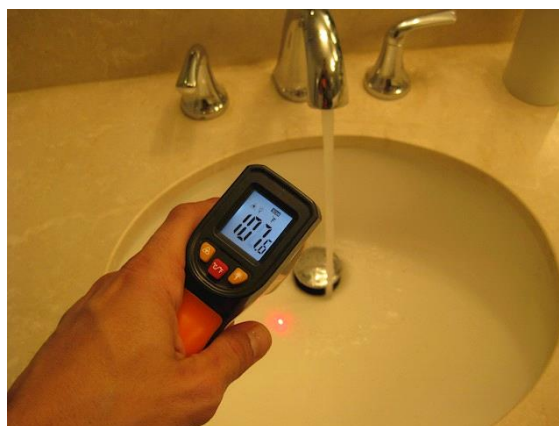
The operation and installation of the water heater appeared to be satisfactory at time of inspection. Routine maintenance such as draining the water heater could prolong its lifespan. Always refer to manufactures' specifications before doing any maintenance on your water heater.

Recommend the water heater be flushed twice a year to reduce sedimentation and maximize efficiency.

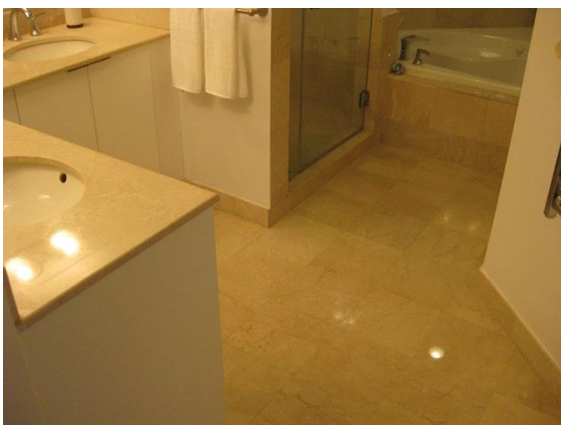
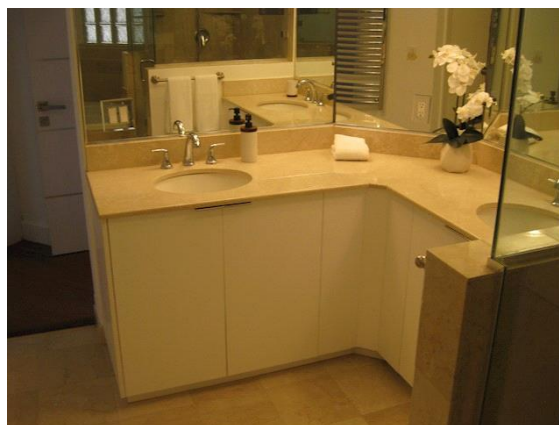
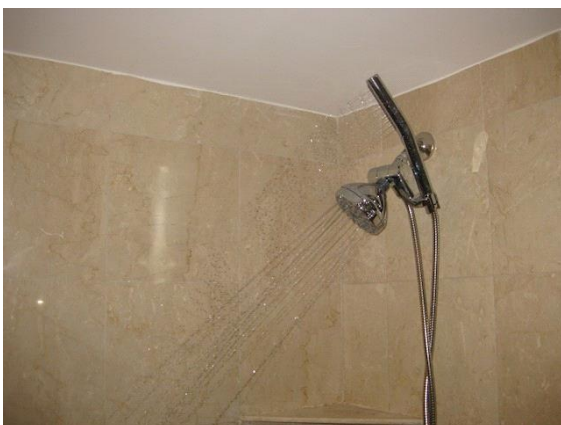
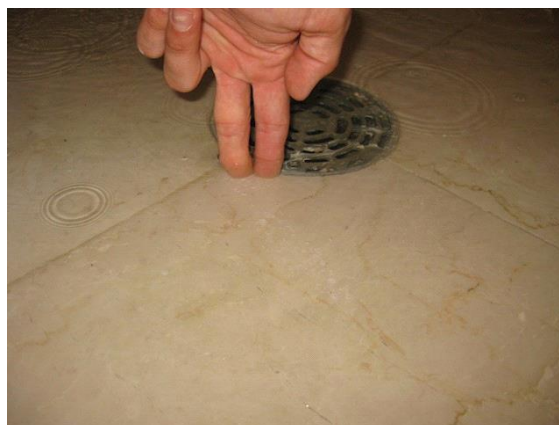
Jetted tub was turned on however the water was noted to be cloudy, recommend general maintenance.

Shower area did not drain at time of inspection, recommend repair

Recommend further evaluation/repair by qualified contractor(s).

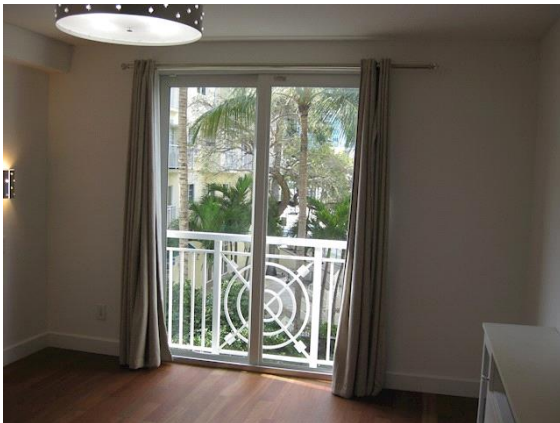
Vinyl flooring showed signs of separation at time of inspection

Vinyl flooring showed signs of separation at time of inspection, recommend repair

Recommend further evaluation/repair by qualified contractor(s).

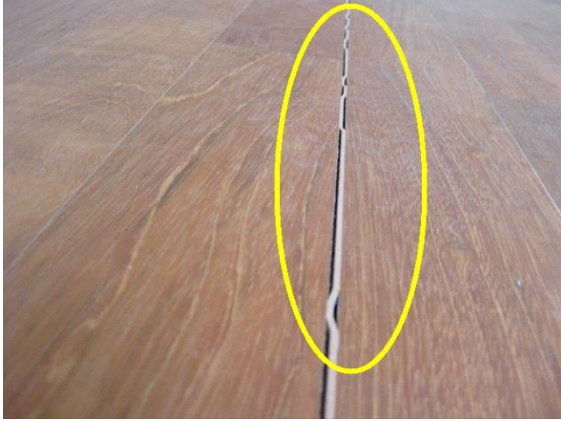
Vinyl flooring showed signs of separation at time of inspection, recommend repair

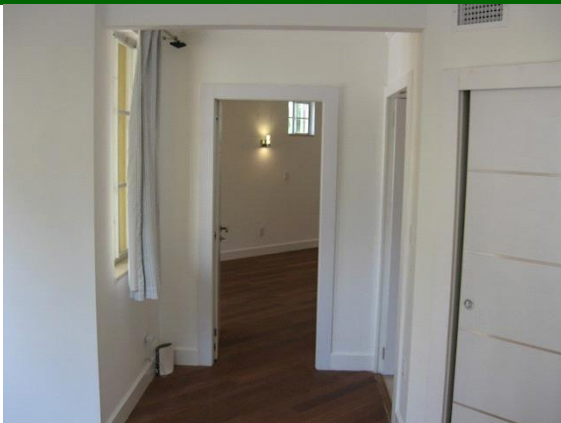
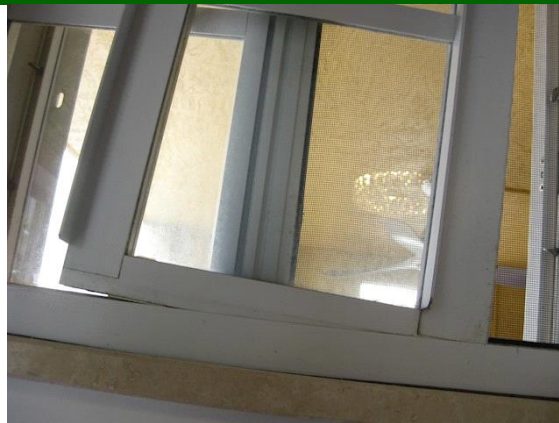
Window in bedroom 2 showed signs of deterioration, recommend repair for ease of use
Recommend further evaluation/repair by qualified contractor(s).

Window in bedroom 2 showed signs of deterioration, recommend repair for ease of use

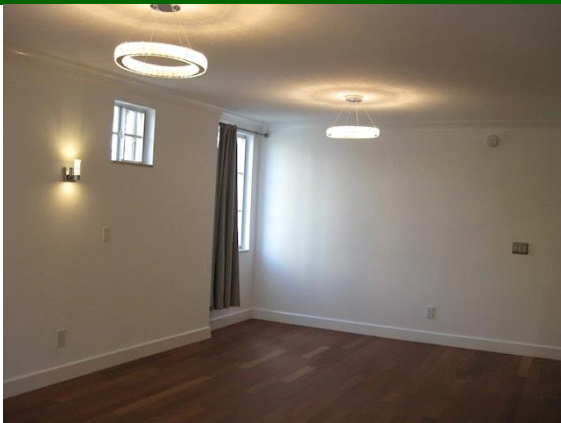
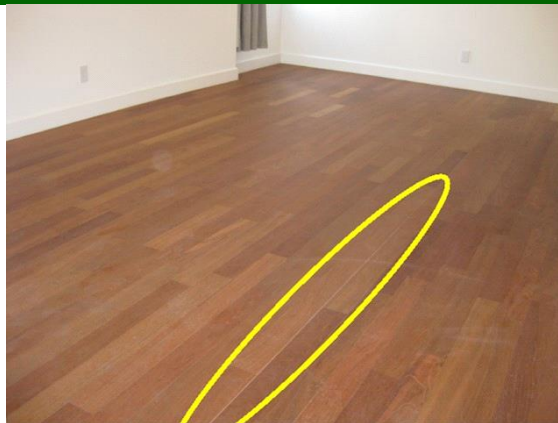
Vinyl flooring showed signs of separation at time of inspection, recommend repair

Recommend further evaluation/repair by qualified contractor(s).

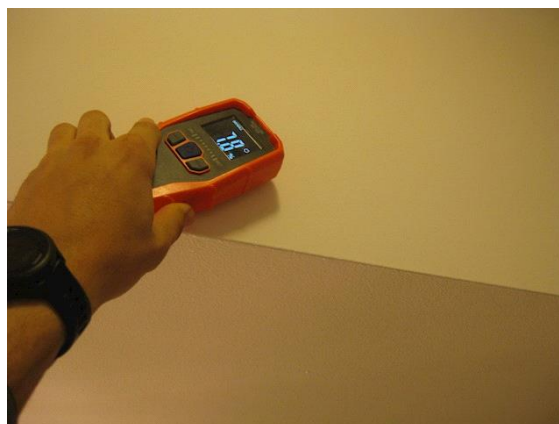
Humidity reading taken in main room bathroom

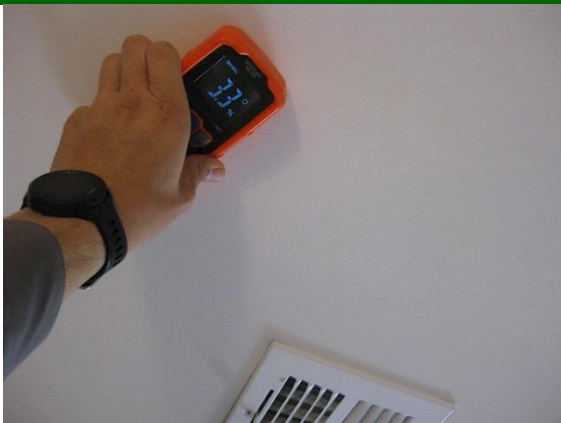
Humidity reading taken in bathroom 2 ceiling

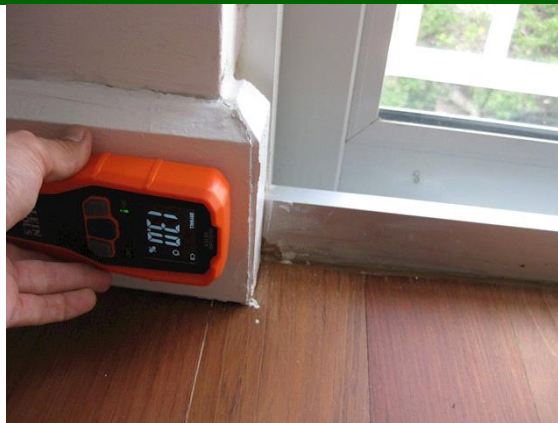
Humidity reading taken in main bedroom along baseboards near sliding glass door, areas was dry at time of inspection.
Baseboards were seen separated from themselves most likely due to elevated humidity in the area as the sliding glass door does now have a weather strip

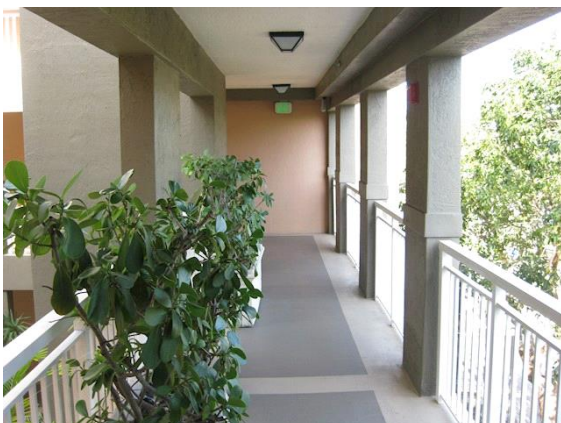
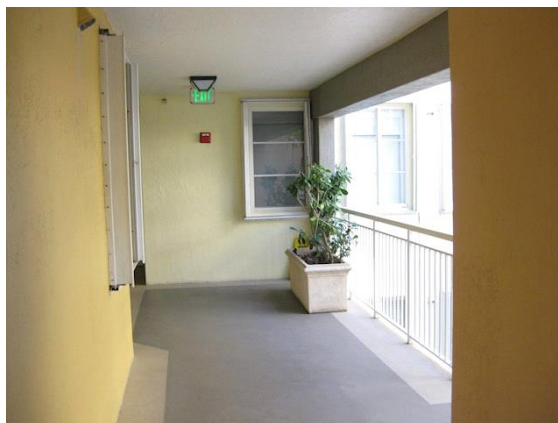
Corridor access to units is acceptable at time of inspection.

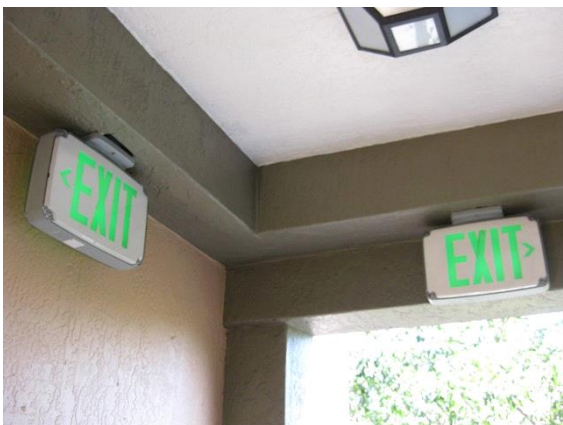
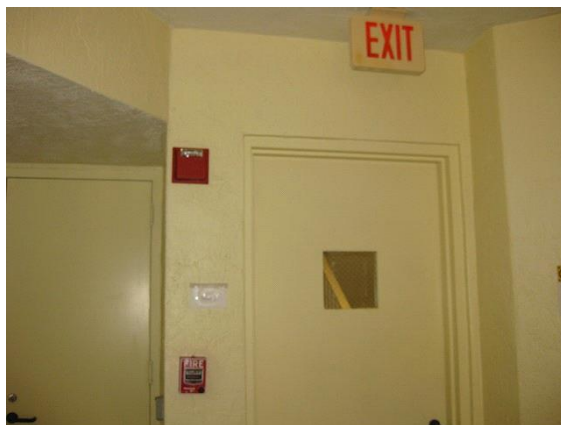
Fire and emergency exit signage properly posted throughout

Fire Suppression System maintained by HOA and appear acceptable at time of inspection.

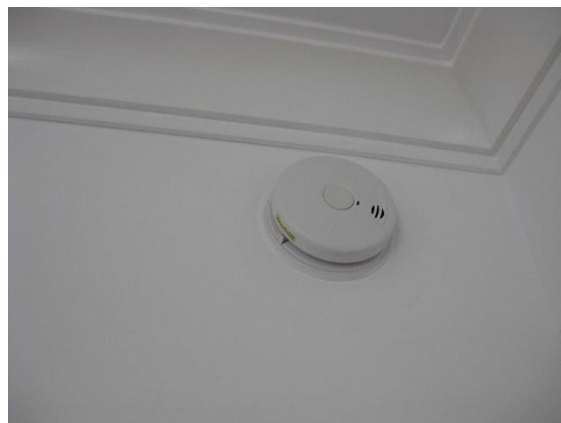
One of the smoke detectors in the unit did not turn off and had a constant beeping.
Recommend further evaluation/repair by qualified contractor(s).

Smoke detector had a constant beeping observed,
recommend repair

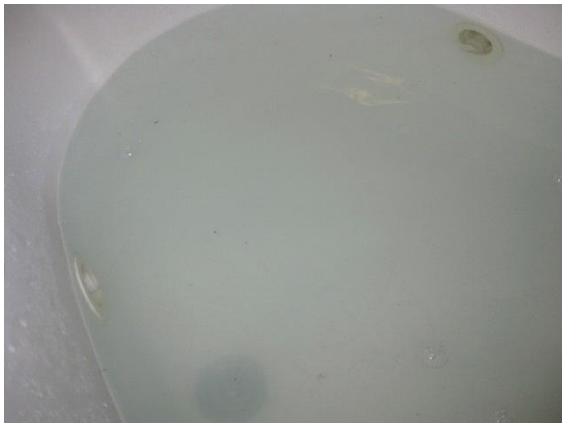
When jetted tub was turned on and filled the water was seen to be cloudy at time of inspection, this may due to lack of use and maintenance.

Recommend regular maintenance of unit to allow for comfort of use and prevent deterioration

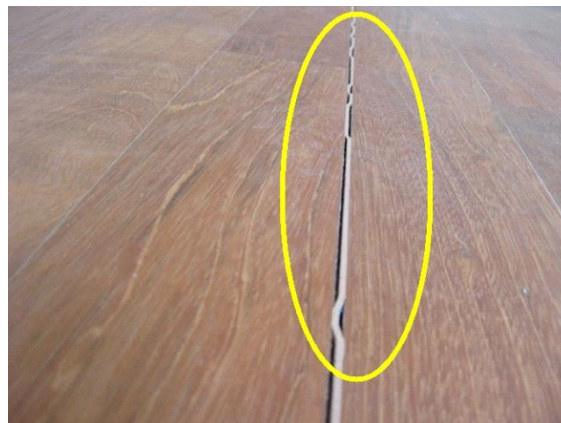
Vinyl flooring showed signs of separation at time of inspection, recommend repair

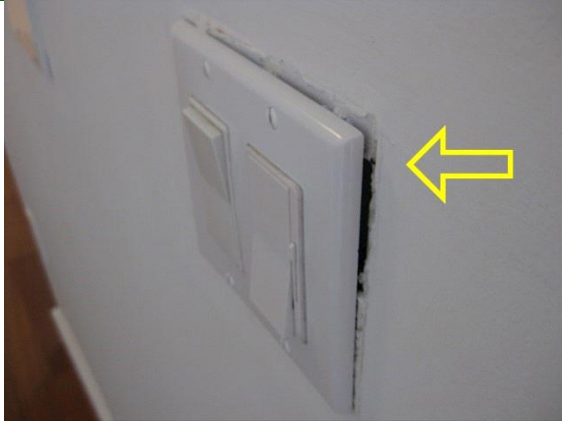
Electrical switch trim showed signs of damage

Electrical switch trim showed signs of damage, recommend repair
