# Fixing Air Leakage in Connecticut Town Houses

*After energy improvements were made to some town houses, a second look revealed big opportunities for energy and money savings.*

Mill Pond Village is a 360-unit affordable housing development built in 1975 and located in Broad Brook, Connecticut. Owned and managed by Winn Companies, this property has undergone many improvements over the past few years, but energy

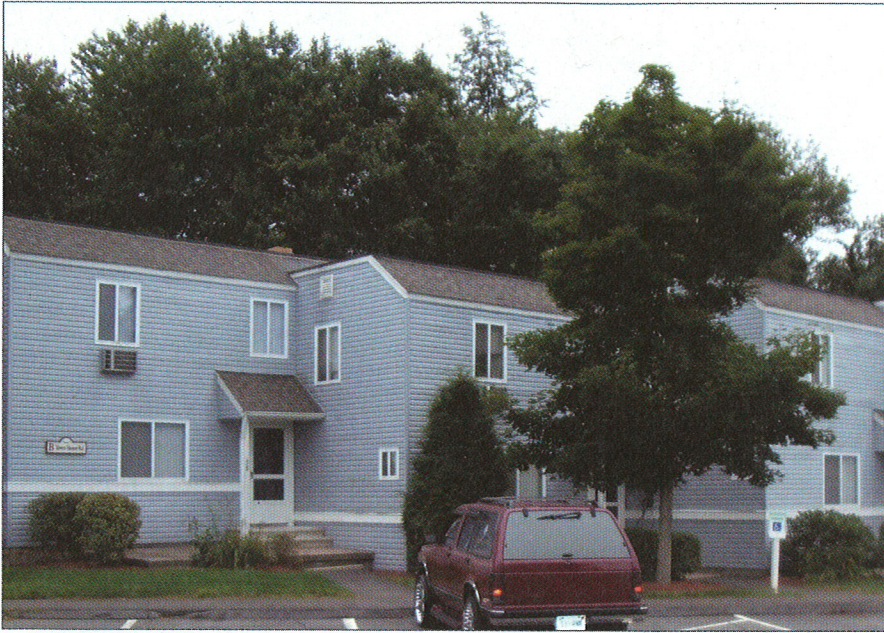
The porch roof connection has a gap in the wall sheathing.

The main entrance to the town house unit has a small porch roof above it. This porch roof is located directly below the hallway window seen in the infrared photo. When the perforated-vinyl soffit panel was removed to access the area above this porch roof, it was found that entire sections of sheathing, some as large as 3–4 square feet, were missing, leaving the fiberglass insulation in the walls directly exposed to outside air (see photos, p. 28). As the photos show, the insulation in these areas is discolored with dirt from years of air passing through it. This windwashing reduces the effective R-value of the insulation in the wall in addition to being a source of air leakage.
