Report V1.0

# Engineer's Foundation Evaluation

123 Main St, Your City, SC, 12345

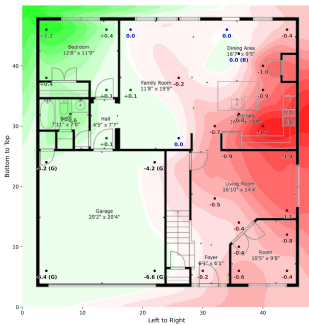
Figure A

This evaluation indicates clear signs of foundation issues. Calculations were not found to be within industry standard limits. Remedial measures are required to bring the foundation to a more level condition. It is recommended that foundation stabilization be completed as soon as possible, if possible within the next year. In addition, visual deficiencies noted should be resolved after foundation improvements have been completed. We also recommend you perform another house elevation plot after repairs have been completed to memorialize the elevation changes. Due to the nature that foundation work is recommended, it is imperative that you read the entire report in detail for a comprehensive explanation of this conclusion.
