www.azinspector.com**PROPERTY CONDITION REPORT**

Client(s):	Client Name
Property Address:	12345 Address Dr Town, AZ 85379
Realtor:	Agent Name, Realty Office
Date:	05/11/2024
Inspector:	Steve Anderson
Report #:	S051103-24RT

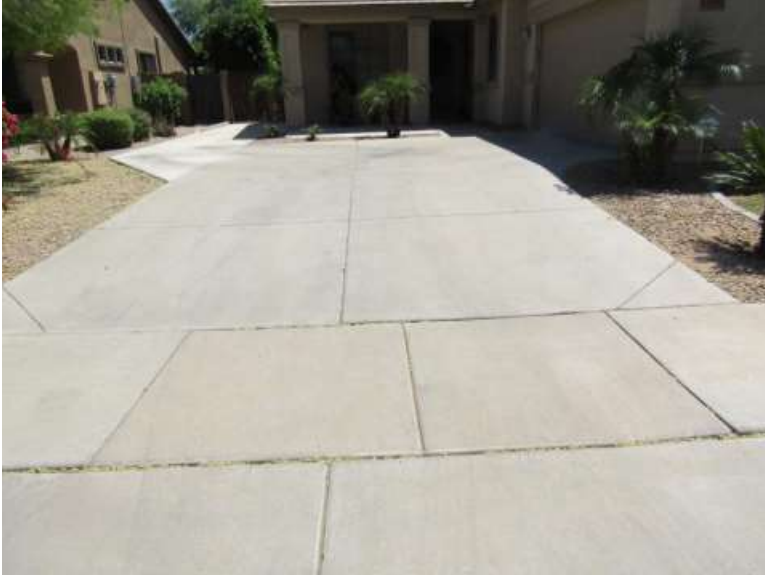
Some cracks are noted.

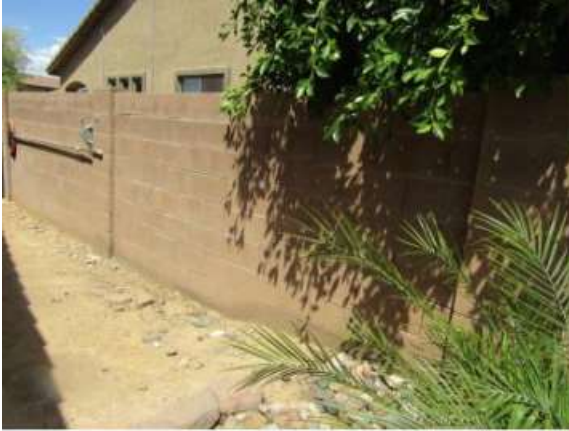
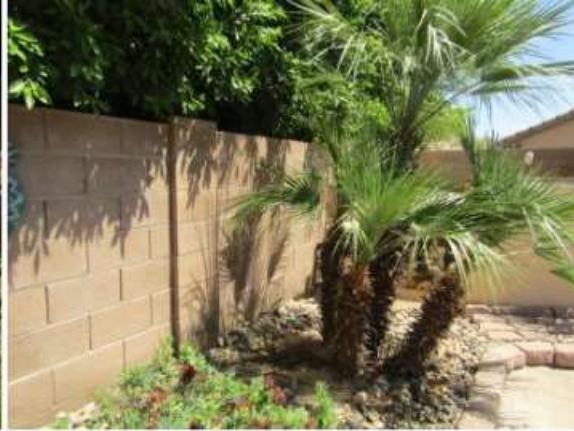
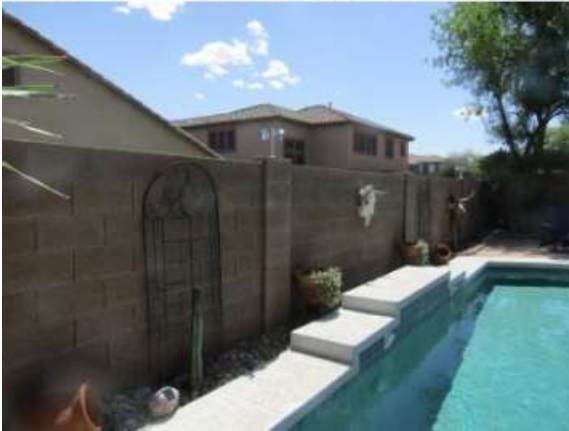
Repair: A couple of the column caps are loose on the fence around the yard. This should be corrected for the safety of anyone playing around the fence, especially children.

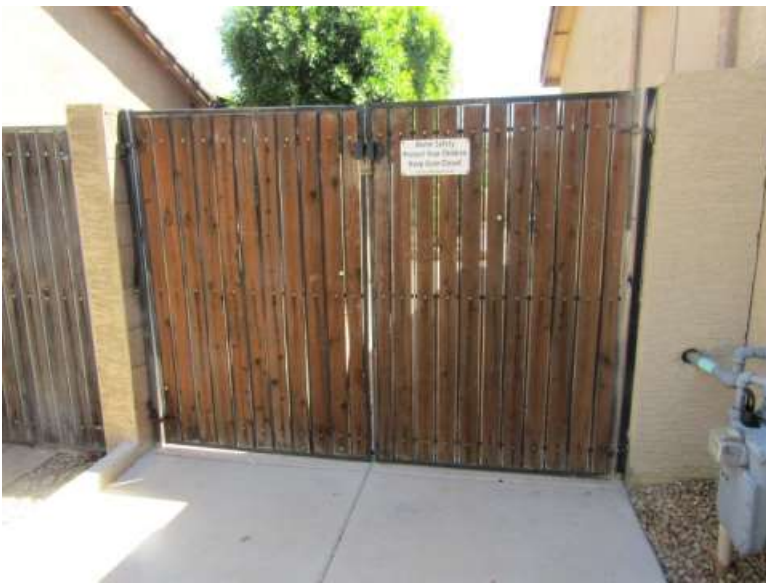
Note: It is important that the gate be self-closing and self-latching and that this mechanism work all times for the safety of any children in the neighborhood. **Note:** The gate was locked so it could not be tested. We recommend that the gate be tested as soon as possible. Also, it is important that the self-closing and self-latching mechanisms on this gate work for the safety of any children in the neighborhood.

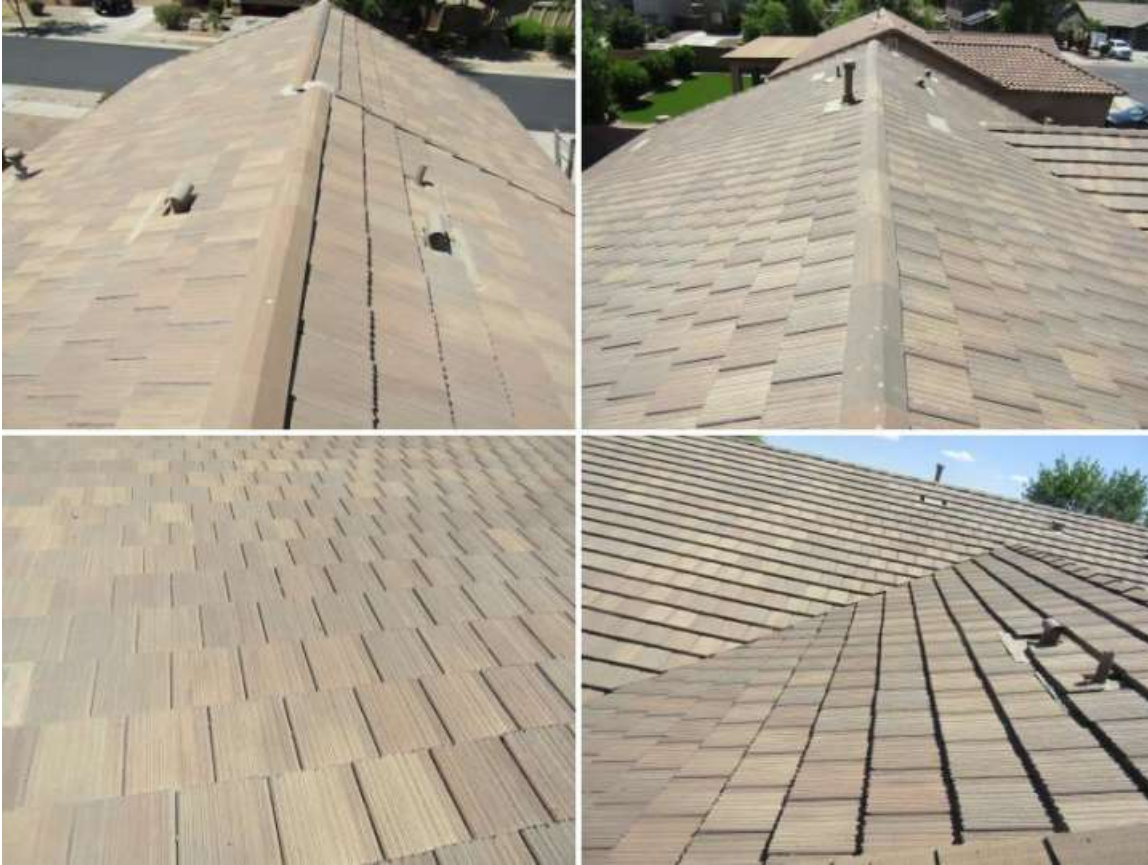
Repair: There is one cracked/broken field tile that should be replaced to prevent the possibility of water draining under the tiles and having access to the underlayment and needs to be repaired by a qualified contractor. The tile is on the east facing.

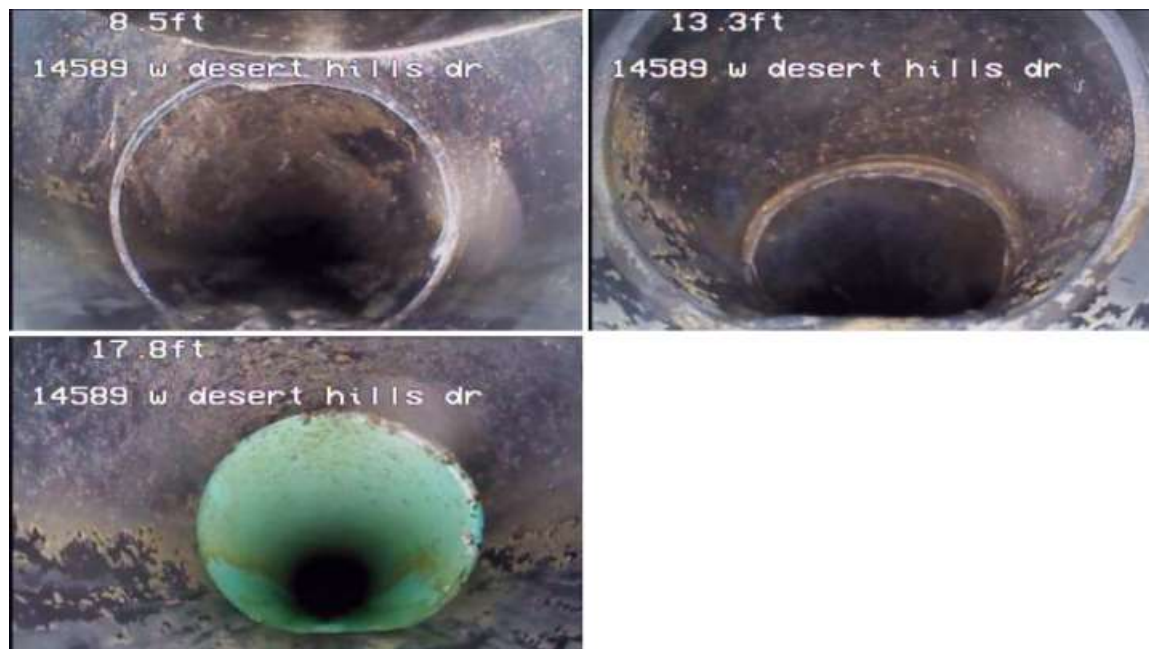
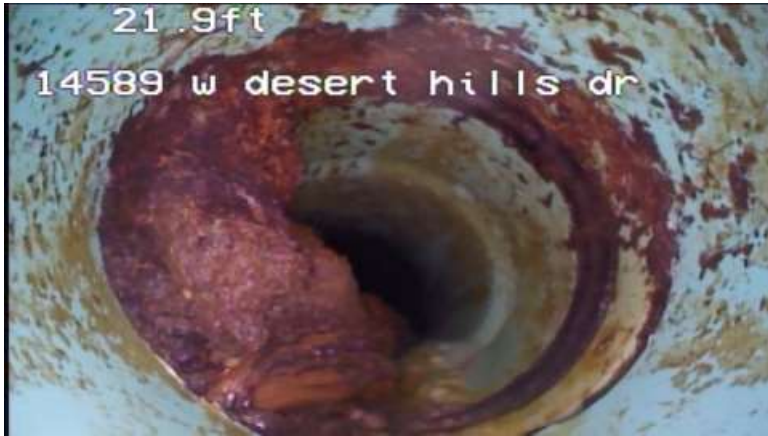
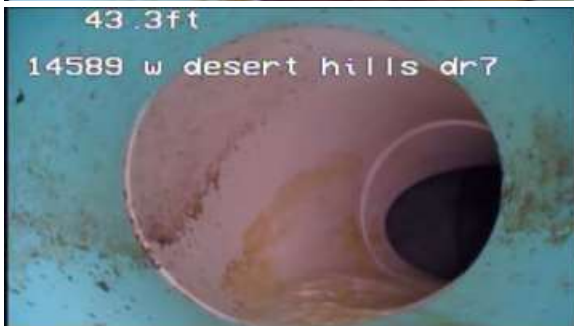
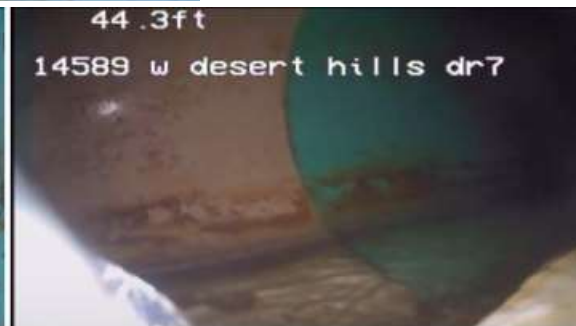
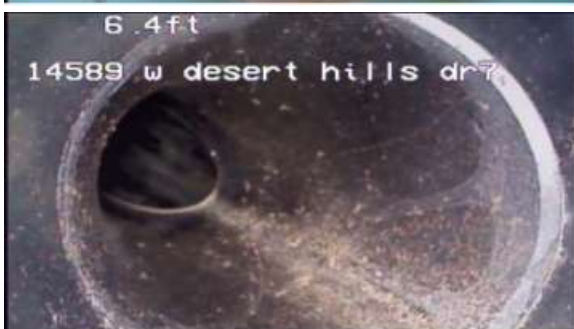
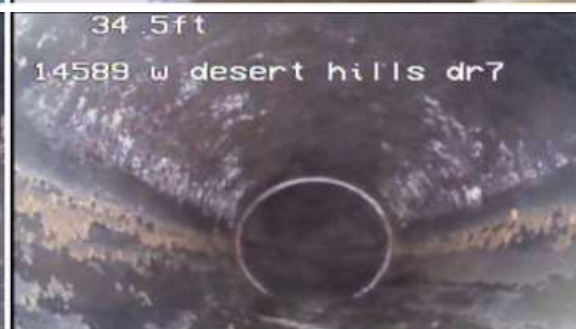
photos of drain line under the slab.

city connection at 44ft.

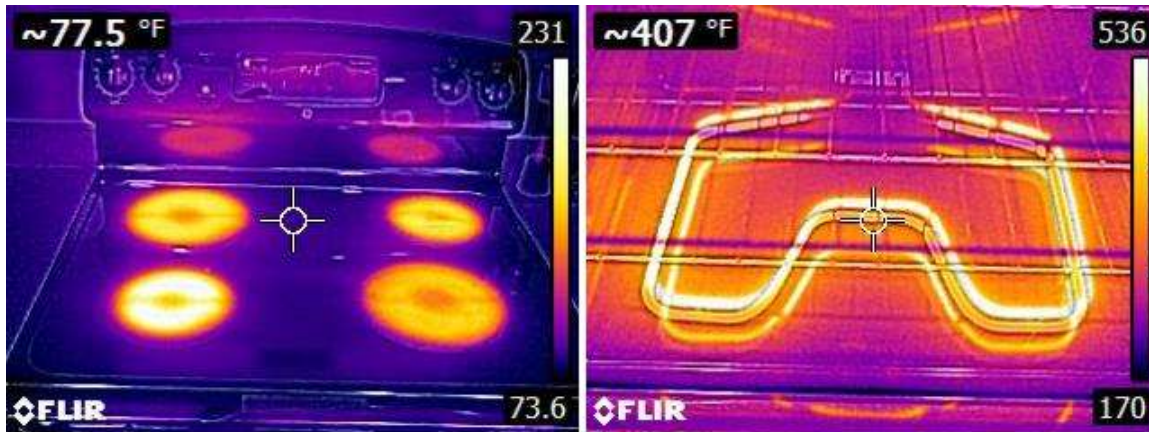
Range/Oven:

The range/oven was turned on with normal controls and found to be adequate. The oven if present was turned on with the normal operating controls (Bake and Broil). No tests were performed to determine the full range of heat settings, calibration or self-cleaning modes.

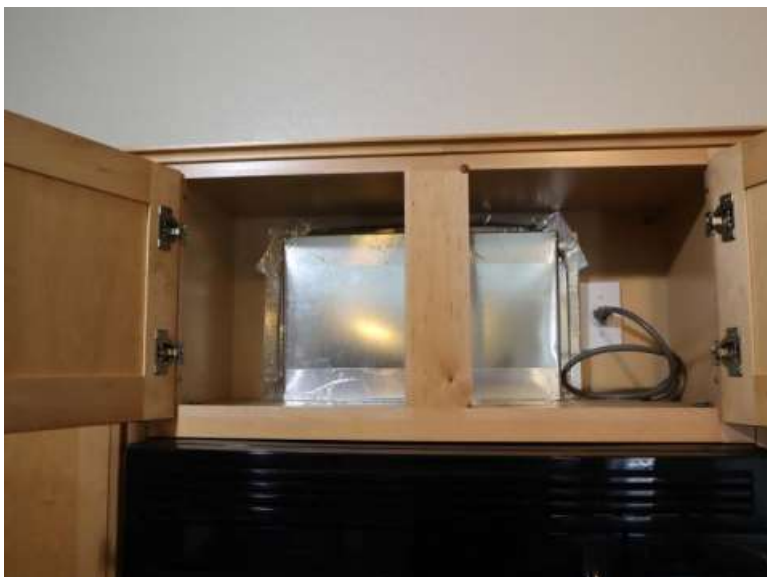
Kitchen Ventilation:

Kitchen ventilation was provided by an exhaust fan under the microwave exhausting to the exterior, which was tested and was found to be adequate and fully operational at the time of the inspection unless otherwise noted below.

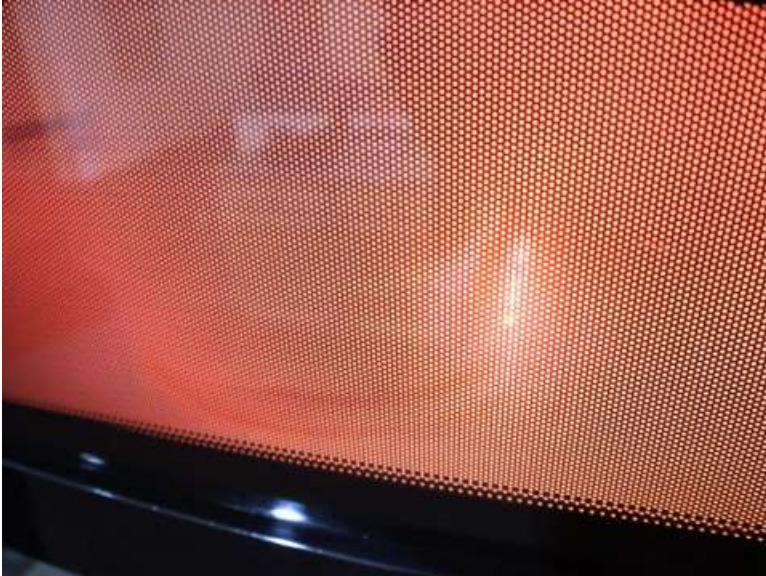
Microwave:

The microwave was tested with normal operating controls and appeared to be working. A microwave leakage test was not performed.

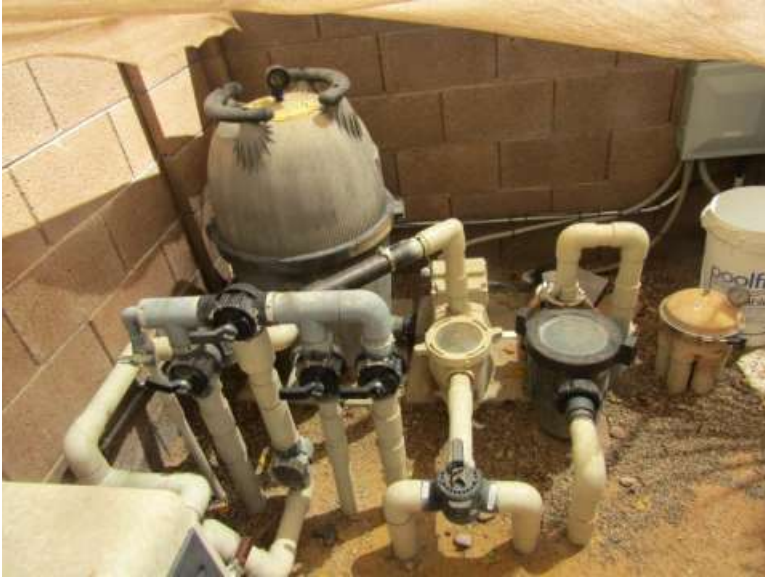
Further Review: We were unable to operate the water feature, consult the seller for further information.

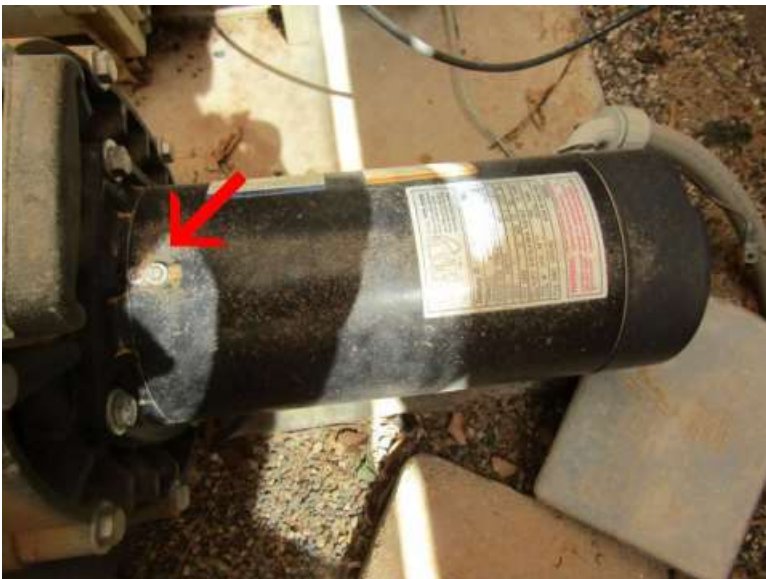
Safety Concern: The pool pump's metal housing is not bonded as it needs to be for safety. Usually there is a clamp on the housing for this purpose.
