# NATIONAL PROPERTY INSPECTIONS

## COMMERCIAL MASTER TEMPLATE

Property Street Address  
City, TX Zip Code

Client Name  
JULY 27, 2022

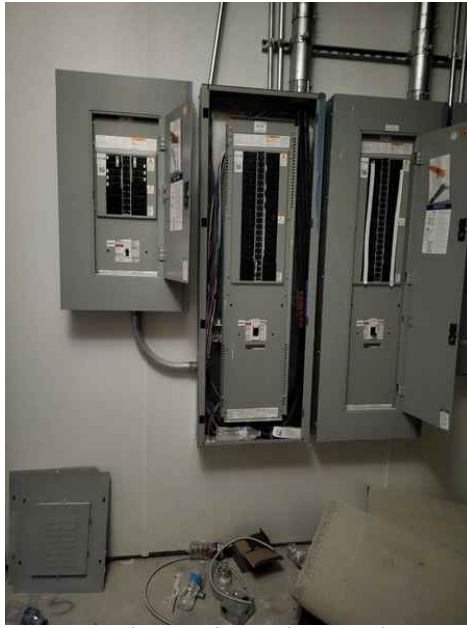
Main electrical panels - 1st Floor

The 3-phase electrical service utilized a 4-wire configuration. The electrical system is still under construction and can not be evaluated beyond a visual examination. Below are representative pictures of the work completed.
